**MUDDY RUN STREAM RESTORATION PROJECT
MONITORING REPORT
MONITORING YEAR 3**

DUPLIN COUNTY, NORTH CAROLINA, PROJECT # 95018

December 2016

**Muddy Run
Duplin County, North Carolina
DMS Project ID 95018**

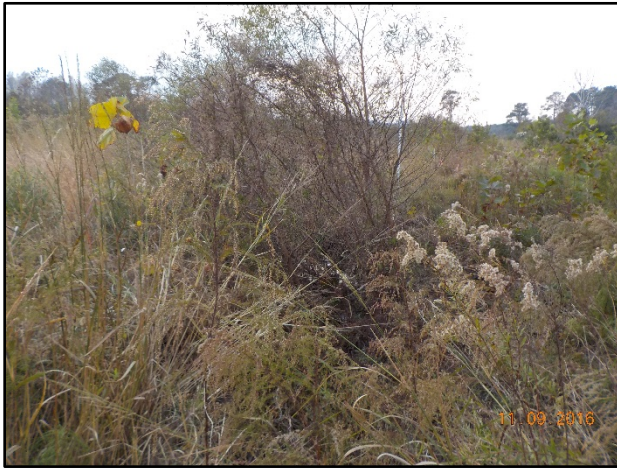
MY2-SP1 Pool widening at Sta 20+90 (Stabilized)
