MUDDY RUN STREAM RESTORATION PROJECT
MONITORING REPORT
MONITORING YEAR 4
FINAL

DUPLIN COUNTY, NORTH CAROLINA
PROJECT NO. 95018

RE: Muddy Run Stream Restoration Site: MY4 Monitoring Report (NCDMS ID 95018)

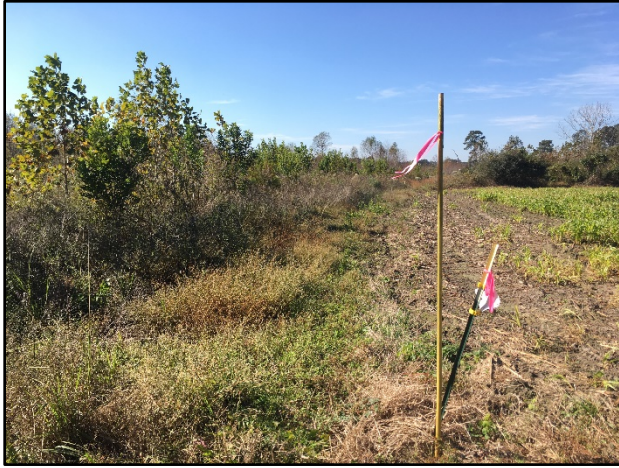
Table 8. Vegetation Problem Areas			
Muddy Run Stream Restoration Project - Project # 95018			
Feature Category	Station Numbers	Suspected Cause	Photo Number
Encroachment	Reach 1B Sta 21+50	Mowing and overspray of crossing	VPA1
Low Stem Density	Reach 1C Sta. 31+60 to 33 + 00	Weed competition and subsequent treatment; continue to monitor	VPA2

MY4-VPA1 Encroachment at Reach 1B Sta 21+50

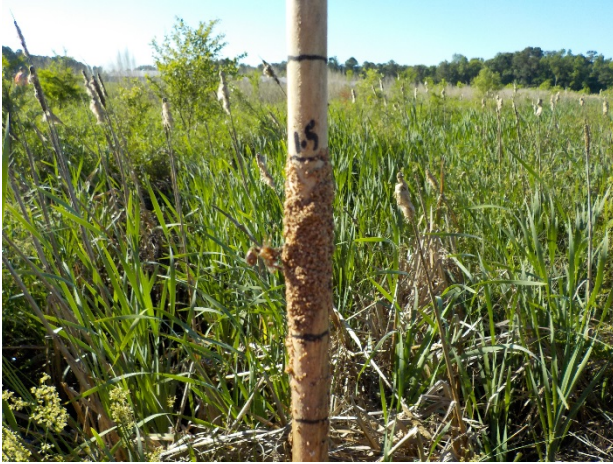
Crest Gauge 1 Reading 1.5' (4/24/2017)

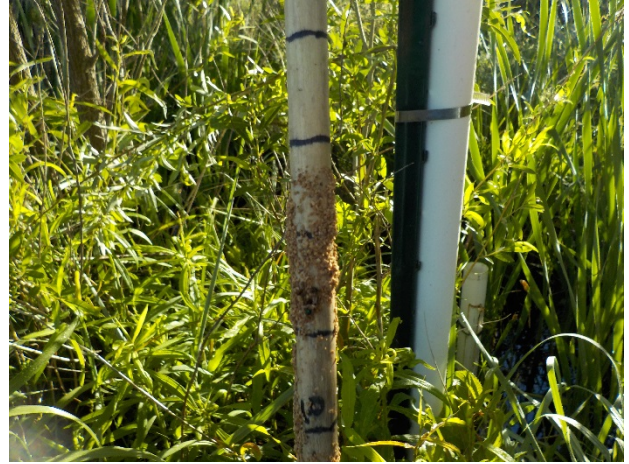
Crest Gauge 3 Reading 1.27' (4/24/2017)

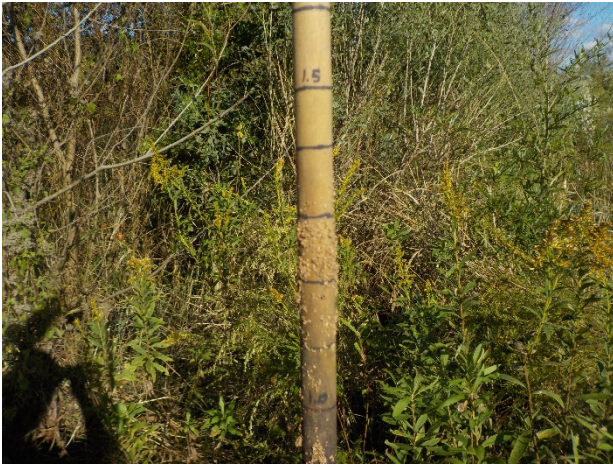
Crest Gauge 2 Reading 1.3' (8/24/2017)

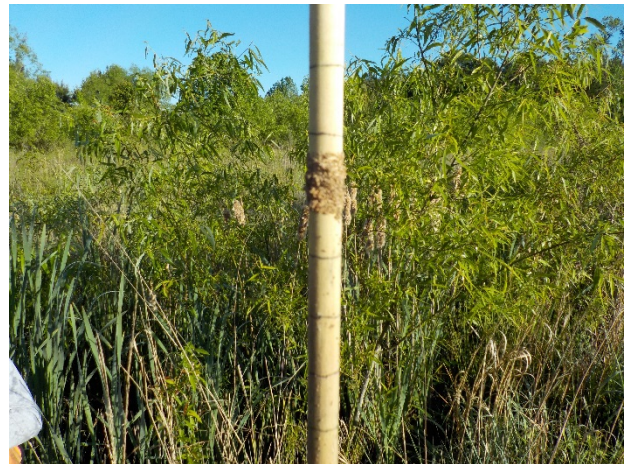
Crest Gauge 4 Reading 2.05' (4/24/2017)
