**MUDDY RUN II STREAM AND WETLAND RESTORATION
PROJECT
FINAL-MONITORING REPORT
MONITORING YEAR 1**

DUPLIN COUNTY, NORTH CAROLINA, PROJECT # 95354

January 2015

**Muddy Run II
Duplin County, North Carolina
EEP Project ID 95354**

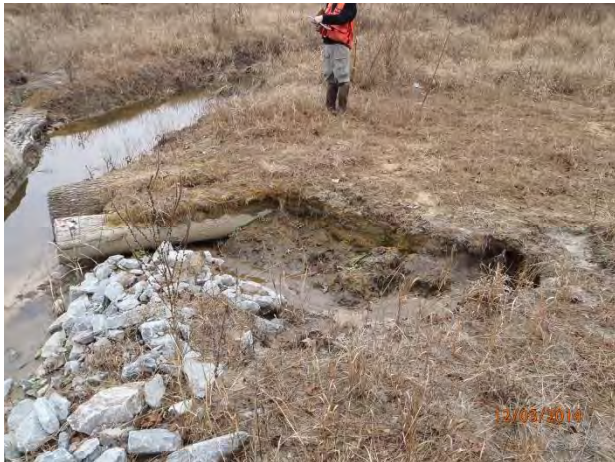
SPA2- Erosion around grade control log - Reach
3A @ Sta 0+25

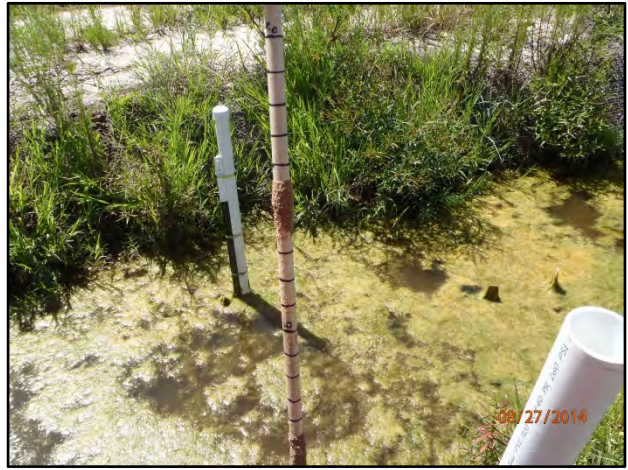
Photo 2a. Crest Gauge 2 (Reach 3A - 1.5 ft. – 8/1/2014)
