**MUDDY RUN II STREAM AND WETLAND RESTORATION  
PROJECT  
MONITORING REPORT  
MONITORING YEAR 2**

DUPLIN COUNTY, NORTH CAROLINA  
CONTRACT NO. 004632 - PROJECT # 95354

**Muddy Run II  
Duplin County, North Carolina  
DMS Project ID 95354**

**Resource Environmental Solutions  
302 Jefferson Street, Suite 110  
Raleigh, NC 27605  
919-829-9909**

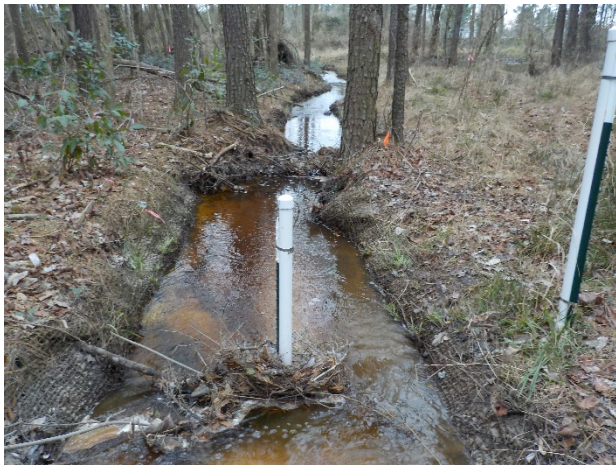
Crest Gauge 3- Reach 3B (2/10/2016)

**Photo 3.** Crest Gauge 3 (Reach 3B – Wrack Lines. – 2/10/2016)

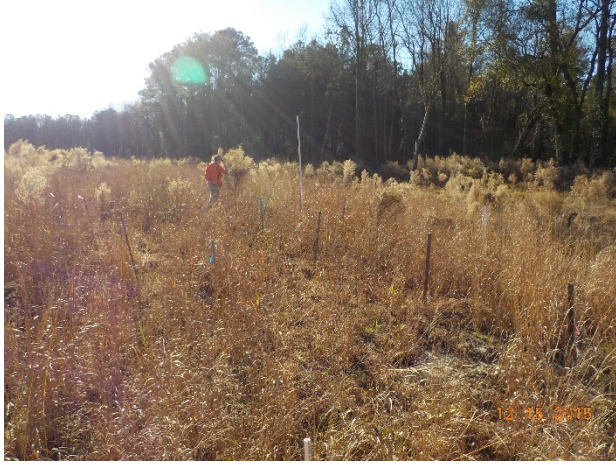
VPA 7- Low stem density: Reach 5A @ Sta 16+50  
– Sta 18+00
