**MUDDY RUN II STREAM AND WETLAND RESTORATION  
PROJECT  
MONITORING REPORT  
MONITORING YEAR 3**

DUPLIN COUNTY, NORTH CAROLINA  
CONTRACT NO. 004632 - PROJECT # 95354

**Muddy Run II  
Duplin County, North Carolina  
DMS Project ID 95354**

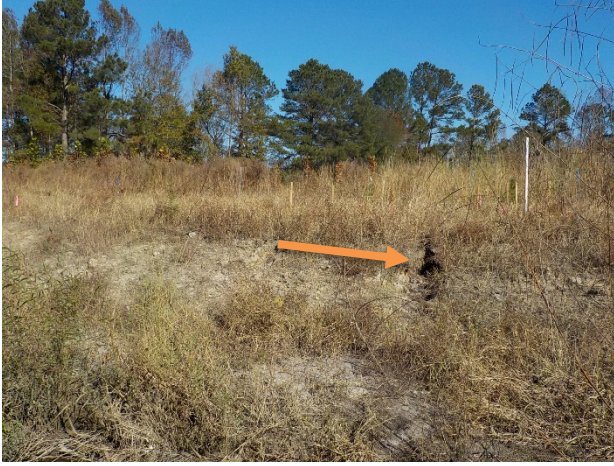
<b>Table 7. Stream Problem Areas</b>			
<b>Muddy Run II Stream and Wetland Restoration Project - Project # 95354</b>			
<b>Feature Issue</b>	<b>Station # / Range</b>	<b>Suspected Cause; Repair</b>	<b>Photo Number</b>
<b>Minor right bank erosion (Head cut forming)</b>	Reach 5A @ 17+40	Concentrated flow; Repair scour on right bank with matting and seed.	SPA1

SPA1- Minor right bank erosion - Reach 5A @ Sta  
17+40

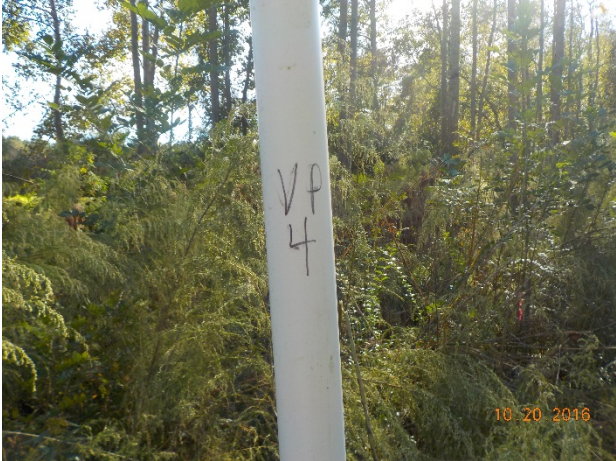
<b>Table 8. Vegetation Problem Areas</b>			
<b>Muddy Run II Stream and Wetland Restoration Project - Project # 95354</b>			
<b>Feature Category</b>	<b>Station Numbers</b>	<b>Suspected Cause; Repair</b>	<b>Photo Number</b>
<b>Low Stem Density</b>	Reach 4 @ Sta 1+00 -2+00	Low density due to low soil fertility; Plant area with approximaely 75 trees	VPA1

VPA1 - Low stem density: Reach 4 @ Sta 1+00 – Sta 2+00
