**MUDDY RUN II STREAM AND WETLAND RESTORATION
PROJECT
MONITORING REPORT
MONITORING YEAR 5
FINAL**

DUPLIN COUNTY, NORTH CAROLINA
DMS CONTRACT No. 004631 – DMS PROJECT No. 95354
SAW-2011-02191
DWR 2013-0653

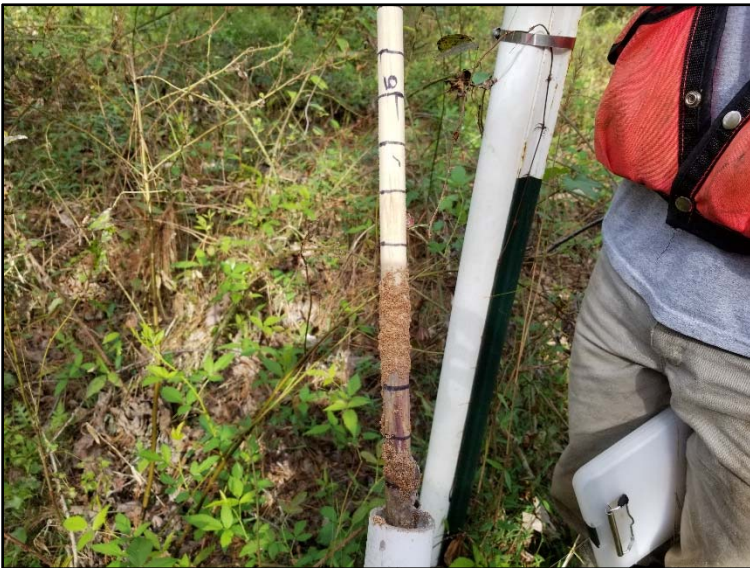
Photo 3. Crest Gauge 3 (Reach 3B – 0.65 – 9/15/2018)
