**MUDDY RUN II STREAM AND WETLAND RESTORATION
PROJECT
MONITORING REPORT
MONITORING YEAR 6
FINAL**

DUPLIN COUNTY, NORTH CAROLINA
DMS CONTRACT No. 004631 – DMS PROJECT No. 95354
SAW-2011-02191
DWR 2013-0653

January 2020

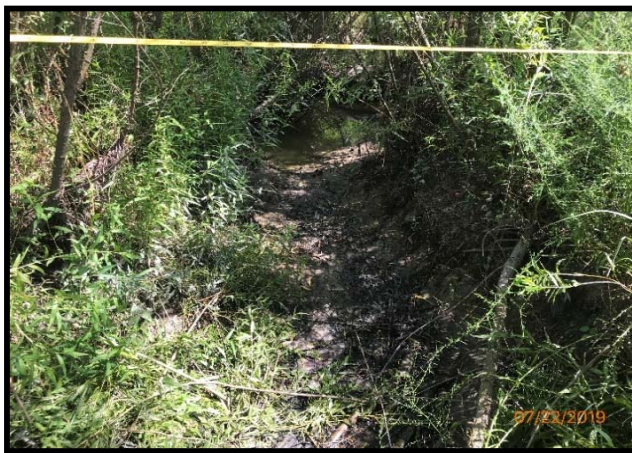
Upstream

Cross Section 52 (Run)						
	Base	MY1	MY2	MY3*	MY5	MY6	MY7
Bankfull Elevation (ft) - Based on AB-XSA ¹	39.8	39.8	39.8	37.0	36.8	36.9	
Bankfull Width (ft) ¹	17.7	17.8	19.3	10.6	8.1	8.8	
Floodprone Width (ft) ¹	50.0	50.0	50.0	50.0	50.0	>49.7	
Bankfull Mean Depth (ft)	1.8	2.1	2.7	1.4	1.8	-	
Bankfull Max Depth (ft) ²	3.1	4.5	5.9	2.1	2.3	2.5	
Low Bank Elevation	-	-	-	-	-	-	37.0
Bankfull Cross Sectional Area (ft ²) ²	31.8	36.9	52.3	14.6	14.6	15.5	
Bankfull Width/Depth Ratio	9.9	8.6	7.1	7.7	4.5	-	
Bankfull Entrenchment Ratio ¹	>2.2	>2.2	>2.2	>2.2	>6.1	>5.7	
Bankfull Bank Height Ratio ¹	1.0	1.0	1.0	1.0	1.1	1.0
