**MUDDY RUN II STREAM AND WETLAND RESTORATION
PROJECT
MONITORING REPORT
MONITORING YEAR 7
FINAL**

DUPLIN COUNTY, NORTH CAROLINA
DMS CONTRACT No. 004631 – DMS PROJECT No. 95354
SAW-2011-02191
DWR 2013-0653

March 2021

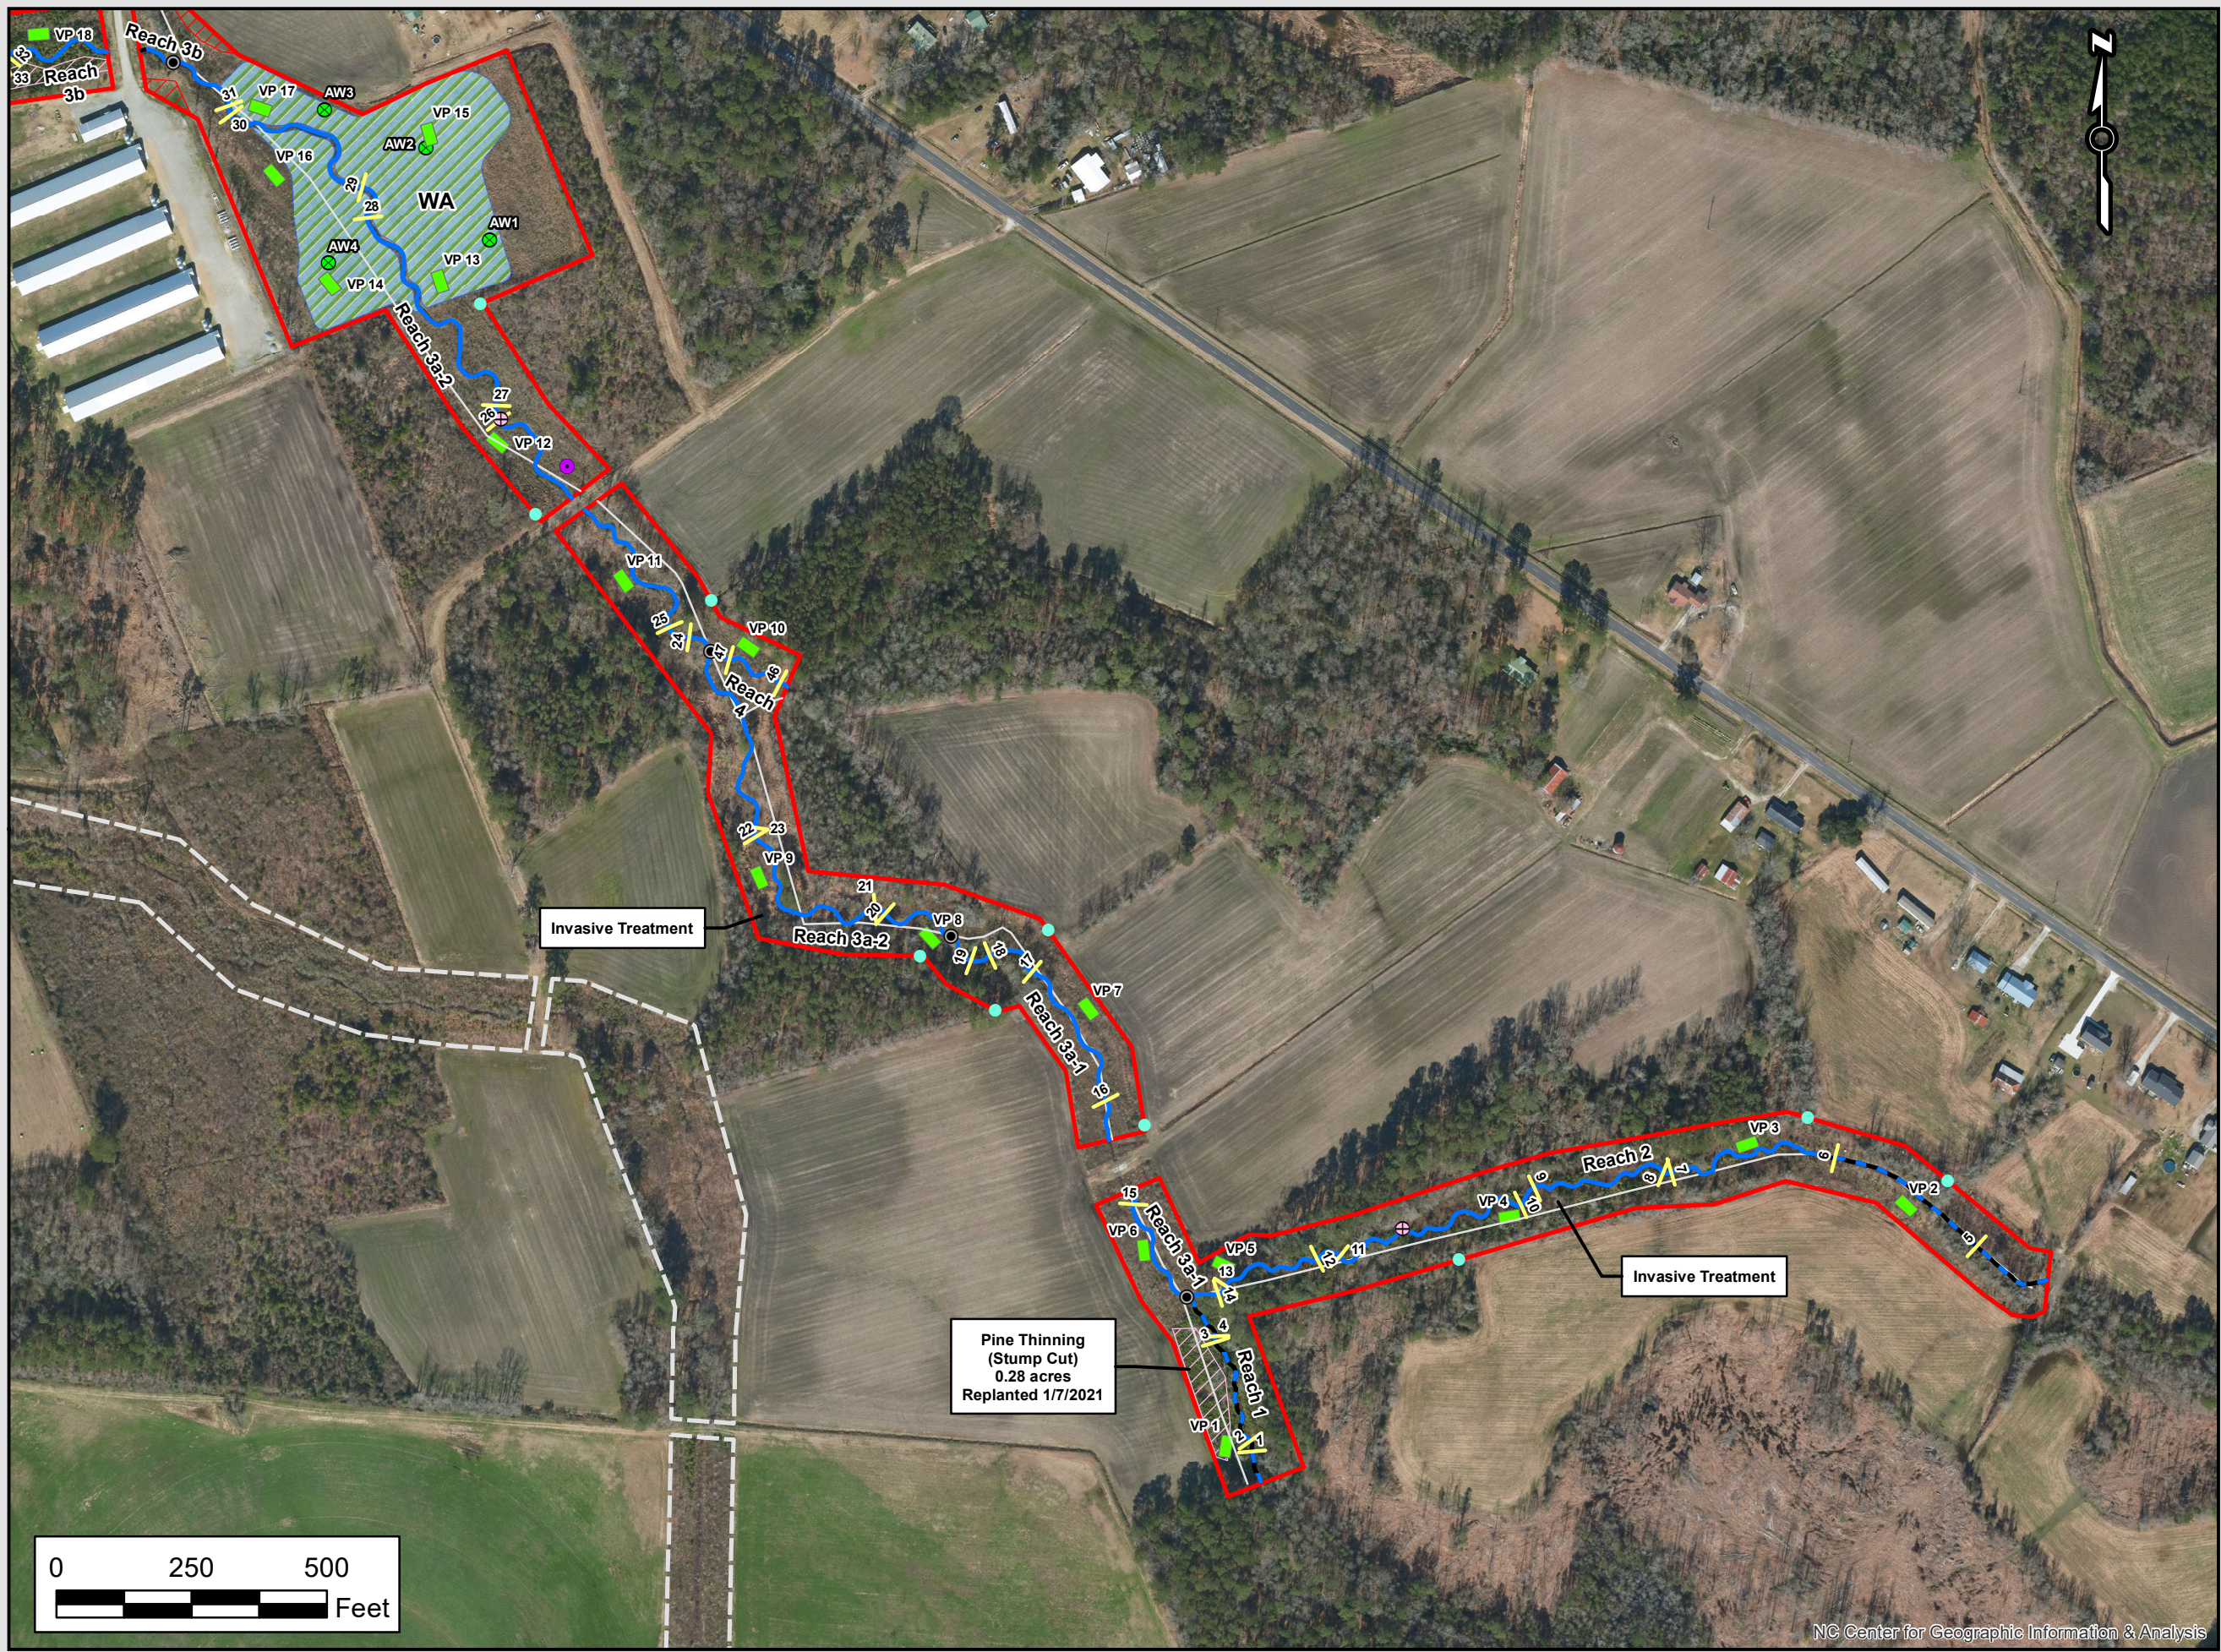
Figure 3b.
Muddy Run II
Mitigation Site
Current Conditions Map
Duplin County, NC
MY7 2020

Invasive Treatment

Pine Thinning
(Stump Cut)
0.28 acres
Replanted 1/7/2021

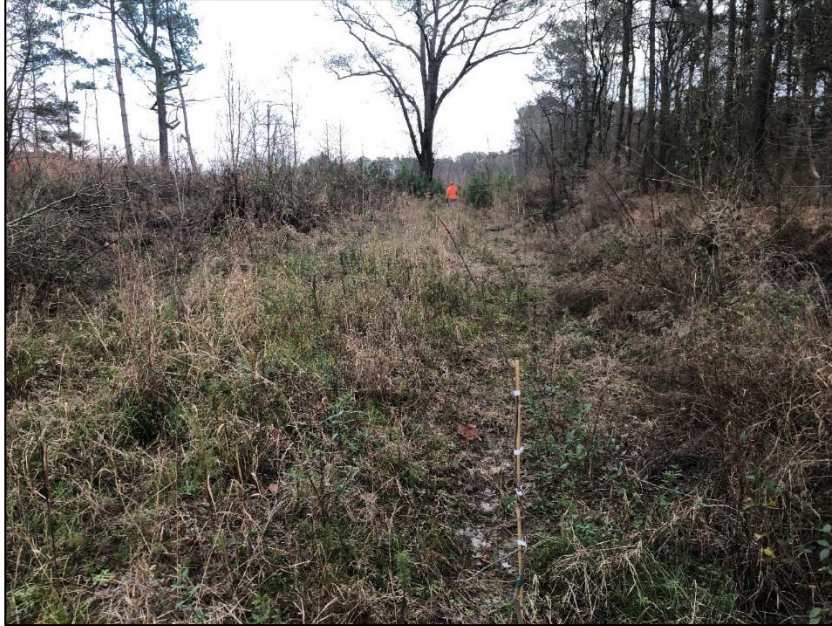
Photo 1 – Low Stem Density Area - RB Reach 5b (Replanted January 2021)
