FINAL
MONITORING REPORT
YEAR 1 (2018)
MUD LICK CREEK MITIGATION SITE

Chatham County, North Carolina

NCDMS Project No. 93482

Data Collection: December 2018

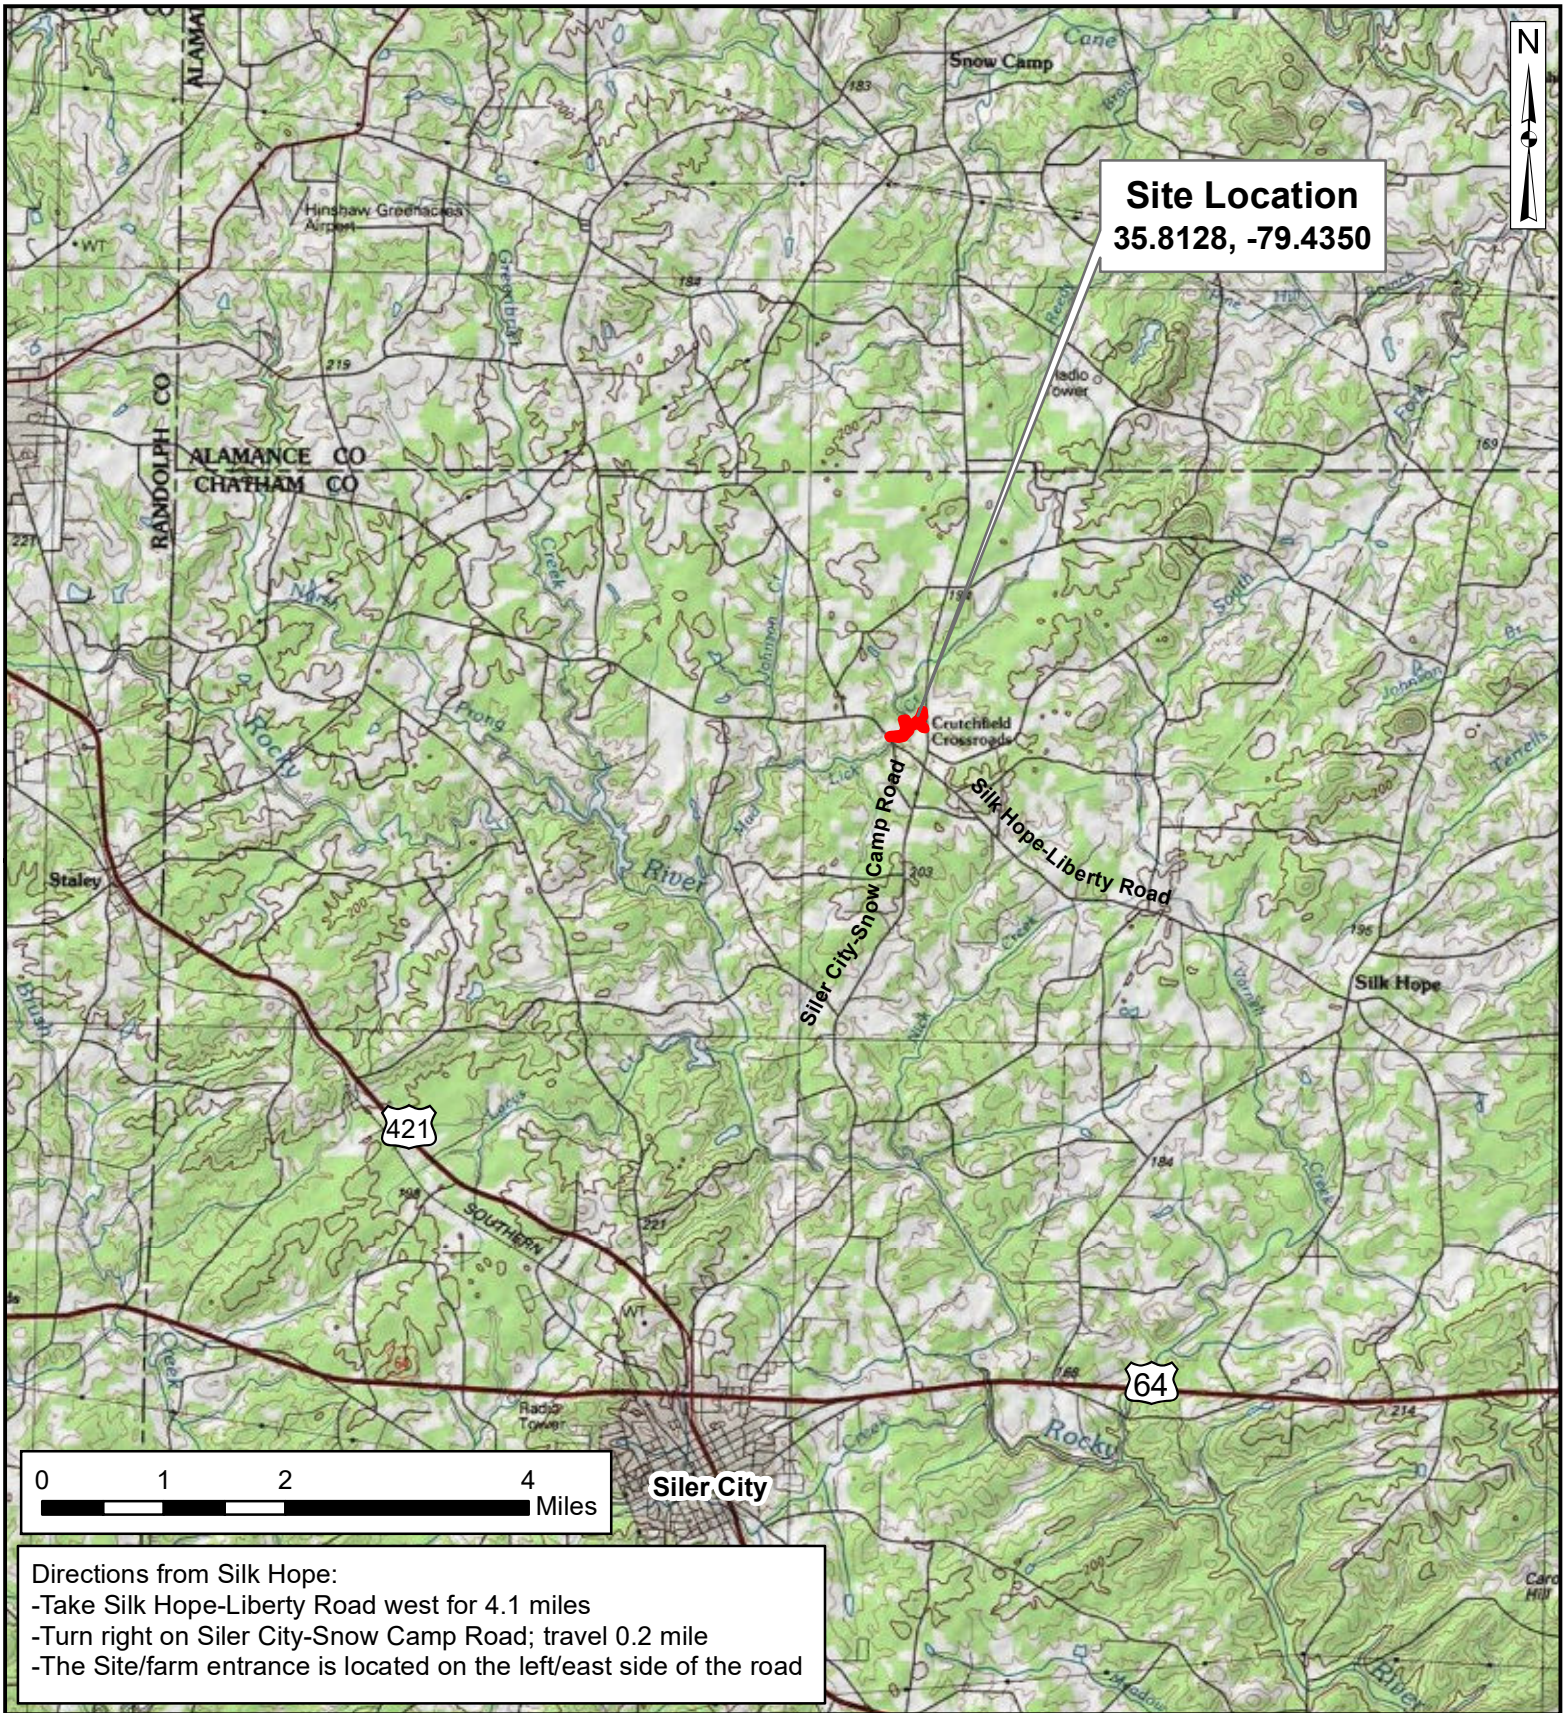
Figure 2. Current Conditions Plan View

One stream area of concern was observed along a large bend in Mud Lick Creek Reach 2 (Figure 2, Appendix B). Approximately 50 feet of the right bank and 20 feet of the left bank have eroded to the point of bank sloughing due to several historical storm events during MY-01. This area is relatively unstable,
