FINAL
MONITORING REPORT
YEAR 5 (2022)
MUD LICK CREEK MITIGATION SITE

Chatham County, North Carolina

NCDMS Project No. 93482

AXIOM ENVIRONMENTAL, INC.
218 SNOW AVENUE
RALEIGH, NORTH CAROLINA 27603

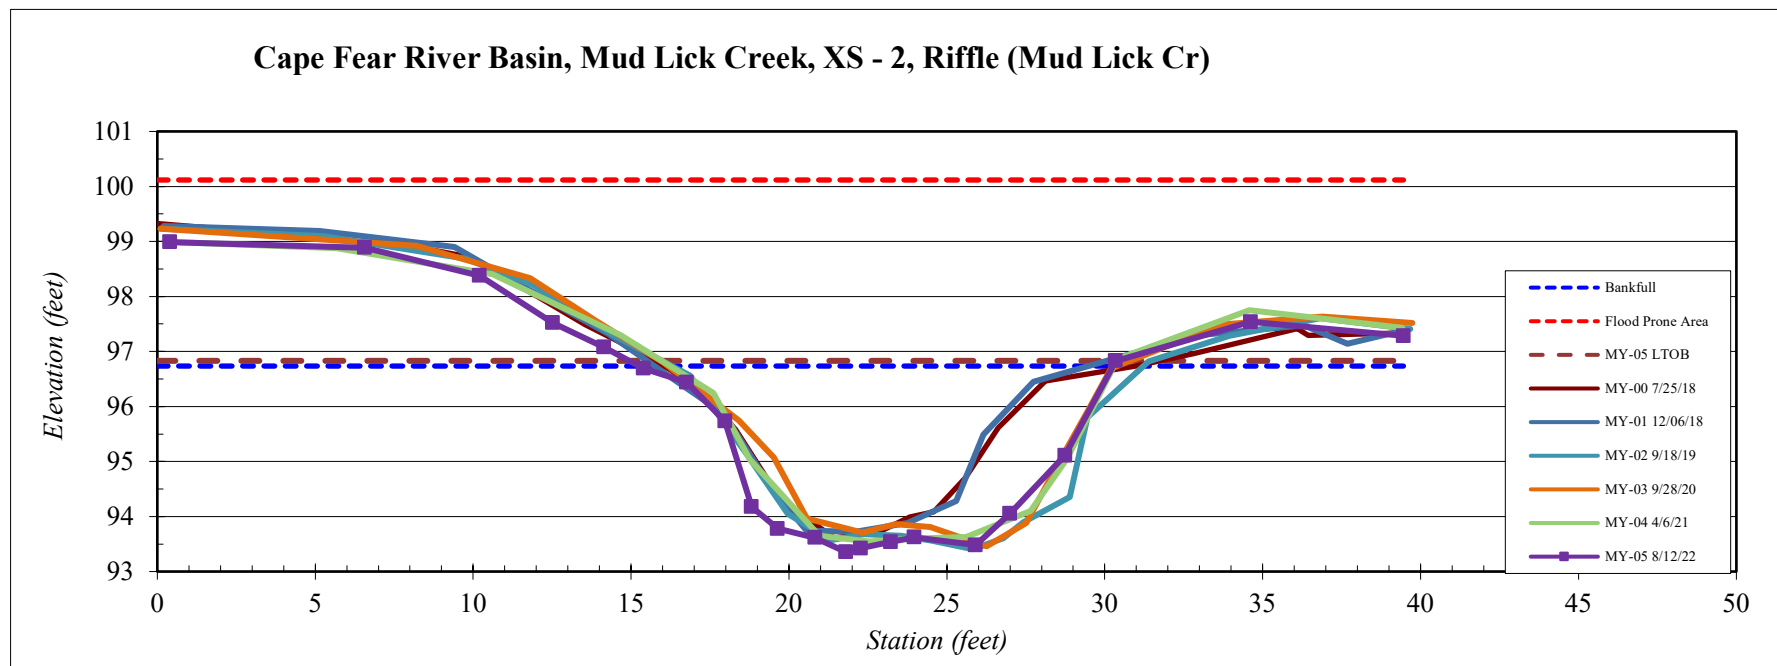
Scouring on the right bank of this cross-section is apparent, however this is an EII reach and localized at this location.

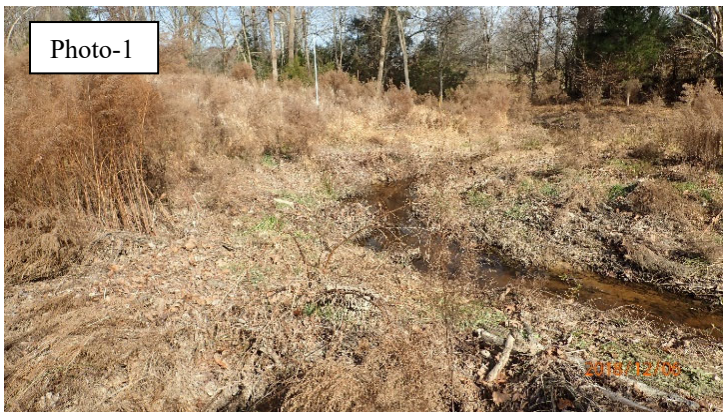
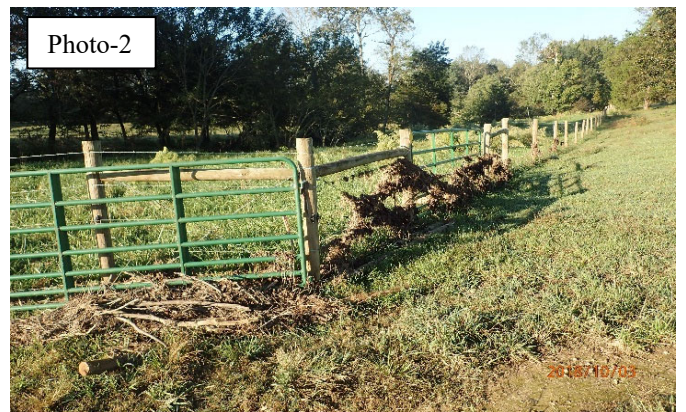
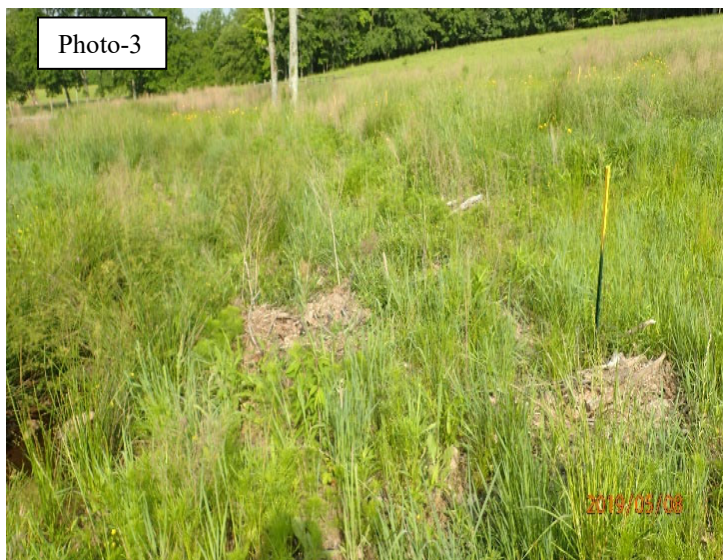
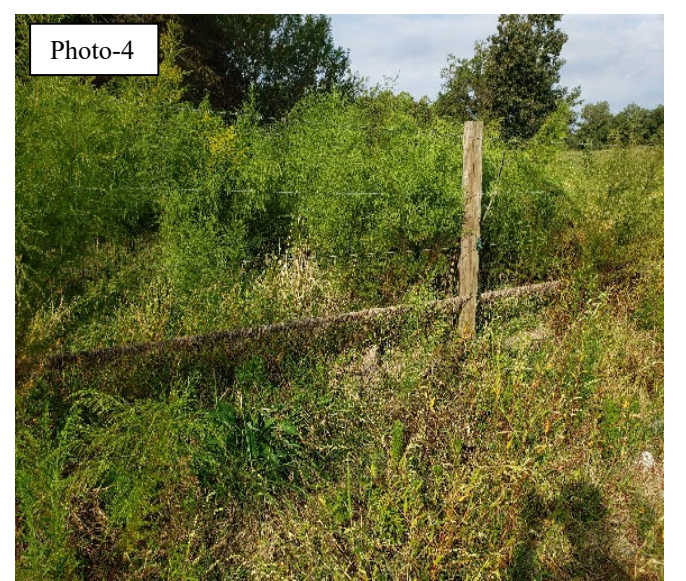
August 12, 2022	July 9, 2022	Observation of wrack in floodplain along North Branch R2 and crest gauge data from all site crest gauges indicate a bankfull event after 2.80 inches of rain fell over 48 hours.	10
