FINAL
MONITORING REPORT
YEAR 6 (2023)
MUD LICK CREEK MITIGATION SITE

Chatham County, North Carolina

NCDMS Project No. 93482

Data Collection: April-September 2023

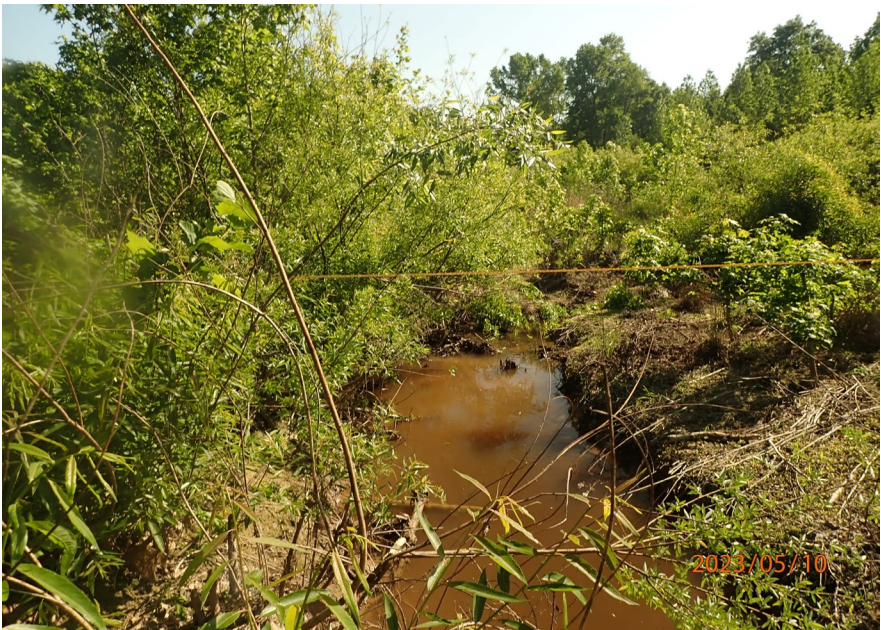
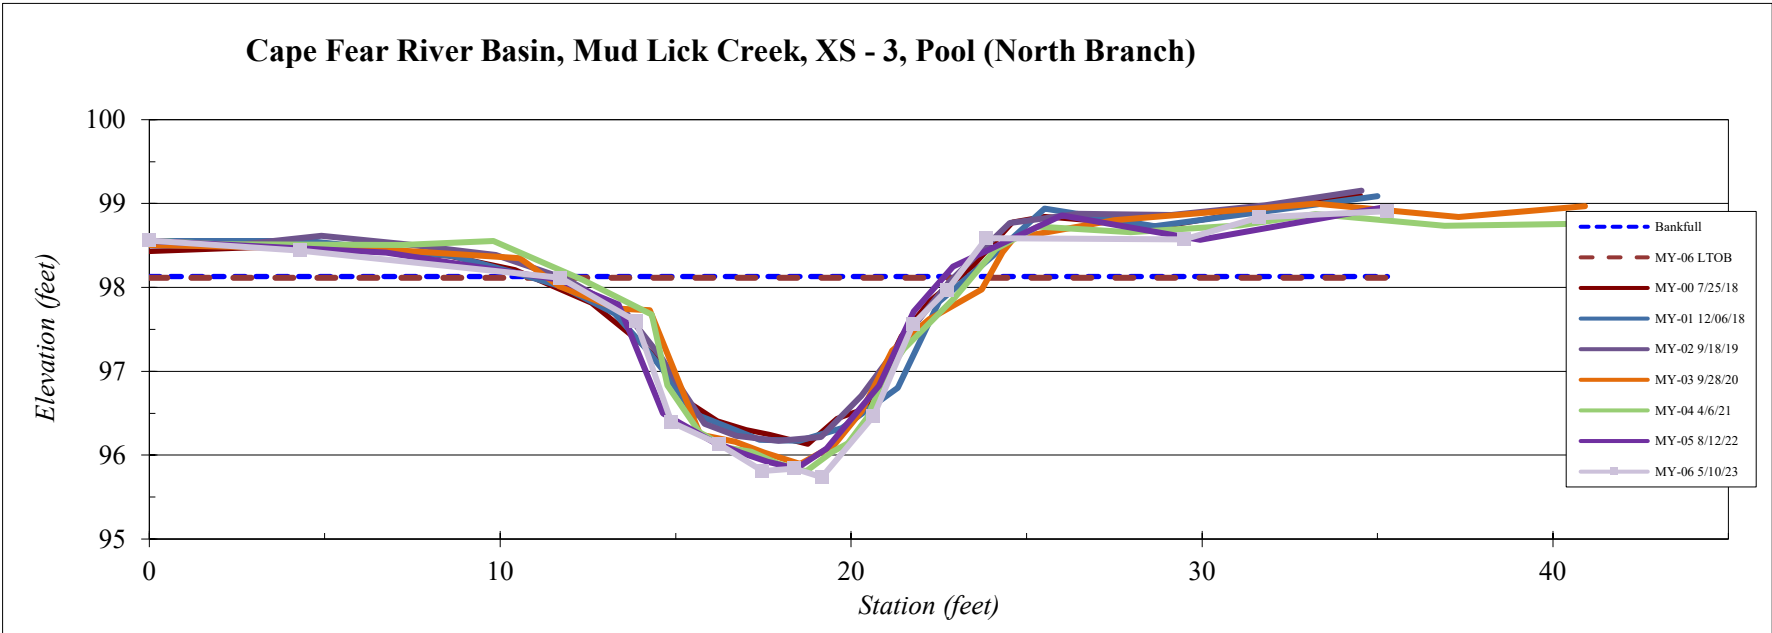
River Basin:	Cape Fear
Site Name	Mud Lick Creek
XS ID	XS - 3, Pool (North Branch)
Drainage Area (sq mi):	0.65
Date:	5/10/2023
Field Crew:	P. Perkinson, K. Jernigan

Scouring on the right bank of this cross-section is apparent, however this is an EII reach and localized at this location.

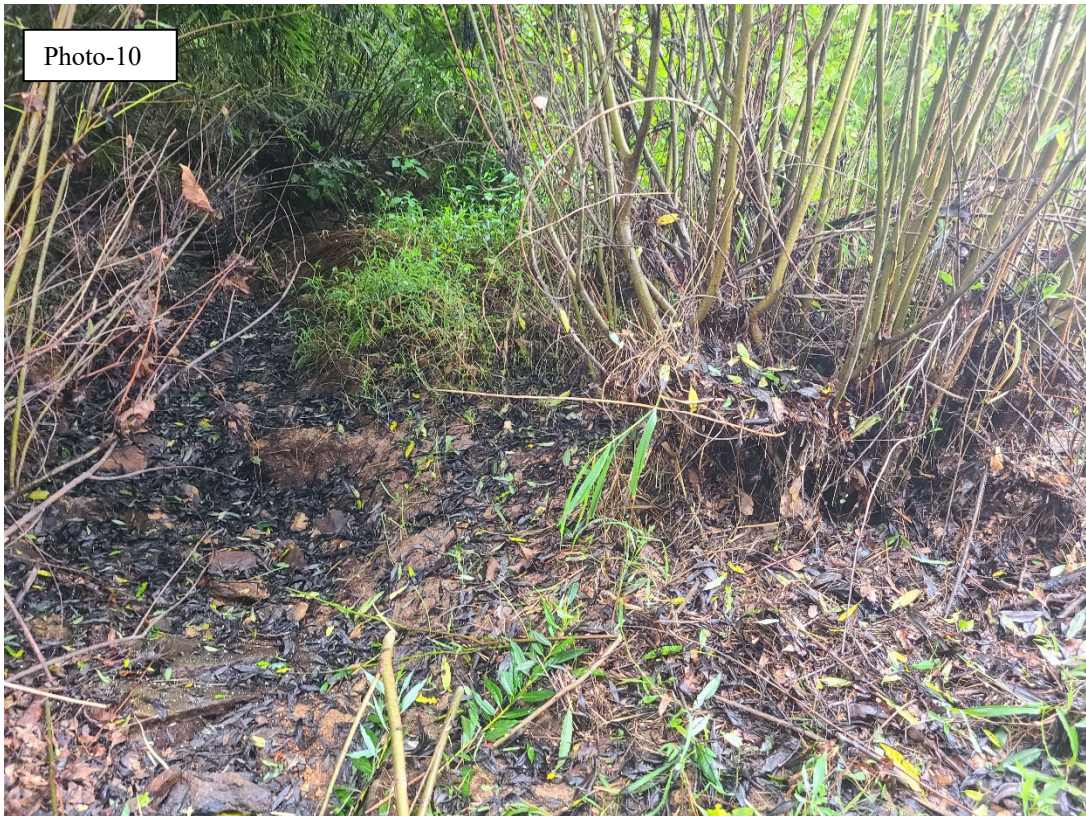
Photo-10

August 12, 2022	July 9, 2022	Observation of wrack in floodplain along North Branch R2 and crest gauge data from all site crest gauges indicate a bankfull event after 2.80 inches of rain fell over 48 hours.	10
May 10, 2023	April 8, 2023	Observation of wrack in floodplain along East Branch R2 and crest gauge data from all site crest gauges indicate a bankfull event after 3.96 inches of rain fell over 48 hours.	11, 12, 13
