FINAL
YEAR 3 (2018) ANNUAL
MONITORING REPORT

**NEIGHBORS BRANCH/WALTON CRAWLEY BRANCH
STREAM & WETLAND RESTORATION SITE**

NCDMS Project No. 92872
Contract No. D09023S
USACE Action ID No. SAW-2009-917 & NCDWR Project No. 10-0122
SCO No. 08-07308-01
McDowell County, North Carolina

Data Collection: May-November 2018
Submission: November 2018

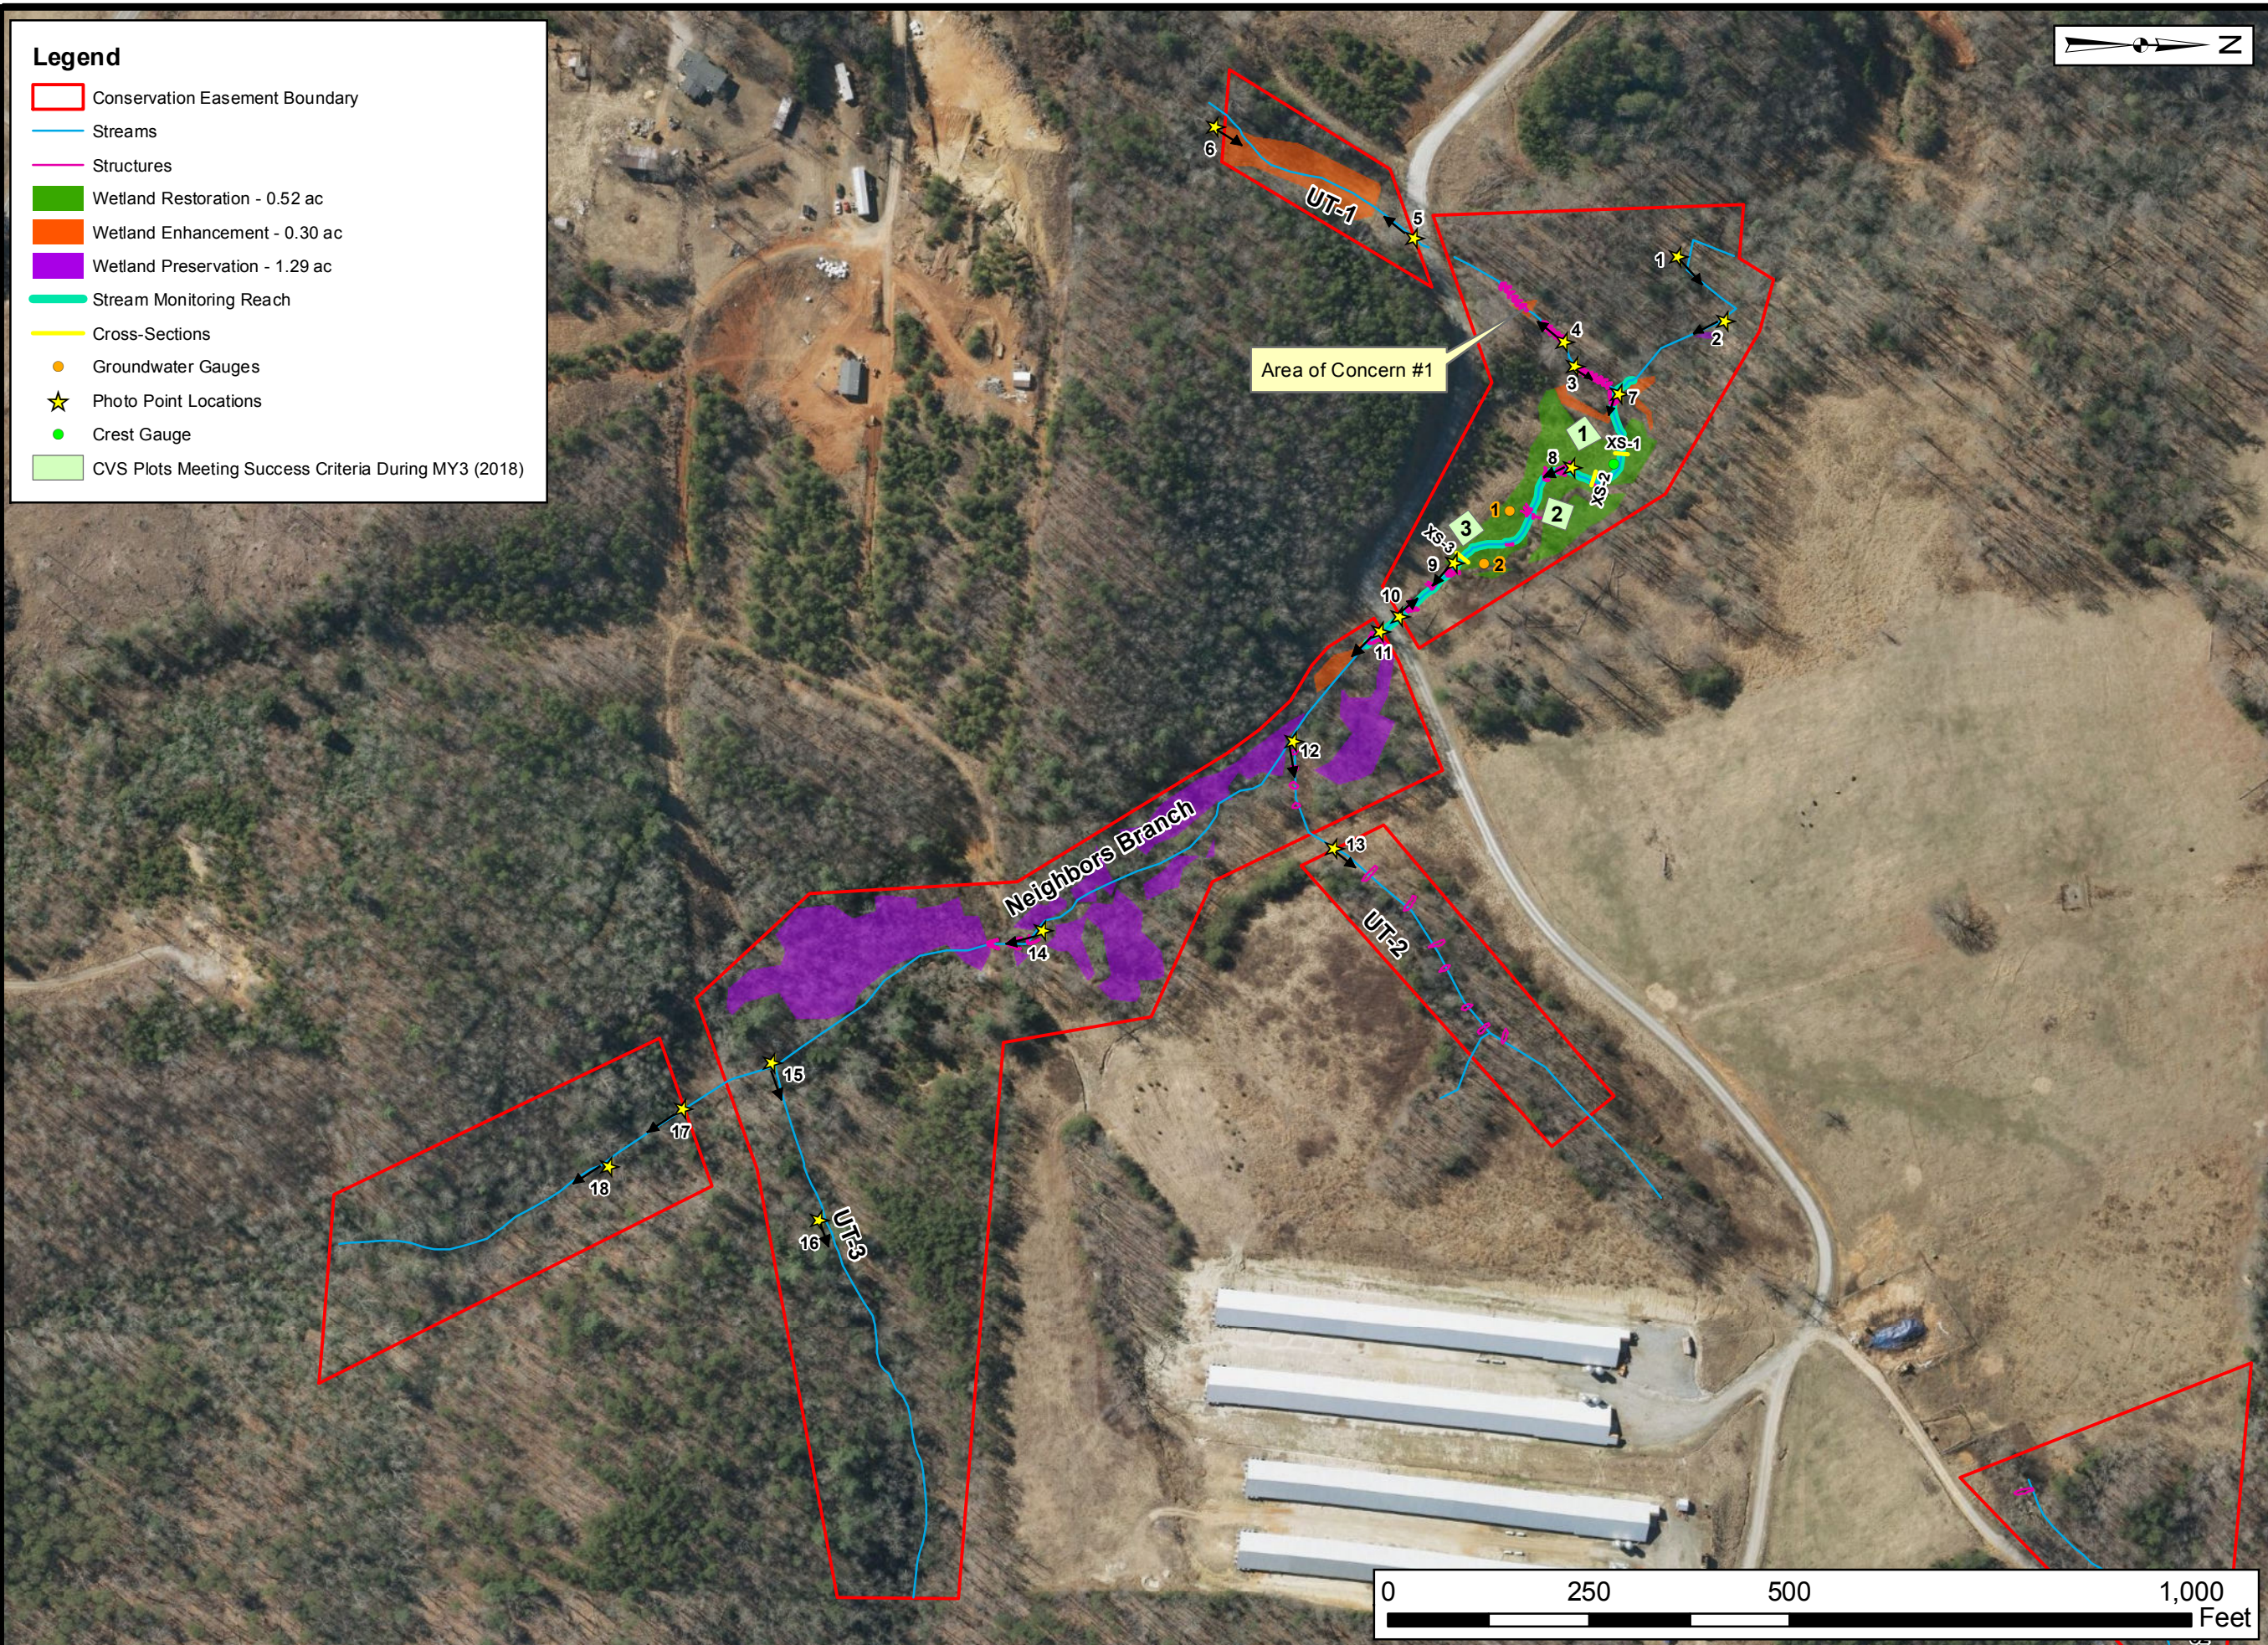
FIGURE
2A

Two groundwater monitoring gauges were installed to take measurements after hydrological modifications were performed at the Site. Hydrological sampling will occur quarterly throughout the growing season (March 26 to November 5). Approximate locations of gauges are depicted on Figure 2A (Appendix B) and hydrology data can be found in Appendix E.

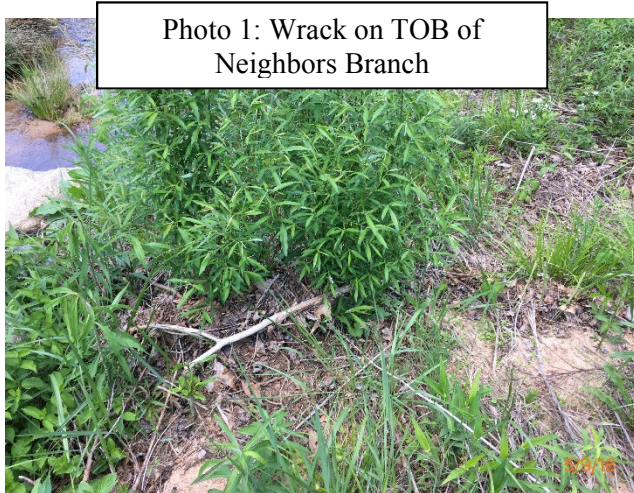
Photo 1: Wrack on TOB of Neighbors Branch

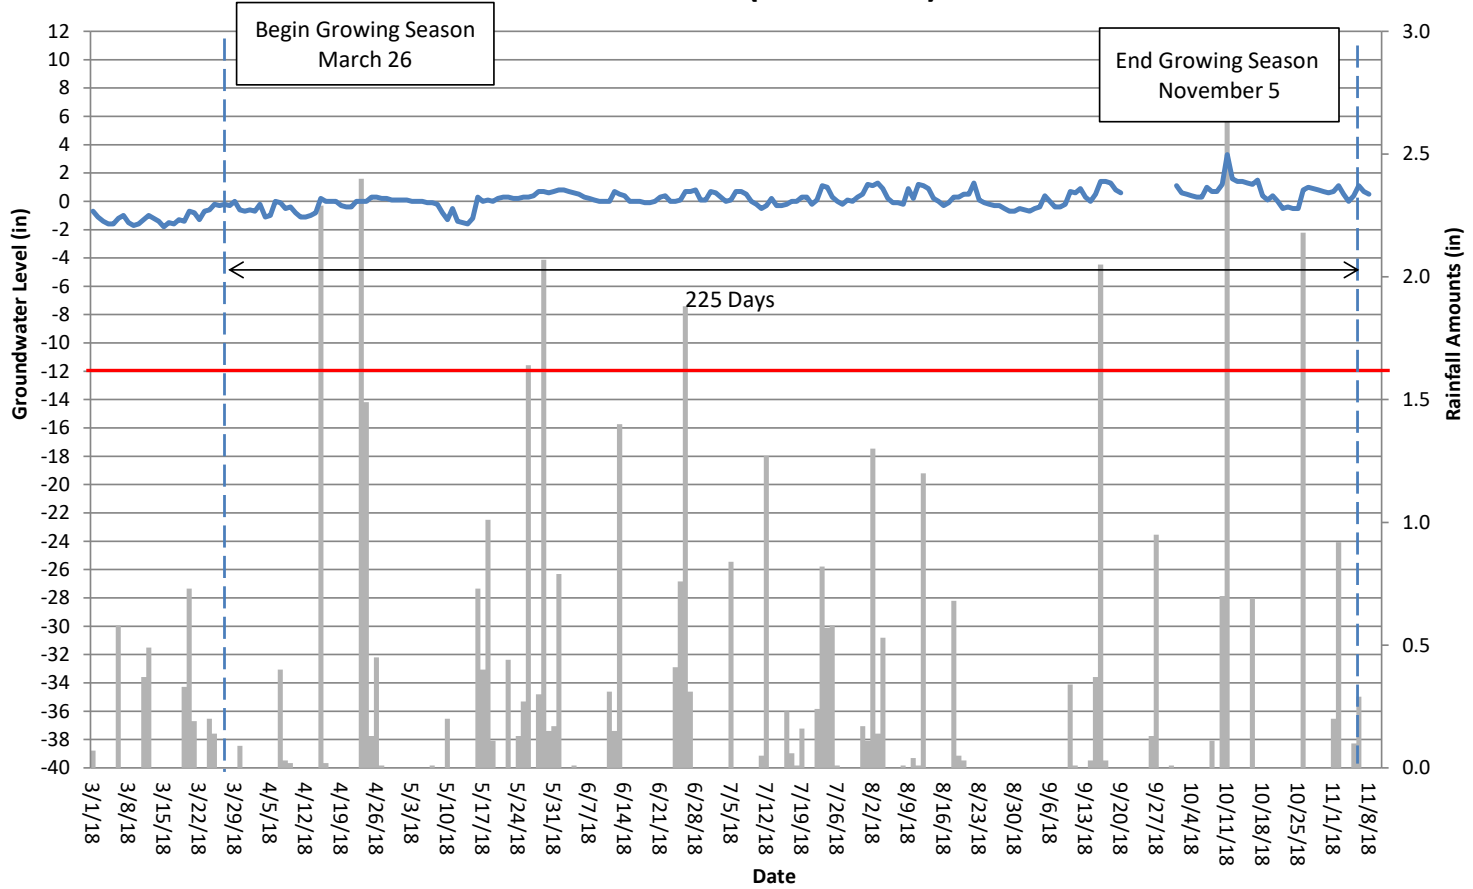
Neighbors Branch Groundwater Gauge 2 Year 3 (2018 Data)

^Gauge 2 missed several days of data collection due to a malfunction caused by excessive inundation during the remnants of Hurricane Florence. It began collecting points again once overbank flow receded.
