FINAL
YEAR 4 (2019) ANNUAL
MONITORING REPORT

**NEIGHBORS BRANCH/WALTON CRAWLEY BRANCH
STREAM & WETLAND RESTORATION SITE**

NCDMS Project No. 92872
Contract No. D09023S
USACE Action ID No. SAW-2009-917 & NCDWR Project No. 10-0122
SCO No. 08-07308-01
McDowell County, North Carolina

Data Collection: May-November 2019
Submission: January 2020

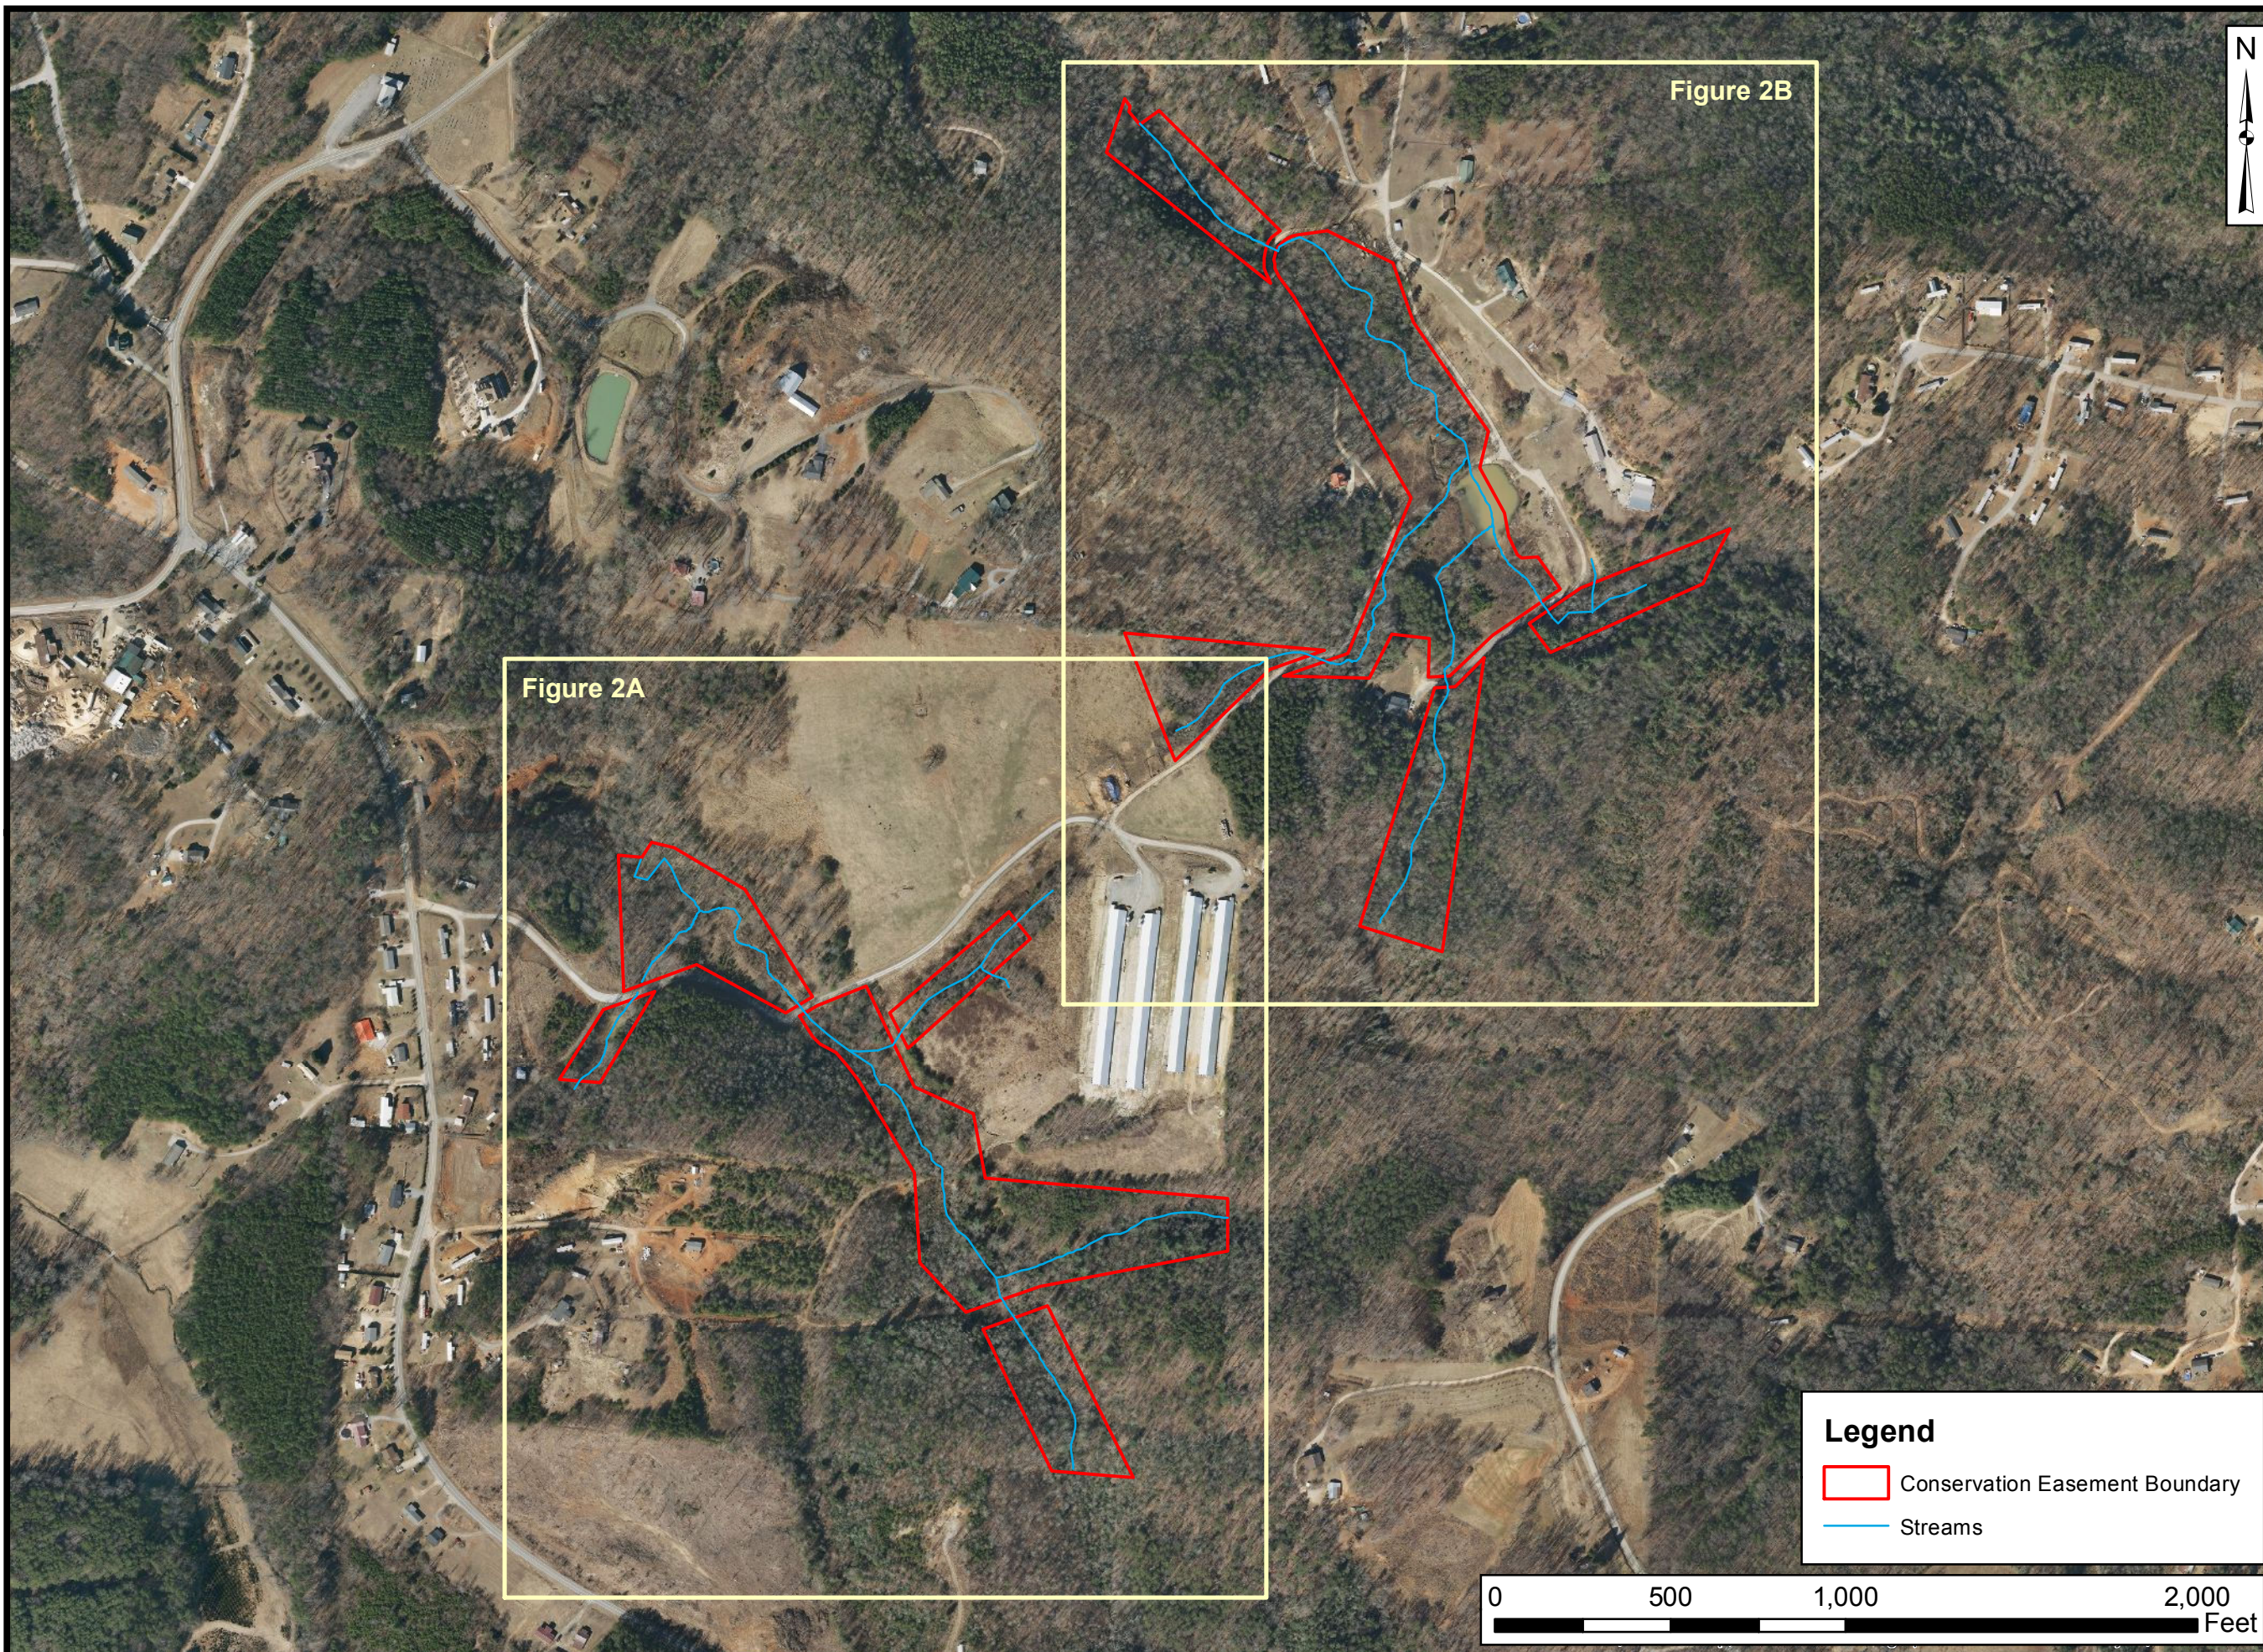
**FIGURE
 2B**

Several dense populations of Chinese privet (*Ligustrum sinense*) were observed along Walton Crawley Branch (Figure 2B, Appendix B). Additional populations of privet and multiflora rose (*Rosa multiflora*) was observed scattered throughout Site restoration reaches in quantities below mapping thresholds. NCDMS currently has implemented an invasive management plan and is under contract for the remaining monitoring period. During the last site visit invasive treatment areas were closely inspected, currently

Several areas of compromised easement integrity were observed during year 4 (2019). The fence on the northeast side of the crossing over UT-2 to Neighbors Brach has been compromised by large amounts of sediment during several high flow events. DMS has notified and is working with the landowner to repair the downed fence. Additionally, the footpath and foot-bridge identified in MY3 that extends through the conservation easement just north of UT-1 remains. DMS and DEQ Stewardship worked with the landowner to limit the width of the path to a minimum cutting for foot traffic only. This foot path will continue to be monitored to ensure no additional vegetation is disturbed. These areas are depicted on Figures 2A-B (Appendix B), and NCDMS is working with the landowner to resolve these issues.

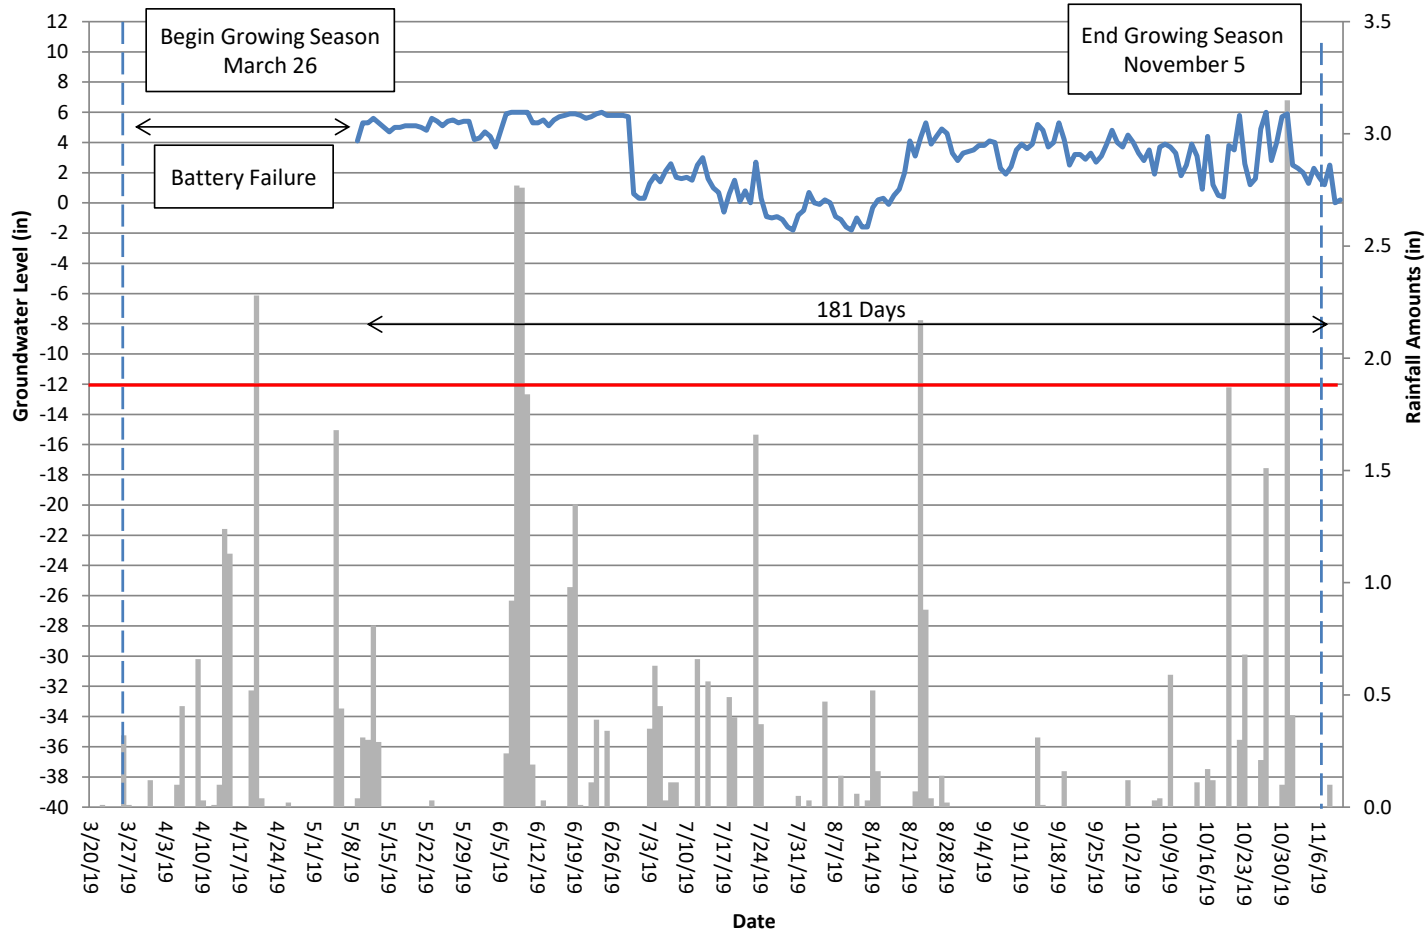
Neighbors Branch Groundwater Gauge 1 Year 4 (2019 Data)

Both gauges were saturated or inundated for well over 12.5 percent of the growing season. The first 44 days of the growing season data was lost due to data logger failure, the gauges were replaced and the groundwater level at both gauges remained within 12 inches of the surface for 181 days. Based on previous years of monitoring both gauges would likely have been inundated for the entire growing season. Wetland hydrology is currently meeting success criteria.

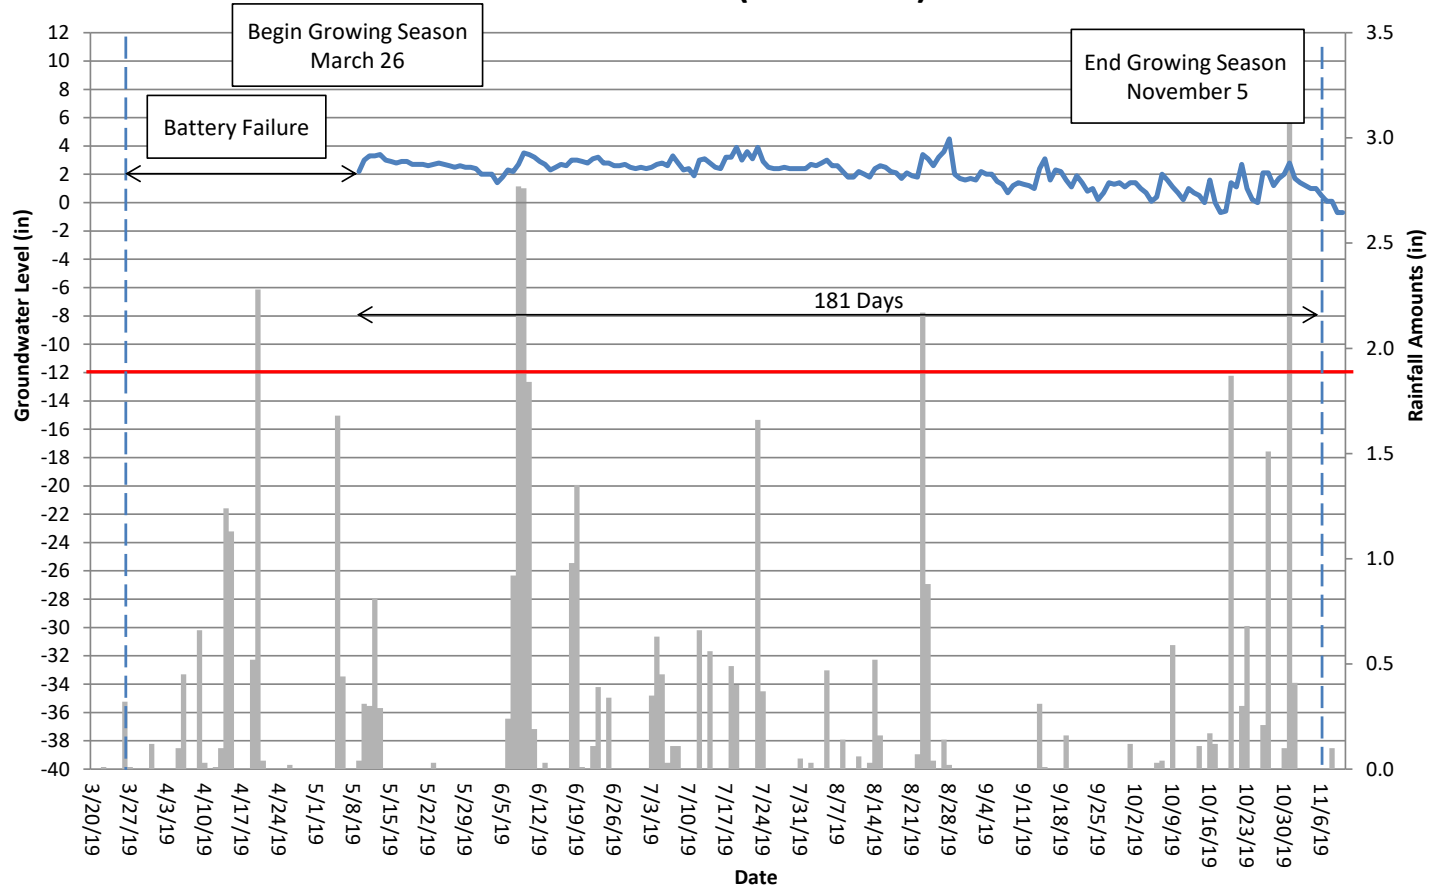
Neighbors Branch Groundwater Gauge 2 Year 4 (2019 Data)

^Gauge 2 missed several days of data collection due to a malfunction caused by excessive inundation during the remnants of Hurricane Florence. It began collecting points again once overbank flow receded.
