FINAL
YEAR 5 (2020) ANNUAL
MONITORING REPORT

**NEIGHBORS BRANCH/WALTON CRAWLEY BRANCH
STREAM & WETLAND RESTORATION SITE**

NCDMS Project No. 92872
Contract No. D09023S
USACE Action ID No. SAW-2009-917 & NCDWR Project No. 10-0122
SCO No. 08-07308-01
McDowell County, North Carolina

Data Collection: May-November 2020
Submission: January 2021

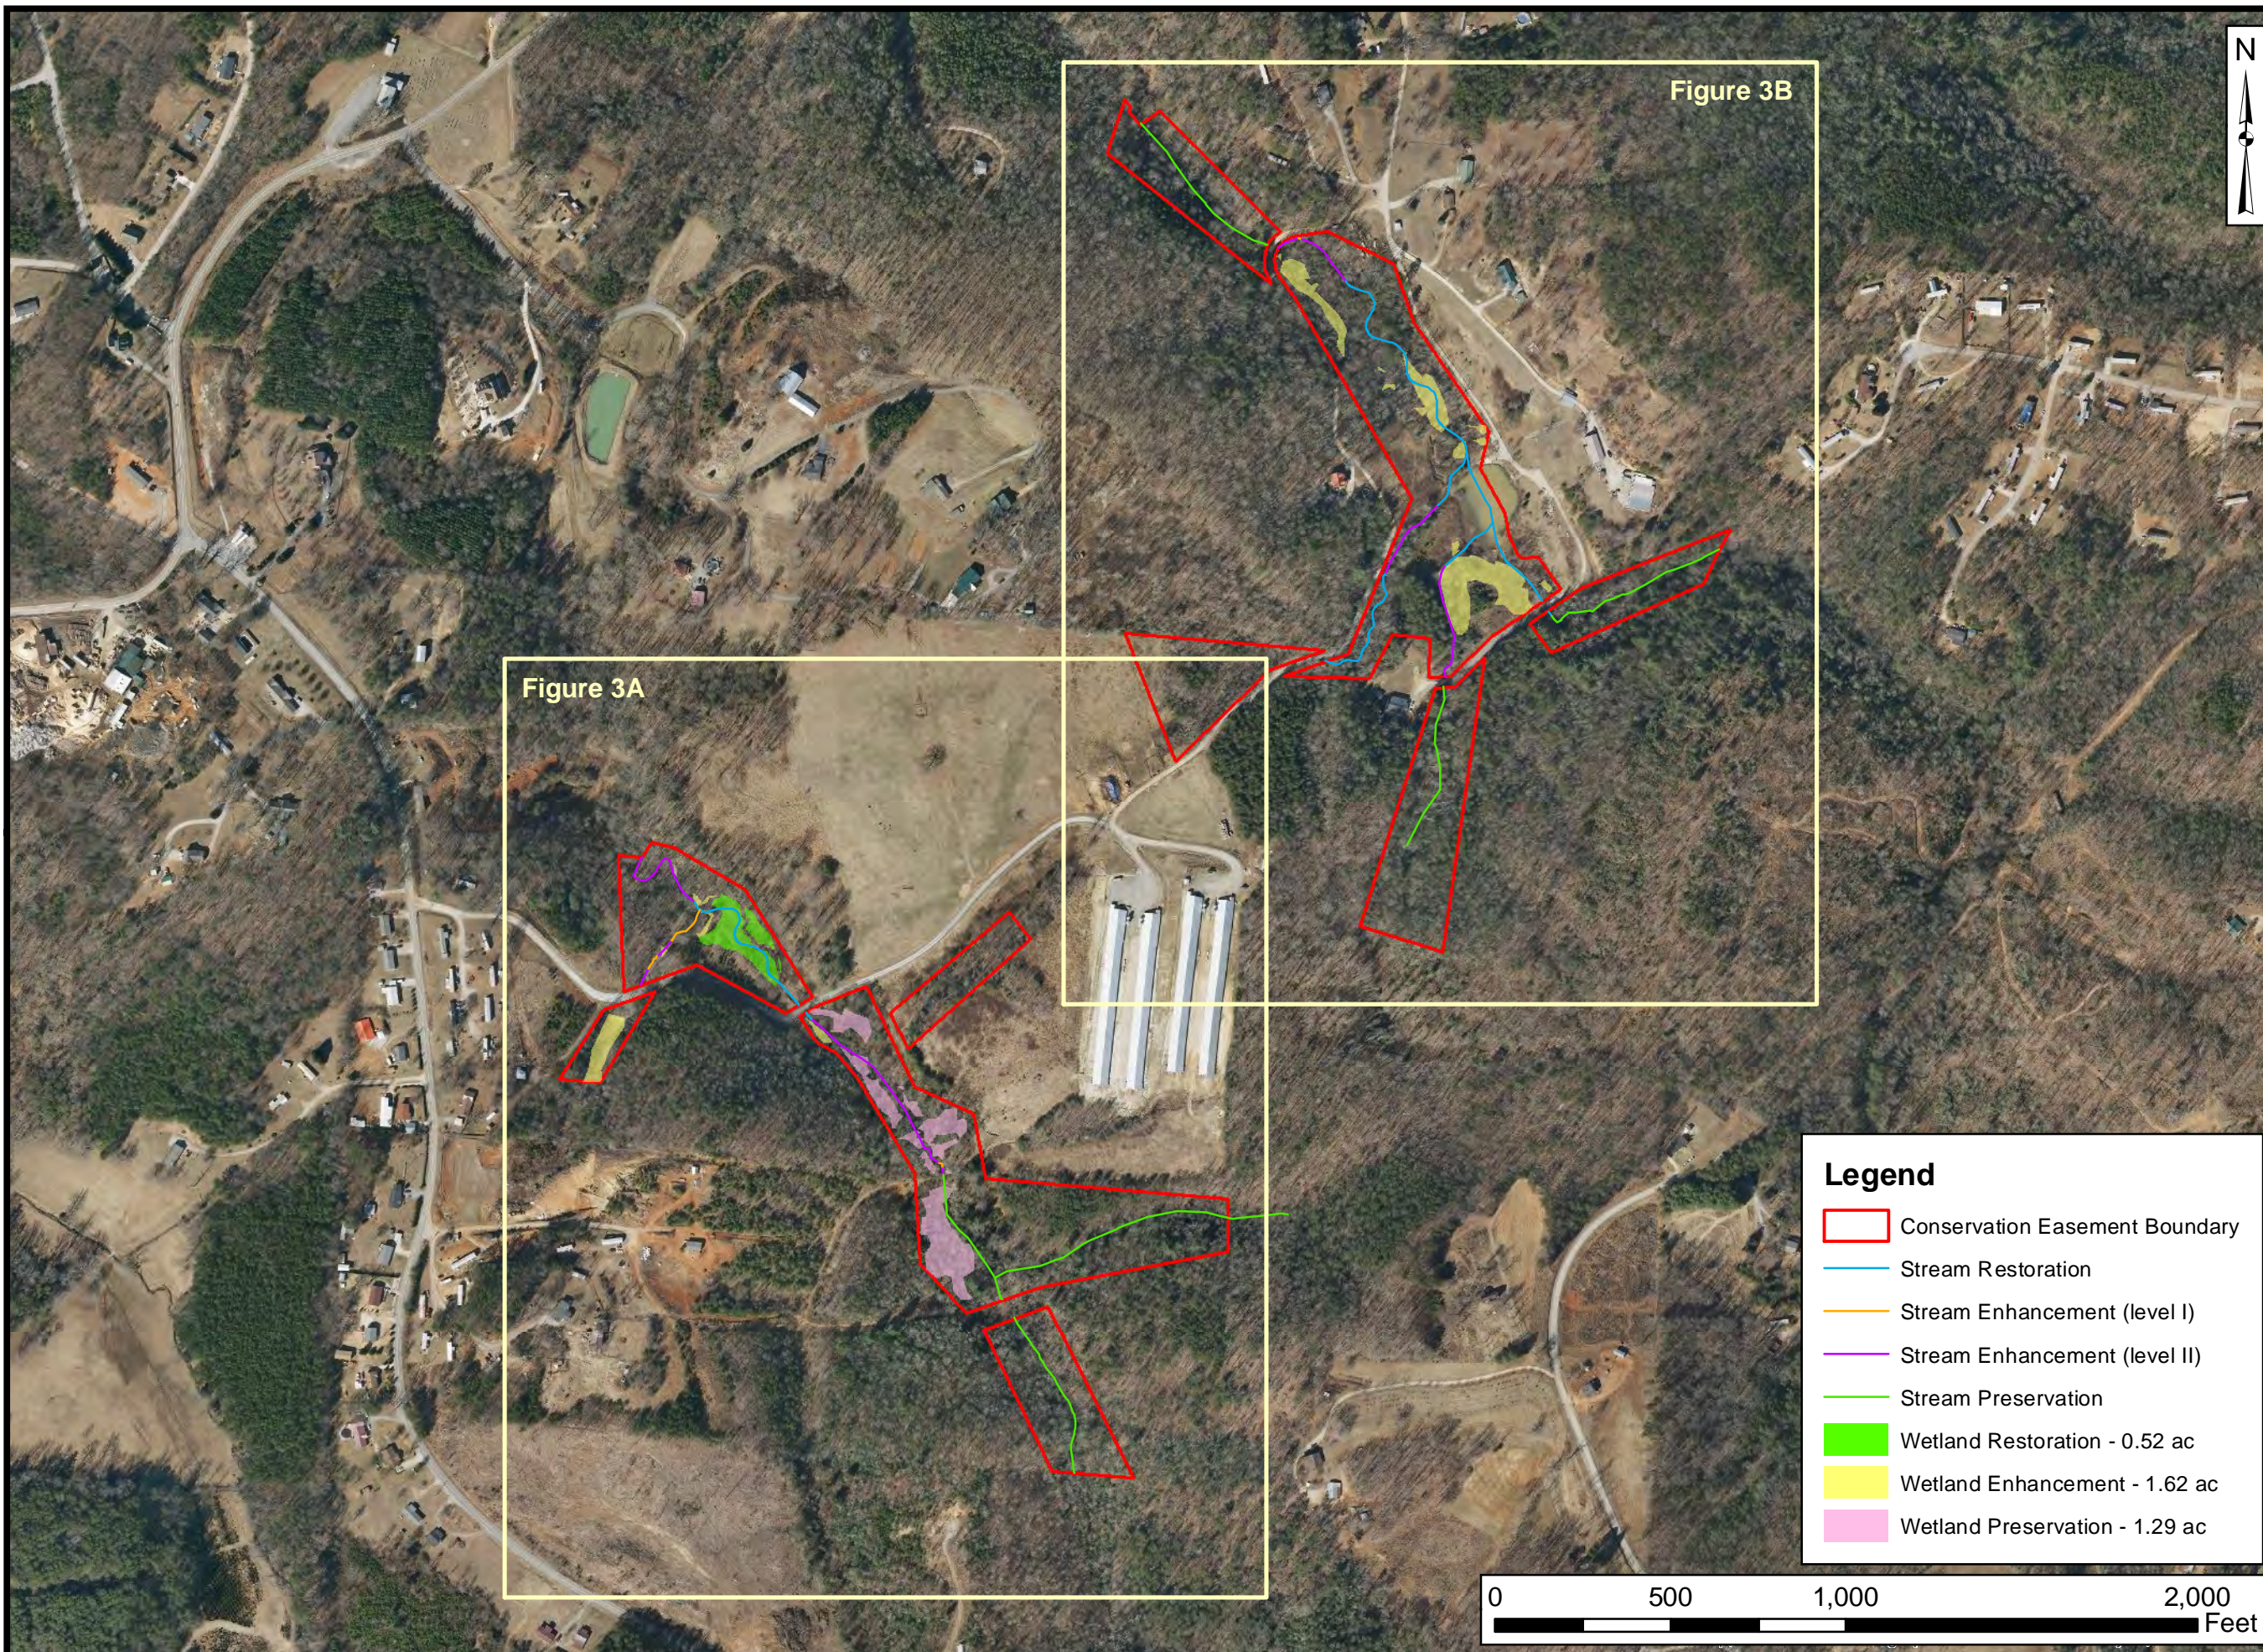
**FIGURE
 2B**

- It appears that there are 2 encroachment features in the digital submission, but only one is displayed on Fig 2B. Please include this encroachment on the CCPV and discuss briefly in report, or remove the encroachment feature from the digital submission if it is not relevant.
The irrelevant encroachment area was removed from the shapefile.

Several dense populations of Chinese privet (*Ligustrum sinense*) and multiflora rose (*Rosa multiflora*) were observed along Neighbors Branch, Walton Crawley Branch, and UT-2 to Walton-Crawley Branch (Figures 2A-B, Appendix B). NCDMS currently has implemented an invasive management plan and is under contract through closeout. During the last site visit invasive treatment areas were closely inspected. Treatments throughout the site have been extremely successful, and populations of invasive species have

Several areas of compromised easement integrity were observed during year 5 (2020). The fence on the northeast side of the crossing over UT-2 to Neighbors Branch has been compromised by large amounts of sediment during several high flow events. DMS has been working with the landowner to repair the downed fence, and some repairs have been made; however, the overall integrity of the fence remains compromised. Additionally, the footpath and foot-bridge identified in MY3 that extends through the conservation easement just north of UT-1 remains. DMS and DEQ Stewardship worked with the landowner to limit the width of the path to a minimum cutting for foot traffic only. Based on visual observations and photo-documentation, the foot path has remained the same width with no additional vegetation disturbed. These areas are depicted on Figures 2A-B (Appendix B).

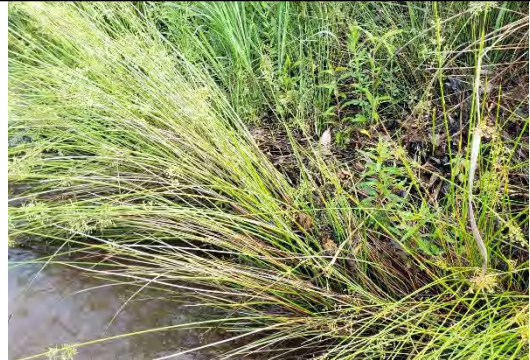
Photo 6: Wrack on the top of bank of Walton-Crawley Branch

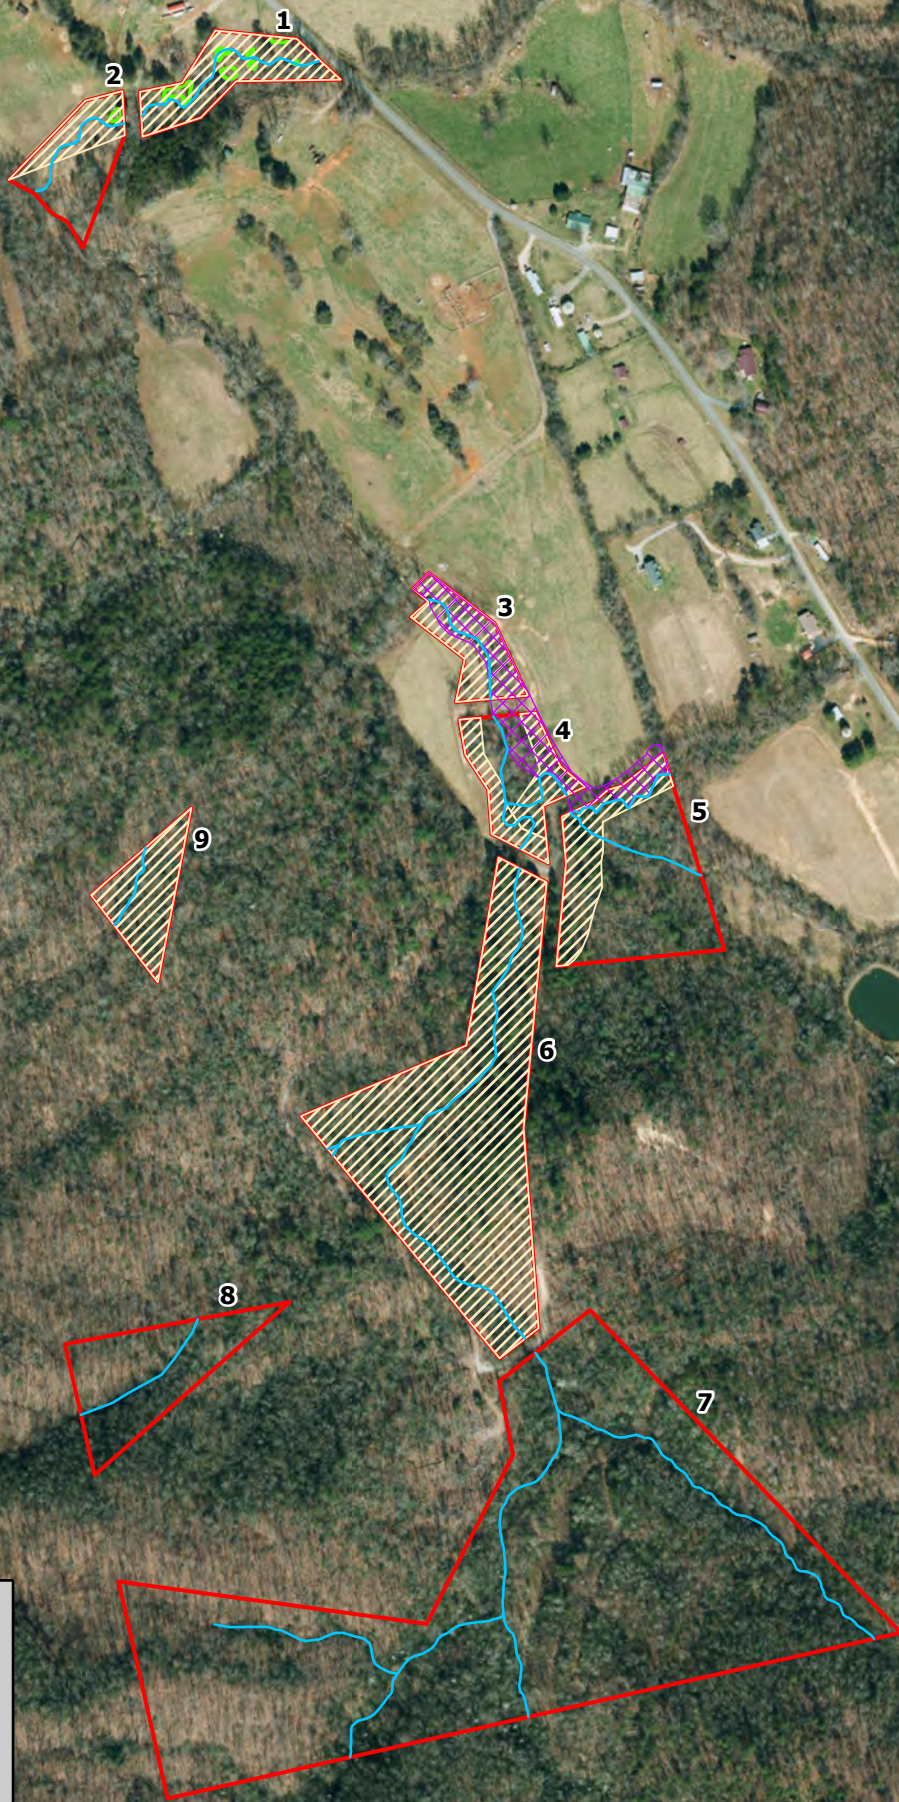
Jason York and Holland Youngman worked at the Neighbors Branch and Bob's Creek easements. Privet was treated with a foliar spray of 3% glyphosate in polygon 9 along the mainstem. Some larger stems were treated mechanically using the hack and squirt method. Polygon 2 was also treated with foliar spray and contained several large multi-flora rose shrubs. Some small privet stems were also treated in this polygon. Oriental bittersweet (*Celastrus orbiculatus*) was found for the first time in polygon 2 and was sprayed. 12 gallons of 3% glyphosate and 32 oz of 50% glyphosate were applied at Neighbors Branch.

We next applied foliar spray at Bob's Creek along the mainstem and along the border of the easement in polygons 3, 4, and 5. Multi-flora rose was the main target species although some privet was encountered and sprayed. 8 gallons of 3% glyphosate was applied at Bob's Creek.
