Neu-Con Umbrella Wetland and Stream Mitigation Bank

**Westbrook Lowgrounds Wetland and Stream Mitigation Site
Annual Monitoring Report for 2004 (Year 2)**

ANNUAL REPORT FOR 2004 (Year 2)

Westbrook Lowgrounds Mitigation Site

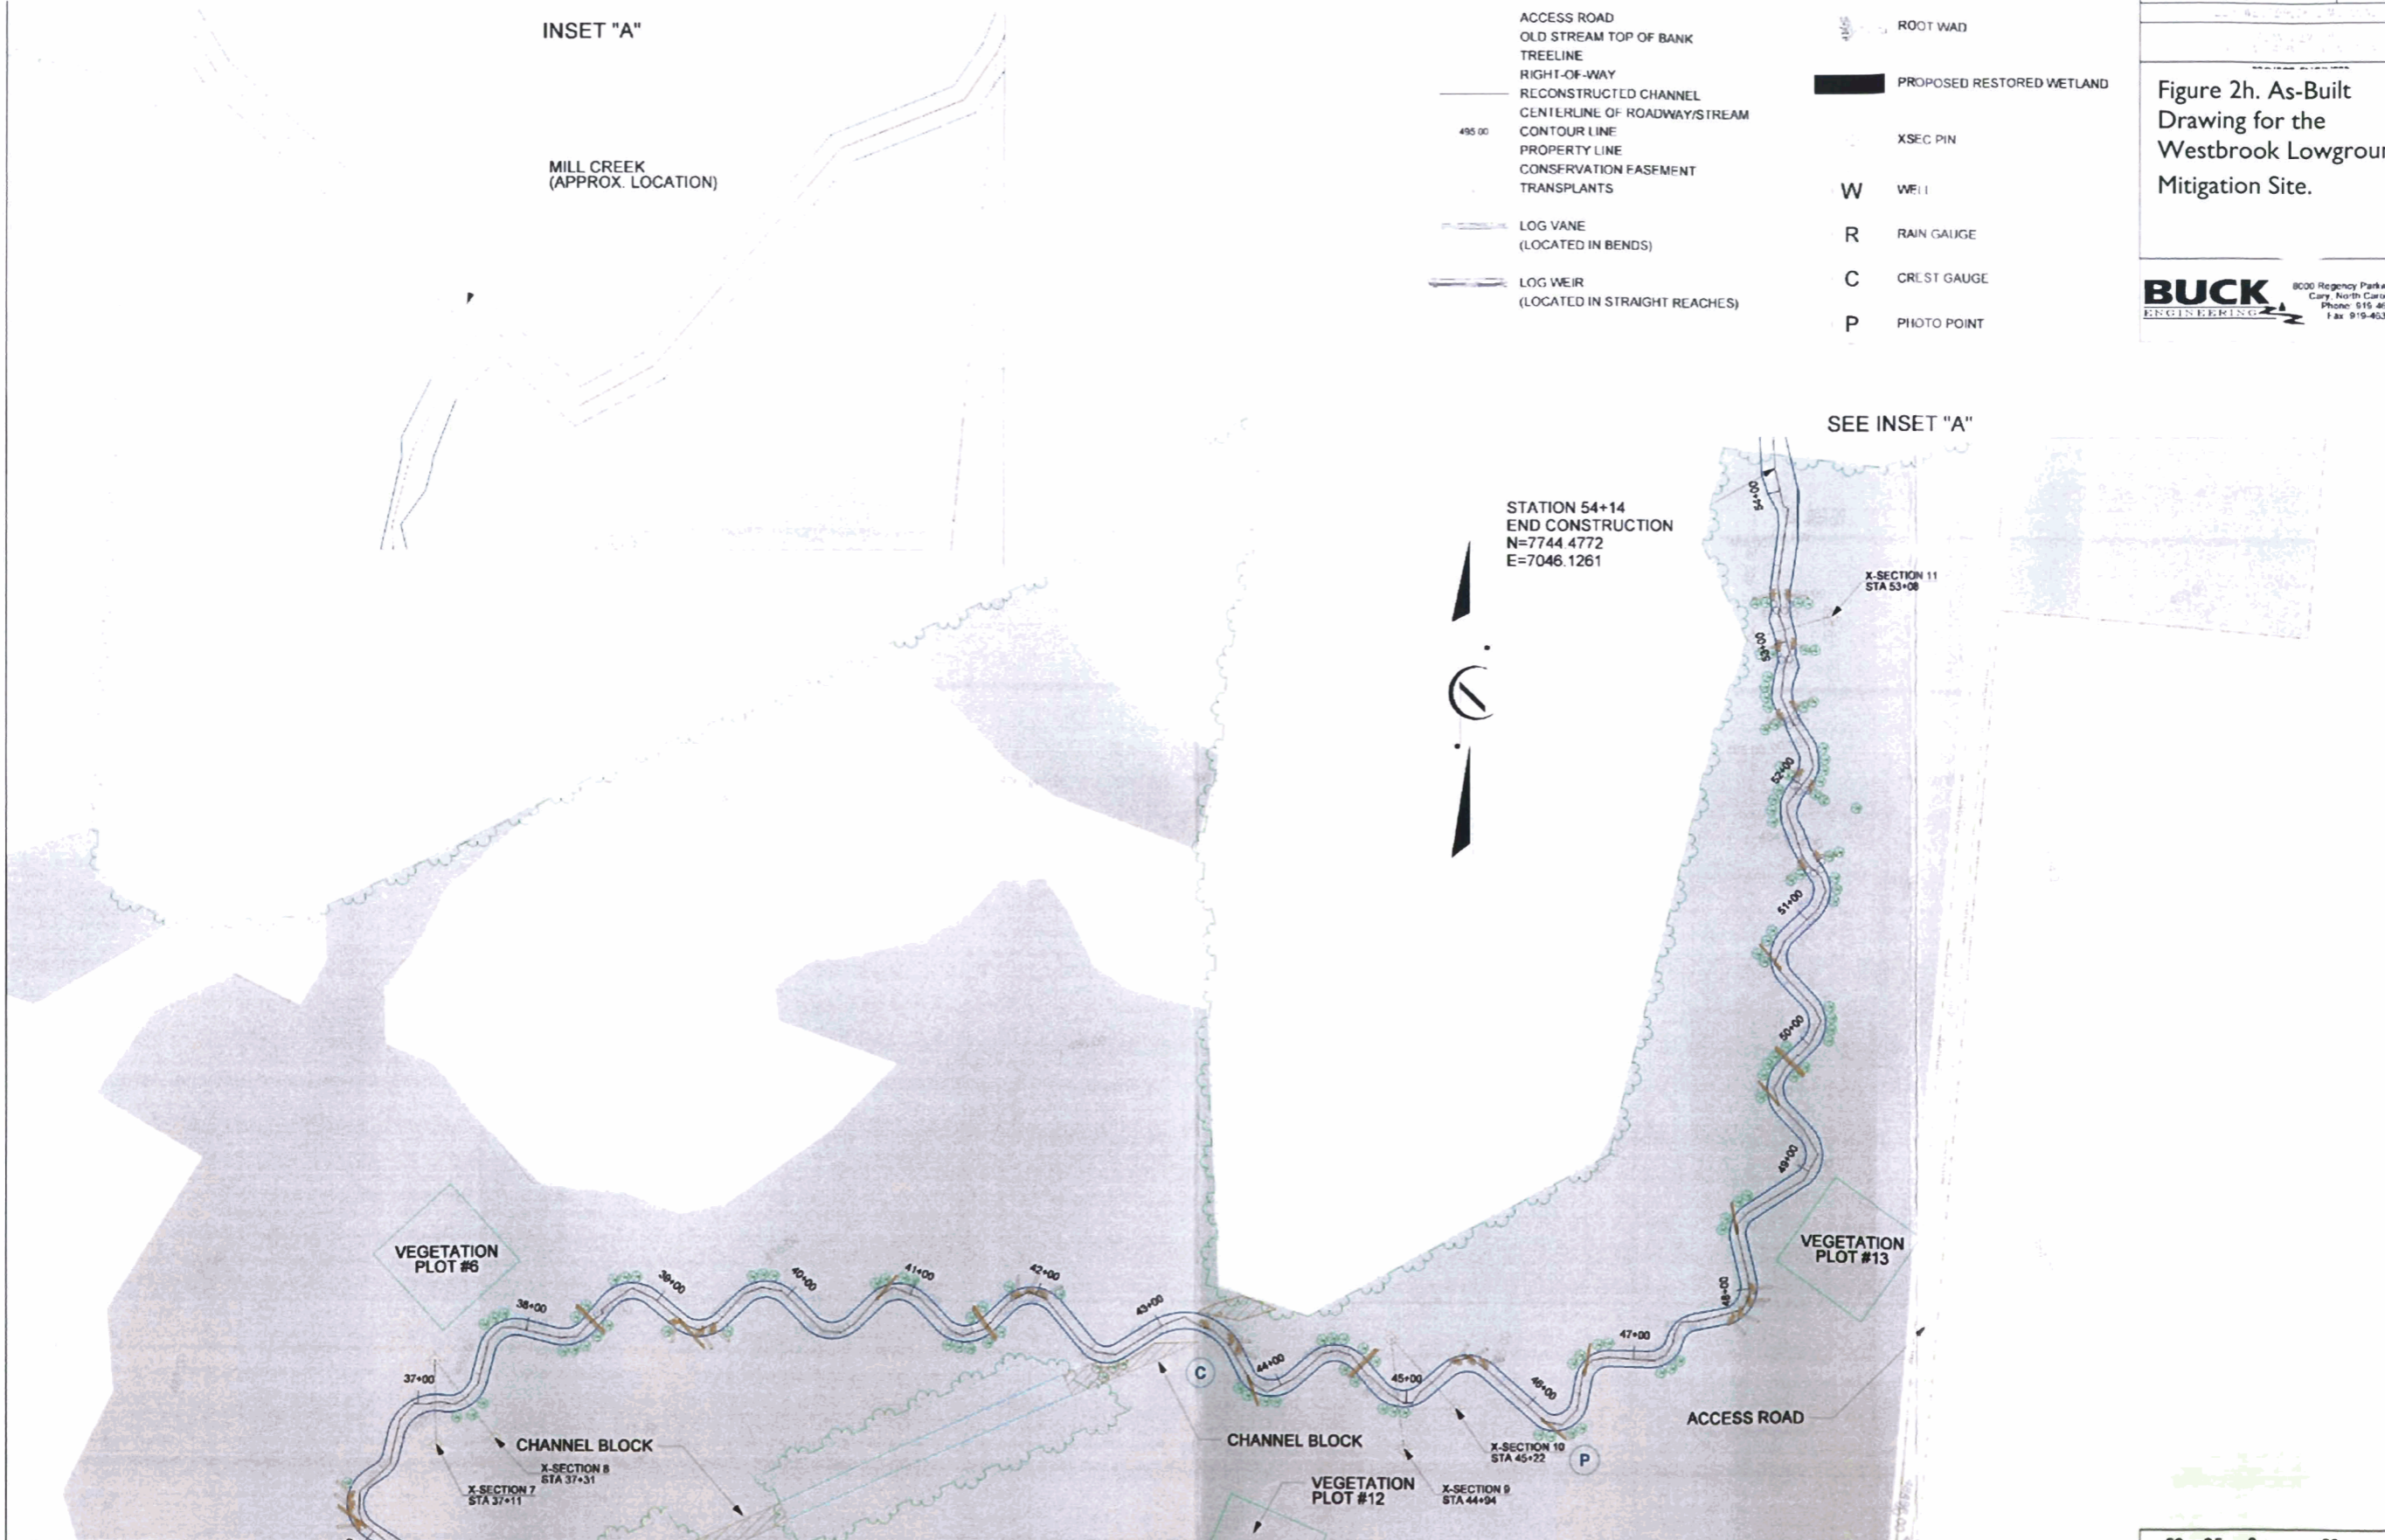
Figure 2h. As-Built Drawing for the Westbrook Lowgrounds Mitigation Site.

Bankfull Events: A crest gauge was installed on the site to document bankfull events. The gauge is checked each month, and records the highest out-of-bank flow event that occurred during the past month. The gauge is located near stream station 43+50 (see Figure 2h).
