**Newfound Creek Stream Restoration  
2015 Final Monitoring Report  
Monitoring Year Four**

**NC Division of Mitigation Services Project Number 92497**

Submitted: March 21, 2016

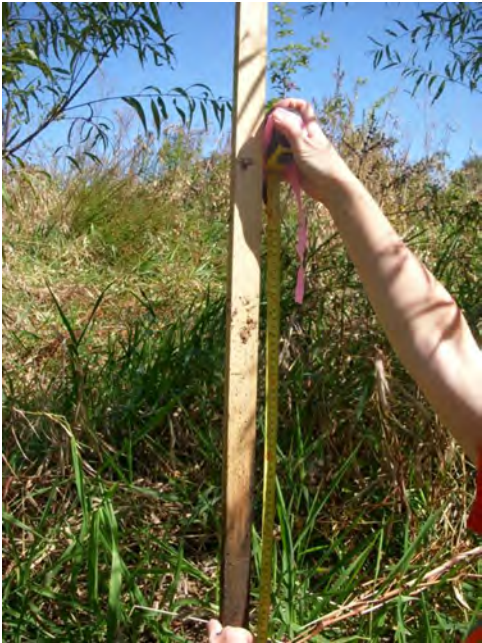
Photo 239. Crest gauge 2, November 2014
