**Newtown Stream and Wetland  
Restoration Project  
Union County, North Carolina  
EEP Project #94150  
Contract No. 002025**

**MY-03 Monitoring Report-Final**

Data Collected: September 2013  
Submitted: November 2013

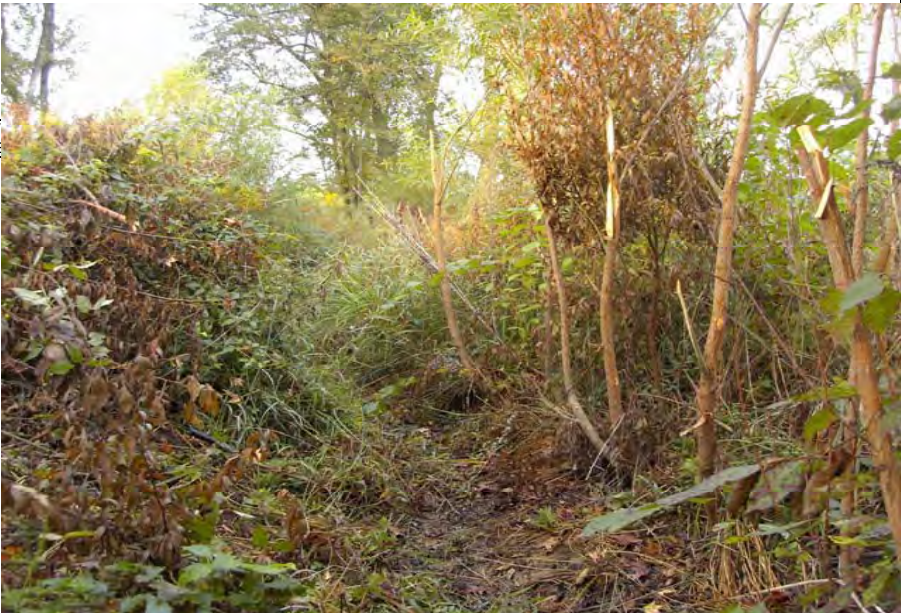
Cross Section 1

Photo of XS-1, looking in the downstream direction

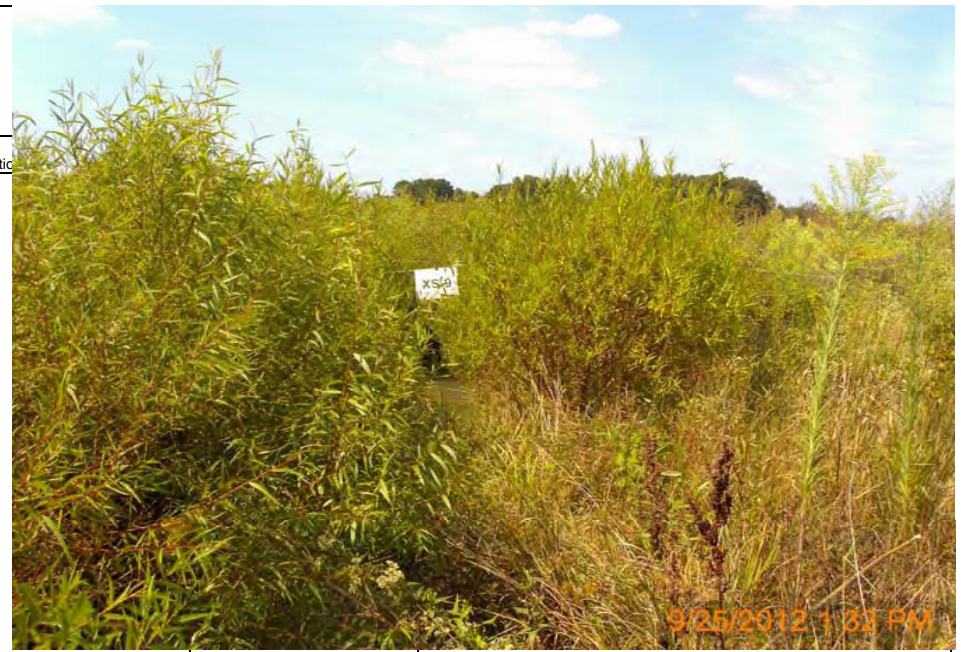
Cross Section 9

Photo of XS-9, looking in the downstream direction
