**MONITORING YEAR 1
ANNUAL REPORT**
Final

NORKETT BRANCH STREAM MITIGATION SITE
Union County, NC
DENR Contract 004673
NCEEP Project Number 95360

Data Collection Period: September 2014-October 2014
Draft Submission Date: December 17, 2014
Final Submission Date: January 13, 2015

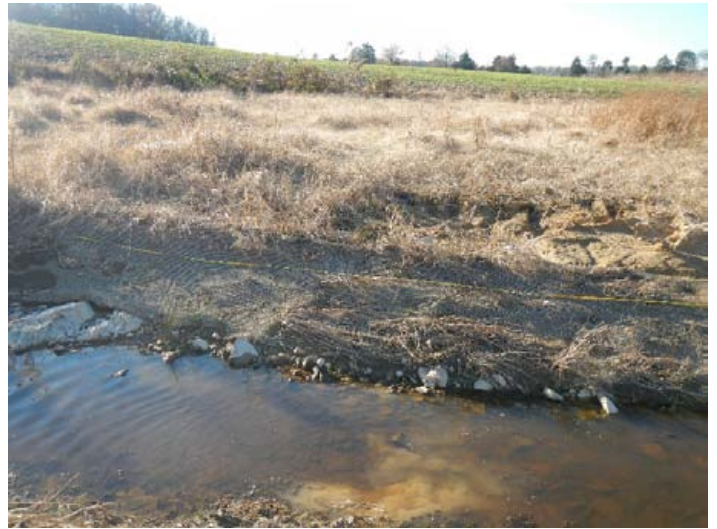
AOC-2: Bare bank on Norkett Branch Reach 1 left bank, 12-1-2014

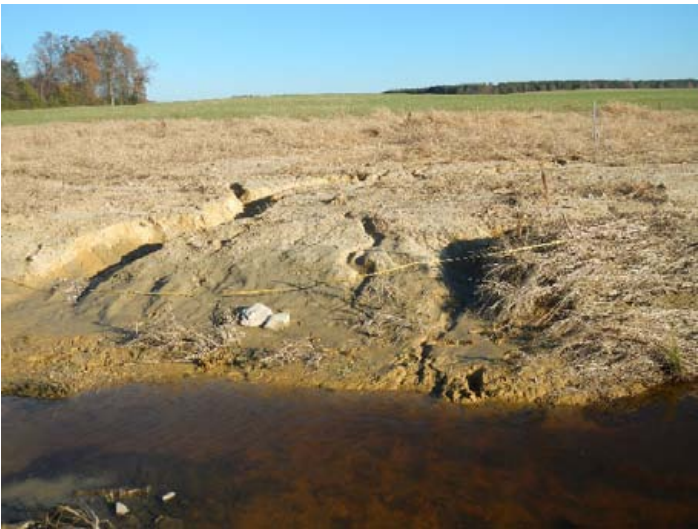
AOC-3: Rill erosion Norkett Branch Reach 1 right bank, 12-1-2014
