# **MONITORING YEAR 2 ANNUAL REPORT**

**NORKETT BRANCH STREAM MITIGATION SITE**  
Union County, NC  
NCDEQ Contract 004673  
NCDMS Project Number 95360

Data Collection Period: April - October 2015  
Draft Submission Date: November 13, 2015  
Final Submission Date: November 20, 2015

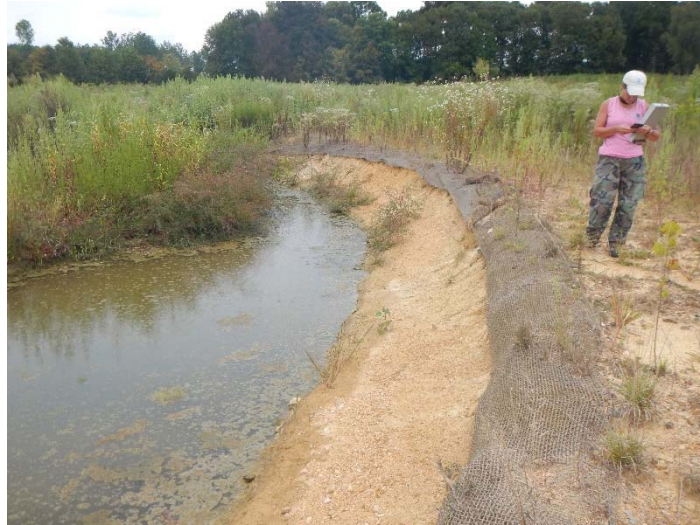
Bare bank Norkett Branch Reach 2 right bank, continuing to erode. 9-21-2015

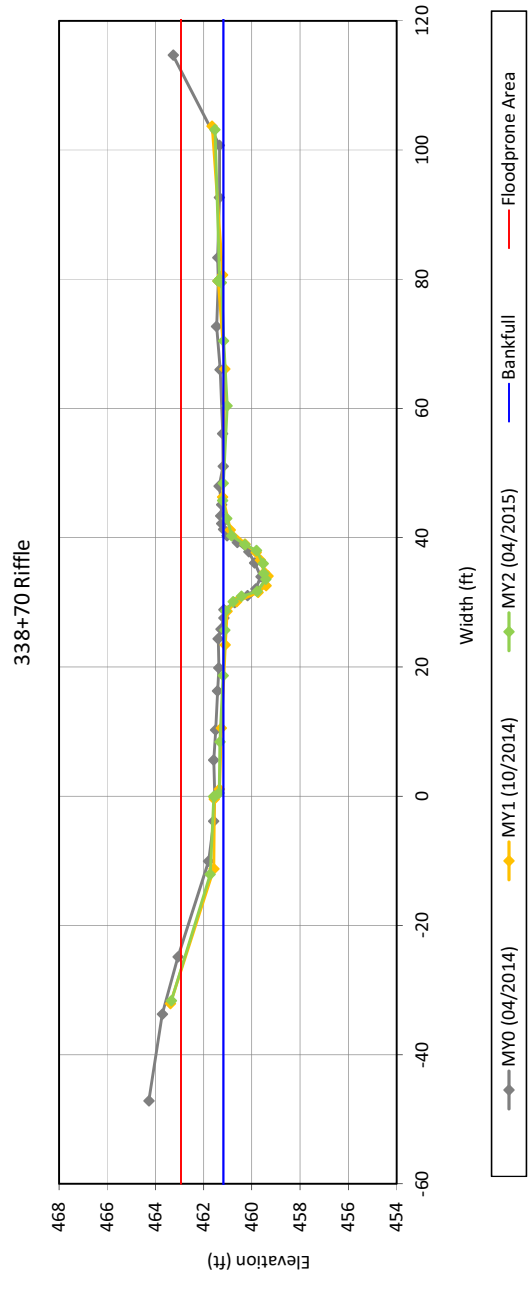
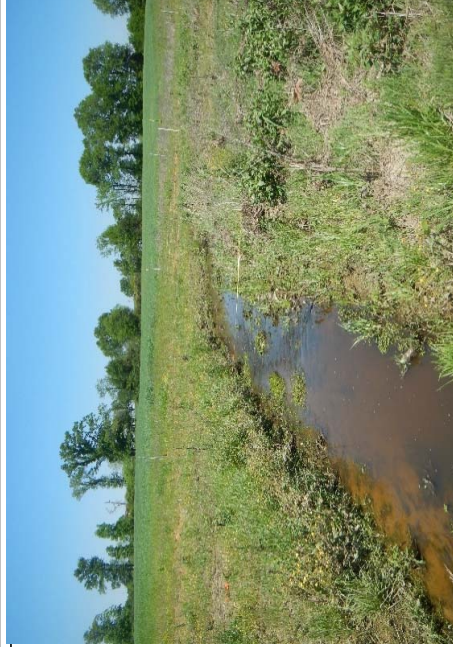
**Cross Section 19-UT2 Reach 3B**

14.3	x-section area (ft.sq.)
14.3	width (ft)
1.0	mean depth (ft)
1.8	max depth (ft)
15.0	wetted perimeter (ft)
1.0	hyd radi (ft)
14.4	width-depth ratio
146.0	W flood prone area (ft)
10.2	entrenchment ratio
1.0	low bank height ratio

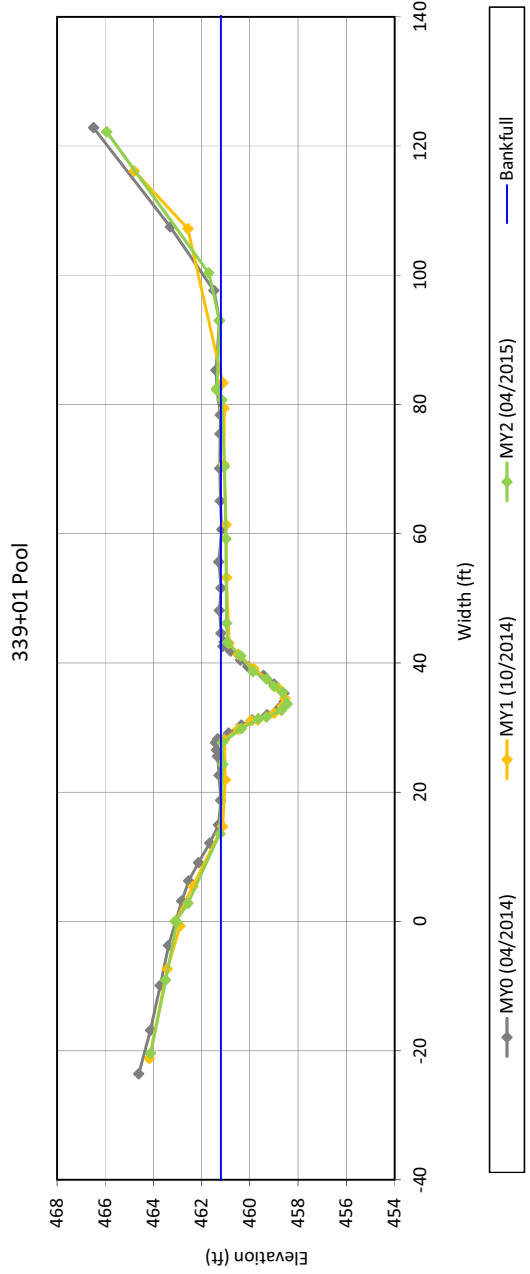
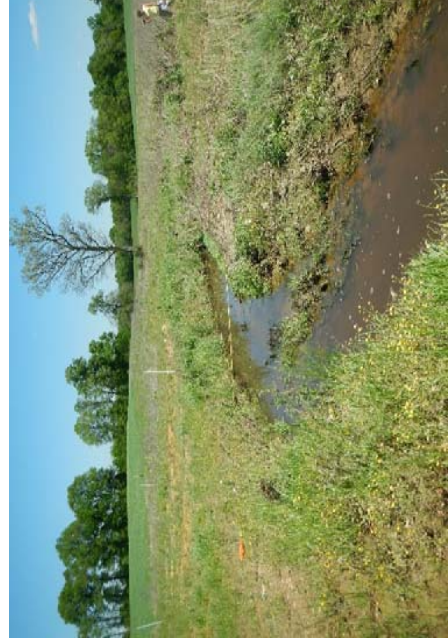
**Cross Section 20-UT2 Reach 3B**

23.0	x-section area (ft.sq.)
15.5	width (ft)
1.5	mean depth (ft)
2.7	max depth (ft)
16.5	wetted perimeter (ft)
1.4	hyd radi (ft)
10.4	width-depth ratio
