MONITORING YEAR 5 ANNUAL REPORT

NORKETT BRANCH STREAM MITIGATION SITE

Union County, NC
DEQ Contract 004673
DMS Project Number 95360

Data Collection Period: June - October 2018
Final Submission Date: December 12, 2018

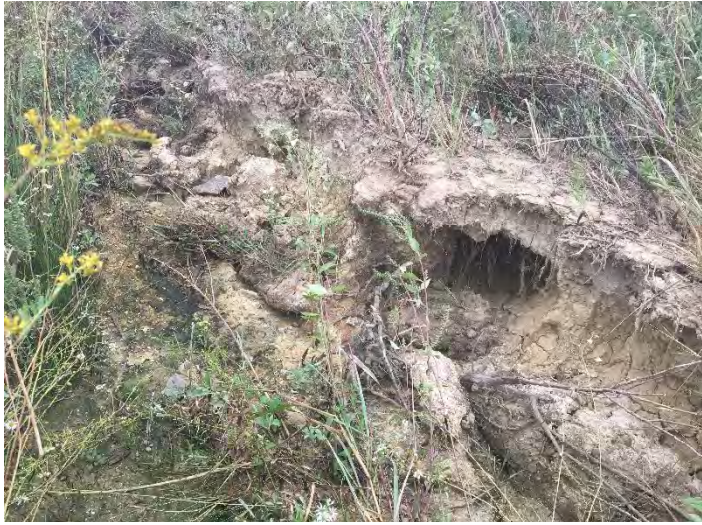
Old Scour: Norkett Branch Station 103+00 – 10/9/2018

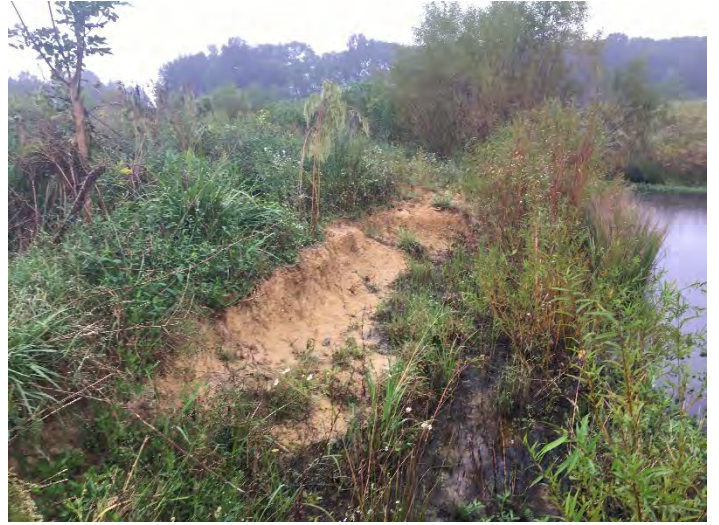
Bare Bank: Norkett Branch Station 132+75) – 10/17/2018
