# **MONITORING YEAR 6 ANNUAL REPORT Final**

## **NORKETT BRANCH STREAM MITIGATION SITE**

Union County, NC

DMS Project Number 95360

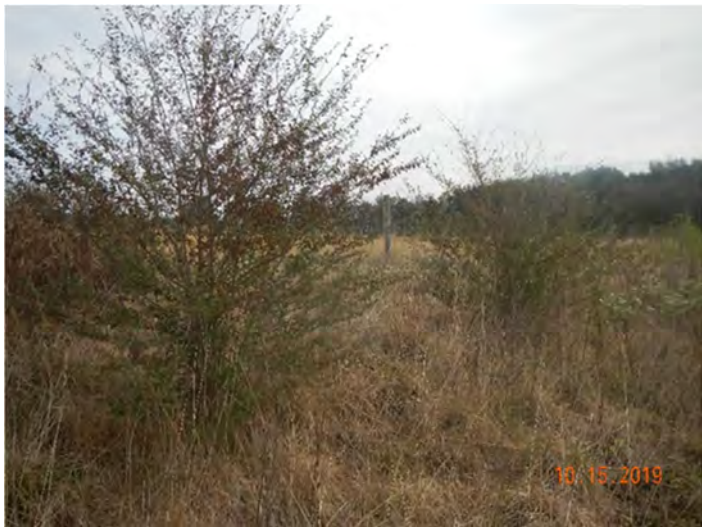
Invasive Plant Population (Chinese Privet) – 10/15/2019

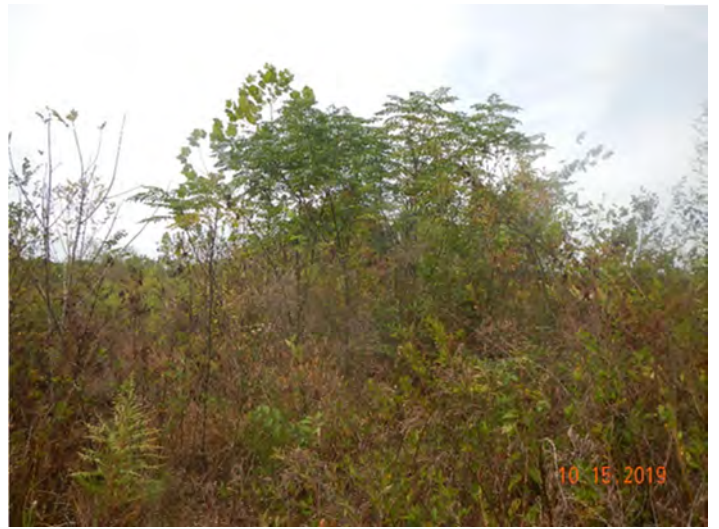
Invasive Plant Population (Chinaberry) – 10/15/2019

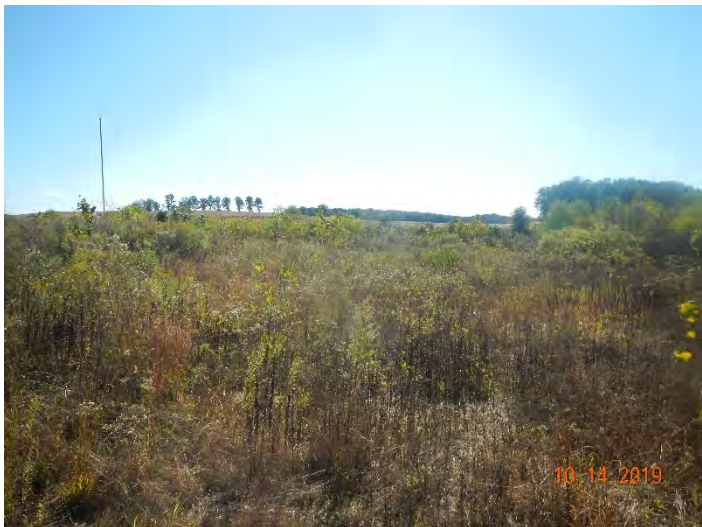
Poor Woody Growth Norkett Branch Reach 1 – 10/14/2019

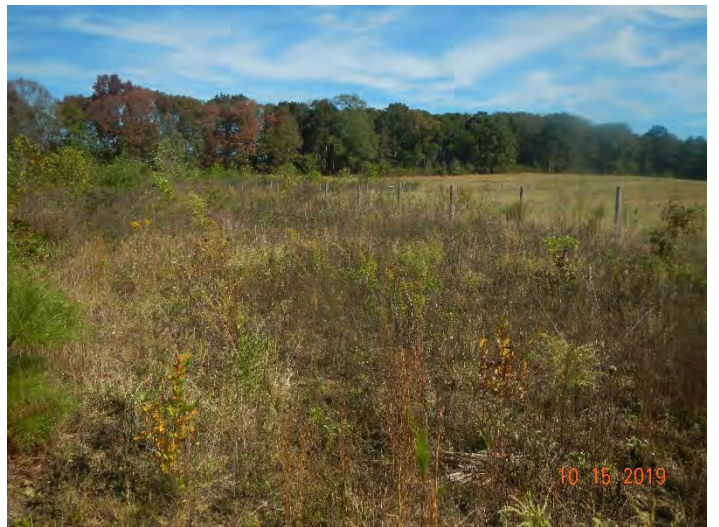
Poor Woody Growth Norkett Branch Reach 2 – 10/15/2019

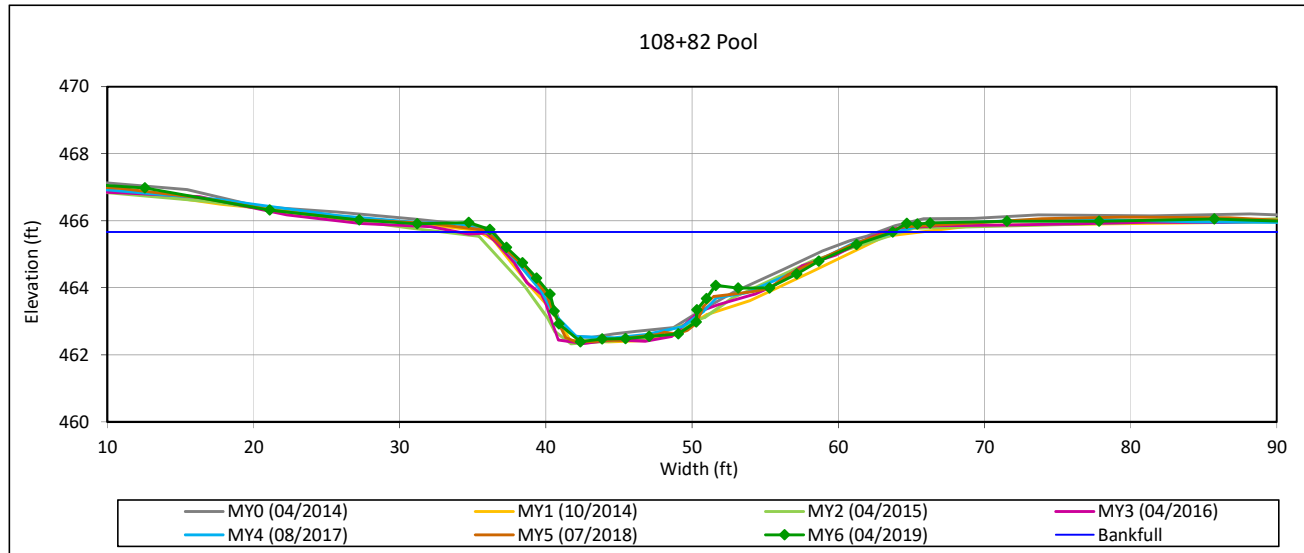
#### Cross-Section 1-Norkett Branch Reach 1

- 49.1 x-section area (ft.sq.)
- 27.4 width (ft)
- 1.8 mean depth (ft)
- 3.3 max depth (ft)
- 29.1 wetted perimeter (ft)
- 1.7 hyd radi (ft)
- 15.3 width-depth ratio

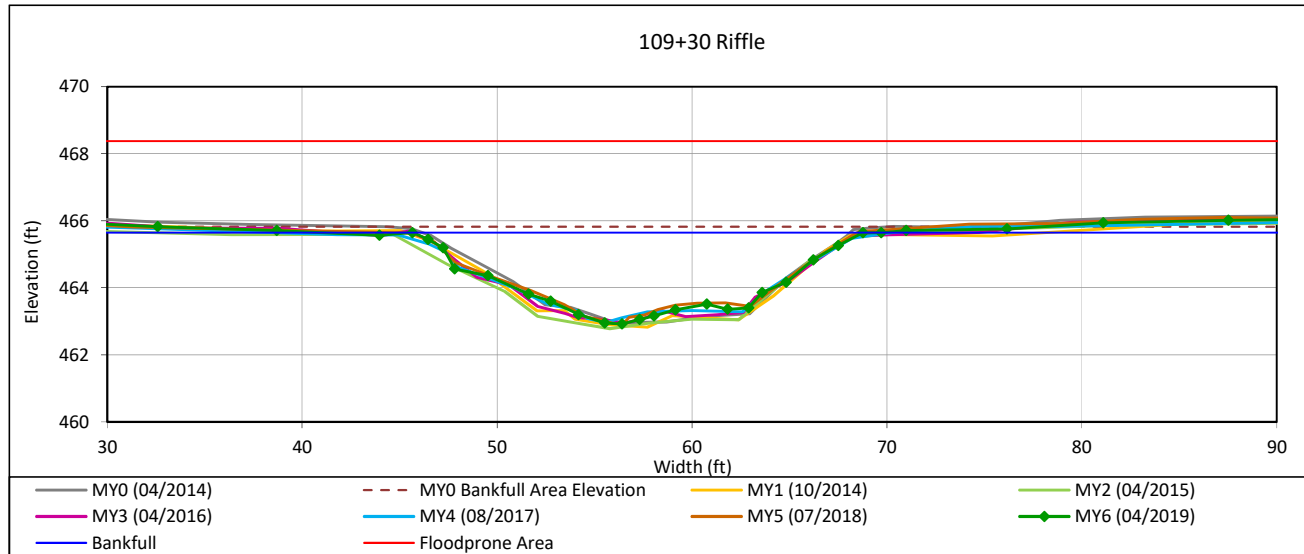
### Cross-Section 2-Norkett Branch Reach 1

38.6	x-section area (ft.sq.)
23.1	width (ft)
1.7	mean depth (ft)
2.7	max depth (ft)
24.1	wetted perimeter (ft)
1.6	hyd radi (ft)
13.8	width-depth ratio
>200	W flood prone area (ft)
>8.7	entrenchment ratio
0.9	low bank height ratio

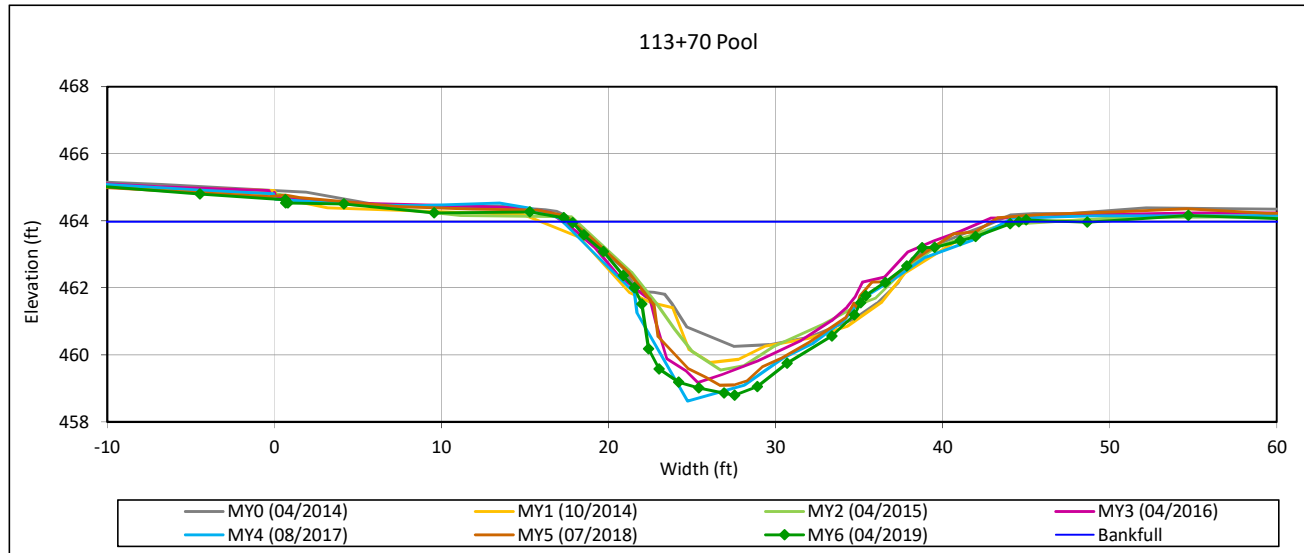
### Cross-Section 3-Norkett Branch Reach 1

69.4 x-section area (ft.sq.)  
26.8 width (ft)  
2.6 mean depth (ft)  
5.2 max depth (ft)  
29.8 wetted perimeter (ft)  
2.3 hyd radi (ft)  
10.3 width-depth ratio

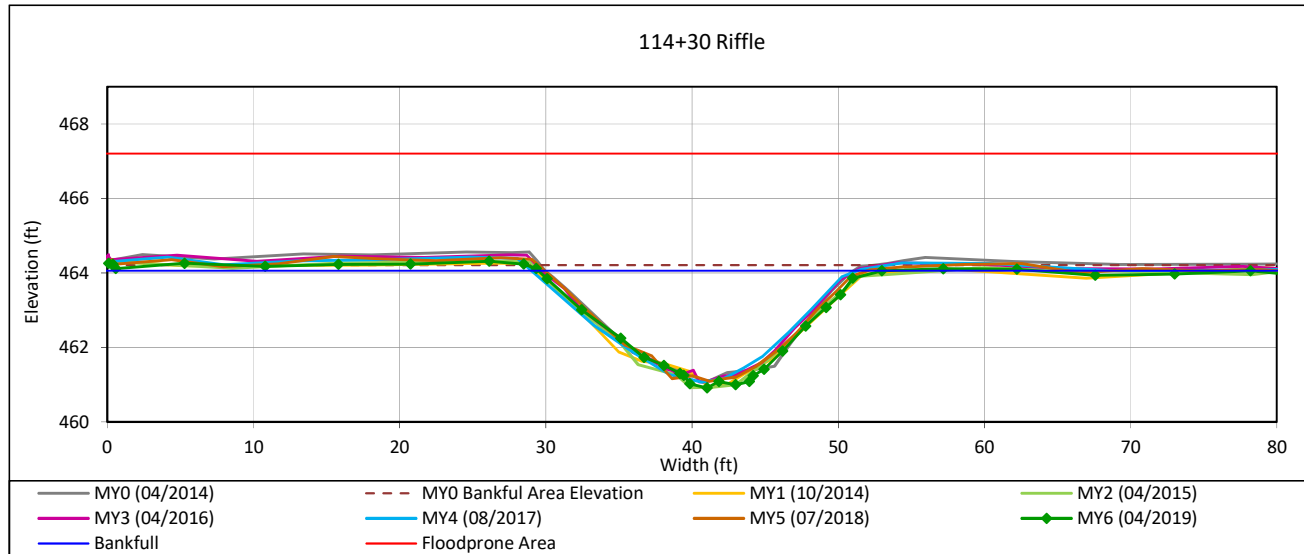
**Cross-Section 4-Norkett Branch Reach 1**

- 41.0 x-section area (ft.sq.)
- 23.5 width (ft)
- 1.7 mean depth (ft)
- 3.1 max depth (ft)
- 24.5 wetted parimeter (ft)
- 1.7 hyd radi (ft)
- 13.4 width-depth ratio
- >173 W flood prone area (ft)
- >7.4 entrenchment ratio
- 1.0 low bank height ratio

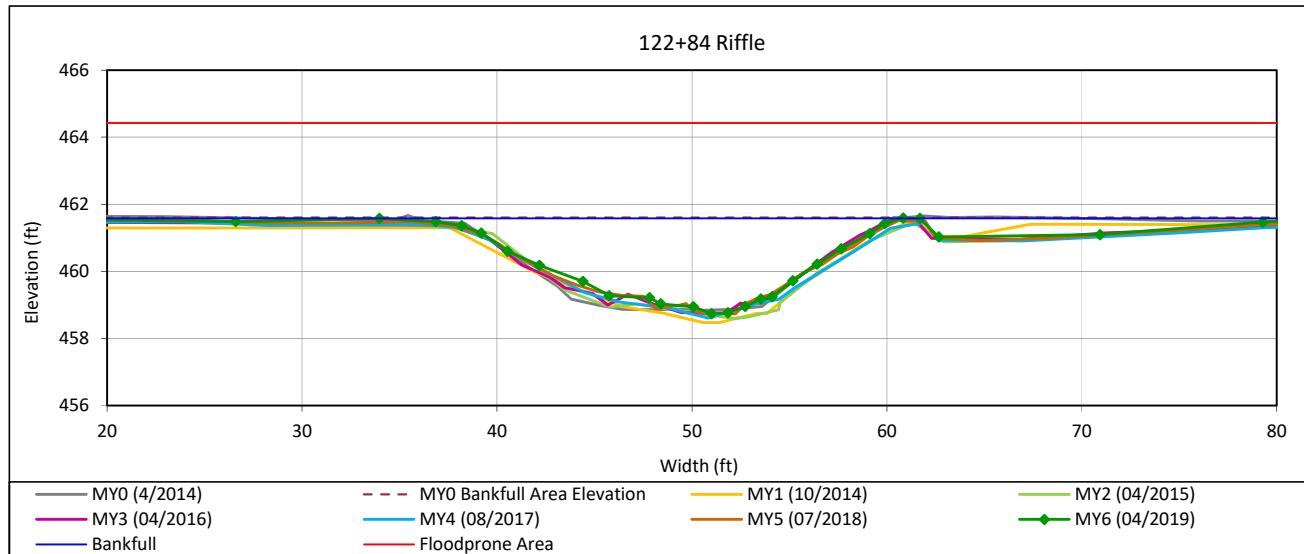
#### Cross-Section 5-Norkett Branch Reach 1

38.4	x-section area (ft.sq.)
26.8	width (ft)
1.4	mean depth (ft)
2.8	max depth (ft)
27.7	wetted perimeter (ft)
1.4	hyd radi (ft)
18.7	width-depth ratio
>200	W flood prone area (ft)
>8	entrenchment ratio
1.0	low bank height ratio

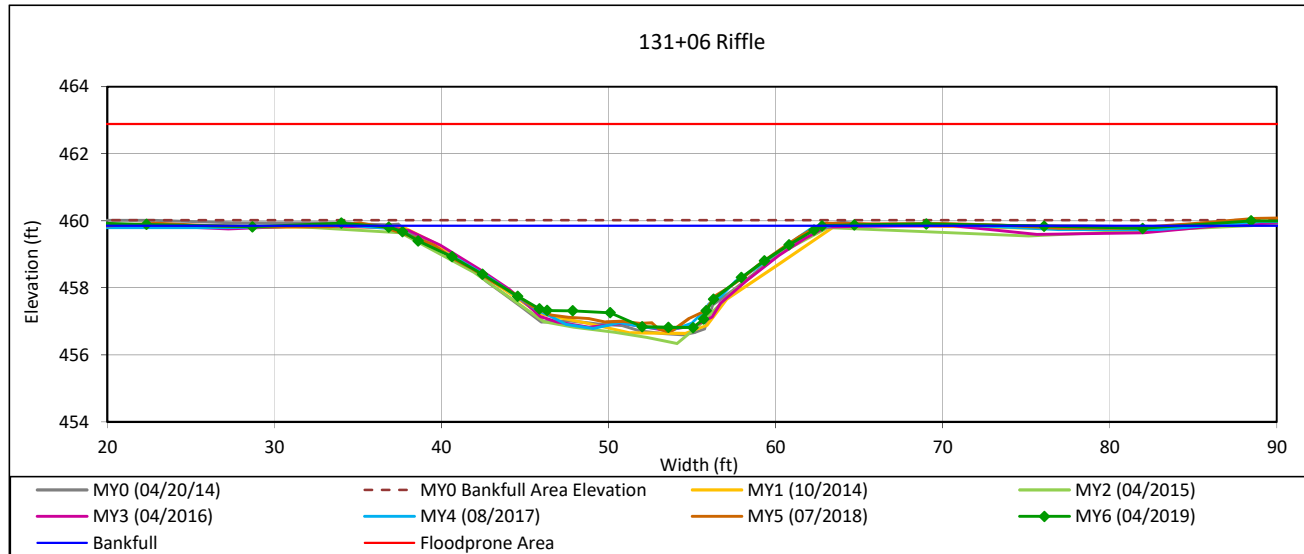
### Cross-Section 6-Norkett Branch Reach 2

46.0	x-section area (ft.sq.)
25.9	width (ft)
1.8	mean depth (ft)
3.0	max depth (ft)
27.0	wetted parimeter (ft)
1.7	hyd radi (ft)
14.6	width-depth ratio
>200	W flood prone area (ft)
>8	entrenchment ratio
0.9	low bank height ratio

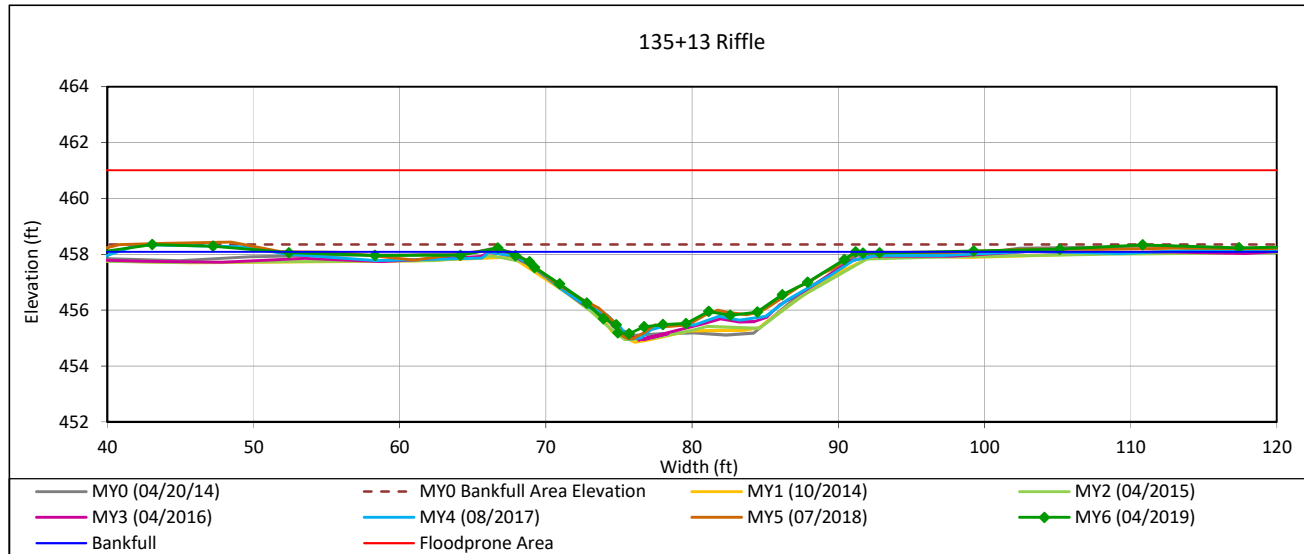
**Cross-Section 7-Norkett Branch Reach 2**

- Bankfull Dimensions**
- 40.3 x-section area (ft.sq.)
  - 23.8 width (ft)
  - 1.7 mean depth (ft)
  - 2.9 max depth (ft)
  - 24.9 wetted parimeter (ft)
  - 1.6 hyd radi (ft)
  - 14.1 width-depth ratio
  - >200 W flood prone area (ft)
  - >8 entrenchment ratio
  - 0.9 low bank height ratio

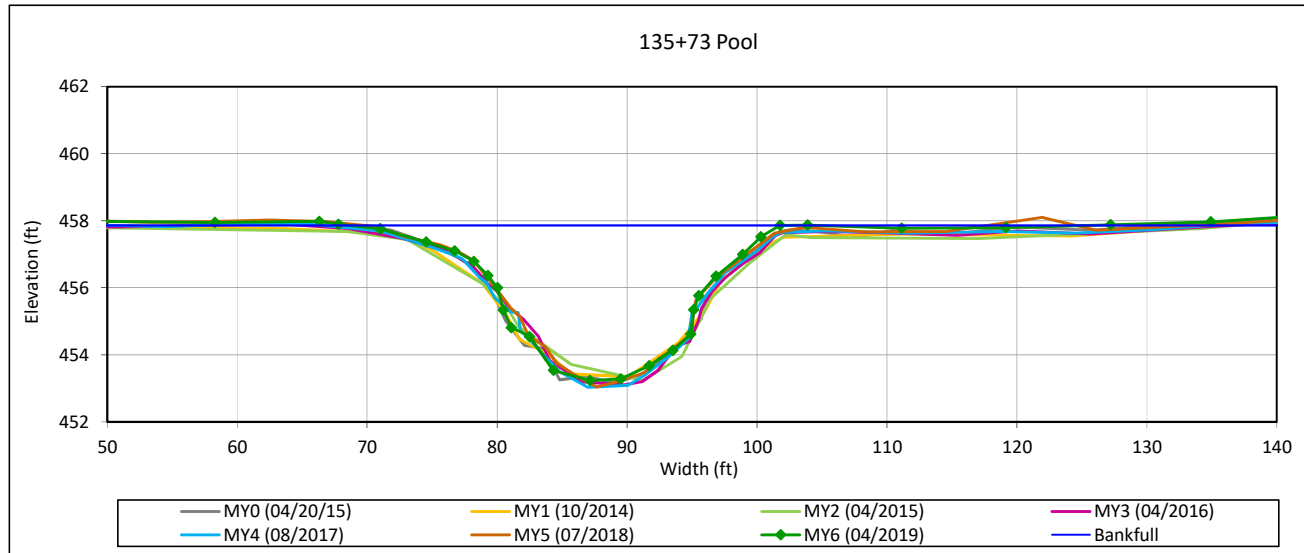
### Cross-Section 8-Norkett Branch Reach 2

<sup>3</sup> MY3 calculations were adjusted on Cross-section 8 because they were found to omit a portion of the bankfull area.

73.3 x-section area (ft.sq.)  
33.1 width (ft)  
2.2 mean depth (ft)  
4.6 max depth (ft)  
35.4 wetted perimeter (ft)  
2.1 hyd radi (ft)  
15.0 width-depth ratio

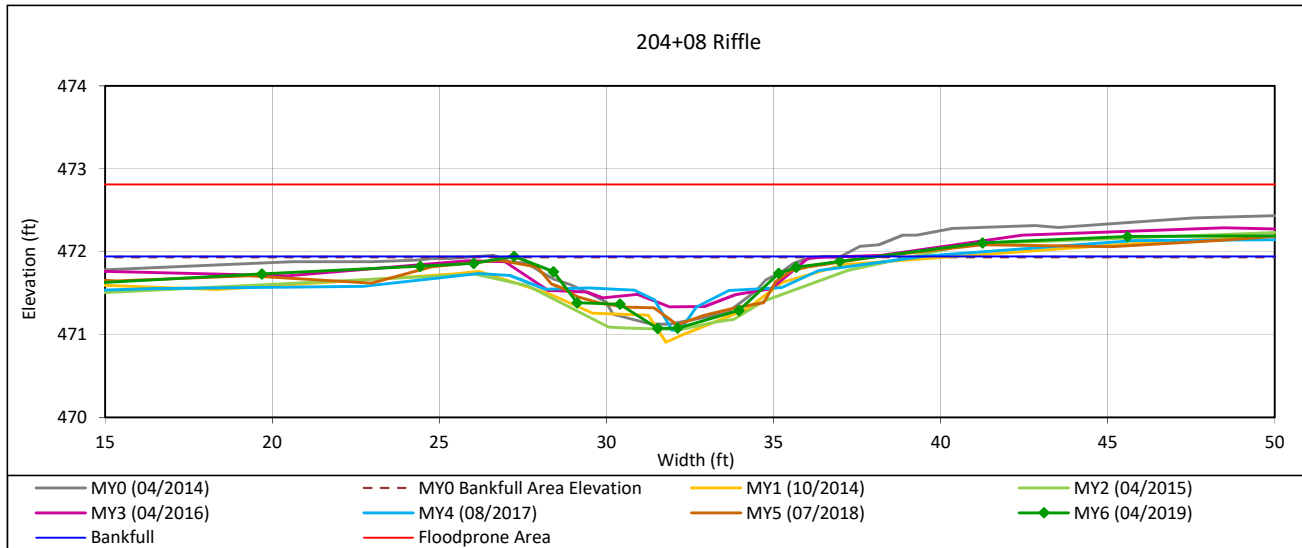
#### Cross-Section 9-UT1

4.6	x-section area (ft.sq.)
10.9	width (ft)
0.4	mean depth (ft)
0.9	max depth (ft)
11.2	wetted perimeter (ft)
0.4	hyd radi (ft)
25.9	width-depth ratio
126.1	W flood prone area (ft)
11.5	entrenchment ratio
1.0	low bank height ratio
