MONITORING YEAR 7 ANNUAL REPORT Final

NORKETT BRANCH STREAM MITIGATION SITE

Union County, NC
DEQ Contract 004673
DMS Project Number 95360
USACE Action ID Number 2012-01082
NCDWR Project Number 13-0250

Data Collection Period: March – November 2020
Final Submission Date: January 19, 2021

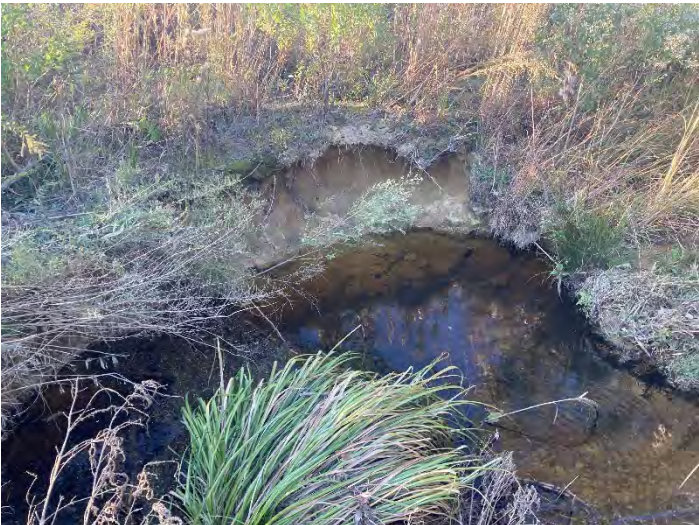
Bank Scour – Norkett Branch Reach 1
11/3/2020
