# North Fork Mountain Creek Stream & Wetland Restoration

## Year 2 of 7 Final Monitoring Report

NCEEP Project Number: 94151

Equinox Environmental Consultation and Design, Inc.

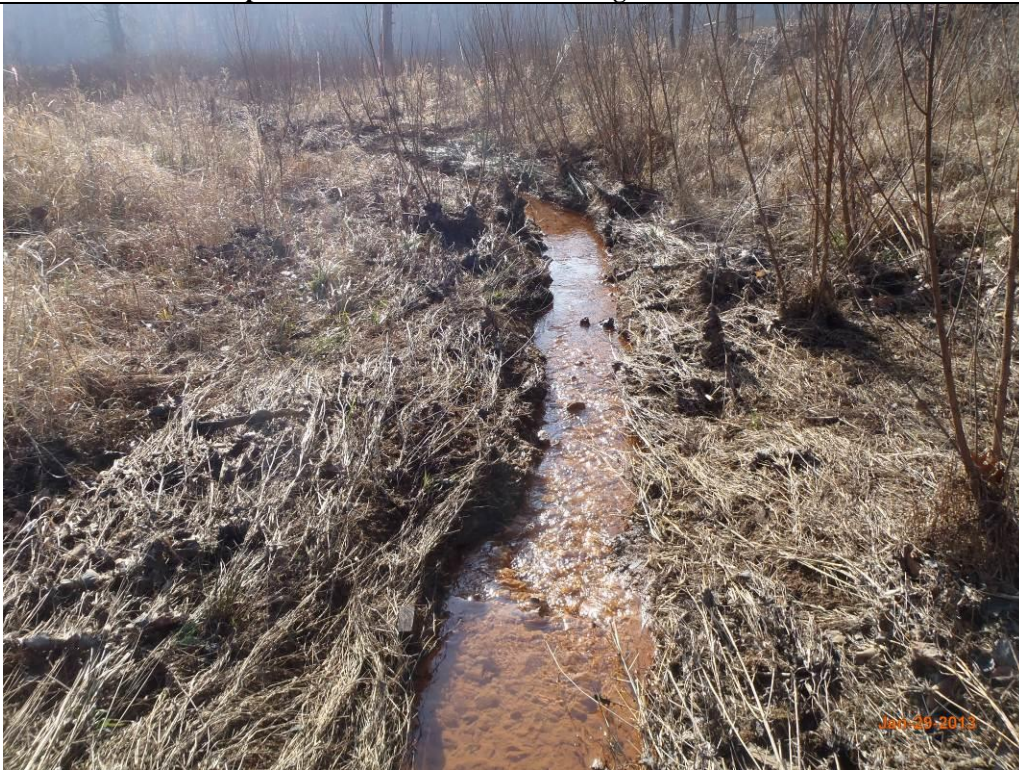
Reach 2 Sta. 118+00 – Wrack Lines

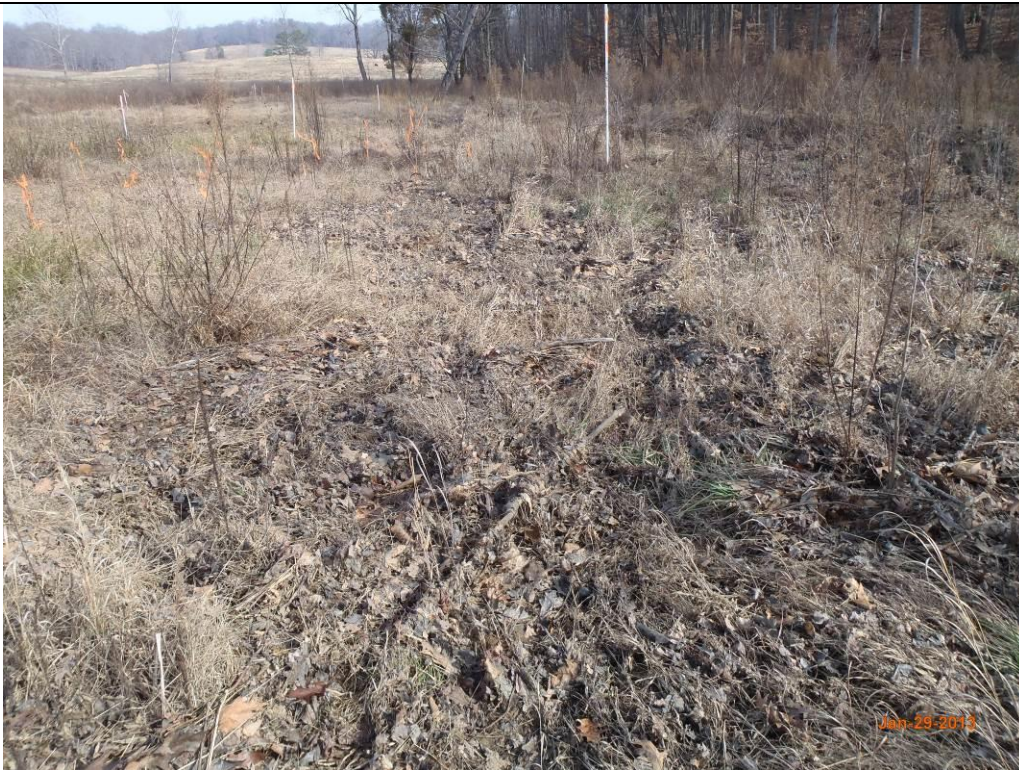
Reach 1 Sta. 311+00 – Wrack Lines

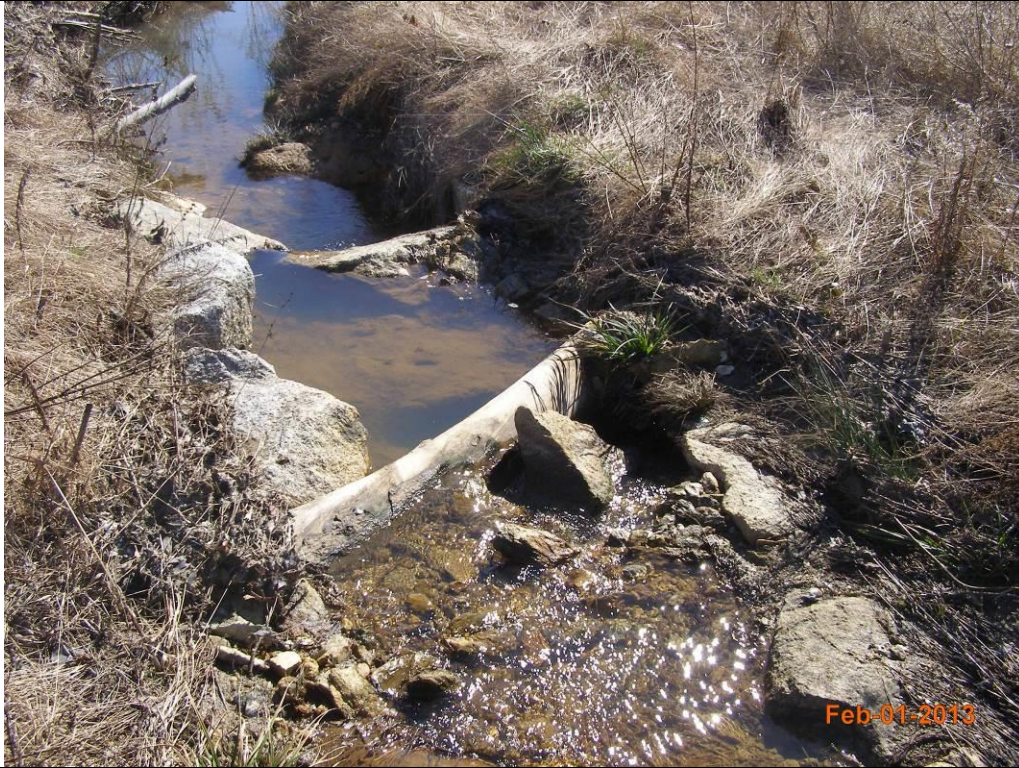
6-S Reach 4 Sta. 102+30 – Stressed Structure

Problem Area and Type <sup>1</sup>	Feature	Reach	STA	Description	Recommendation
1-S	Riffle	1	305+50	Degradation	Continue to monitor
2-S	Riffle	1	318+50	Degradation	Continue to monitor
3-S	Riffle	1	320+50	Degradation	Continue to monitor
4-S	Riffle	1	315+75	Degradation	Continue to monitor
5-S	Riffle	1	314+00	Degradation	Continue to monitor
6-S	Riffle	1	310+00	Degradation	Continue to monitor
7-S	Riffle	1	308+00	Degradation	Continue to monitor
8-S	Riffle	2	123+25	Degradation	Continue to monitor
9-V	Bench	2	118+00	Low Stem Density	Replant
10-V	Easement	3	201+50	Exotic Invasive	Treatment
11-S	Riffle/Structure	4	101+50	Stressed Structure	Continue to monitor
12-S	Structure	4	102+30	Stressed Structure	Continue to monitor
