North Fork Mountain Creek Monitoring Report

Monitoring Year 3 of 7

Stream and Wetland
EEP Contract No.002024
EEP Project No. 94151

Catawba County, NC
Data Collected: 3/21 – 11/13/2014
Submitted: January 2015

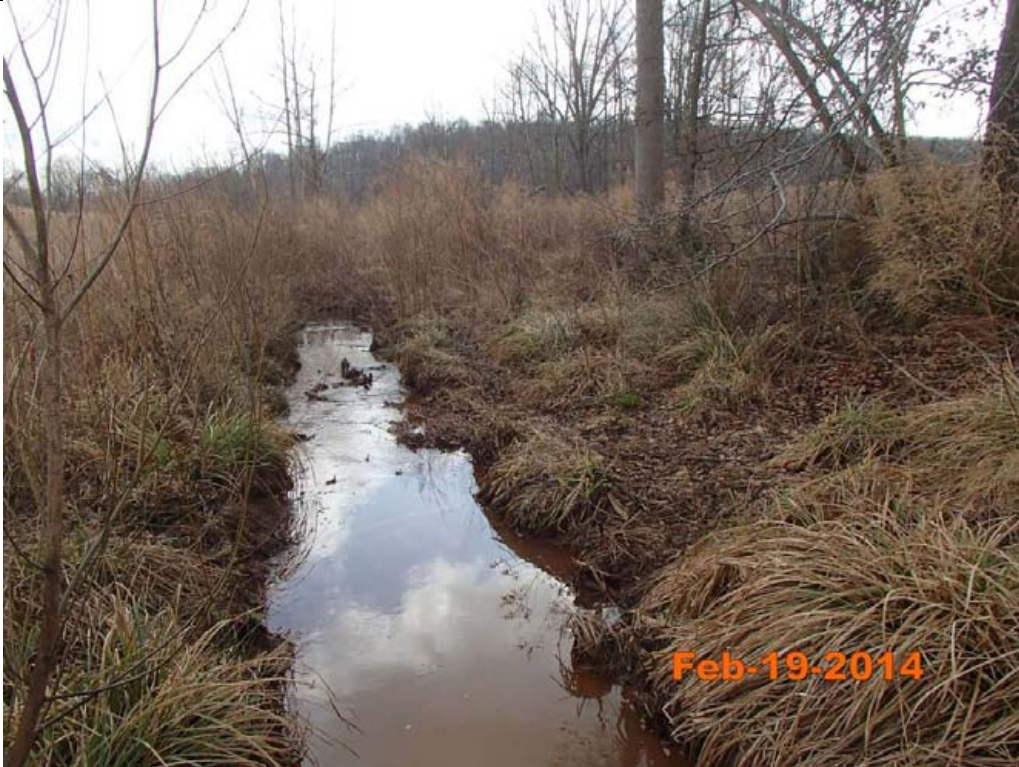
Reach 2 Sta. 114+75 – Wrack Lines

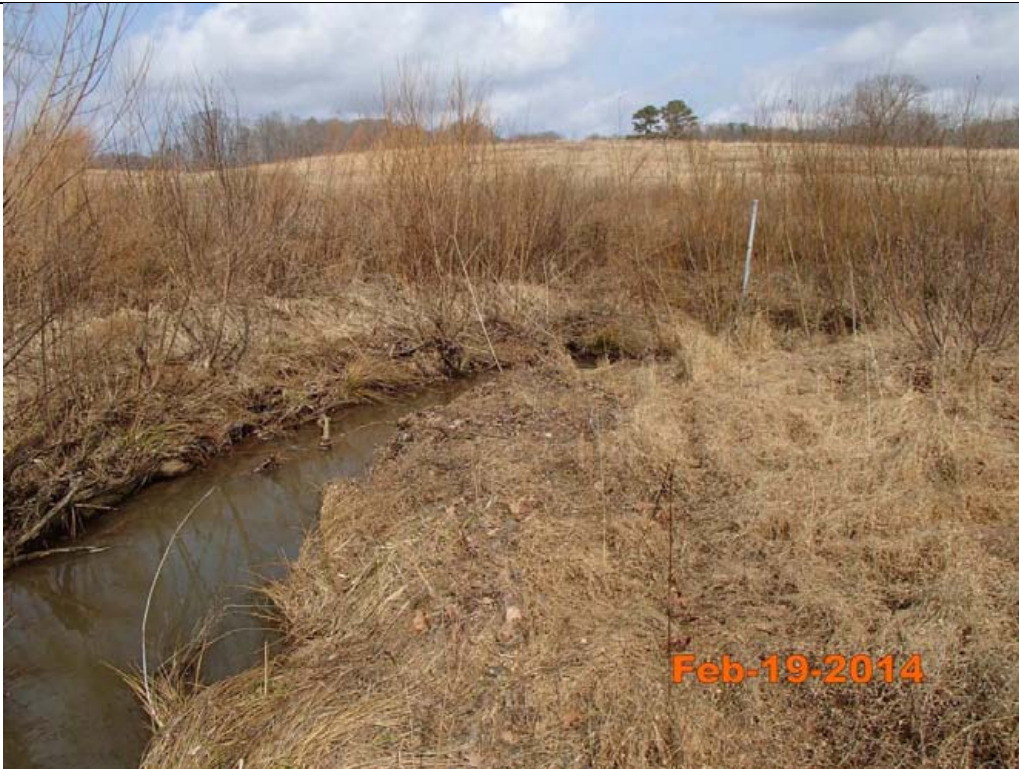
Reach 1 Sta. 320+75 – Wrack Lines
