North Fork Mountain Creek Monitoring Report

Monitoring Year 5 of 7

Stream and Wetland
NCDMS Contract No.002024
NCDMS Project No. 94151

Catawba County, NC
Data Collected: 3/11/2016 – 11/11/2016
Submitted: November 2016

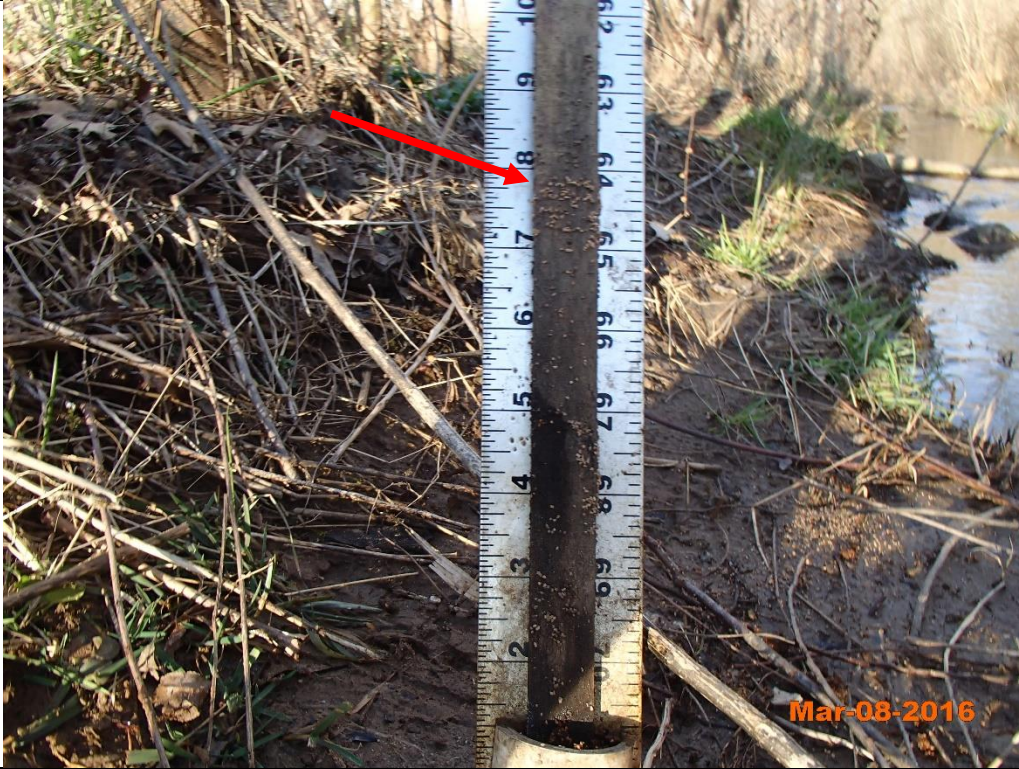
Reach 1 Crest Gauge

Since project completion in June 2012 five bankfull events have occurred at the project site (Table 10). An initial bankfull event occurred in August 2012, which registered 0.58 foot above bankfull on UT1-Reach 2. The crest gauge on North Fork Mountain Creek- Reach 1 was damaged from the event and, as a consequence, the water level above bankfull could not be determined; however, the event was photo documented. A second event was documented using wrack lines in January 2013. The third event registered on the Reach 1 crest gauge as 0.33 foot above bankfull. The Reach 2 crest gauge did not register a bankfull event; however, photo-documentation of wrack lines along the reach indicated that a bankfull event did occur on this reach as well. During MY4, crest gauge data and wrack line observations on both Reach 1 and Reach 2 indicated a bankfull event had occurred (Appendix E; Table 10). During MY5, one bankfull event was noted on Reach 1 with the crest gauge recording a water level 0.10 foot above bankfull.

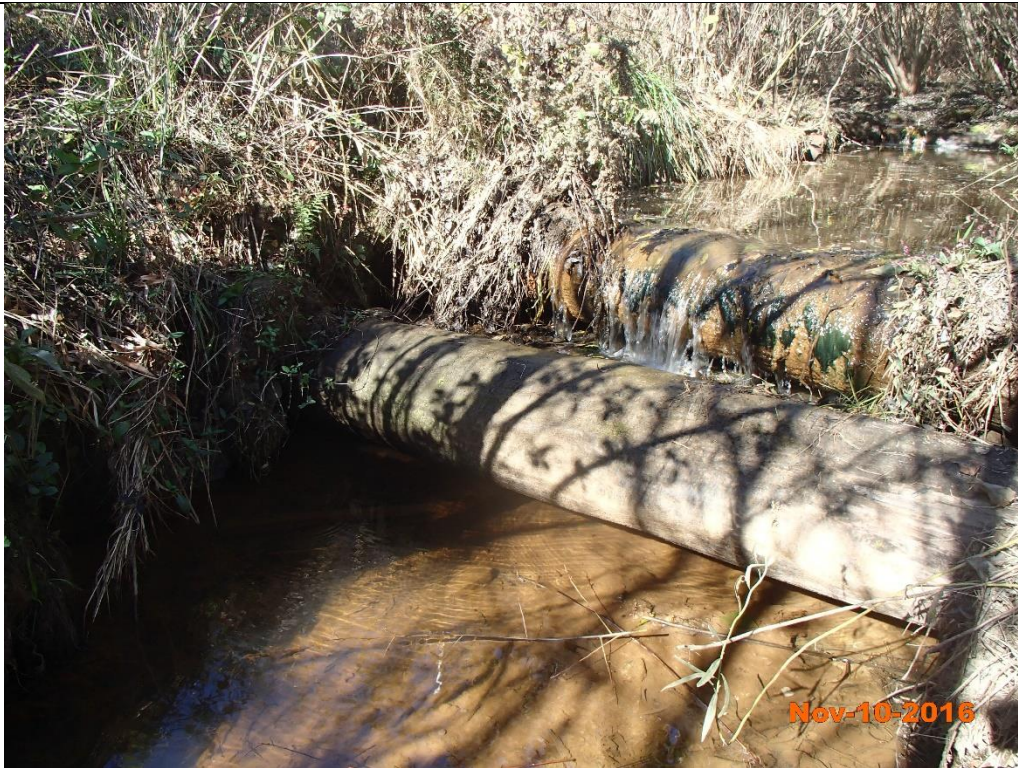
Reach 2 Sta. 106+00– Stressed Structure

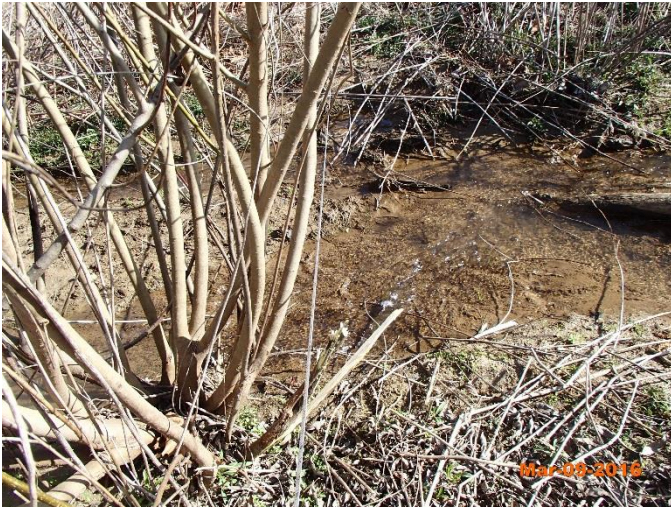
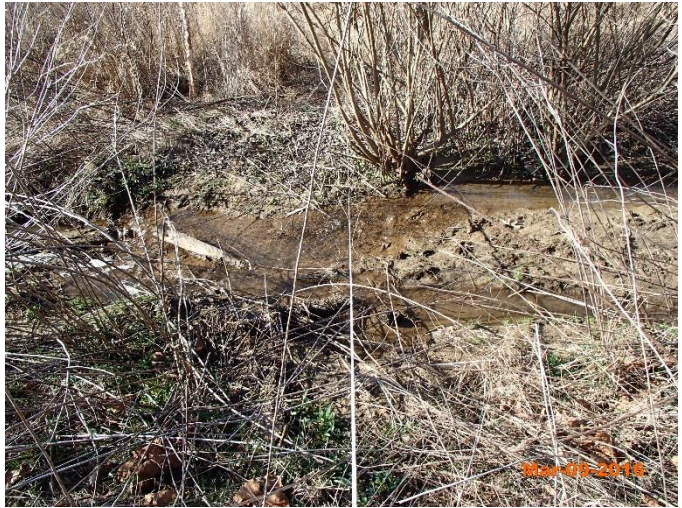
Cross Section 1 Reach 4 – Riffle

Stream morphology data collected during MY5 indicates that, in general, the stream is stable. However, several noticeable changes were noted in the cross-section dimensions between MY3 and MY5 monitoring efforts. Cross-sections 1 and 2, located in Reach 4, remained relatively stable between MY3 and MY5. The formation of a berm on the left descending bank (LDB) of cross-section 1 led to a one foot decrease in bankfull width. Deposition of fine sediment has reduced the max depths at cross-sections 1 and 2, 0.2 feet and 0.3 foot, respectively. Cross-sections 3 through 11, located in Reach 2, remained stable between MY3 and MY5. The most significant changes took place at the lower end of the reach, with cross-sections 10 and 11 demonstrating the greatest change between MY3 and MY5. At cross-section 10 the bankfull width decreased by 1.0 foot and the max depth increased by 0.5 foot, ultimately decreasing the width/depth (W/D) ratio from 17.8 to 12.4. Scour along the right descending bank (RDB) at cross-section 11 led to an increased bankfull width of 1.7 feet. Reach 3, containing cross-sections 12 and 13, also remained somewhat stable between MY3 and MY5. The most substantial change took place at cross-section 13, where deposition along the RDB decreased bankfull width by 1.0 foot. Reach 1 cross-sectional dimensions, which includes cross-sections 14 through 26, remained mostly stable since the last morphological data collection. The most apparent change in morphological dimensions took place at cross-section 22, where the riffle has cut down 0.8 foot between MY3 and MY5.

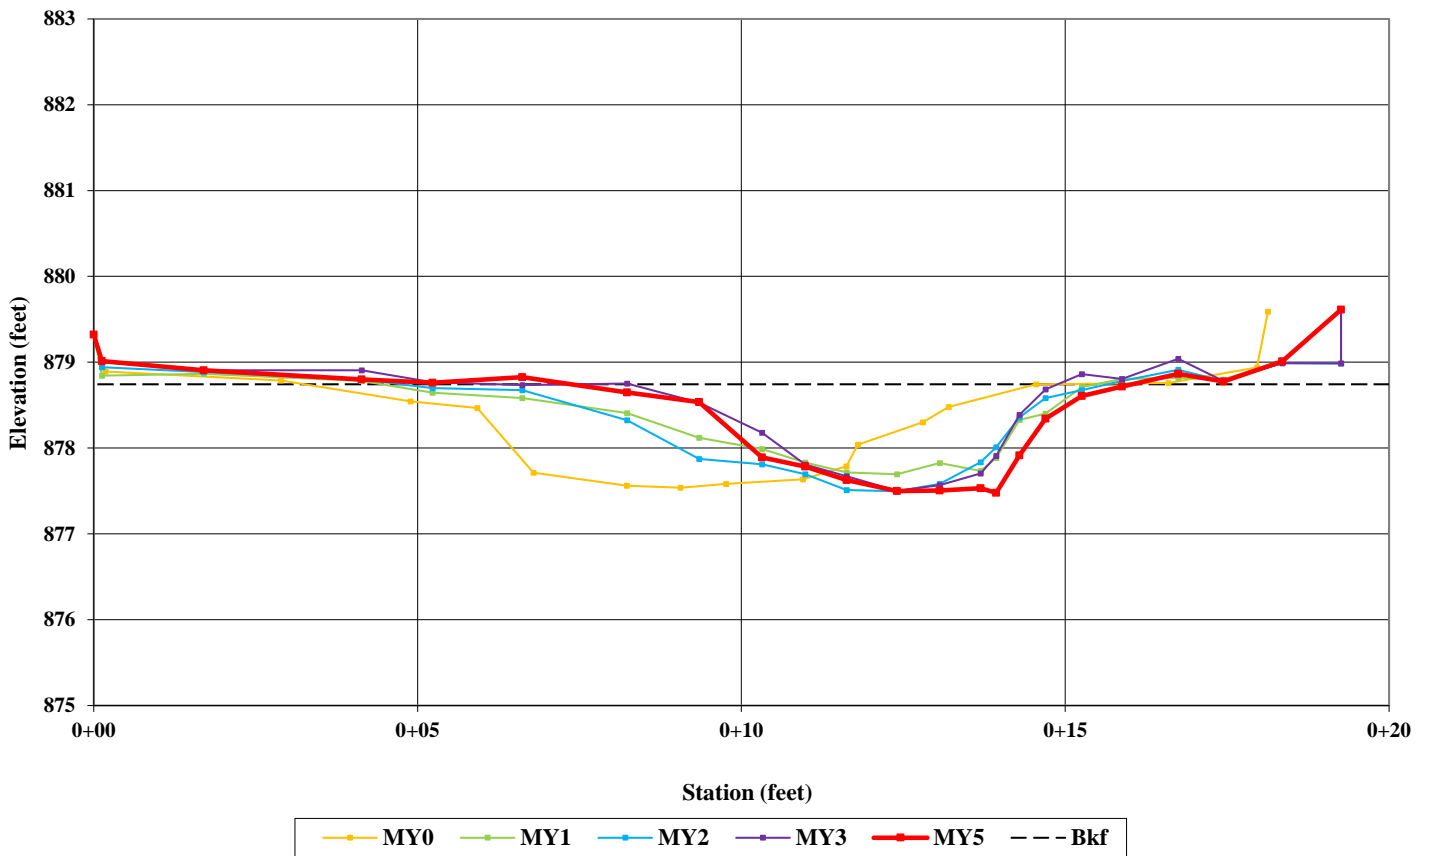
Cross Section 11 Reach 2 - Riffle Station 120+73

*The shift represented in the above figure is due to an inconsistency in surveying the correct pins between monitoring years.
