Annual Monitoring Report

Monitoring Year 6 of 7

North Fork Mountain Creek Stream and Wetland Restoration Site

NCDMS Project No.: 94151

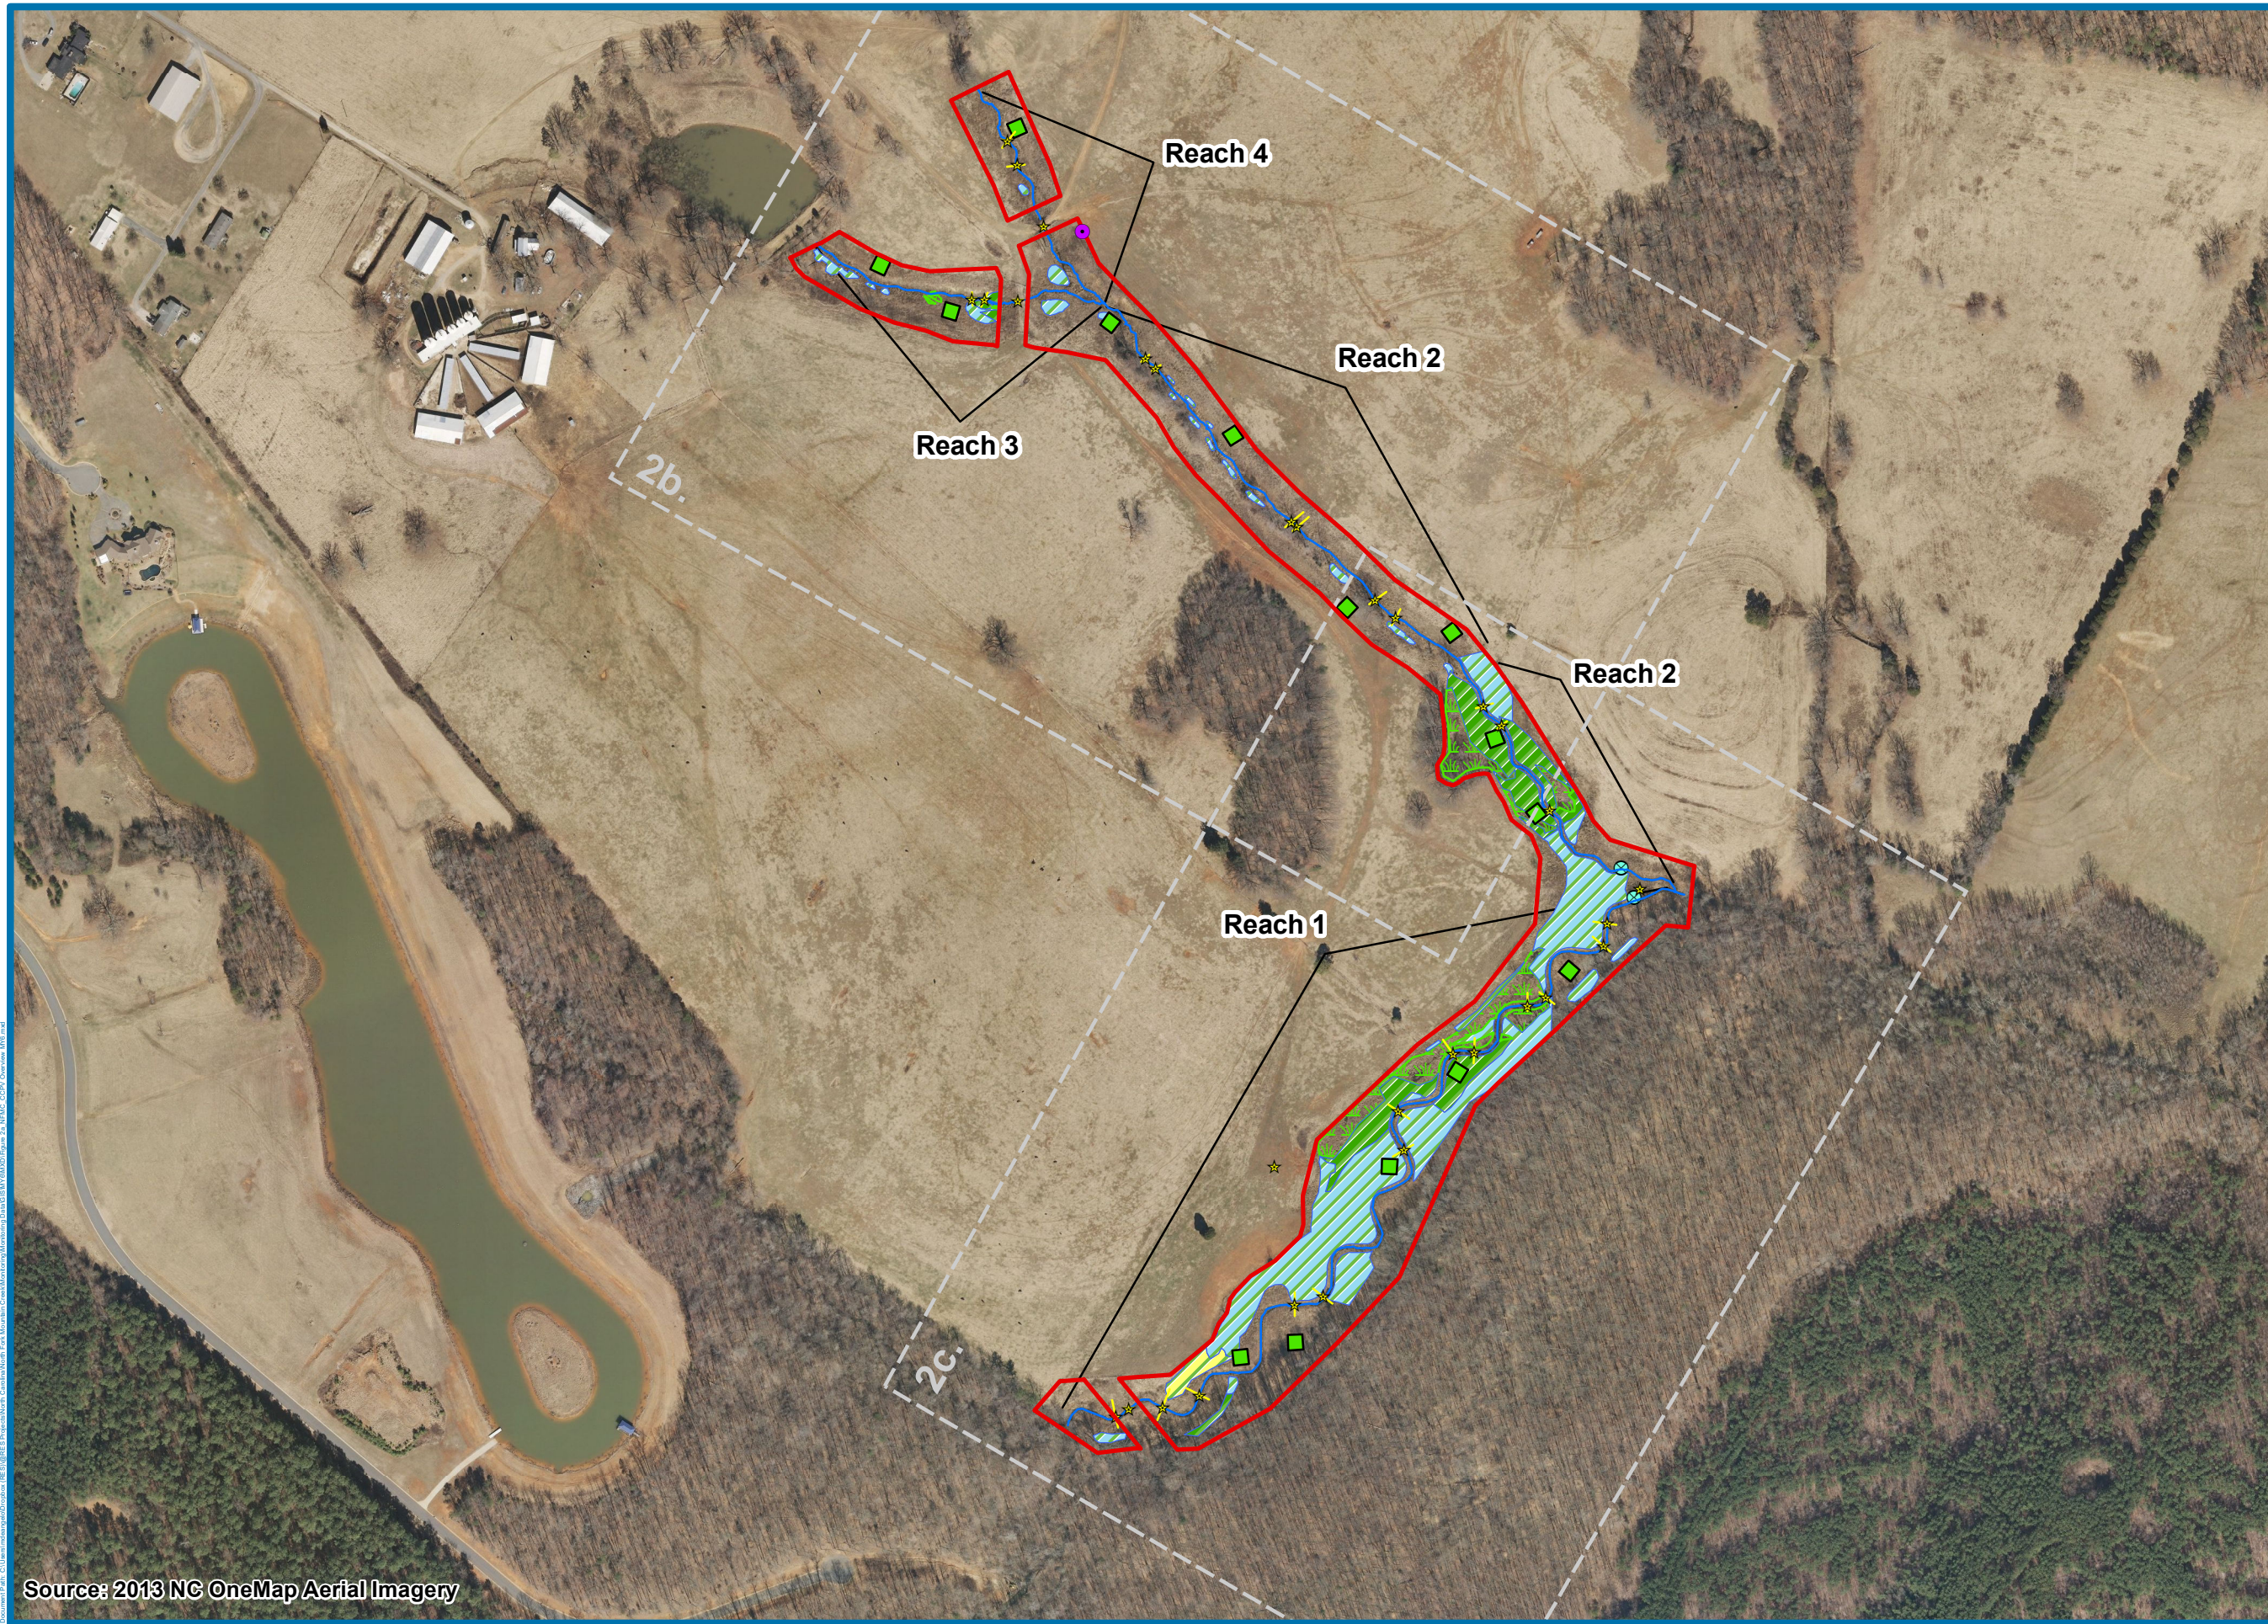
Figure 2a.
NFMC
Stream & Wetland
Restoration Project
MY6 2017

and volunteer vegetation, and documenting the presence of invasive plant species. Stream problem areas consist of stream bed degradation and aggradation, bank scour, and stressed structures (**Figure 2, Table 4a**). RES will address any areas of severe aggradation, degradation, and scour throughout the site that presents a stream stability problem. Remedial work would include adding riffle material, adding live stakes along the banks, and if necessary installing grade control structures in the riffles where degradation is present. A maintenance plan will be developed and implemented in 2018. Vegetation problem areas consist of small, localized pockets of poor growth/vigor and invasive species (**Figure 2, Table 4b**). Representative photos of problem areas are located in Appendix B. Representative photos of problem areas can be accessed through the digital e-submission file submitted to NCDMS. Numerous stream problem areas that were noted in MY5 have improved or become stable and therefore are not considered problem areas in MY6. In particular, several areas of bed degradation from MY5 appeared to re-establish riffle bedform in MY6, while several bank erosion areas from MY5 have stabilized as woody vegetation on the banks have matured. Numerous vegetation problem areas from MY5 have also improved and are not considered problem areas in MY6. In particular, one low stem density area from MY5 has been reclassified as area of poor growth rate/vigor for MY6 as it contains substantial woody vegetation, though with less vigorous growth as compared to the surrounding easement vegetation.

[RES will develop a maintenance plan to address these issues and it will be implemented in 2018. This has been added to the report.](#)

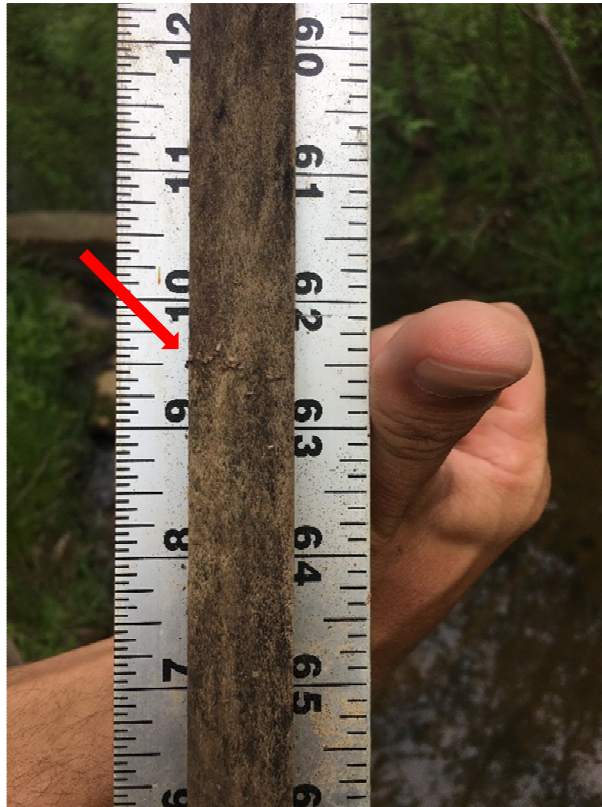
Crest Gauge @ Reach 1 – 0.79 ft. = 0.24 ft. above bankfull
