Annual Monitoring Report

Monitoring Year 7 of 7

North Fork Mountain Creek Stream and Wetland Restoration Site

NCDMS Project No.: 94151

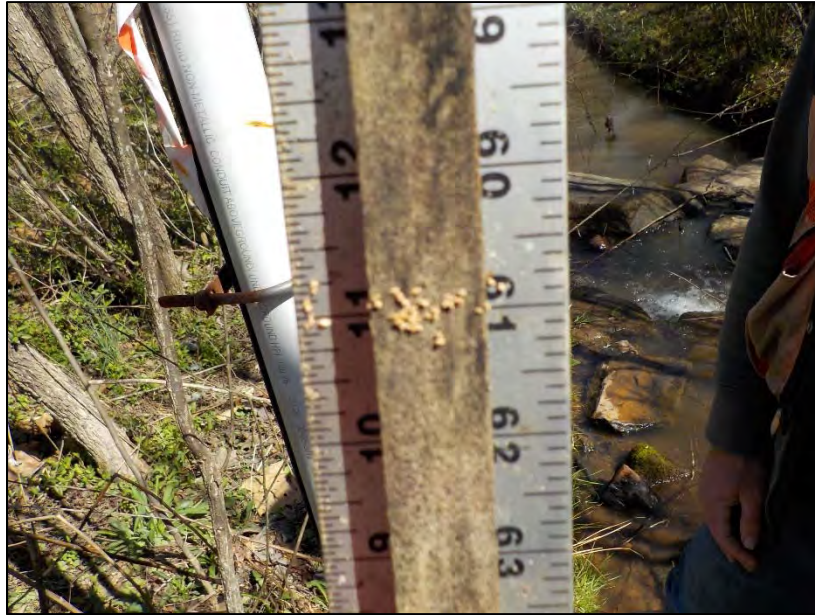
Crest Gauge @ Reach 4 – 0.92 ft above bankfull

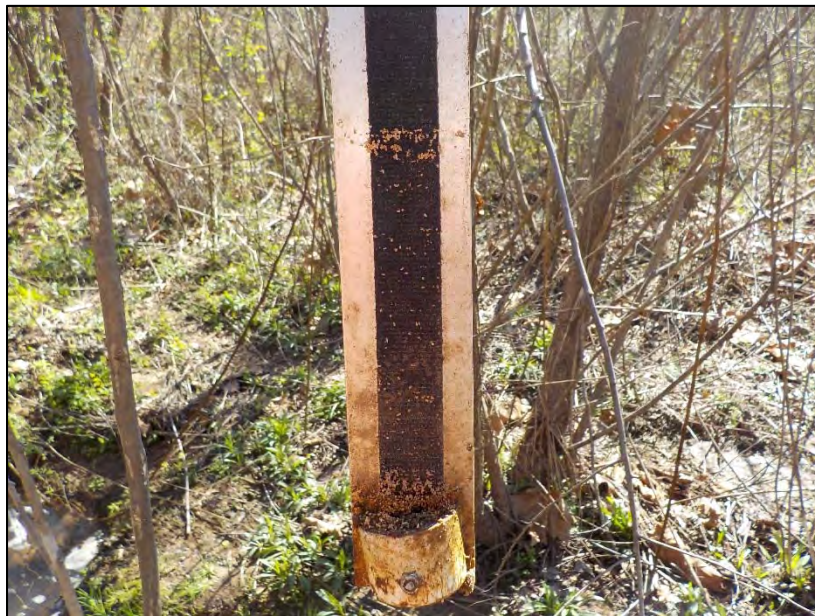
Crest Gauge @ Reach 2 – 0.58 ft above bankfull

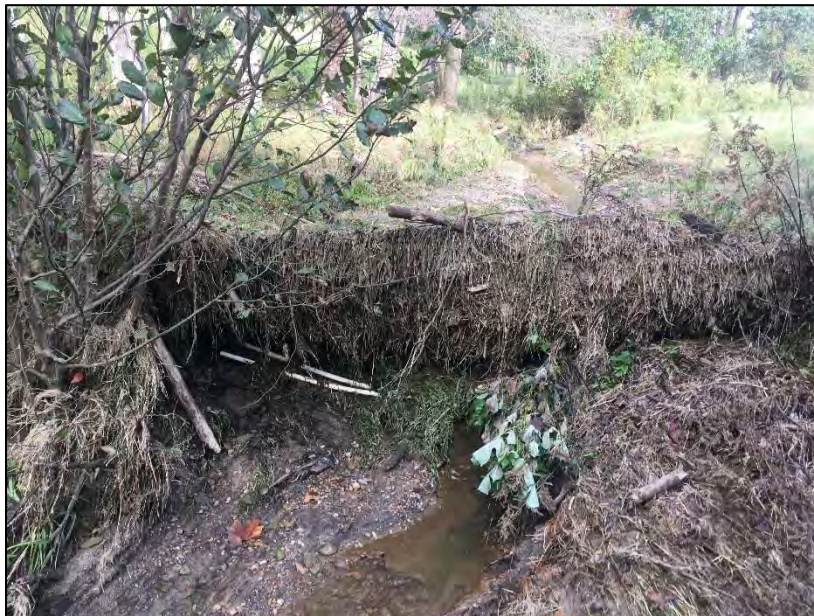
Wrack line on fence @ top of Reach 1
