MONITORING YEAR 1 ANNUAL REPORT FINAL

OAK HILL DAIRY MITIGATION SITE

Gaston County, NC
Catawba River basin
HUC 03050102

DMS Project No. 100120
DMS Contract No. 7867
DMS RFP No. 16-007704 (Issued: September 6, 2018)
USACE Action ID No. SAW-2019-00833
DWR Project No. 2019-0863
Data Collection Dates: June 2023 – December 2023

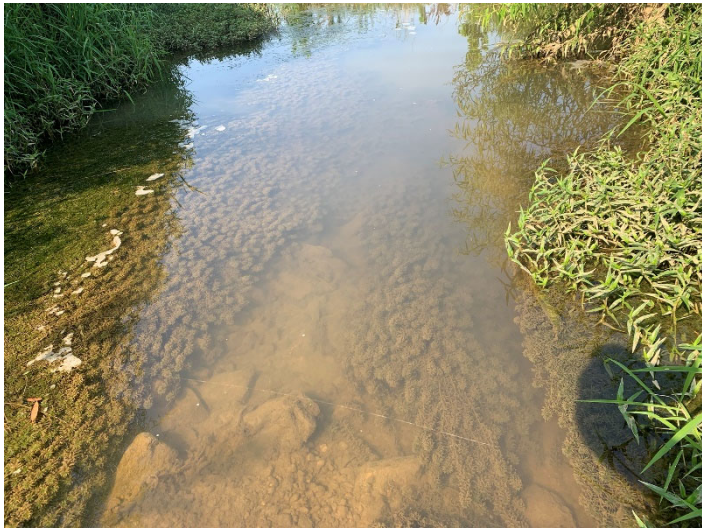
Oak Hill Creek R4 – Hydrilla STA 119+00 – 123+50 (8/2/2023)

Wildlands Response: Hand tools were used to remove Hydrilla. Wildlands will continue to monitor and treat the Hydrilla. Updates will be included in the MY2 (2024) report.

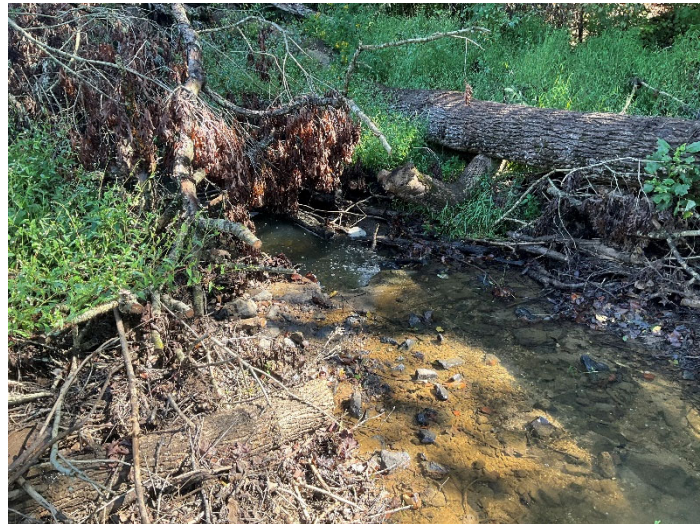
Oak Hill Creek R1 – Downed Tree STA: 104+50 (9/18/2023)
