OAKLEY CROSSROADS  
STREAM & BUFFER RESTORATION  
MONITORING REPORT (YEAR 1 OF 5)

Pitt County, North Carolina  
SCO Project Number 050659701  
EEP Project Number 273

Status of Plan: Final  
Construction Completed: 2011  
Data Collected: 2011  
Submission Date: November 2011

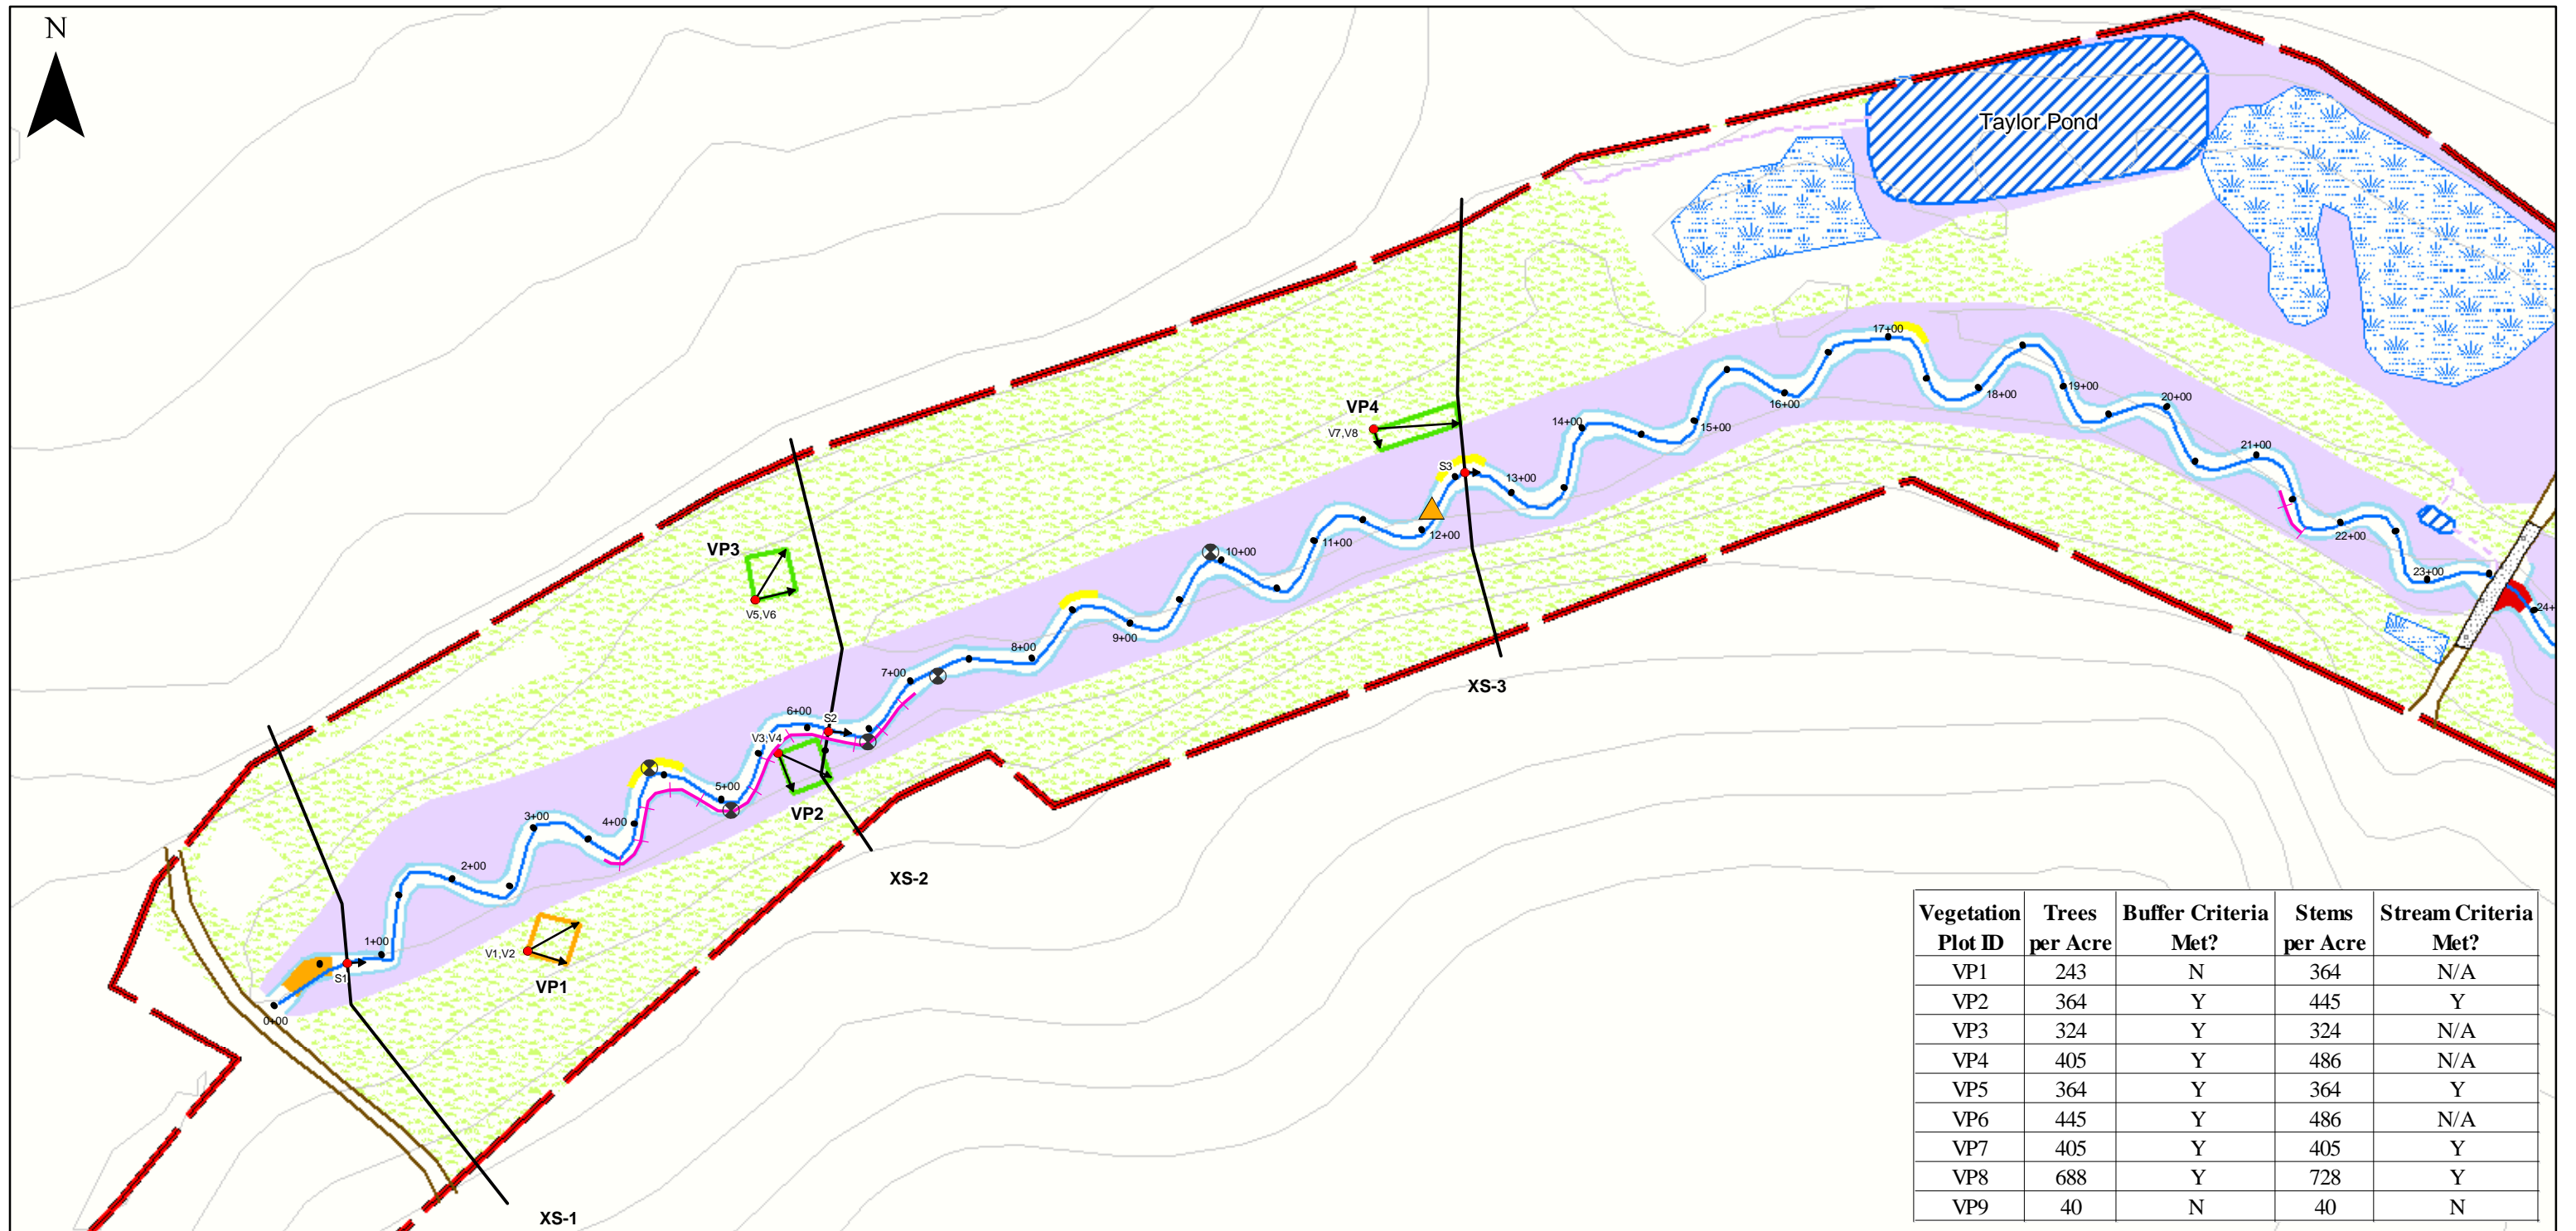
**Figure 2a. Current Condition Plan View**

Vegetation Plot ID	Trees per Acre	Buffer Criteria Met?	Stems per Acre	Stream Criteria Met?
VP1	243	N	364	N/A
VP2	364	Y	445	Y
VP3	324	Y	324	N/A
VP4	405	Y	486	N/A
VP5	364	Y	364	Y
VP6	445	Y	486	N/A
VP7	405	Y	405	Y
VP8	688	Y	728	Y
VP9	40	N	40	N

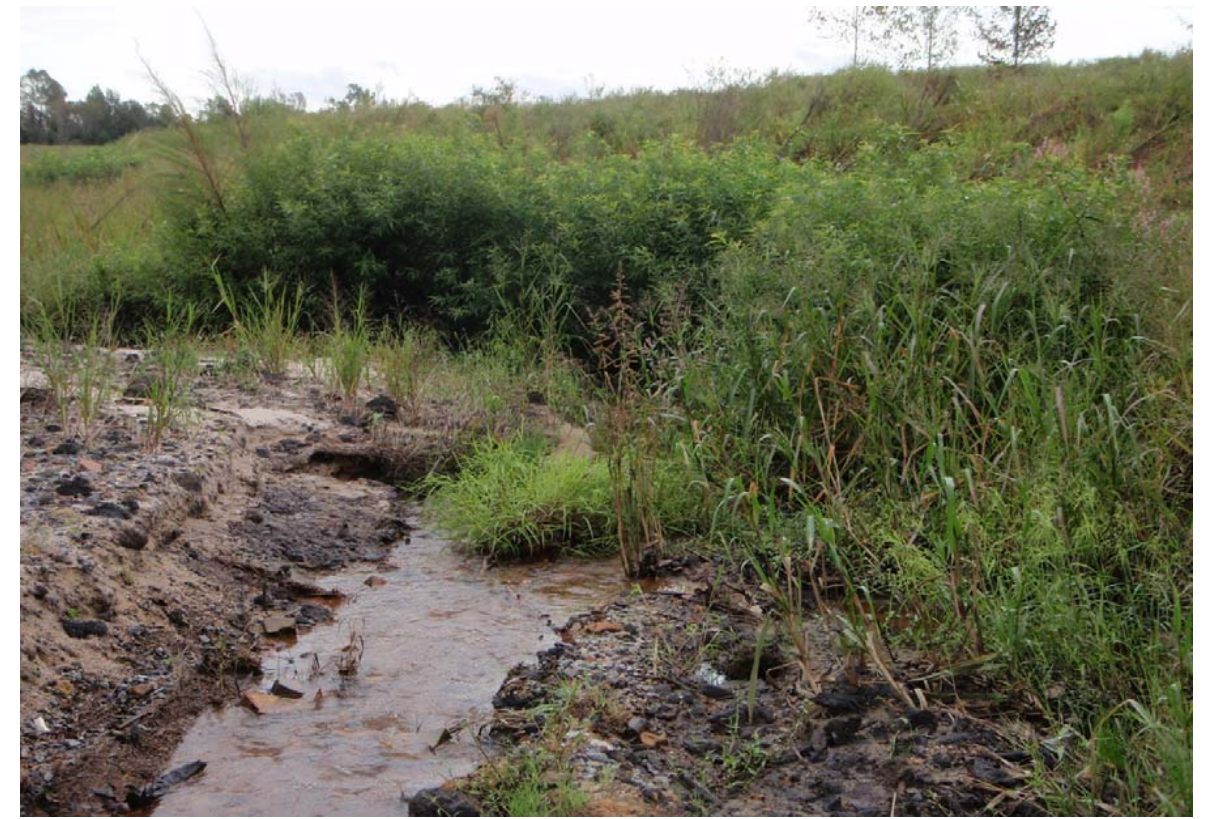
Oakley Crossroads - UT to Tranters Creek  
X-Section 1, Riffle, Station 0+72

SUMMARY DATA	MY00	MY01
Bankfull Elevation	40.63	40.72
Bankfull Cross-Sectional Area	18.33	8.37
Bankfull Width	20.80	12.39
Flood Prone Area Elevation	42.78	41.63
Flood Prone Width	80.66	65.65
Max Depth at Bankfull	2.15	1.14
Mean Depth at Bankfull	0.88	0.68
W/D Ratio	23.64	18.22
Entrenchment Ratio	3.88	5.30
Bank Height Ratio	1.00	1.00
Stream Type	C	C

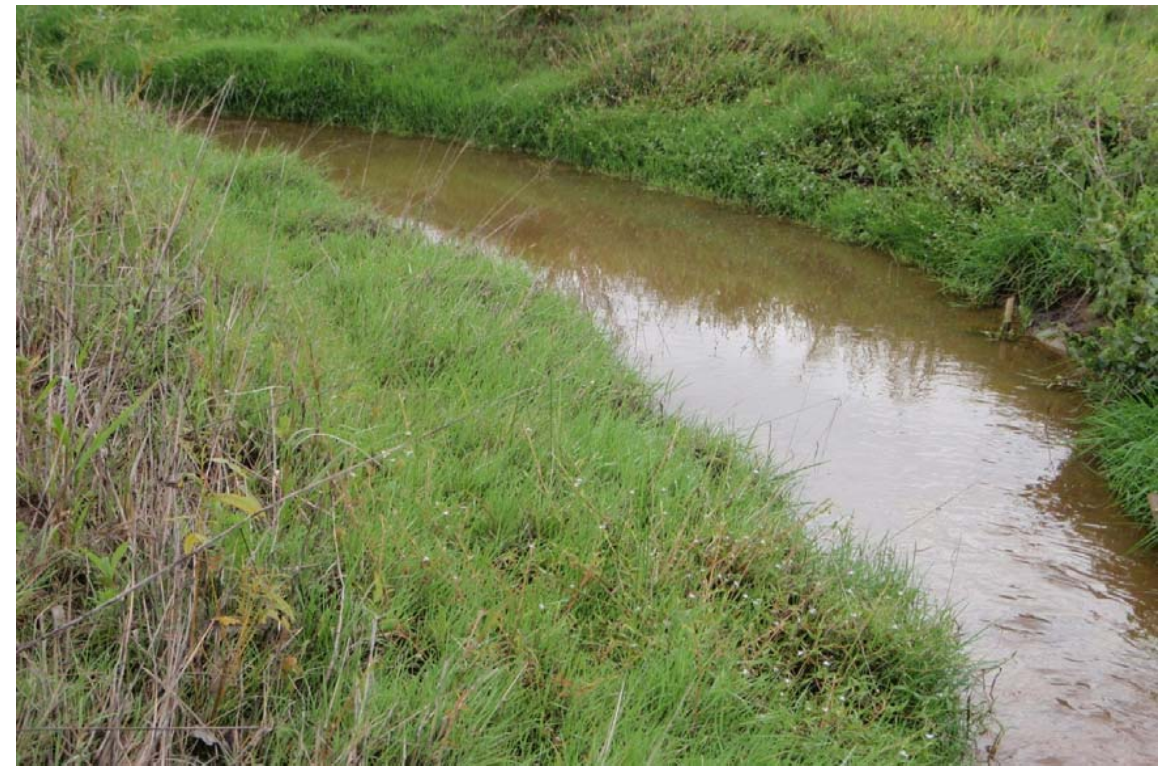
**Oakley Crossroads - UT to Tranters Creek  
X-Section 2, Riffle, Station 6+17**

SUMMARY DATA	MY00	MY01
Bankfull Elevation	40.35	40.38
Bankfull Cross-Sectional Area	18.16	17.88
Bankfull Width	16.60	13.16
Flood Prone Area Elevation	42.89	43.06
Flood Prone Width	124.27	124.27
Max Depth at Bankfull	2.54	2.68
Mean Depth at Bankfull	1.09	1.37
W/D Ratio	15.23	9.61
Entrenchment Ratio	7.49	9.44
Bank Height Ratio	1.00	1.00
Stream Type	C	C

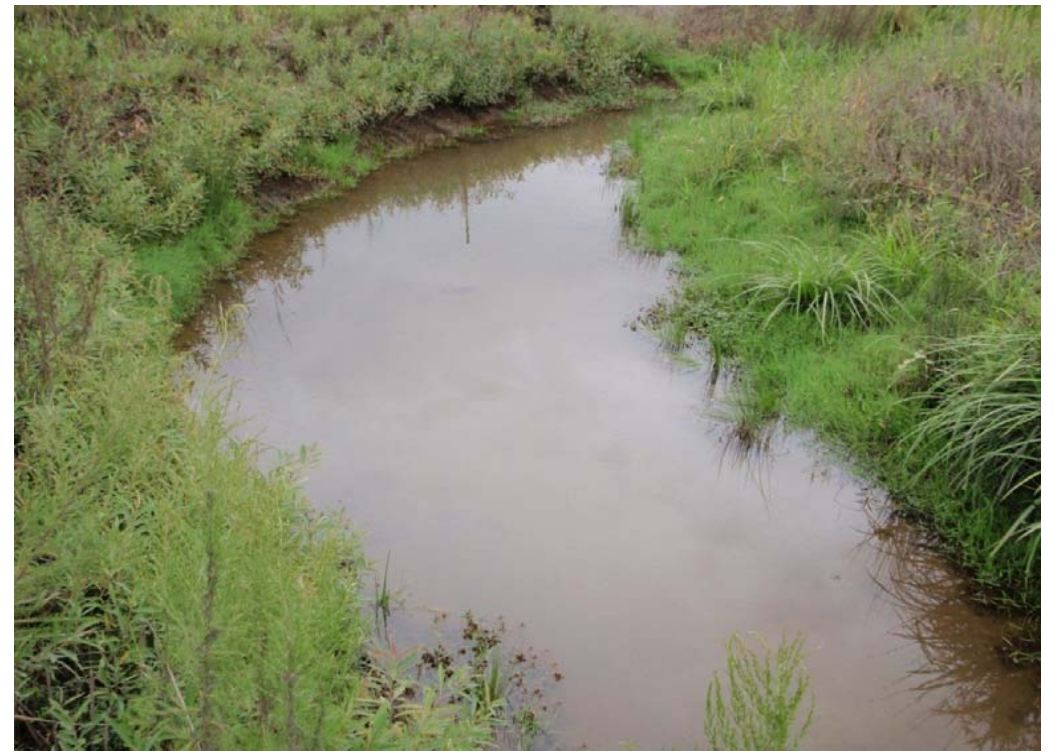
**Oakley Crossroads - UT to Tranters Creek**  
**X-Section 3, Pool, Station 12+59**

SUMMARY DATA	MY00	MY01
Bankfull Elevation	39.68	39.70
Bankfull Cross-Sectional Area	36.86	37.87
Bankfull Width	20.58	24.45
Flood Prone Area Elevation	43.11	43.11
Flood Prone Width	248.46	248.07
Max Depth at Bankfull	3.43	3.41
Mean Depth at Bankfull	1.79	1.55
W/D Ratio	11.50	15.77
Entrenchment Ratio	12.07	10.15
Bank Height Ratio	1.00	1.00
Stream Type	C	C

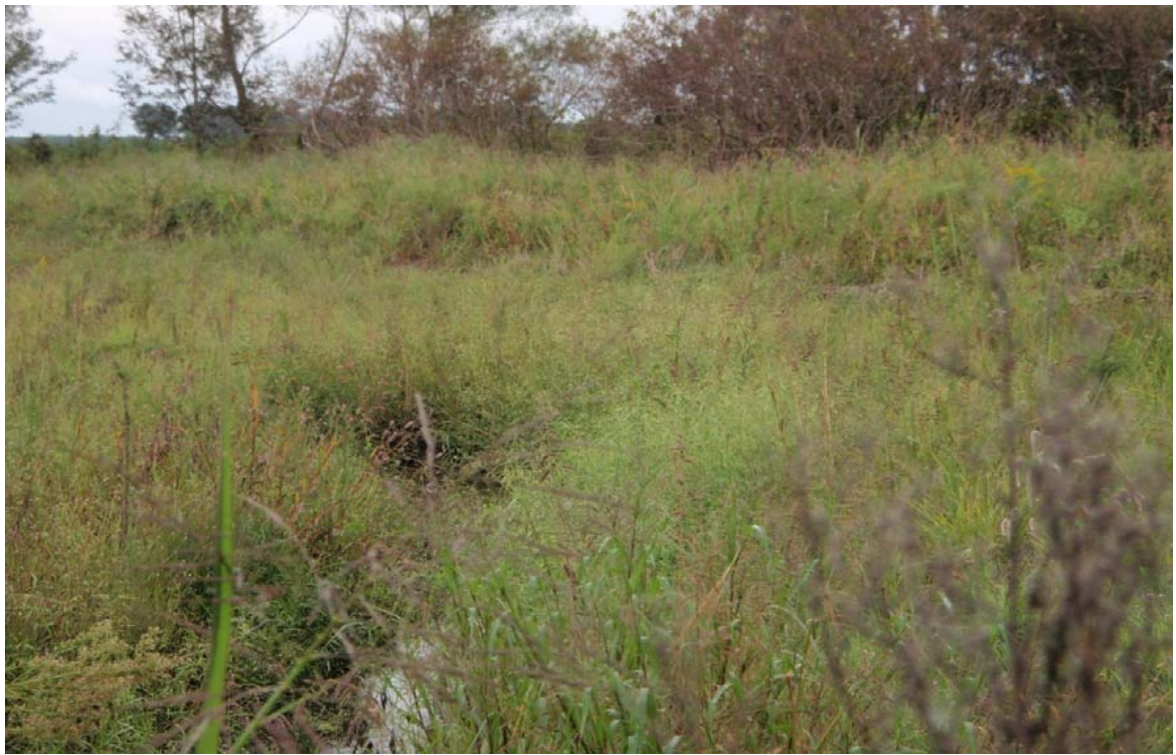
**Oakley Crossroads - UT to Tranters Creek  
X-Section 4, Riffle, Station 28+46**

SUMMARY DATA	MY00	MY01
Bankfull Elevation	38.24	37.85
Bankfull Cross-Sectional Area	20.90	18.22
Bankfull Width	14.64	13.70
Flood Prone Area Elevation	41.23	40.54
Flood Prone Width	367.14	332.68
Max Depth at Bankfull	2.99	2.69
Mean Depth at Bankfull	1.43	1.33
W/D Ratio	10.24	10.30
Entrenchment Ratio	25.08	24.28
Bank Height Ratio	1.00	1.00
Stream Type	C	C

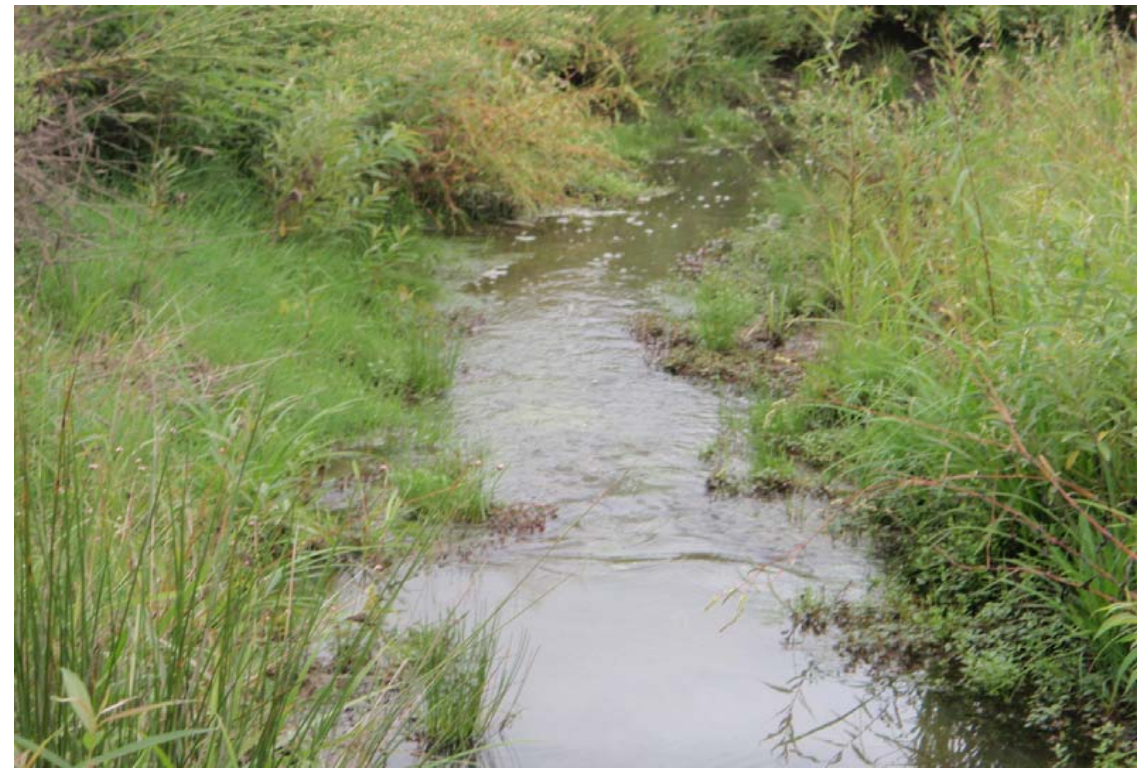
**Oakley Crossroads - UT to Tranters Creek  
X-Section 5 Pool, Station 32+71**

SUMMARY DATA	MY00	MY01*
Bankfull Elevation	37.26	37.33
Bankfull Cross-Sectional Area	29.47	35.63
Bankfull Width	19.06	29.71
Flood Prone Area Elevation	40.07	40.98
Flood Prone Width	289.16	315.10
Max Depth at Bankfull	2.81	3.65
Mean Depth at Bankfull	1.55	1.20
W/D Ratio	12.30	24.76
Entrenchment Ratio	15.17	10.61
Bank Height Ratio	1.00	1.00
Stream Type	C	C

\*Floodprone width adjusted to not include adjacent farm pond.

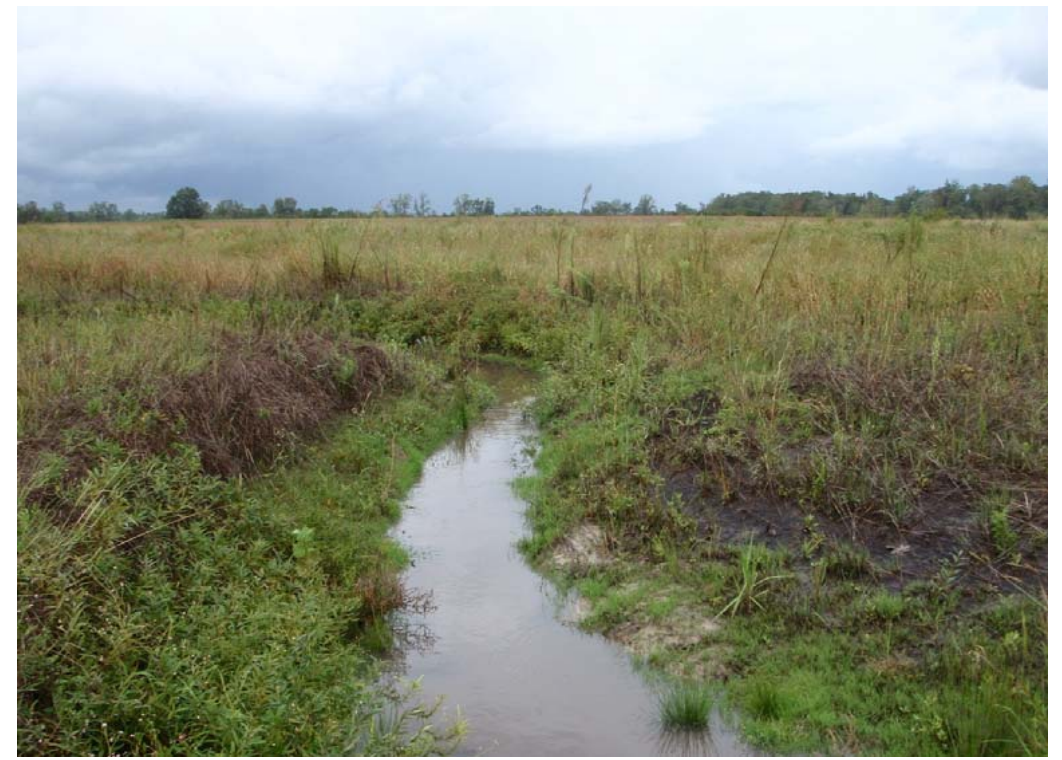
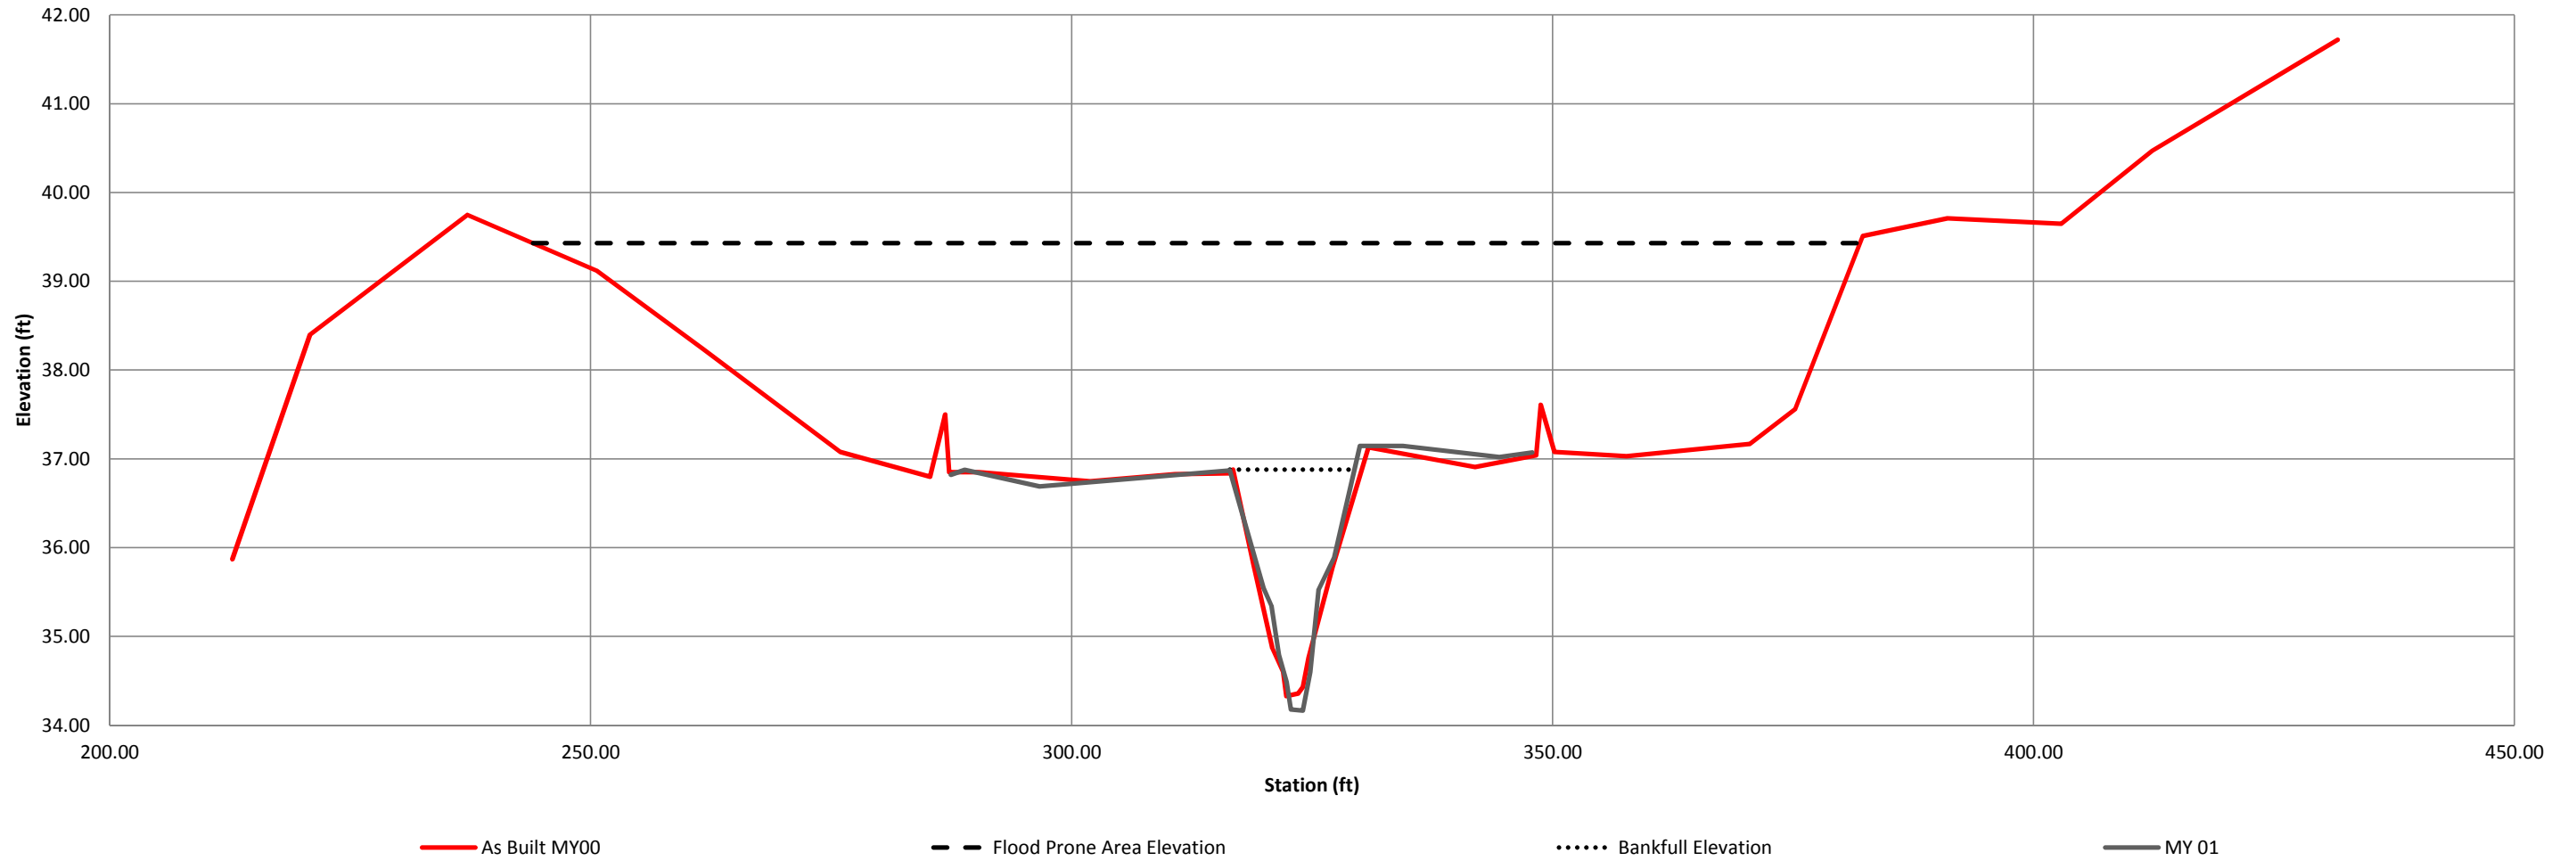
**Oakley Crossroads - UT to Transters Creek**  
**X-Section 6, Riffle, Station 35+24**

SUMMARY DATA	MY00	MY01
Bankfull Elevation	36.88	36.87
Bankfull Cross-Sectional Area	18.91	17.43
Bankfull Width	17.17	12.92
Flood Prone Area Elevation	39.43	39.57
Flood Prone Width	158.46	166.08
Max Depth at Bankfull	2.55	2.70
Mean Depth at Bankfull	1.10	1.35
W/D Ratio	15.61	9.59
Entrenchment Ratio	9.23	12.82
Bank Height Ratio	1.00	0.95
Stream Type	C	C

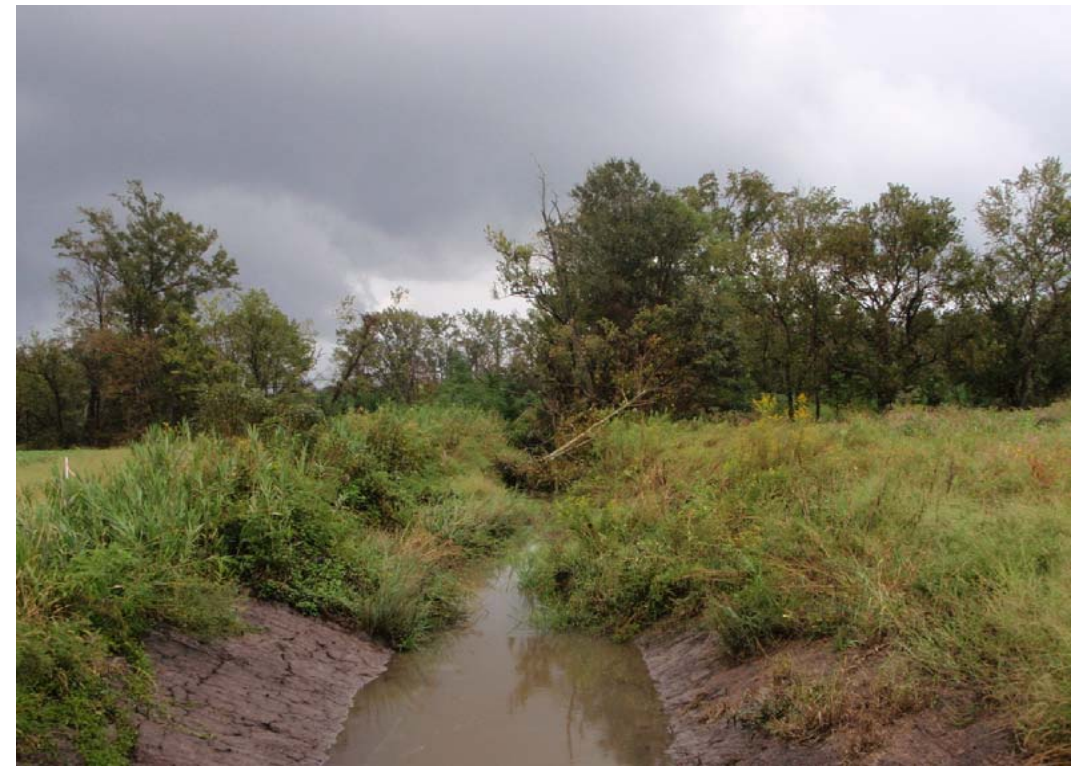
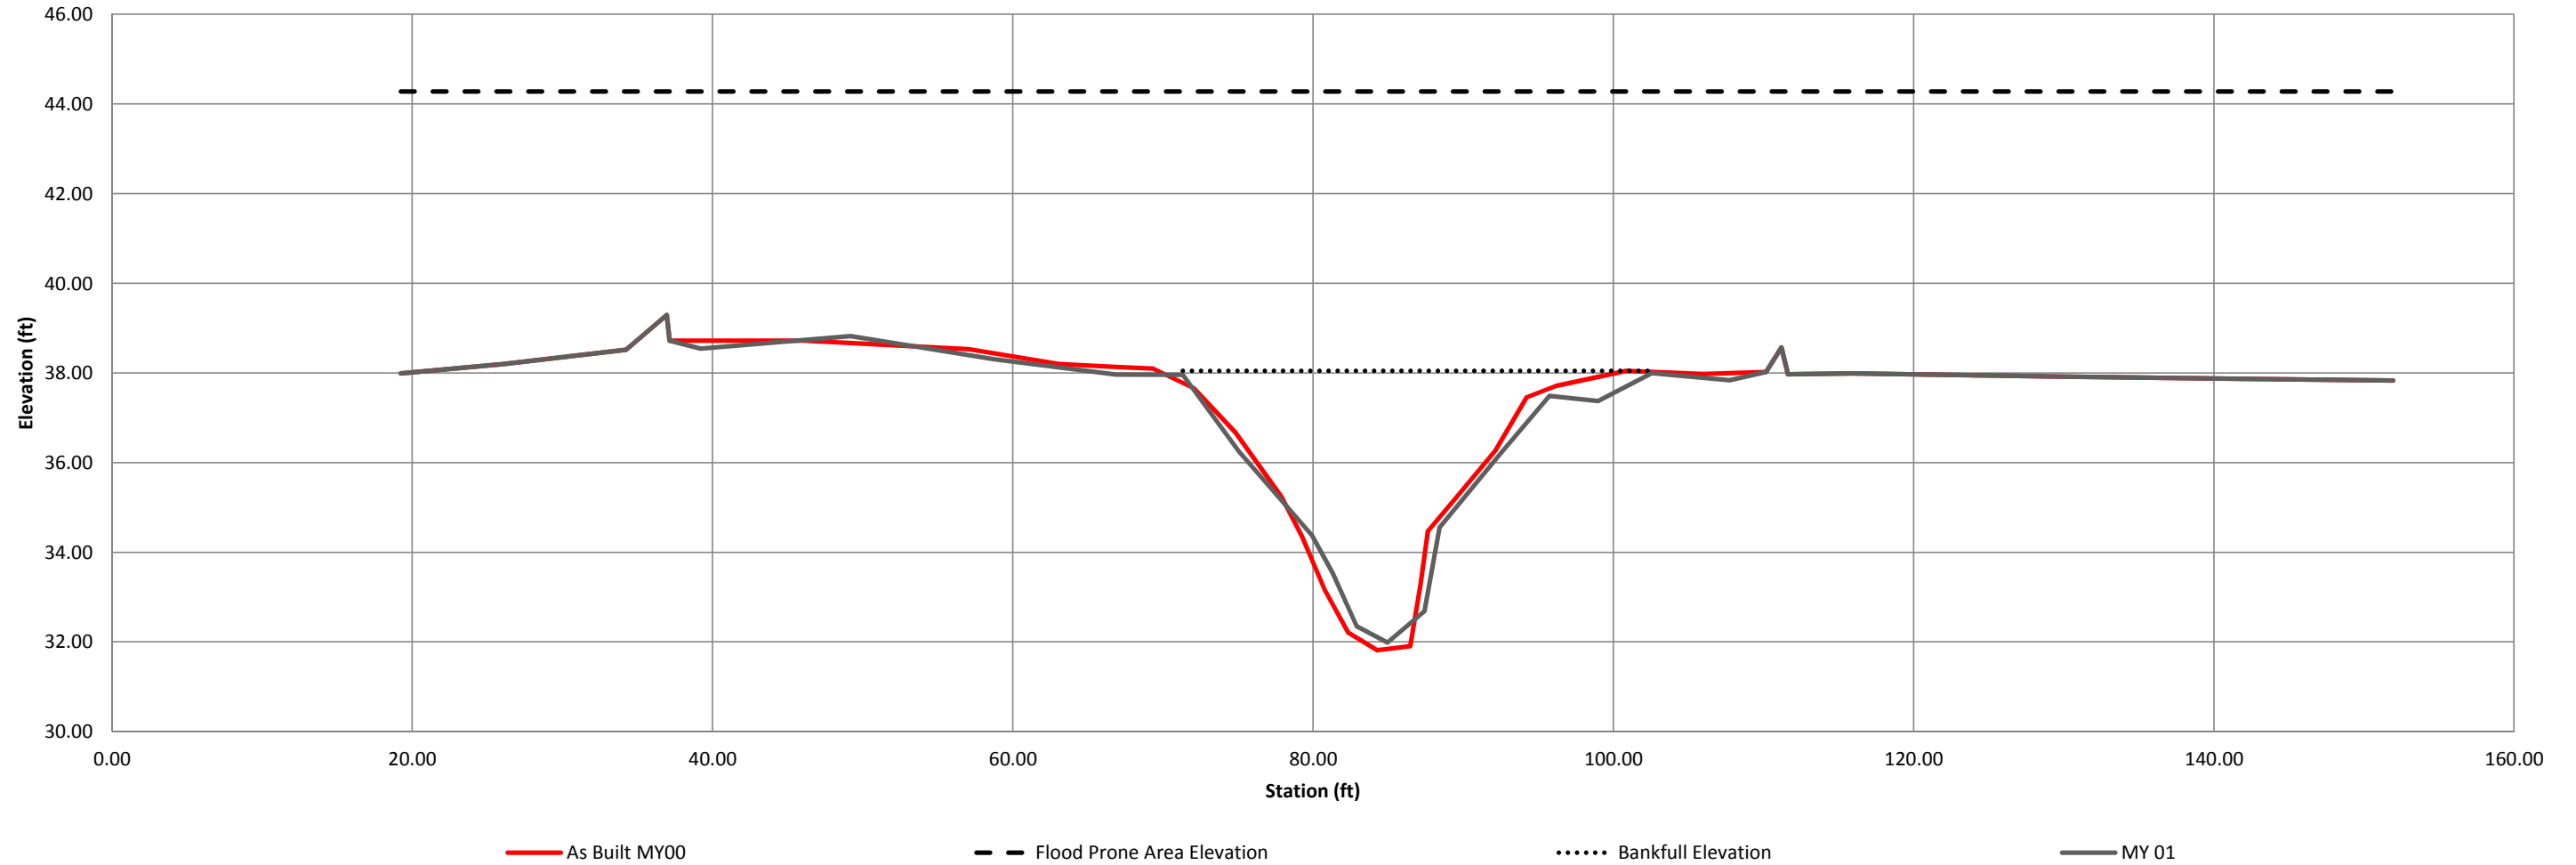
**Oakley Crossroads - UT to Tranters Creek  
X-Section 7 Riffle, Station 38+71**

SUMARY DATA	MY00*	MY01
Bankfull Elevation	38.05	38.00
Bankfull Cross-Sectional Area	75.91	77.93
Bankfull Width	31.46	36.52
Flood Prone Area Elevation	44.28	44.01
Flood Prone Width	132.69	132.69
Max Depth at Bankfull	6.23	6.01
Mean Depth at Bankfull	2.41	2.13
W/D Ratio	13.05	17.15
Entrenchment Ratio	4.22	3.63
Bank Height Ratio	1.00	1.00
Stream Type	C	C
