OAKLEY CROSSROADS (G)
STREAM & BUFFER RESTORATION
MONITORING REPORT (YEAR 4 OF 5)

Pitt County, North Carolina
SCO Project Number 050659701
EEP Project Number 273

Status of Plan: Final
Construction Completed: 2011
Data Collected: 2014
Submission Date: December 2014

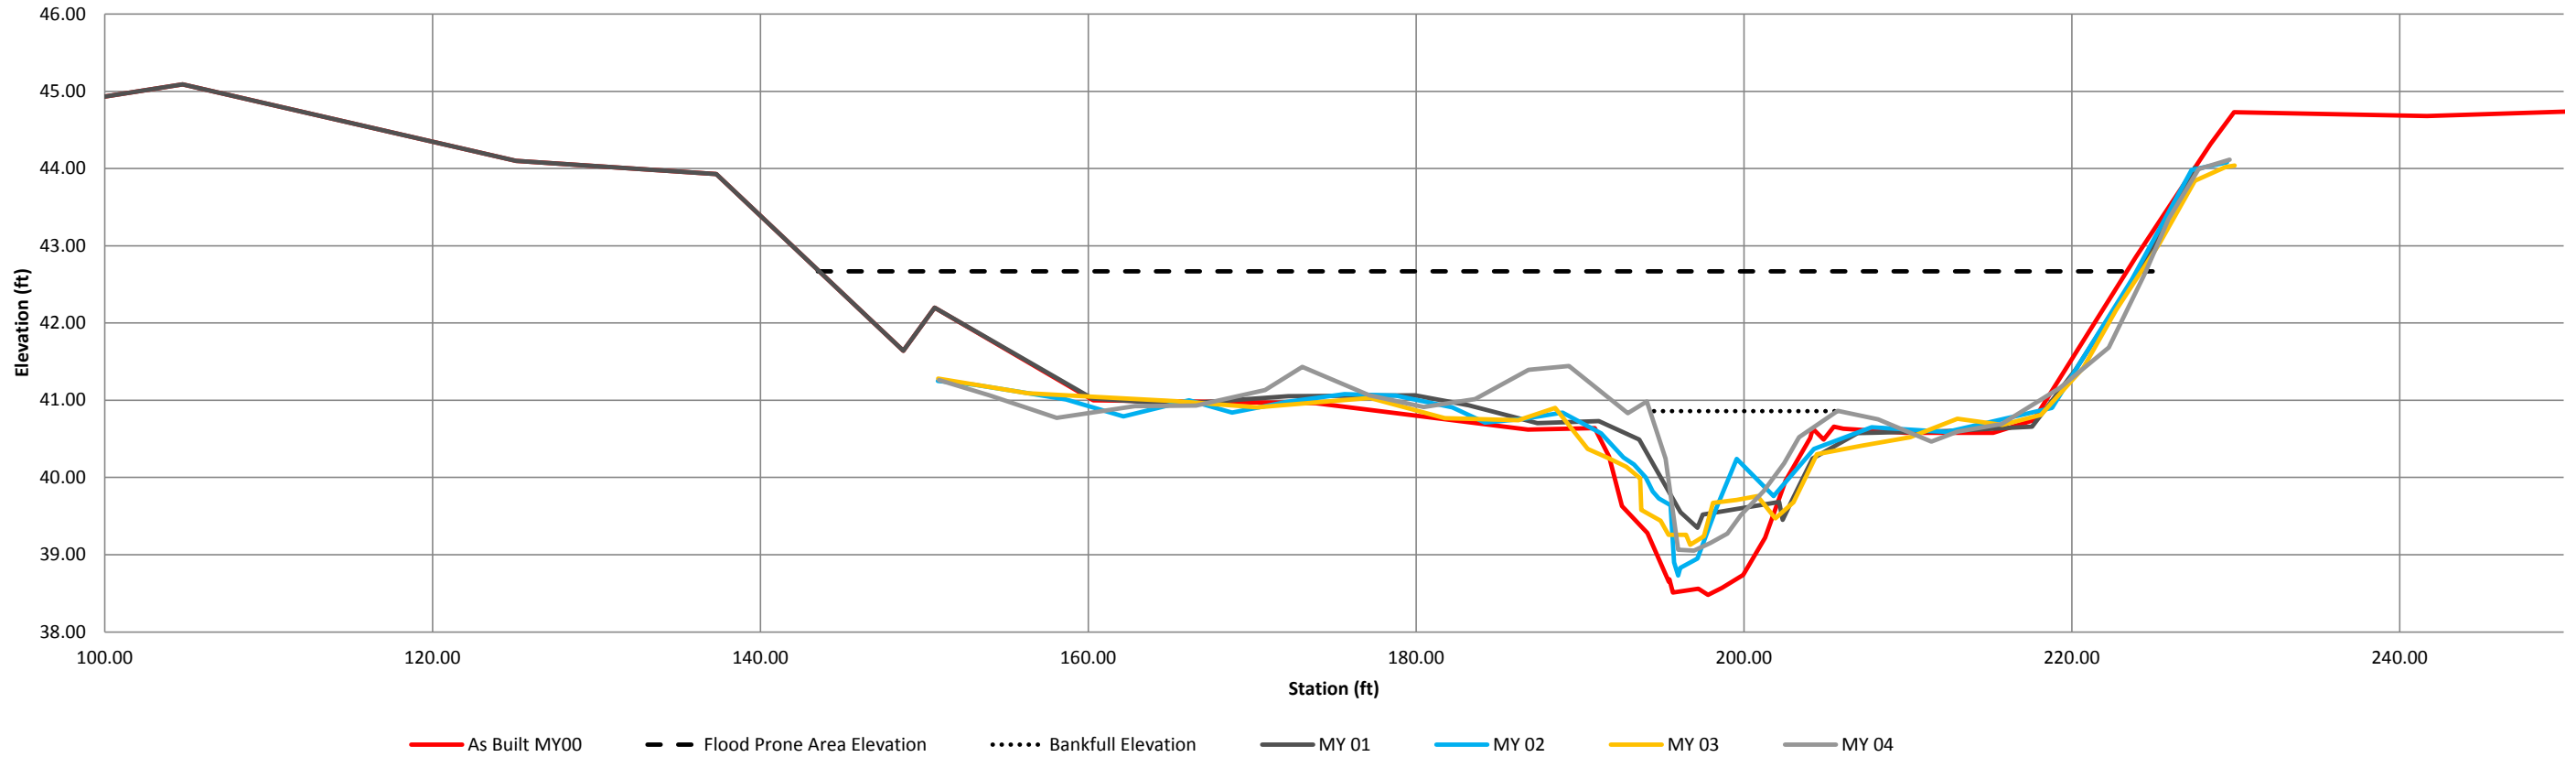
Oakley Crossroads - UT to Tranters Creek
X-Section 1, Riffle, Station 0+72

SUMMARY DATA	MY00	MY01	MY02	MY03	MY04
Bankfull Elevation	40.63	40.72	40.57	40.37	40.86
Bankfull Cross-Sectional Area	18.33	8.37	9.77	9.15	11.21
Bankfull Width	20.80	12.39	15.49	15.73	11.65
Flood Prone Area Elevation	42.78	41.63	42.41	41.61	42.67
Flood Prone Width	80.66	65.65	78.50	70.36	80.93
Max Depth at Bankfull	2.15	1.14	1.84	1.24	1.81
Mean Depth at Bankfull	0.88	0.68	0.63	0.58	0.96
W/D Ratio	23.64	18.22	24.59	27.12	12.14
Entrenchment Ratio	3.88	5.30	5.07	4.47	6.95
Bank Height Ratio	1.00	1.00	1.00	1.00	1.00
Stream Type	C	C	C	C	C

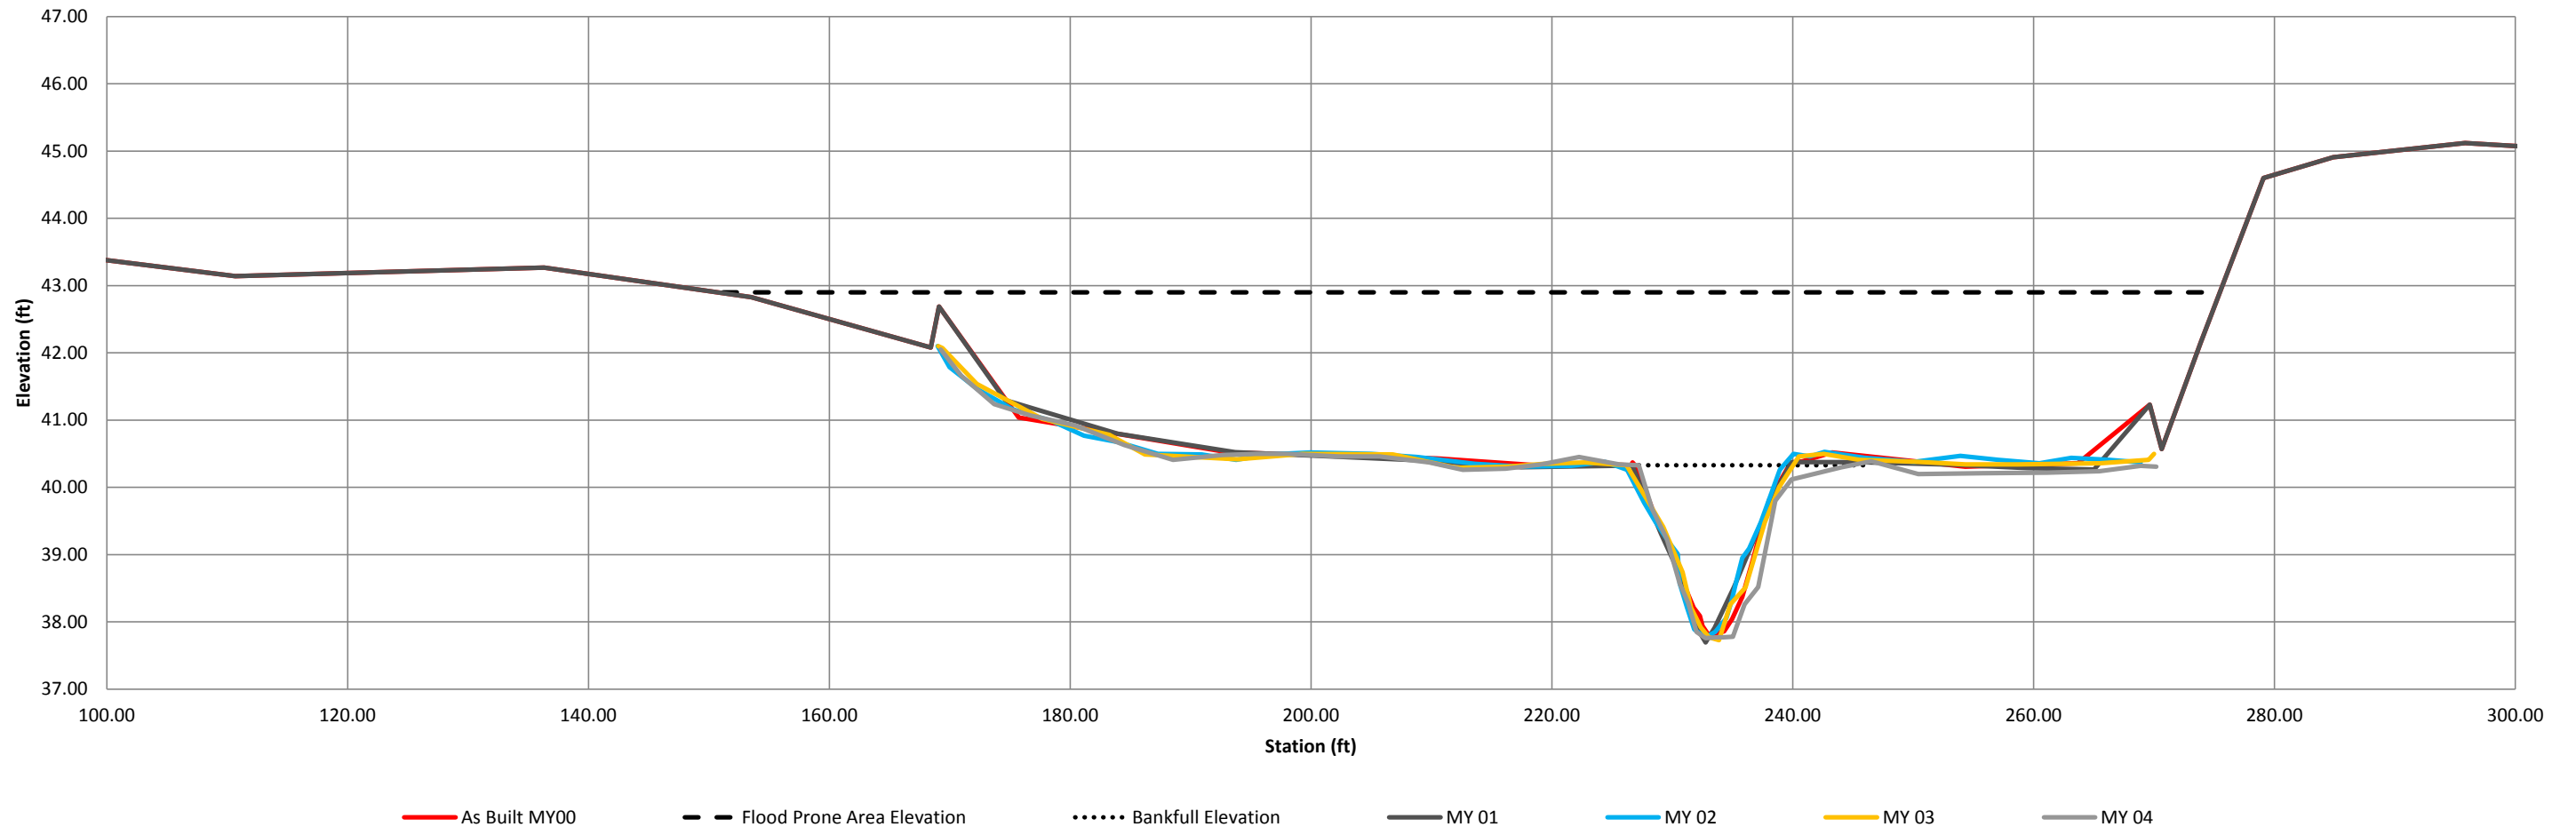
Oakley Crossroads - UT to Tranterns Creek
X-Section 2, Riffle, Station 6+17

SUMMARY DATA	MY00	MY01	MY02	MY03	MY04
Bankfull Elevation	40.35	40.38	40.38	40.33	40.33
Bankfull Cross-Sectional Area	18.16	17.88	18.17	18.06	20.68
Bankfull Width	16.60	13.16	15.09	13.85	17.67
Flood Prone Area Elevation	42.89	43.06	42.99	42.93	42.90
Flood Prone Width	124.27	124.27	124.27	125.00	124.68
Max Depth at Bankfull	2.54	2.68	2.61	2.60	2.57
Mean Depth at Bankfull	1.09	1.37	1.20	1.30	1.17
W/D Ratio	15.23	9.61	12.58	10.65	15.10
Entrenchment Ratio	7.49	9.44	8.24	9.03	7.06
Bank Height Ratio	1.00	1.00	1.00	1.00	1.00
Stream Type	C	C	C	C	C

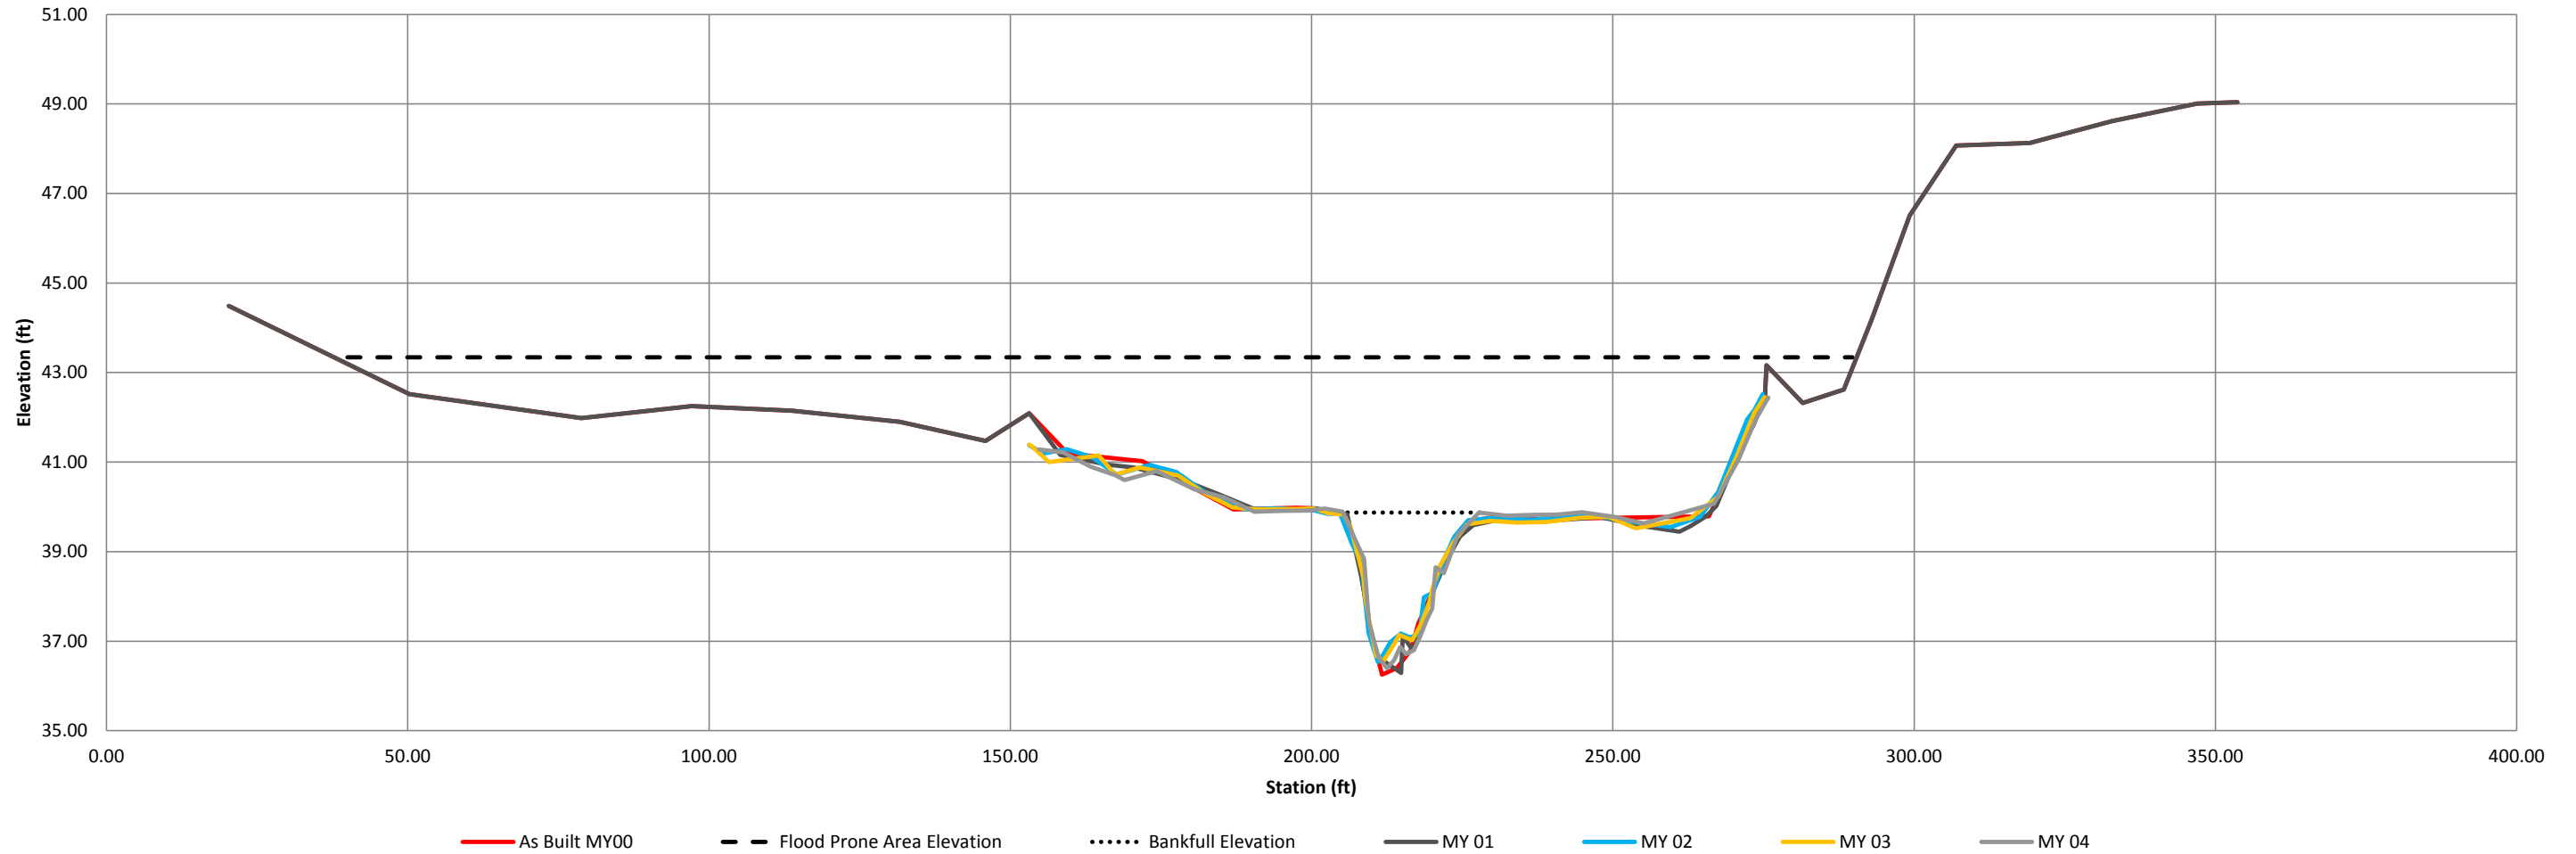
Oakley Crossroads - UT to Tranters Creek
X-Section 3, Pool, Station 12+59

SUMMARY DATA	MY00	MY01	MY02	MY03	MY04
Bankfull Elevation	39.68	39.70	39.70	39.61	39.87
Bankfull Cross-Sectional Area	36.86	37.87	34.50	32.69	40.27
Bankfull Width	20.58	24.45	20.80	19.56	22.77
Flood Prone Area Elevation	43.11	43.11	42.87	42.66	43.34
Flood Prone Width	248.46	248.07	244.10	245.00	252.64
Max Depth at Bankfull	3.43	3.41	3.17	3.05	3.47
Mean Depth at Bankfull	1.79	1.55	1.66	1.67	1.77
W/D Ratio	11.50	15.77	12.53	11.71	12.86
Entrenchment Ratio	12.07	10.15	11.74	12.53	11.10
Bank Height Ratio	1.00	1.00	1.00	1.00	1.00
Stream Type	C	C	C	C	C

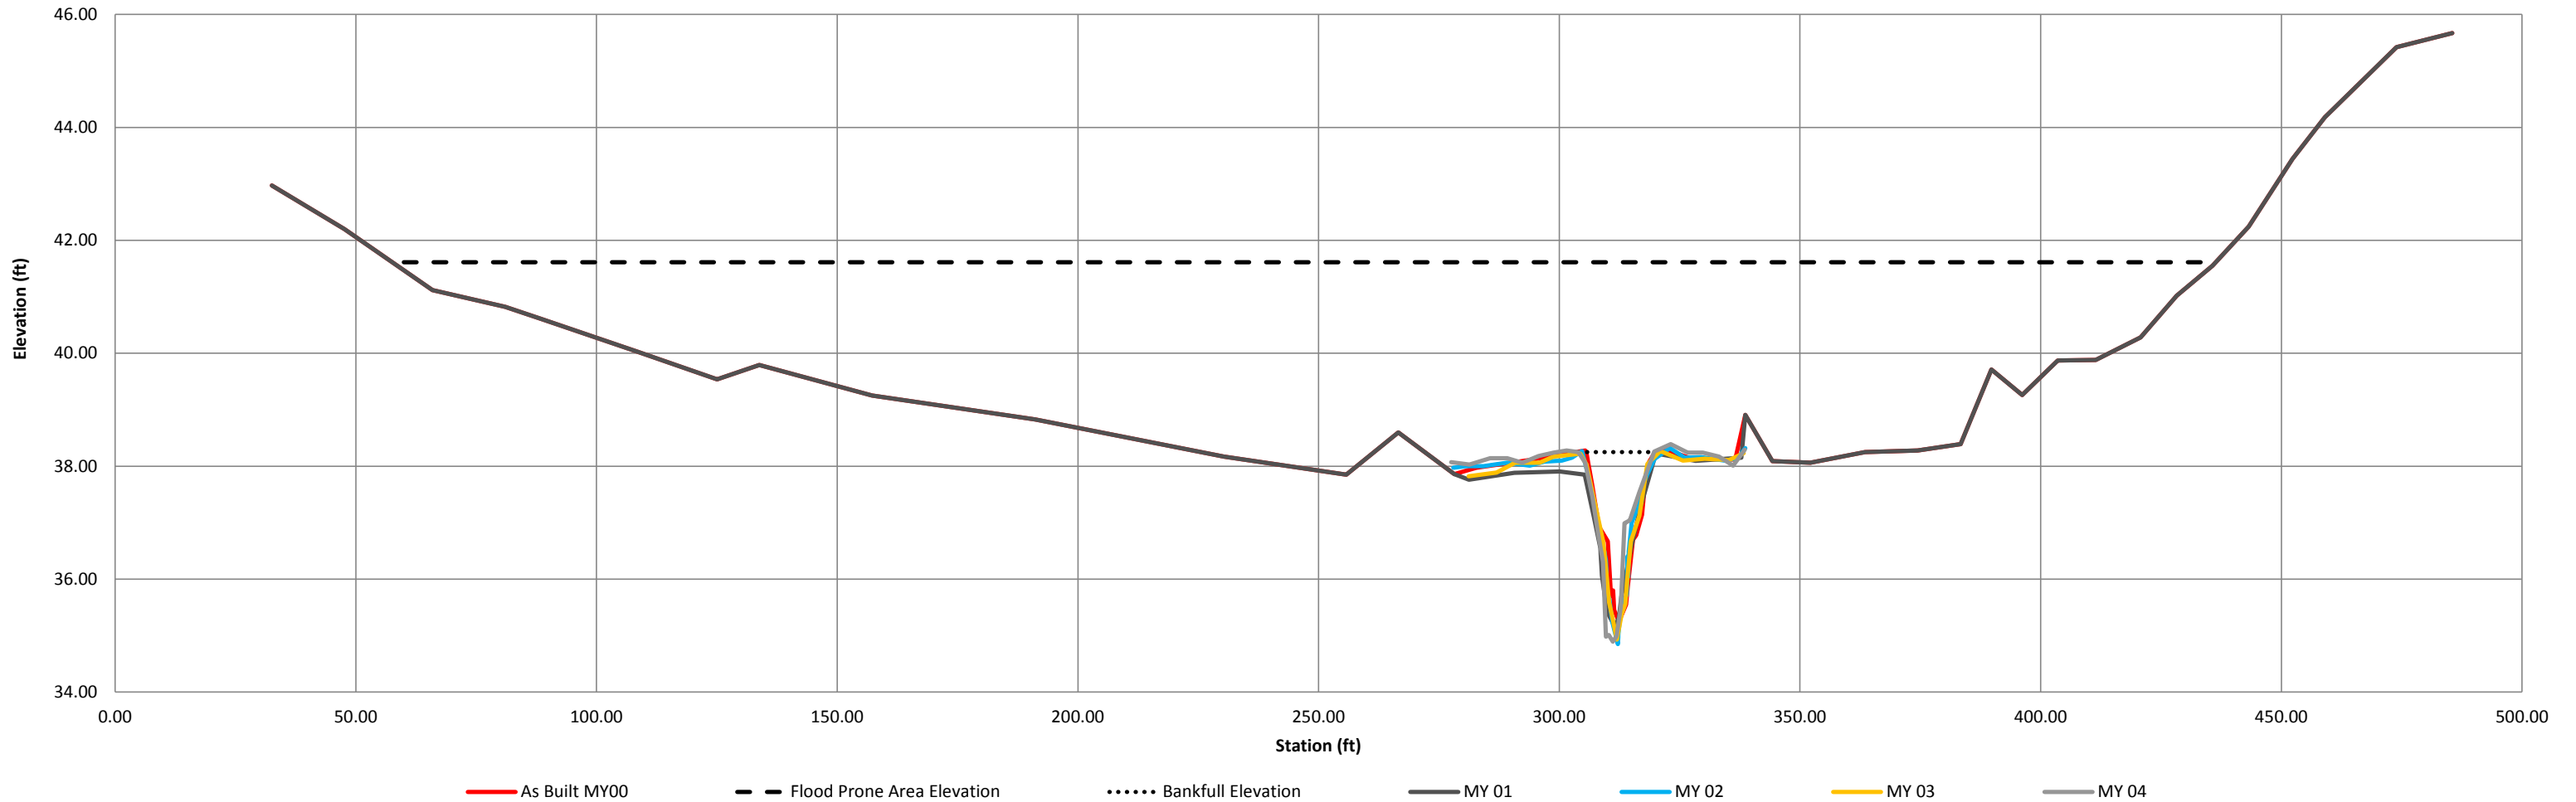
Oakley Crossroads - UT to Tranters Creek
X-Section 4, Riffle, Station 28+46

SUMMARY DATA	MY00	MY01	MY02	MY03	MY04
Bankfull Elevation	38.24	37.85	38.13	38.22	38.25
Bankfull Cross-Sectional Area	20.90	18.22	19.85	21.57	21.30
Bankfull Width	14.64	13.70	14.70	16.10	15.73
Flood Prone Area Elevation	41.23	40.54	41.41	41.51	41.61
Flood Prone Width	367.14	332.68	367.00	367.00	378.73
Max Depth at Bankfull	2.99	2.69	3.28	3.29	3.36
Mean Depth at Bankfull	1.43	1.33	1.35	1.34	1.35
W/D Ratio	10.24	10.30	10.89	12.01	11.65
Entrenchment Ratio	25.08	24.28	24.97	22.80	24.08
Bank Height Ratio	1.00	1.00	1.00	1.00	1.00
Stream Type	C	C	E	C	E

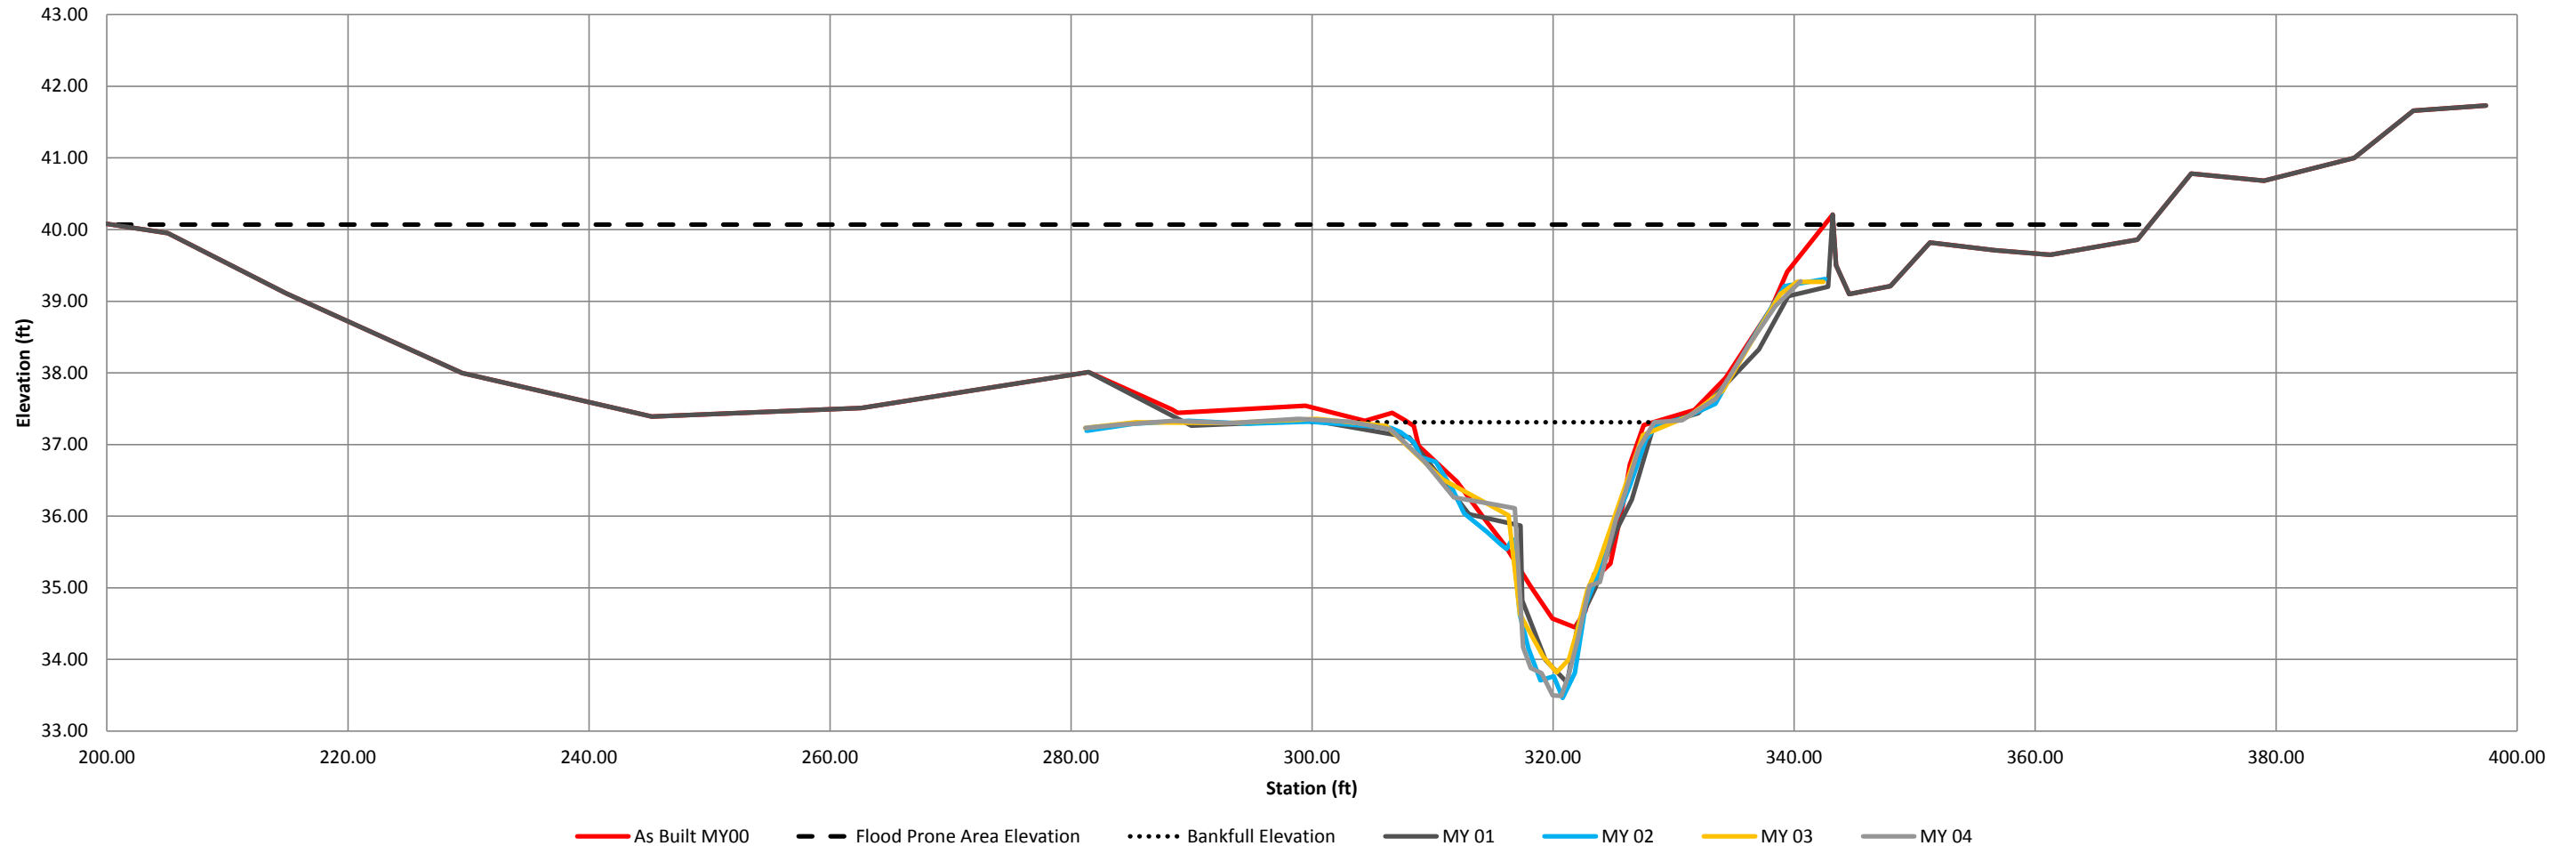
Oakley Crossroads - UT to Tranters Creek
X-Section 5 Pool, Station 32+71

*Floodprone width adjusted to not include adjacent farm pond.

SUMARY DATA	MY00	MY01*	MY02	MY03	MY04
Bankfull Elevation	37.26	37.33	37.23	37.19	37.31
Bankfull Cross-Sectional Area	29.47	35.63	34.74	30.33	35.00
Bankfull Width	19.06	29.71	23.49	21.70	24.97
Flood Prone Area Elevation	40.07	40.98	41.00	40.56	41.13
Flood Prone Width	289.16	315.10	301.17	300.00	300.00
Max Depth at Bankfull	2.81	3.65	3.77	2.82	3.82
Mean Depth at Bankfull	1.55	1.20	1.48	1.40	1.40
W/D Ratio	12.30	24.76	15.87	15.50	17.84
Entrenchment Ratio	15.17	10.61	12.82	13.82	12.01
Bank Height Ratio	1.00	1.00	1.00	1.00	1.00
Stream Type	C	C	C	C	C

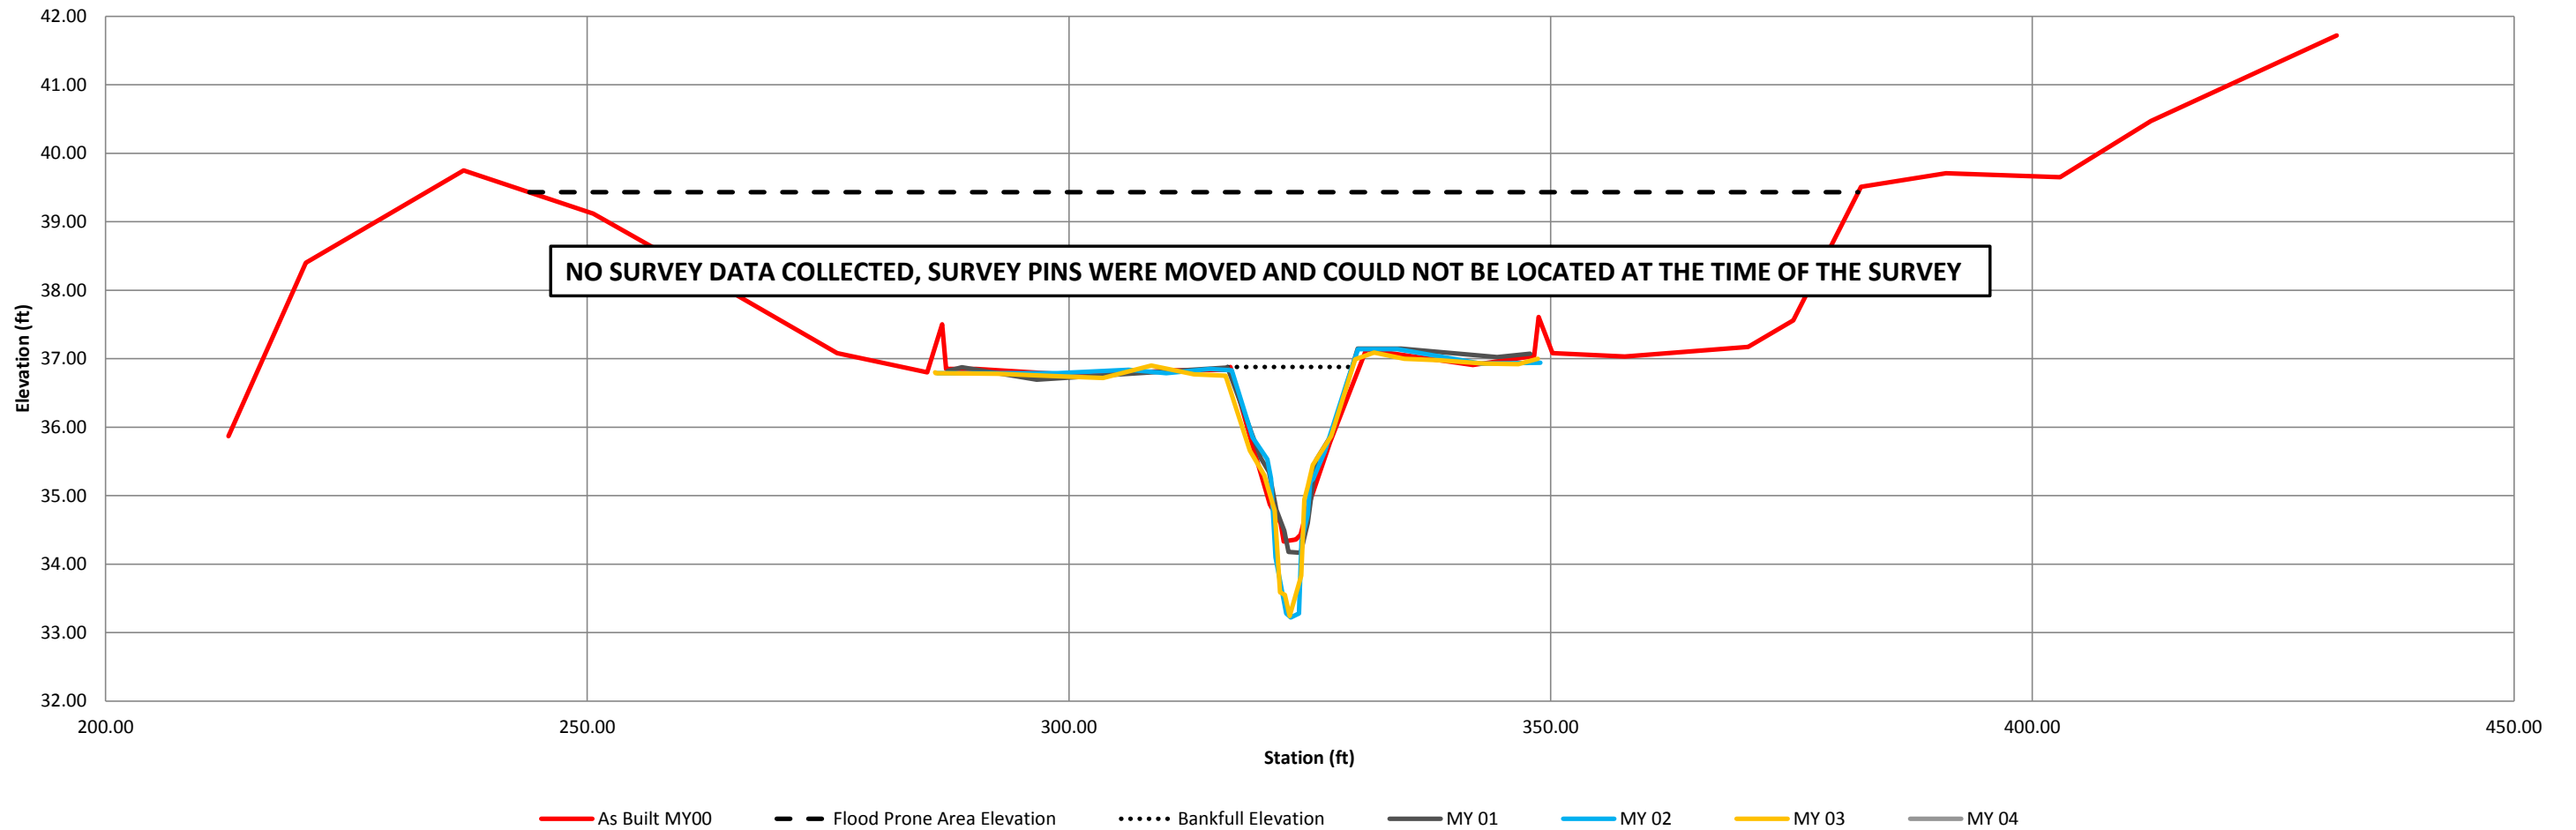
Oakley Crossroads - UT to Tranters Creek
X-Section 6, Riffle, Station 35+24

SUMARY DATA	MY00	MY01	MY02	MY03
Bankfull Elevation	36.88	36.87	36.83	36.75
Bankfull Cross-Sectional Area	18.91	17.43	19.10	18.74
Bankfull Width	17.17	12.92	12.37	12.92
Flood Prone Area Elevation	39.43	39.57	40.44	40.26
Flood Prone Width	158.46	166.08	160.00	160.00
Max Depth at Bankfull	2.55	2.70	3.61	3.51
Mean Depth at Bankfull	1.10	1.35	1.54	1.45
W/D Ratio	15.61	9.59	8.03	8.91
Entrenchment Ratio	9.23	12.82	12.93	12.38
Bank Height Ratio	1.00	0.95	1.00	1.00
Stream Type	C	C	E	E

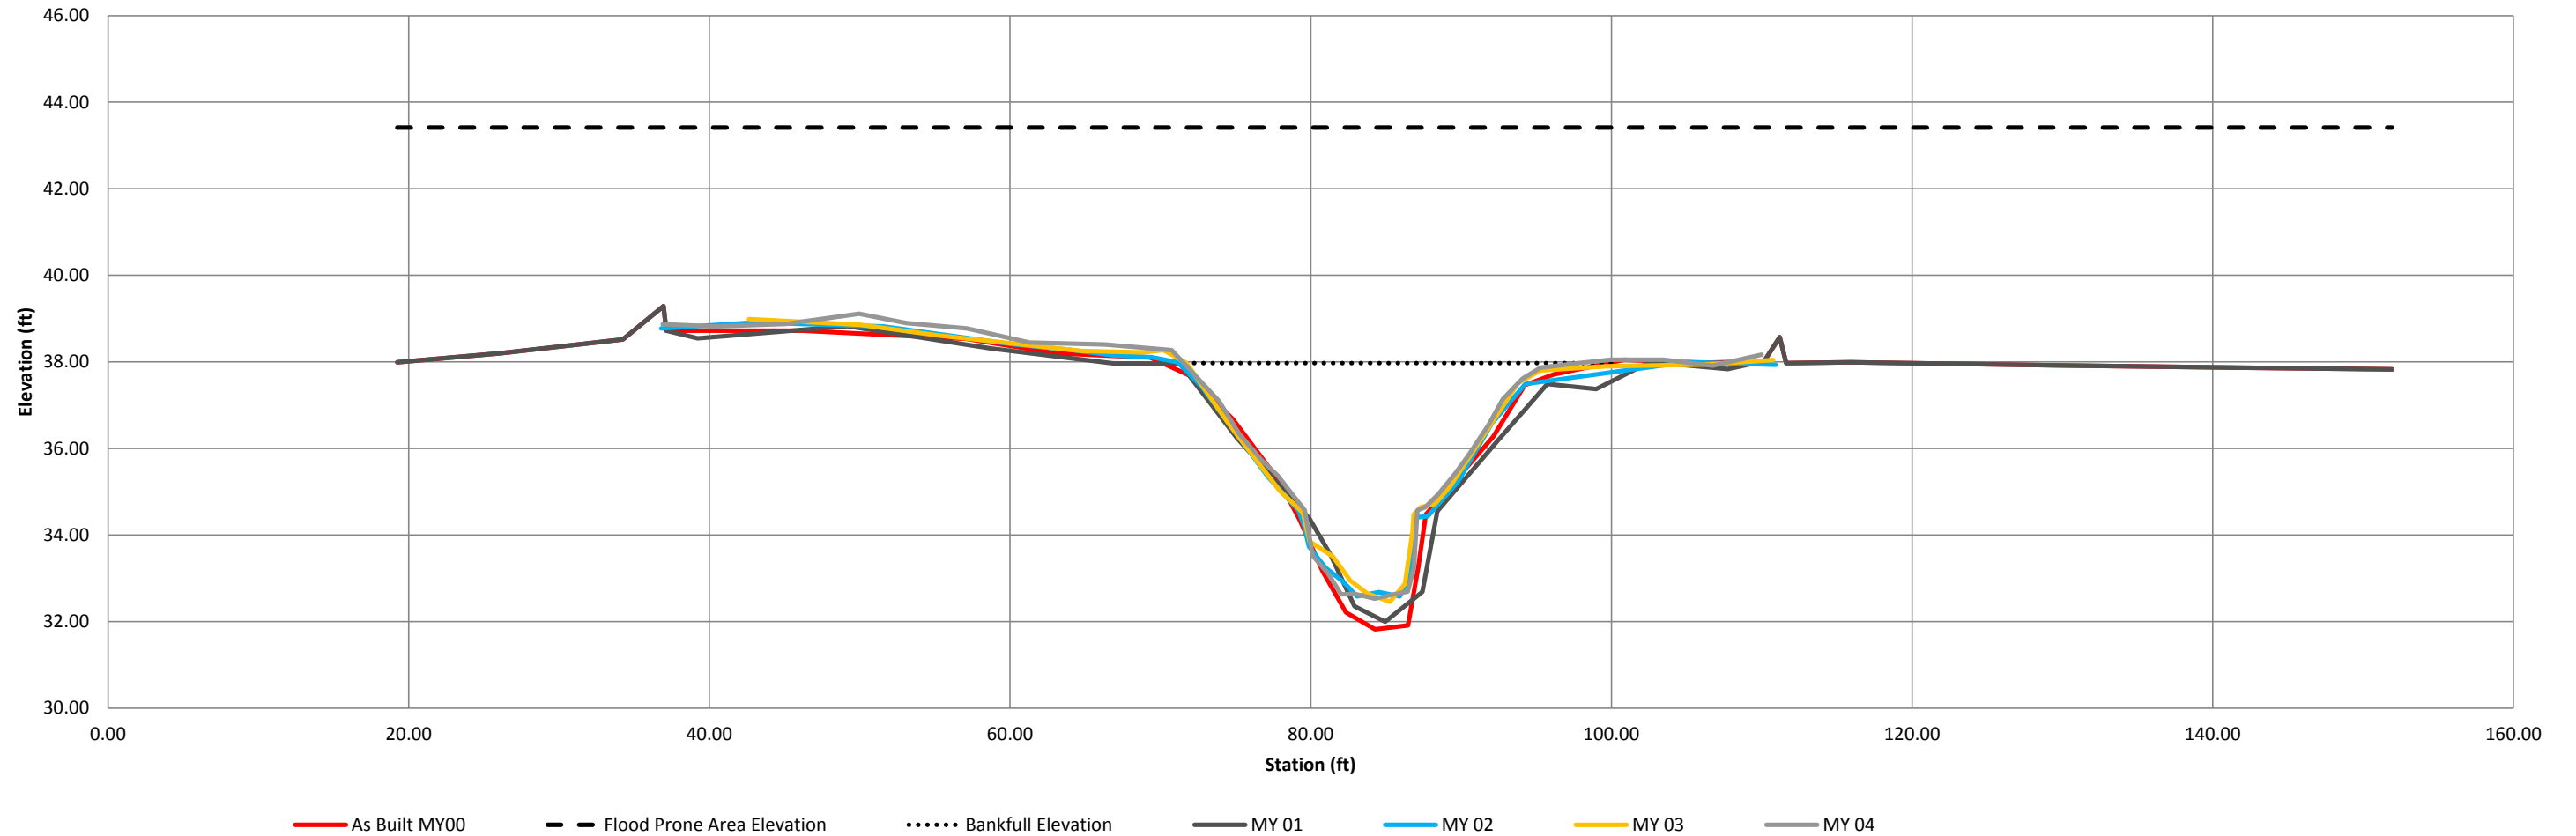
Oakley Crossroads - UT to Tranters Creek
X-Section 7 Riffle, Station 38+71

SUMARY DATA	MY00*	MY01	MY02	MY03	MY04
Bankfull Elevation	38.05	38.00	38.00	37.85	37.97
Bankfull Cross-Sectional Area	75.91	77.93	71.24	62.90	65.91
Bankfull Width	31.46	36.52	34.07	25.52	26.26
Flood Prone Area Elevation	44.28	44.01	43.42	43.24	43.41
Flood Prone Width	132.69	132.69	>200	200.00	200.00
Max Depth at Bankfull	6.23	6.01	5.42	5.39	5.44
Mean Depth at Bankfull	2.41	2.13	2.09	2.46	2.51
W/D Ratio	13.05	17.15	16.30	10.37	10.46
Entrenchment Ratio	4.22	3.63	5.87	7.84	7.62
Bank Height Ratio	1.00	1.00	1.00	1.00	1.00
Stream Type	C	C	C	E	E

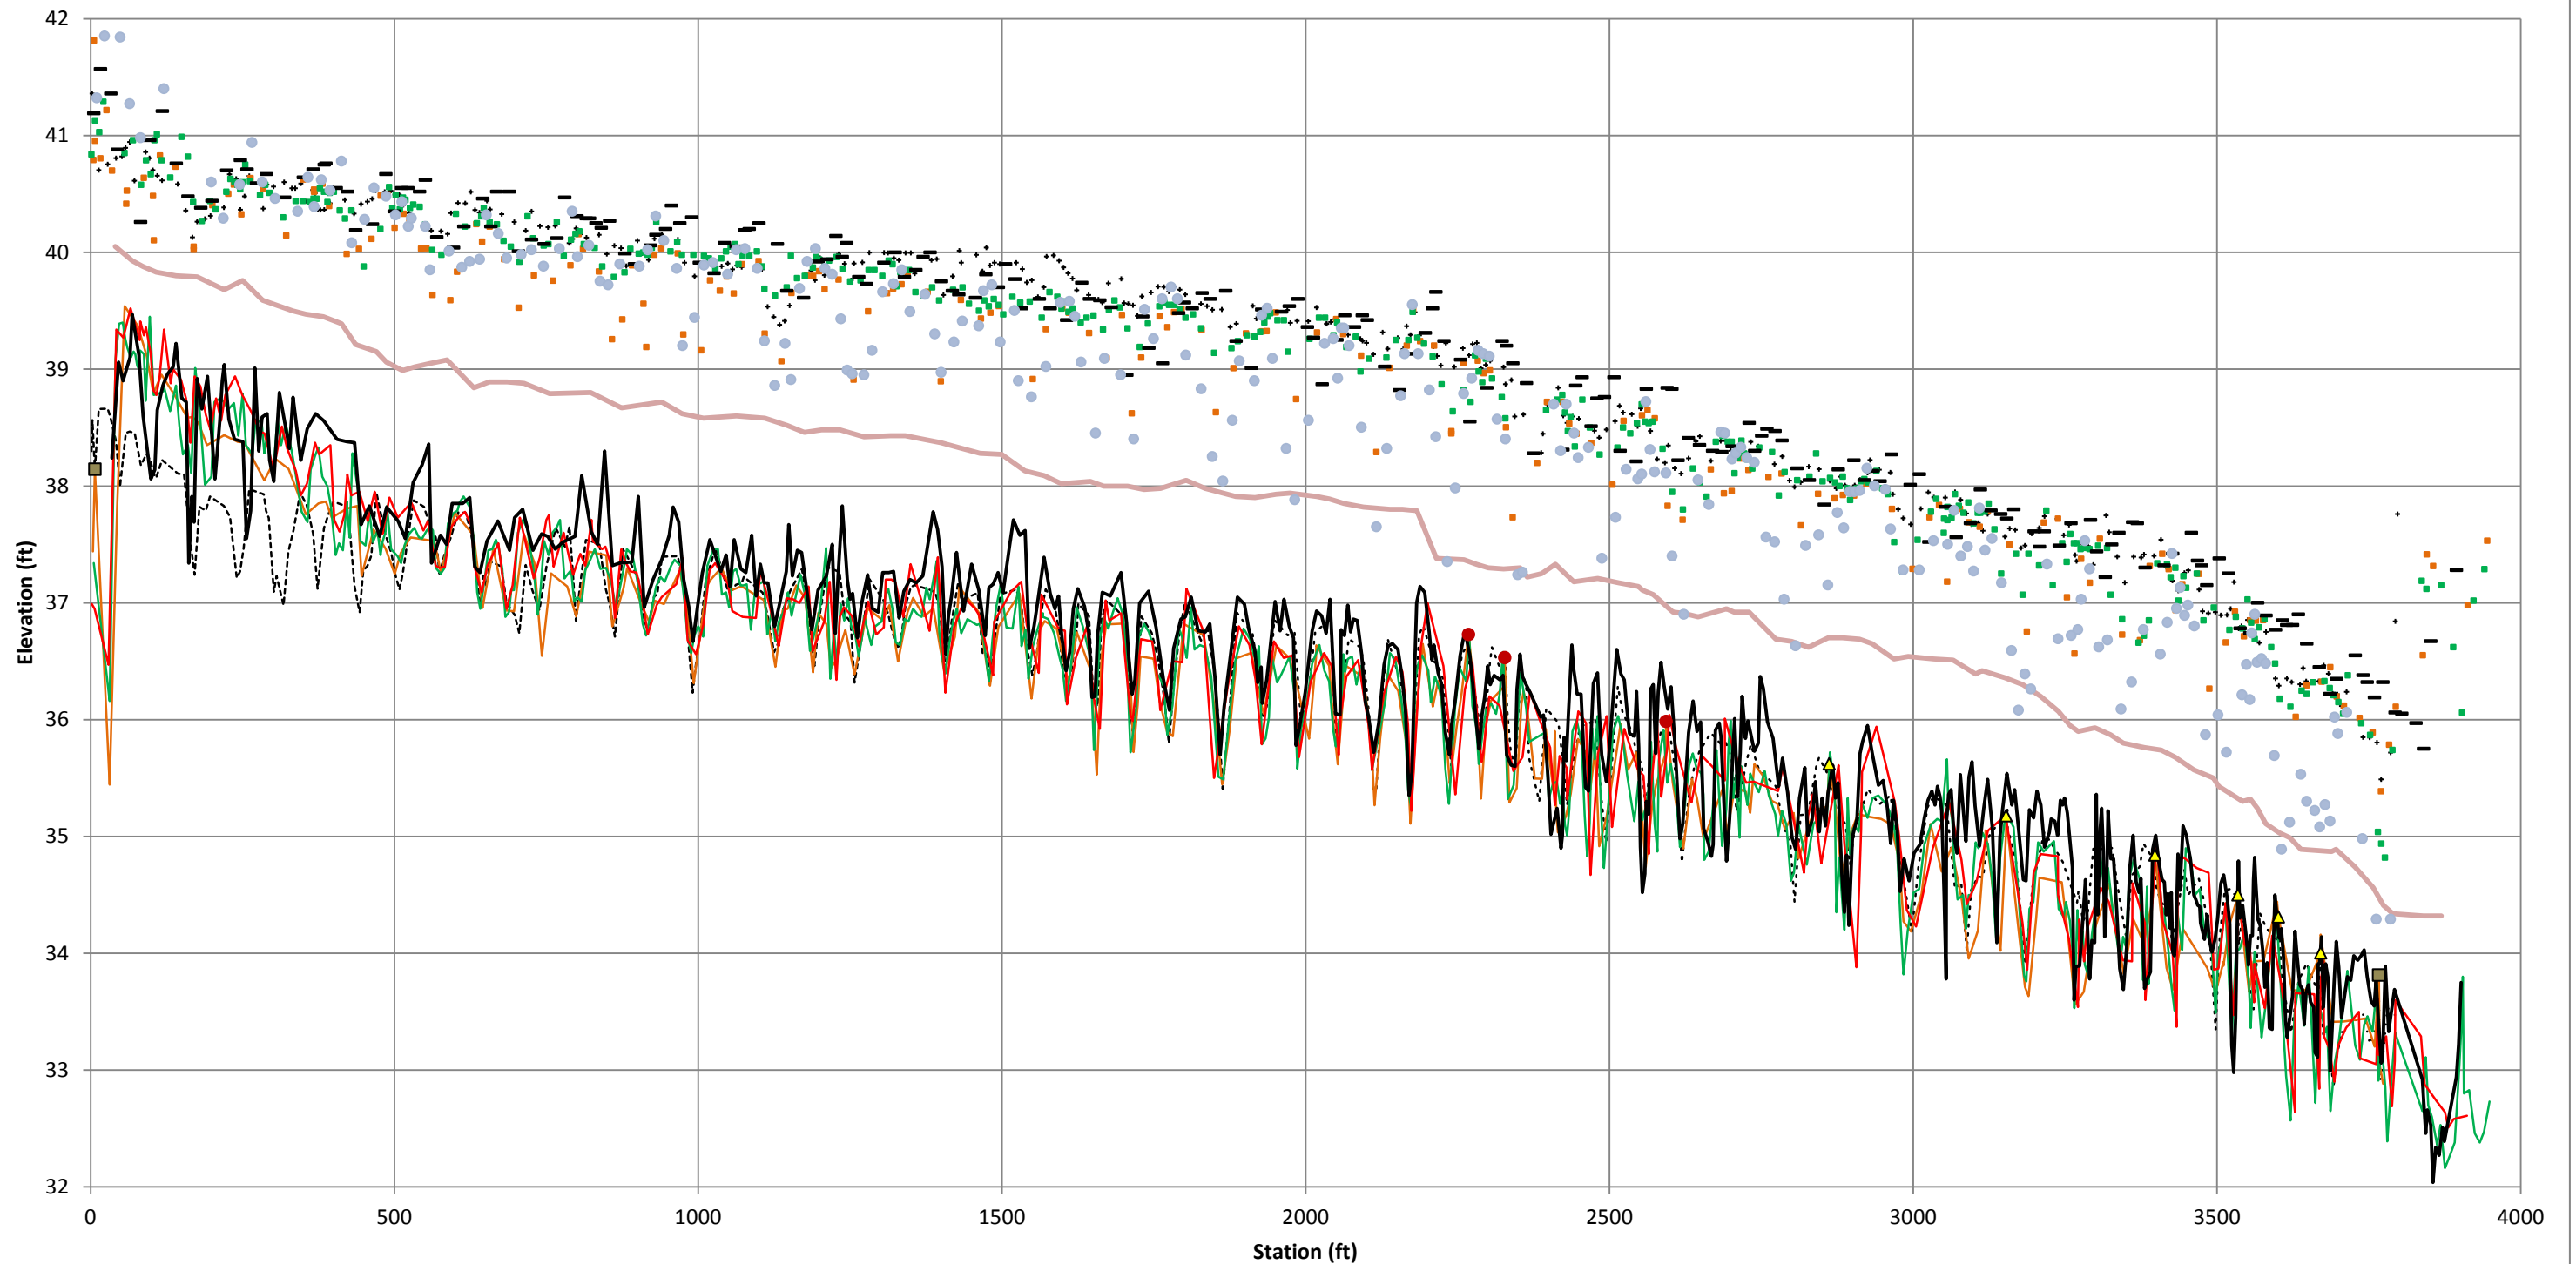
Oakley Crossroads Stream and Buffer Restoration - Longitudinal Profile
Station 0+00 to 38+79
2014 Monitoring - Year 0, Year 01, Year 02, Year 03, Year 04

An area of aggradation, noted in previous years, was again observed below the upstream culvert between Station 0+00 and 6+00. Only one structure, a log sill at Station 23+27.75, was observed to be losing grade control, but the area appears to be working toward an equilibrium. The areas of profile adjustment do not currently threaten the stability of the stream. These areas will continue to be monitored during future field visits to document any changes. A few relict nutria burrows were also observed between Station 4+40 and 10+00, but the livestakes are maintaining bank stability and these areas do not threaten the stability of the stream. *Callitriche heterophylla* (water starwort), a non-invasive species, was again observed in several areas along all three sections of the stream. This aquatic plant was also noted to be present in monitoring years 1, 2, and 3 as well as prior to the construction of the restoration project. Neither the nutria nor the water starwort currently threaten the stability of the restored stream. These issues will continue to be monitored during future field visits to document any changes. The permanent pins for Cross-section 6 had been removed and could not be surveyed. The pins will be reset during the initial assessment of spring 2015.
