OAKLEY CROSSROADS (G)  
STREAM & BUFFER RESTORATION  
MONITORING REPORT (YEAR 5 OF 5)

Pitt County, North Carolina  
SCO Project Number 050659701  
DMS Project Number 273

Status of Plan: Final  
Construction Completed: 2011  
Data Collected: 2015  
Submission Date: December 2015

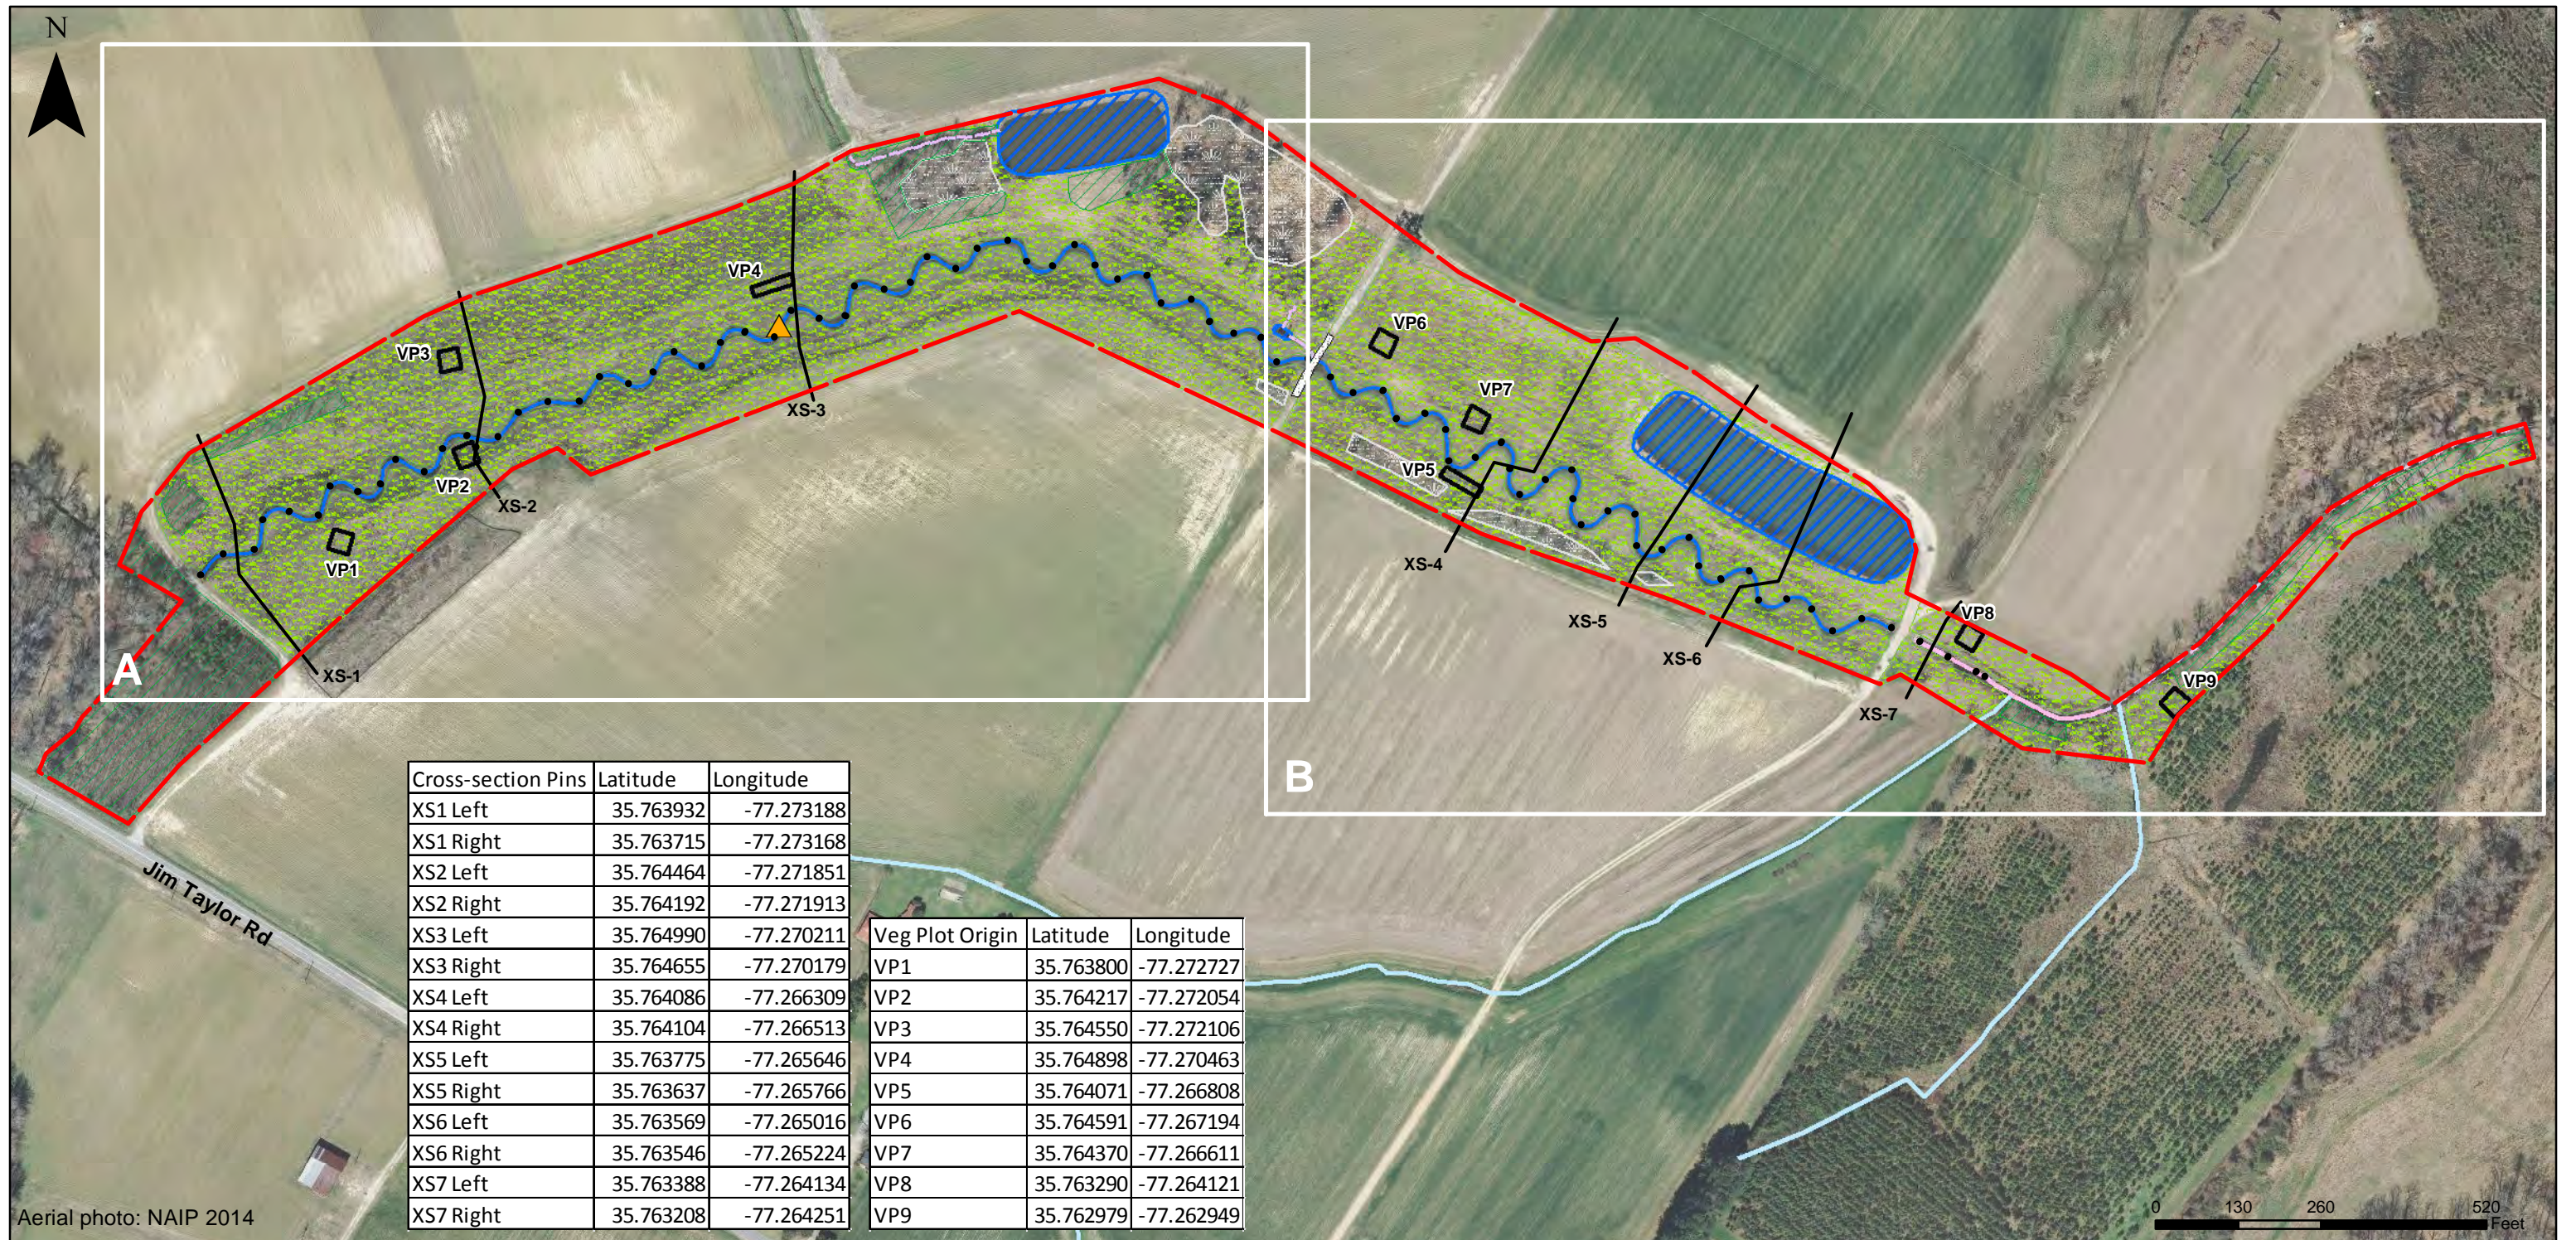
**Figure 2. Project Status Map MY5**

A visual assessment of the vegetative cover of brush mattresses along the entire stream exhibited greater than 80% vegetative cover and were thriving for MY5. Figure 2 in Appendix A has been updated to remove, the areas where brush mattresses had less than the required 80% vegetative cover that were observed in 2012.

Neither wetland restoration nor enhancement credit is being sought for this project. Existing jurisdictional wetlands as depicted in Figure 2 in Appendix A are being preserved. The wetland preservation areas are visually assessed during each monitoring year.

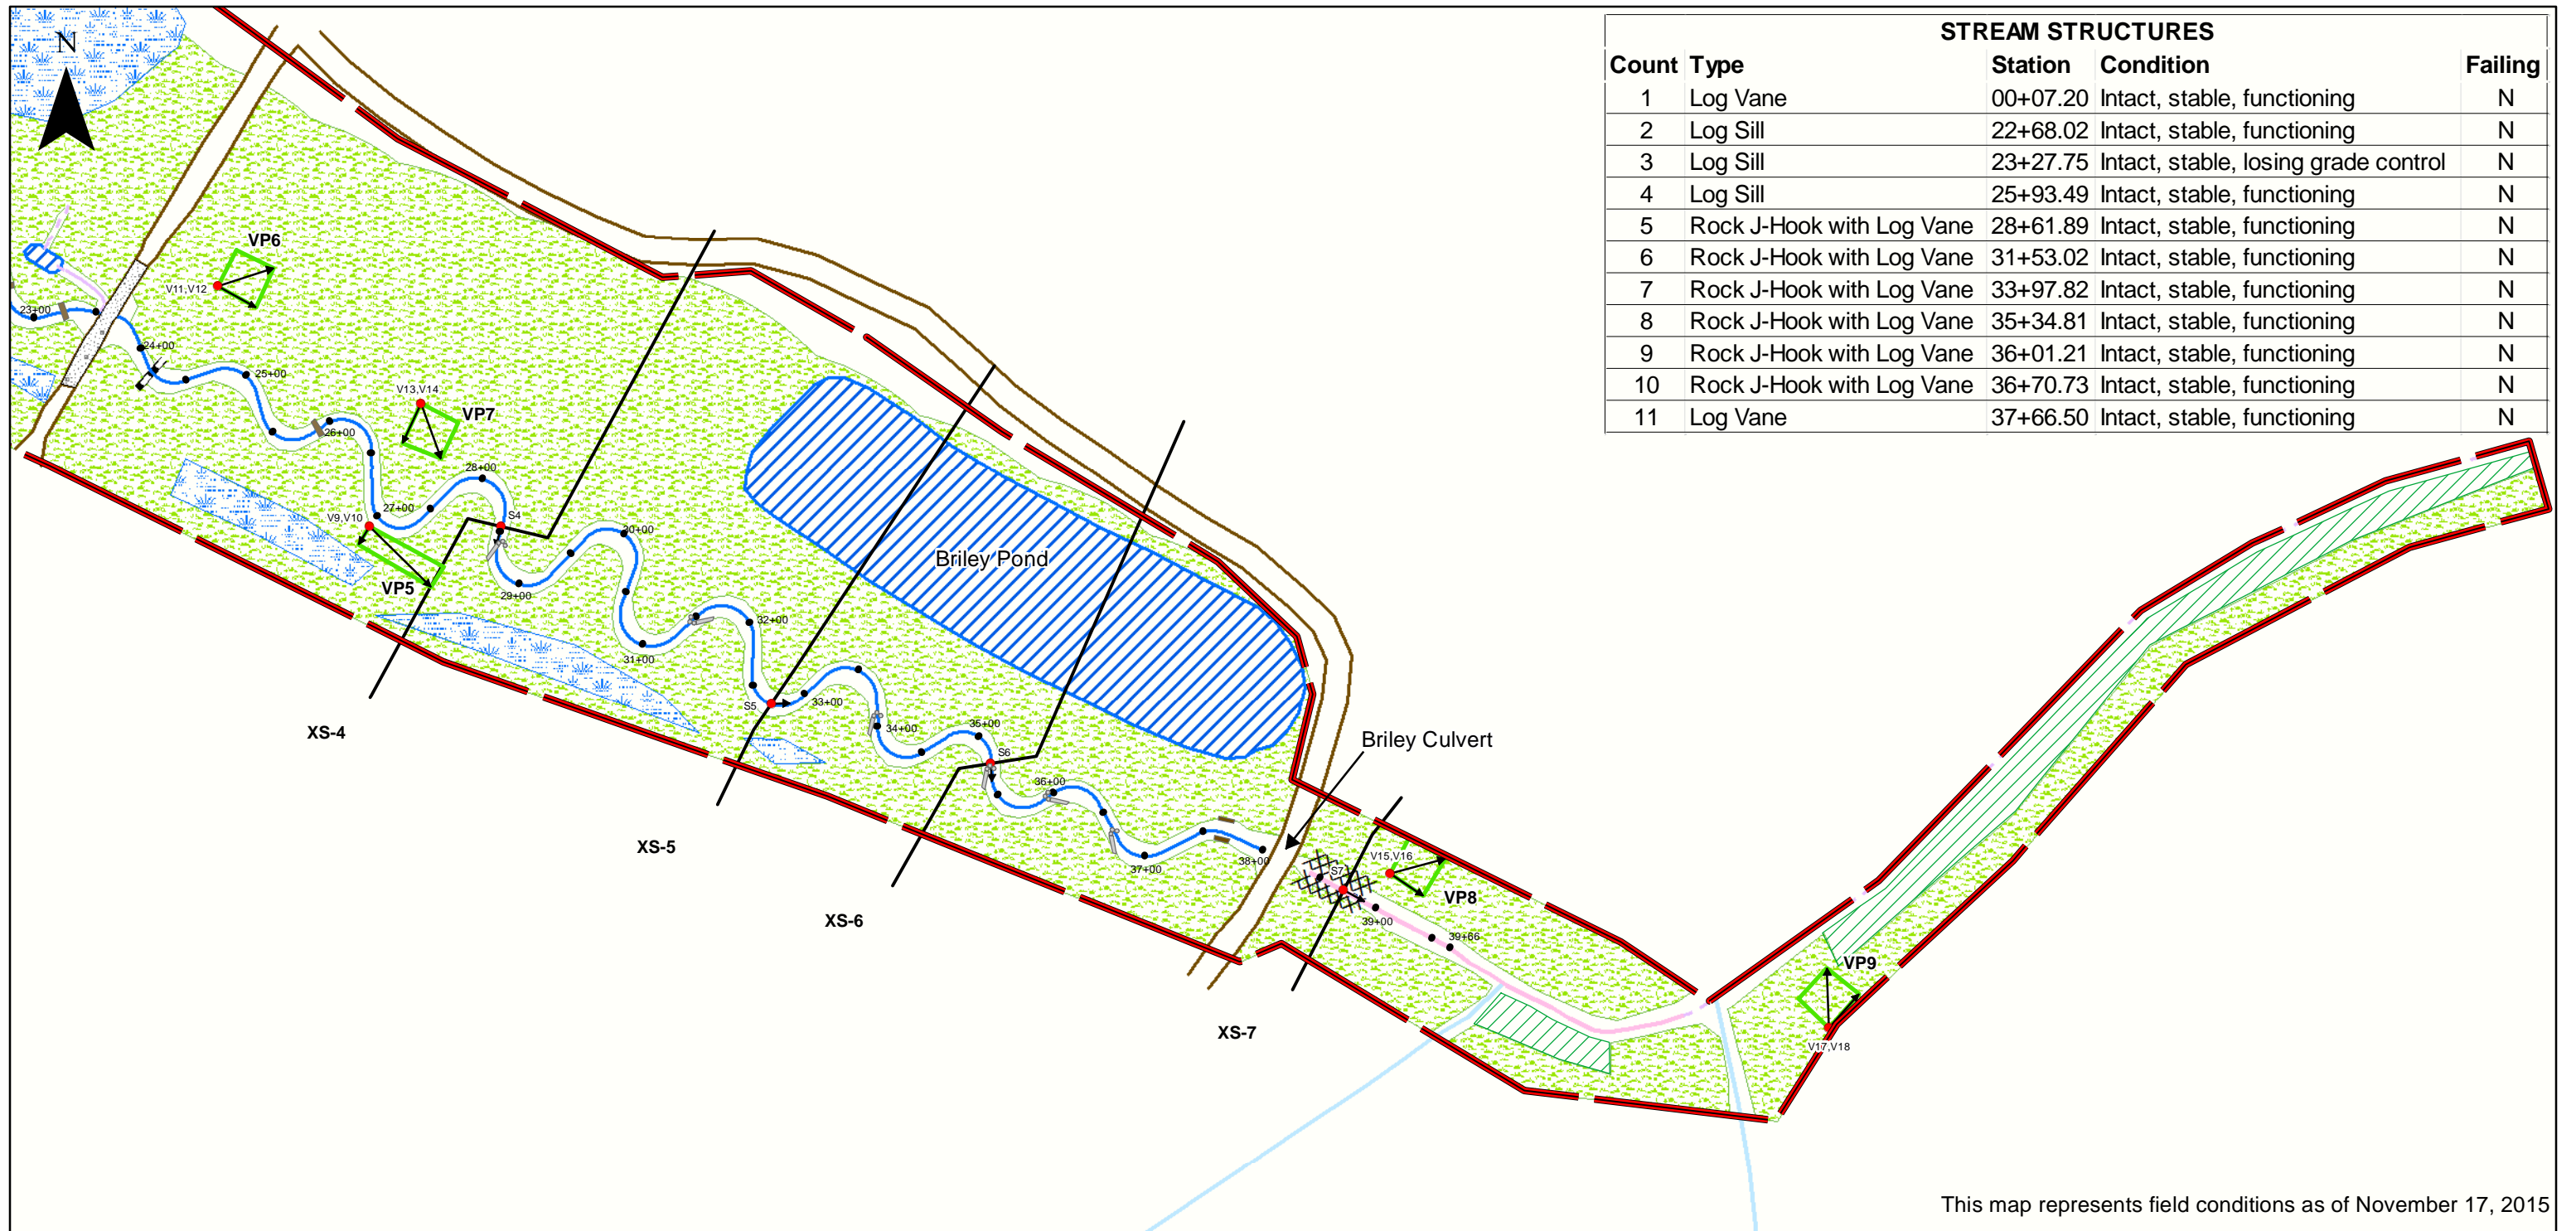
**Figure 2b. Current Condition Plan View MY5**

Four structures (two log sills at Station 22+68 and 23+27, and two log vanes with rock j-hooks at Station 35+34 and 36+01) appear to be losing grade control when looking at the longitudinal profile. When visually assessed in the field during the survey, these areas were still holding grade and no instabilities were noted.

STREAM STRUCTURES				
Count	Type	Station	Condition	Failing
1	Log Vane	00+07.20	Intact, stable, functioning	N
2	Log Sill	22+68.02	Intact, stable, functioning	N
3	Log Sill	23+27.75	Intact, stable, losing grade control	N
4	Log Sill	25+93.49	Intact, stable, functioning	N
5	Rock J-Hook with Log Vane	28+61.89	Intact, stable, functioning	N
6	Rock J-Hook with Log Vane	31+53.02	Intact, stable, functioning	N
7	Rock J-Hook with Log Vane	33+97.82	Intact, stable, functioning	N
8	Rock J-Hook with Log Vane	35+34.81	Intact, stable, functioning	N
9	Rock J-Hook with Log Vane	36+01.21	Intact, stable, functioning	N
10	Rock J-Hook with Log Vane	36+70.73	Intact, stable, functioning	N
11	Log Vane	37+66.50	Intact, stable, functioning	N

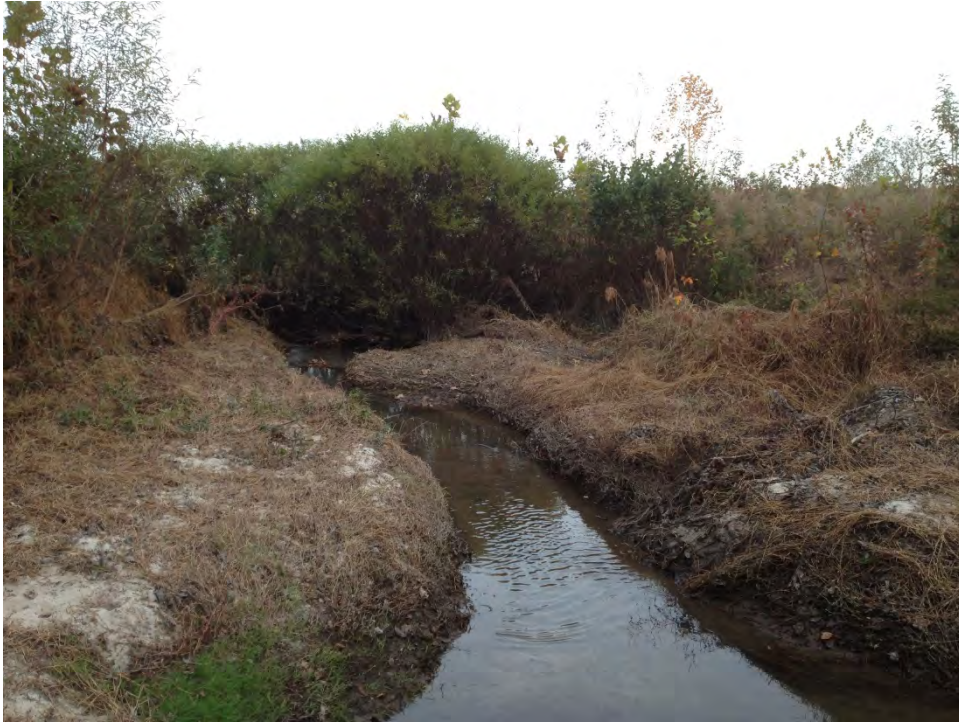
**Photo Station S1** – Stream channel looking downstream at cross-section 1  
Station 00+72 - Priority 2 (11/17/15 Year 5)

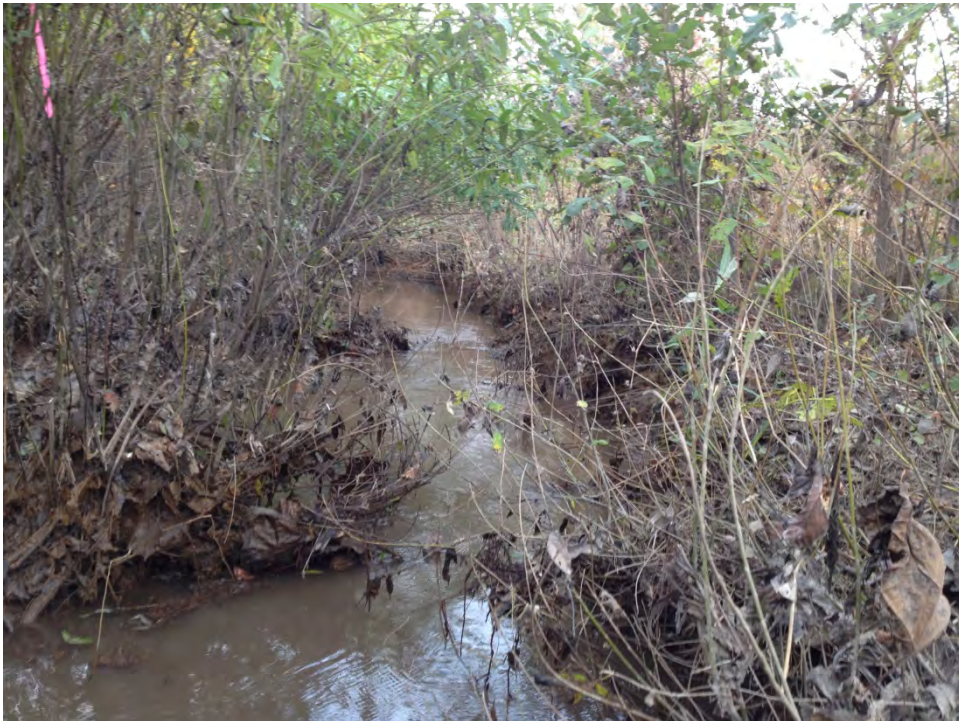
**Photo Station S2** – Stream channel looking downstream at cross-section 2  
Station 06+17 – Priority 2 (11/17/15 Year 5)

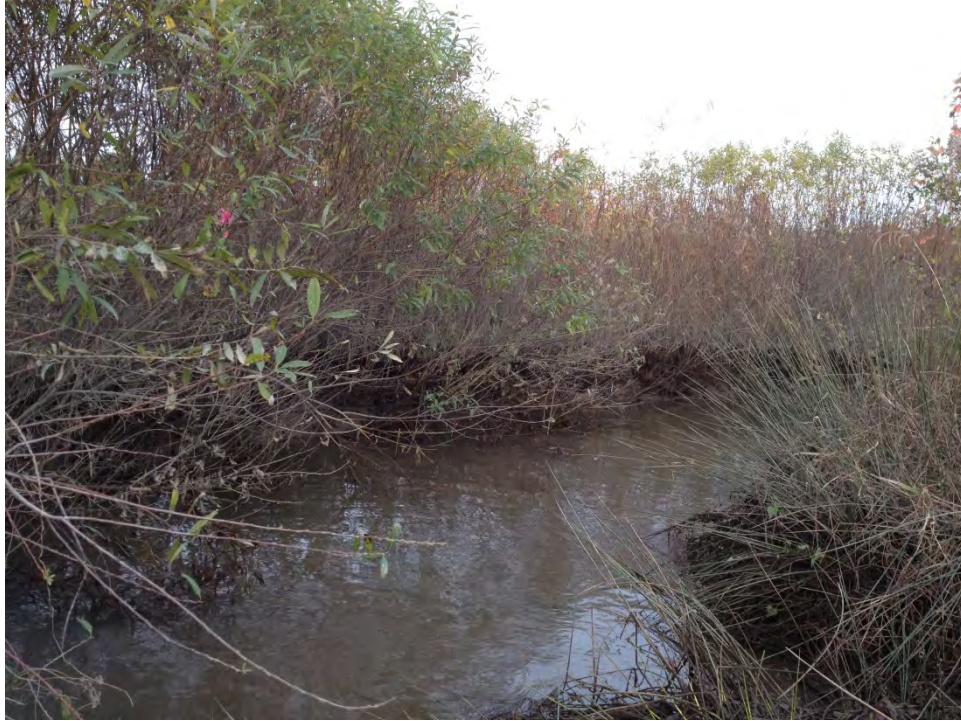
**Photo Station S3** – Stream channel looking downstream at cross-section 3  
Station 12+59 – Priority 2 (11/17/2015 Year 5)

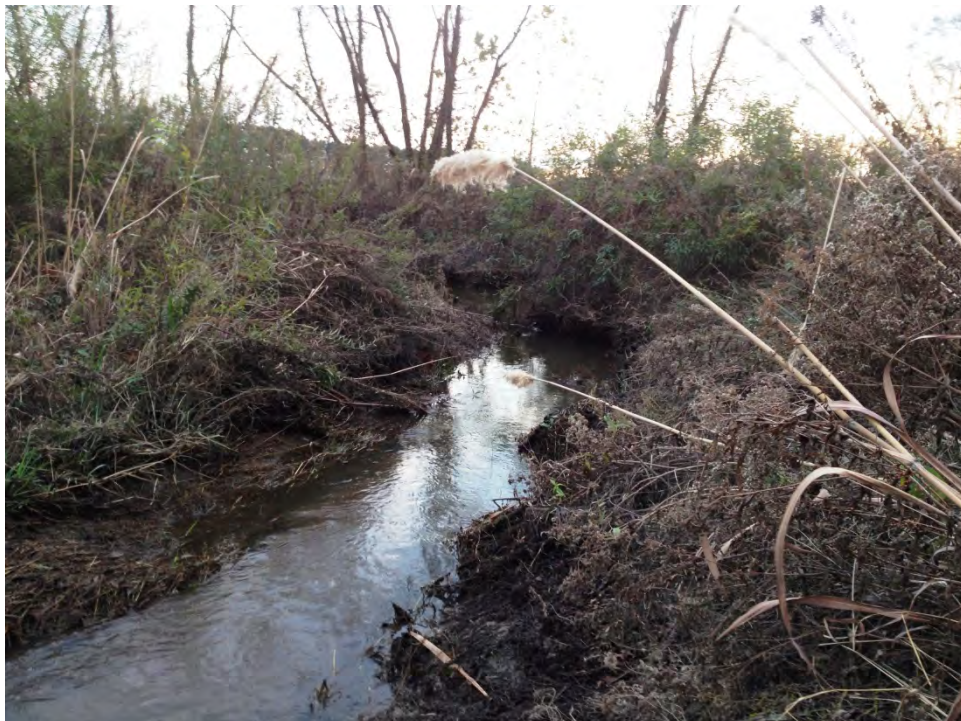
**Photo Station S4** – Stream channel looking downstream at cross-section 4  
Station 28+46 – Priority 2 (11/17/2015 Year 5)

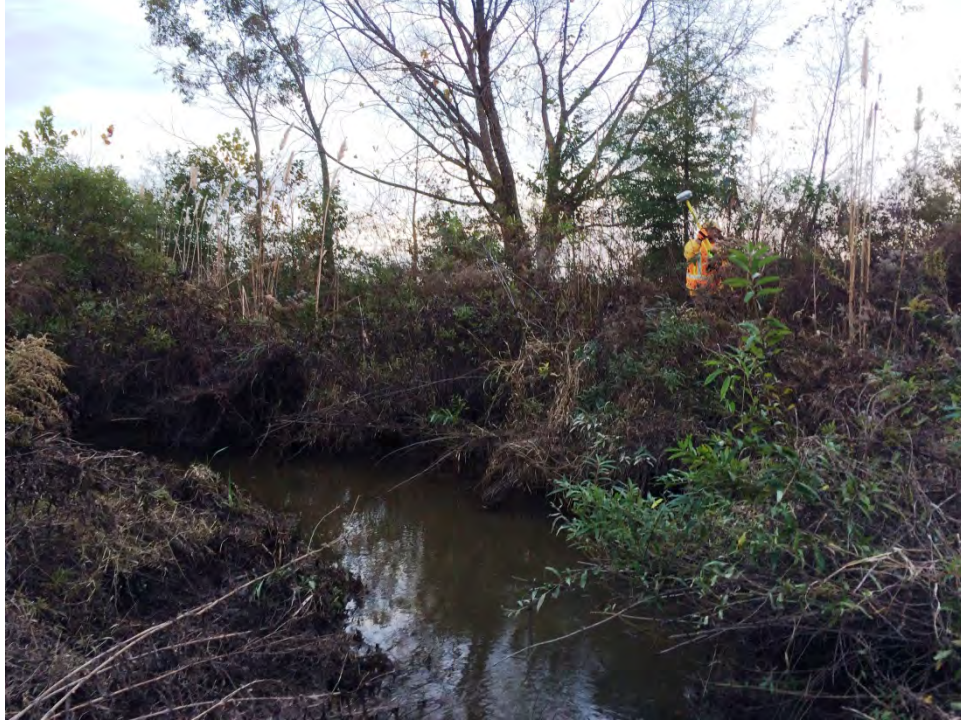
**Photo Station S5** – Stream channel looking downstream at cross-section 5  
Station 32+71 – Priority 2 (11/17/2015 Year 5)

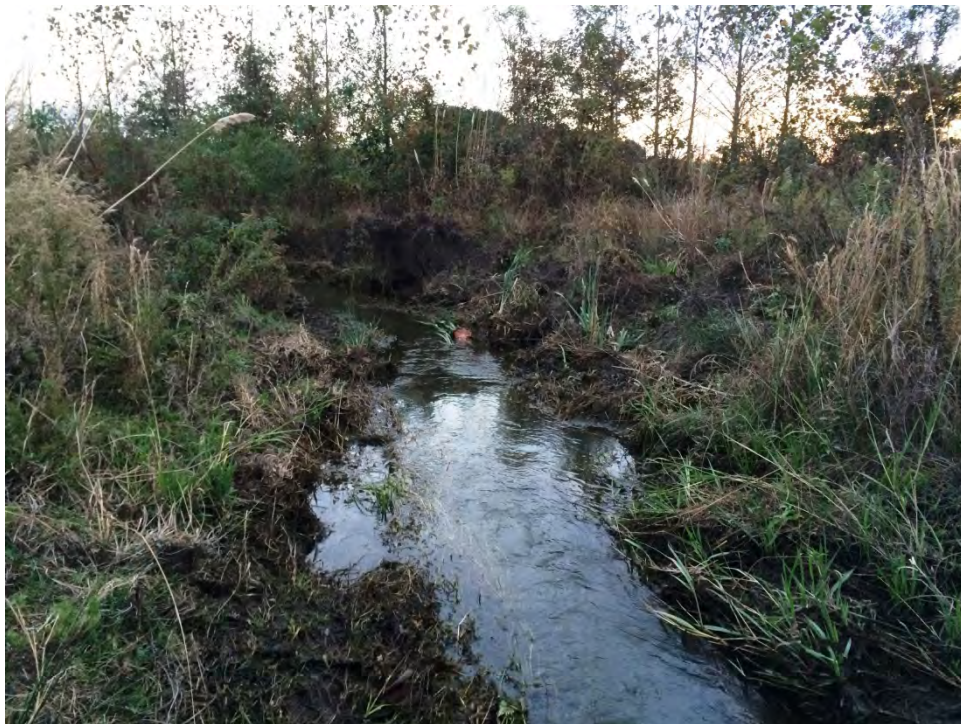
**Photo Station S6** – Stream channel looking downstream at cross-section 6  
Station 35+24 – Priority 2 (11/17/2015 Year 5)

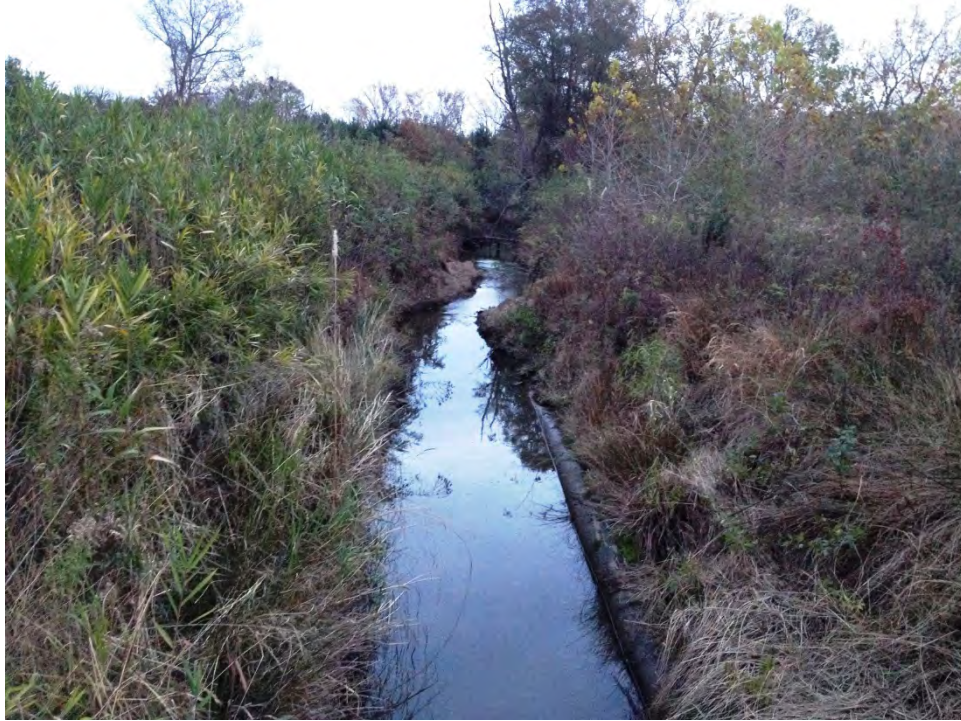
**Photo Station S7** – Stream channel looking downstream at cross-section 7  
Station 38+71 – Enhancement 2 (11/17/2015 Year 5)
