# MY1 FINAL MONITORING REPORT

Odell's House Mitigation Project

Johnston County

DMS Project # 100041

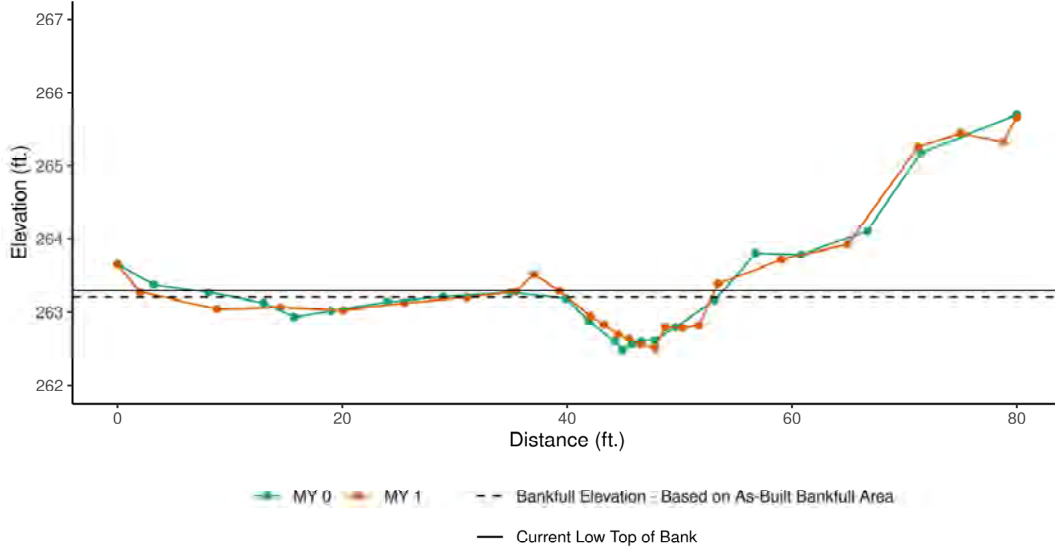
Cross-Section 1 (R1 - Headwater) MY1

MY0	MY1	MY2	MY3	MY4	MY5	MY6	MY7
Bankfull Elevation - Based on As-Built Bankfull Area	263.18	263.20						
Bank Height Ratio - Based on As-Built Bankfull Area	0.96	1.13						
Thalweg Elevation	262.48	262.51						
LTOB Elevation	263.16	263.29						
LTOB Max Depth	0.674	0.778						
LTOB Cross Sectional Area	4.77	6.27

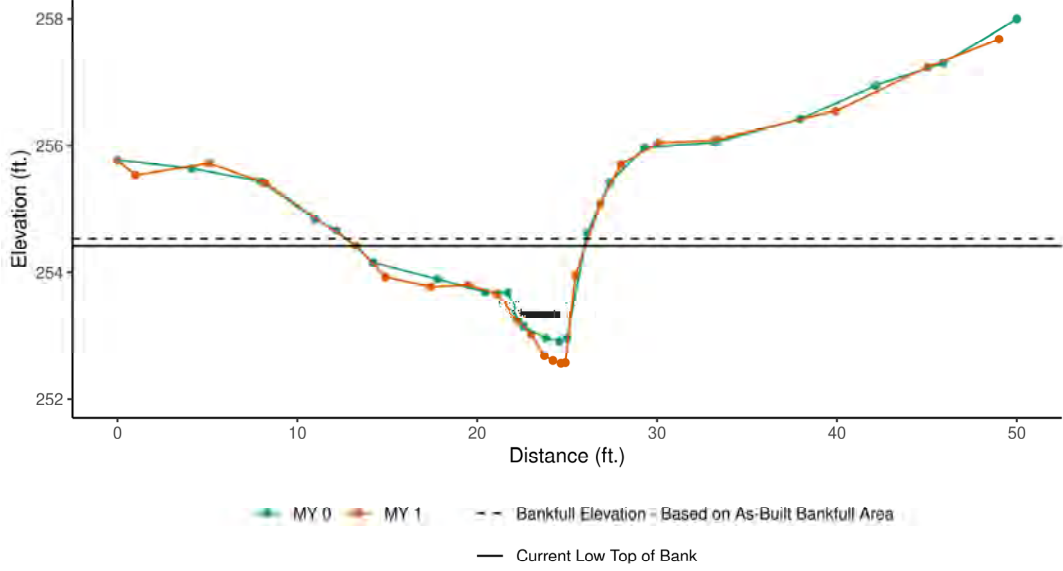
Cross-Section 2 (R2 - Pool) MY1

MY0	MY1	MY2	MY3	MY4	MY5	MY6	MY7
Bankfull Elevation - Based on As-Built Bankfull Area	254.61	254.52						
Bank Height Ratio - Based on As-Built Bankfull Area	1.00	0.94						
Thalweg Elevation	252.91	252.56						
LTOB Elevation	254.61	254.41						
LTOB Max Depth	1.704	1.852						
LTOB Cross Sectional Area	11.76	10.33

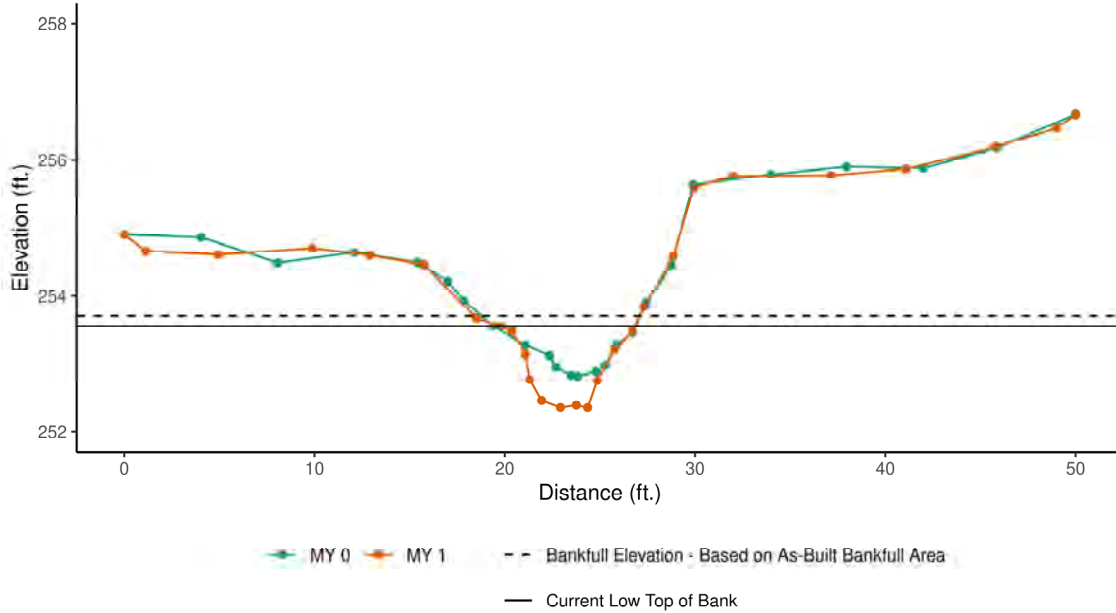
Cross-Section 3 (R2 - Riffle) MY1

MY0	MY1	MY2	MY3	MY4	MY5	MY6	MY7
Bankfull Elevation - Based on As-Built Bankfull Area	253.90	253.70						
Bank Height Ratio - Based on As-Built Bankfull Area	1.00	0.89						
Thalweg Elevation	252.81	252.35						
LTOB Elevation	253.90	253.55						
LTOB Max Depth	1.095	1.205						
LTOB Cross Sectional Area	6.03	5.00

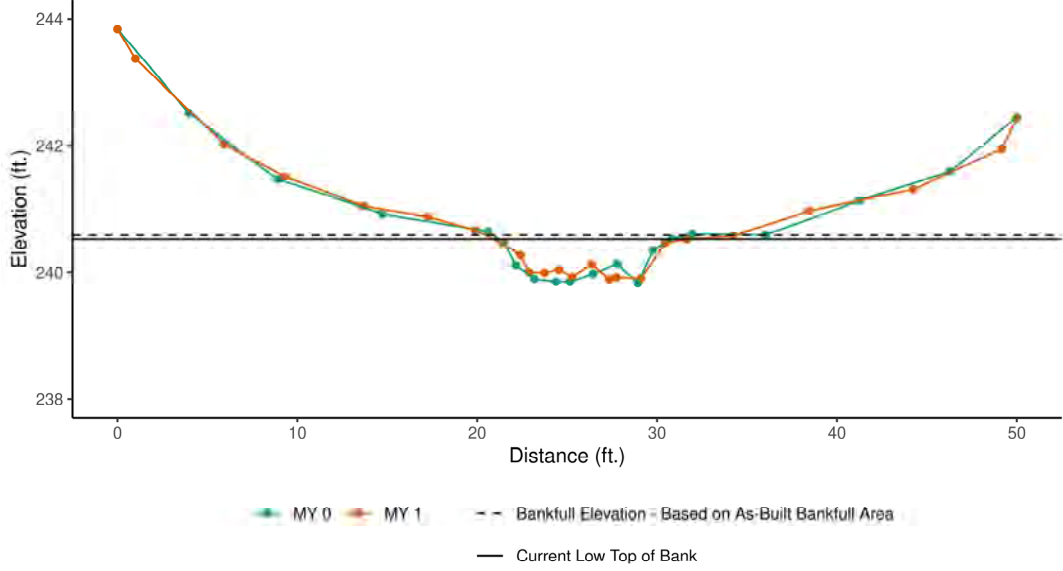
Cross-Section 4 (R3 - Riffle) MY1

MY0	MY1	MY2	MY3	MY4	MY5	MY6	MY7
Bankfull Elevation - Based on As-Built Bankfull Area	240.60	240.58						
Bank Height Ratio - Based on As-Built Bankfull Area	1.00	0.90						
Thalweg Elevation	239.85	239.89						
LTOB Elevation	240.60	240.52						
LTOB Max Depth	0.752	0.629						
LTOB Cross Sectional Area	4.90	4.18

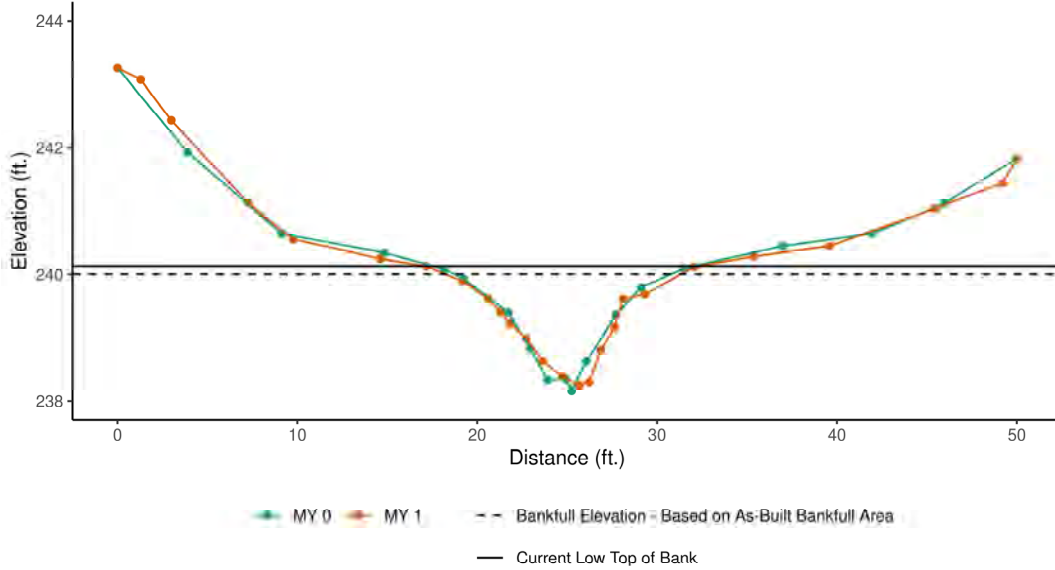
Cross-Section 5 (R3 - Pool) MY1

MY0	MY1	MY2	MY3	MY4	MY5	MY6	MY7
Bankfull Elevation - Based on As-Built Bankfull Area	240.09	240.00						
Bank Height Ratio - Based on As-Built Bankfull Area	1.00	1.07						
Thalweg Elevation	238.34	238.24						
LTOB Elevation	240.09	240.13						
LTOB Max Depth	1.749	1.892						
LTOB Cross Sectional Area	10.02	11.78

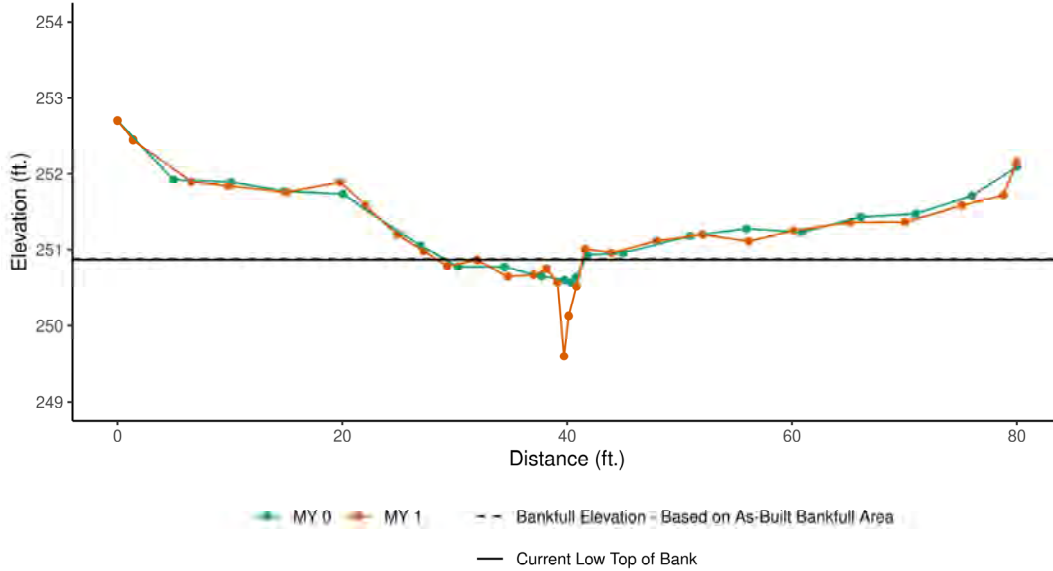
Cross-Section 6 (R5 - Headwater) MY1

MY0	MY1	MY2	MY3	MY4	MY5	MY6	MY7
Bankfull Elevation - Based on As-Built Bankfull Area	250.93	250.88						
Bank Height Ratio - Based on As-Built Bankfull Area	1.00	0.99						
Thalweg Elevation	250.57	249.60						
LTOB Elevation	250.93	250.87						
LTOB Max Depth	0.359	1.267						
LTOB Cross Sectional Area	2.55	2.46

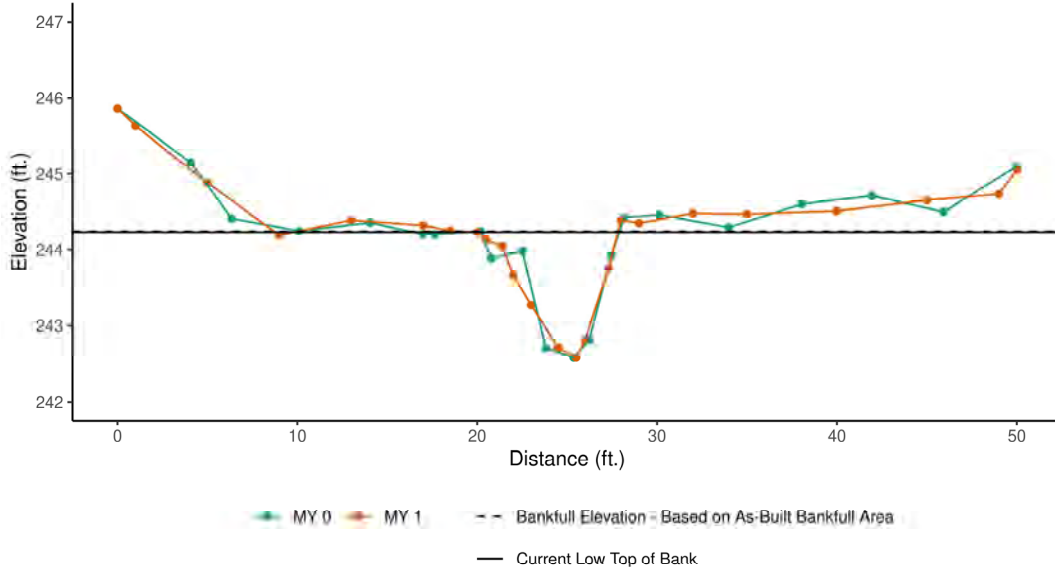
Cross-Section 7 (R6 - Pool) MY1

MY0	MY1	MY2	MY3	MY4	MY5	MY6	MY7
Bankfull Elevation - Based on As-Built Bankfull Area	244.24	244.24						
Bank Height Ratio - Based on As-Built Bankfull Area	1.00	0.99						
Thalweg Elevation	242.58	242.58						
LTOB Elevation	244.24	244.23						
LTOB Max Depth	1.663	1.65						
LTOB Cross Sectional Area	6.78	6.70

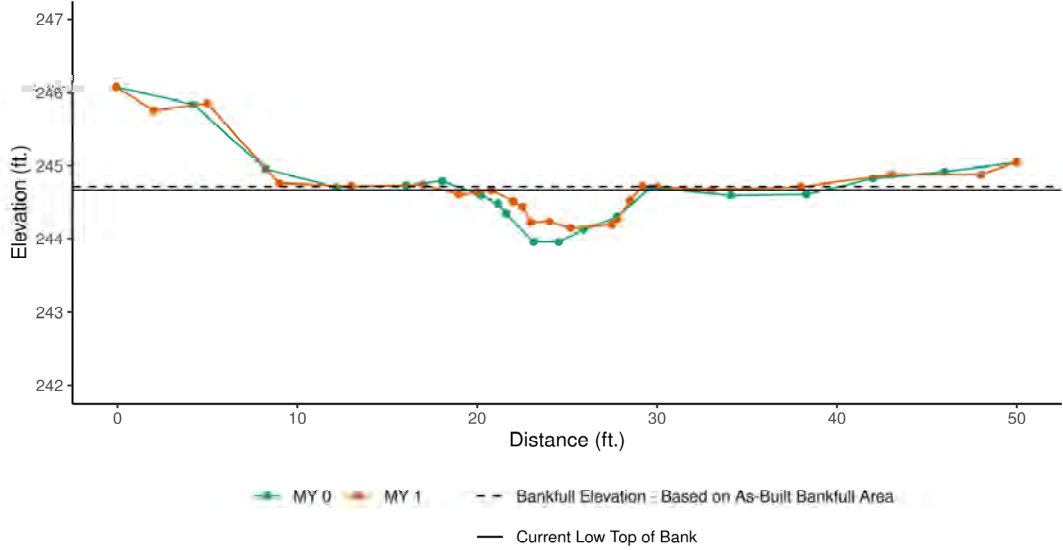
Cross-Section 8 (R6 - Riffle) MY1

MY0	MY1	MY2	MY3	MY4	MY5	MY6	MY7
Bankfull Elevation - Based on As-Built Bankfull Area	244.59	244.71						
Bank Height Ratio - Based on As-Built Bankfull Area	1.00	0.90						
Thalweg Elevation	243.96	244.15						
LTOB Elevation	244.59	244.66						
LTOB Max Depth	0.632	0.51						
LTOB Cross Sectional Area	3.23	2.79

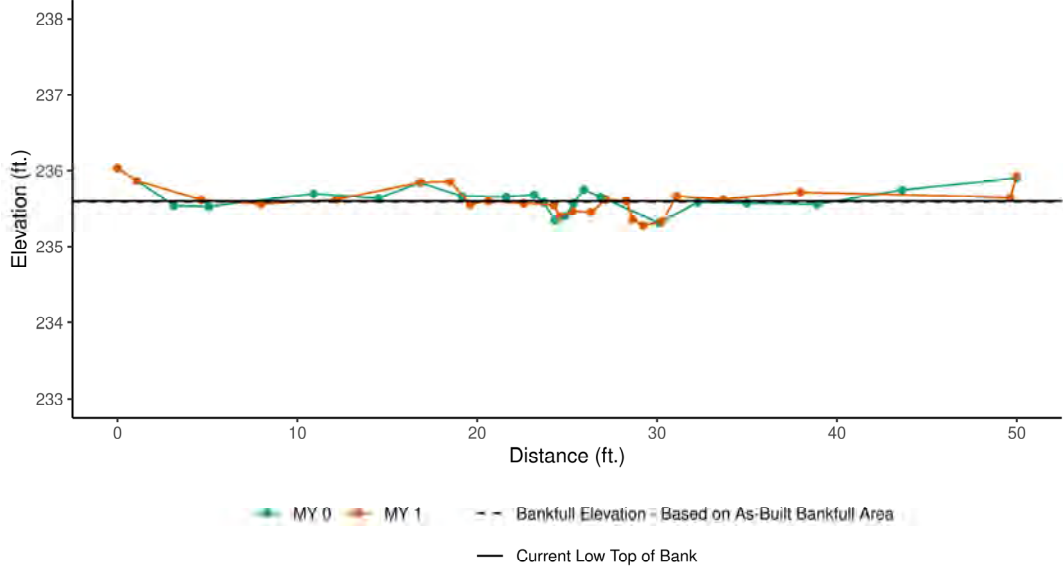
Cross-Section 9 (R7 upper - Riffle) MY1

MY0	MY1	MY2	MY3	MY4	MY5	MY6	MY7
Bankfull Elevation - Based on As-Built Bankfull Area	235.65	235.59						
Bank Height Ratio - Based on As-Built Bankfull Area	0.97	1.05						
Thalweg Elevation	235.35	235.40						
LTOB Elevation	235.65	235.60						
LTOB Max Depth	0.299	0.197						
LTOB Cross Sectional Area	0.39	0.45

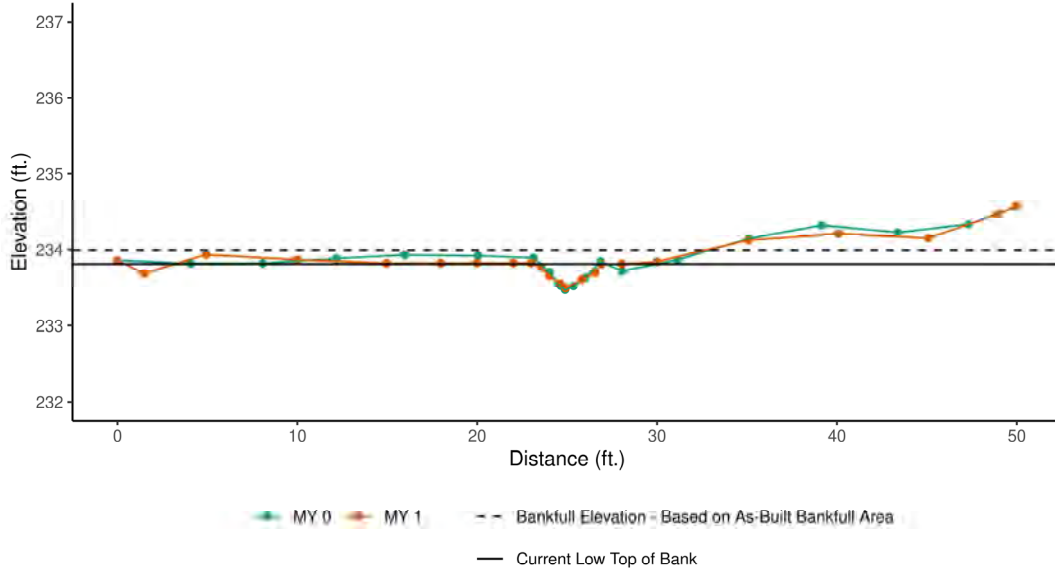
Cross-Section 10 (R7 upper - Pool) MY1

MY0	MY1	MY2	MY3	MY4	MY5	MY6	MY7
Bankfull Elevation - Based on As-Built Bankfull Area	233.89	233.99						
Bank Height Ratio - Based on As-Built Bankfull Area	0.68	0.64						
Thalweg Elevation	233.47	233.50						
LTOB Elevation	233.85	233.81						
LTOB Max Depth	0.371	0.316						
LTOB Cross Sectional Area	0.70	0.63
