MY2 FINAL MONITORING REPORT

Odell's House Mitigation Project

DMS Project # 100041

Calendar Year of Data Collection: 2022

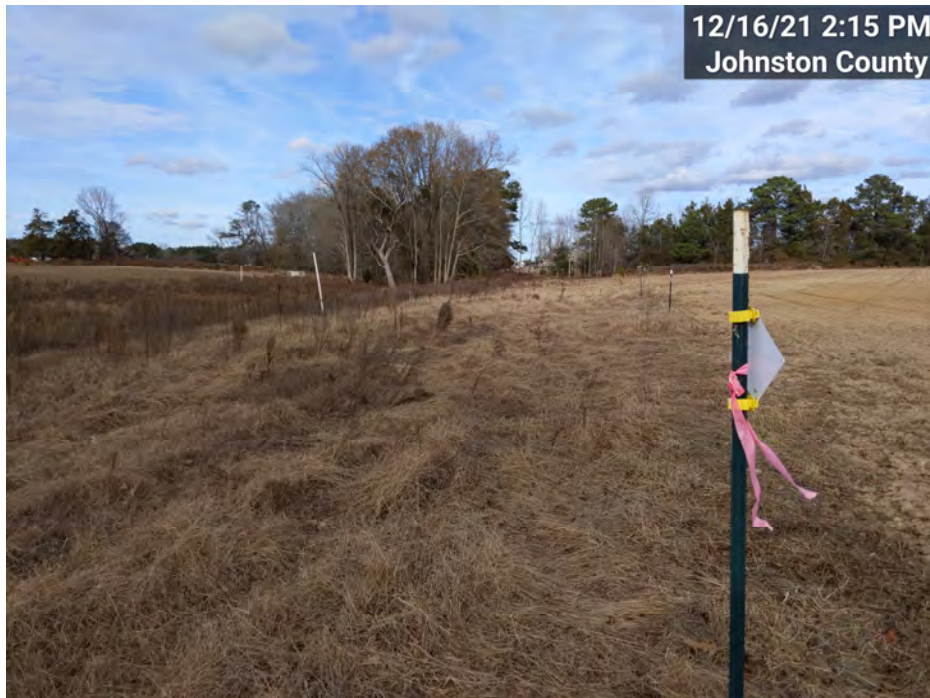
Encroachment Area, R3, Facing South (MY-02)

Visual assessment of vegetation outside of the monitoring plots indicates that the herbaceous vegetation is becoming well established throughout the project. One area of encroachment was noted in MY1 along R3 left bank slope (~0.12 acres). An active farm field along the easement has led to farm equipment encroachment. Prior to MY2, additional t-posts, string, and flagging was added to the easement (see photos in Appendix A). No trees were damaged from the encroachment, only herbaceous vegetation. No further encroachment in this area was found during MY2, but this area will continue to be monitored closely in MY3.

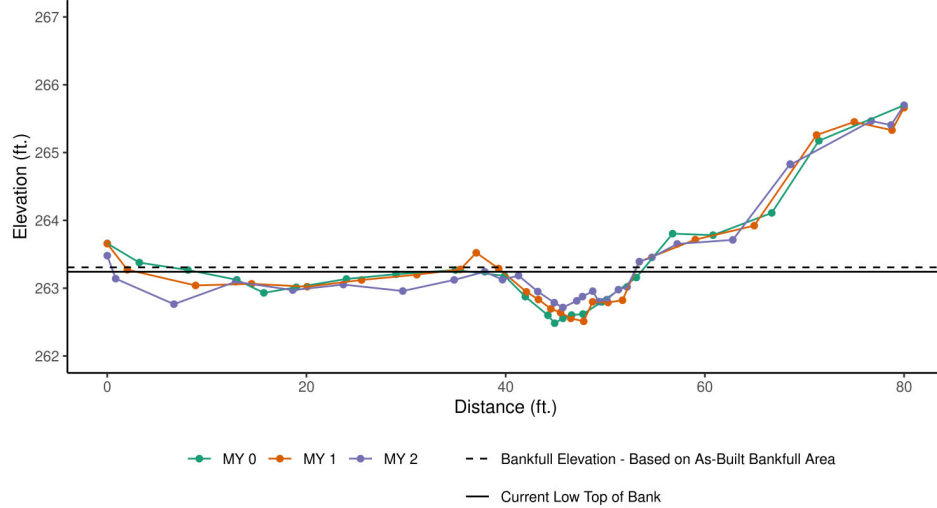
Cross-Section 1 (R1 - Headwater) MY2

MY0	MY1	MY2	MY3	MY4	MY5	MY6	MY7
Bankfull Elevation - Based on As-Built Bankfull Area	263.18	263.20	263.31					
Bank Height Ratio - Based on As-Built Bankfull Area	0.96	1.13	0.89					
Thalweg Elevation	262.48	262.51	262.72					
LTOB Elevation	263.16	263.29	263.24					
LTOB Max Depth	0.674	0.778	0.527					
LTOB Cross Sectional Area	4.77	6.27	4.11

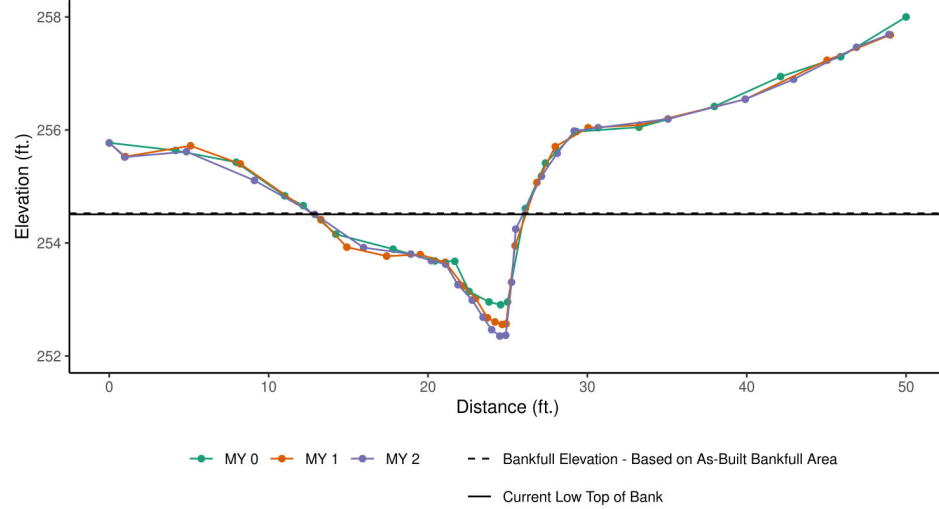
Cross-Section 2 (R2 - Pool) MY2

MY0	MY1	MY2	MY3	MY4	MY5	MY6	MY7
Bankfull Elevation - Based on As-Built Bankfull Area	254.61	254.52	254.53					
Bank Height Ratio - Based on As-Built Bankfull Area	1.00	0.94	0.99					
Thalweg Elevation	252.91	252.56	252.35					
LTOB Elevation	254.61	254.41	254.51					
LTOB Max Depth	1.704	1.852	2.155					
LTOB Cross Sectional Area	11.76	10.33	11.53

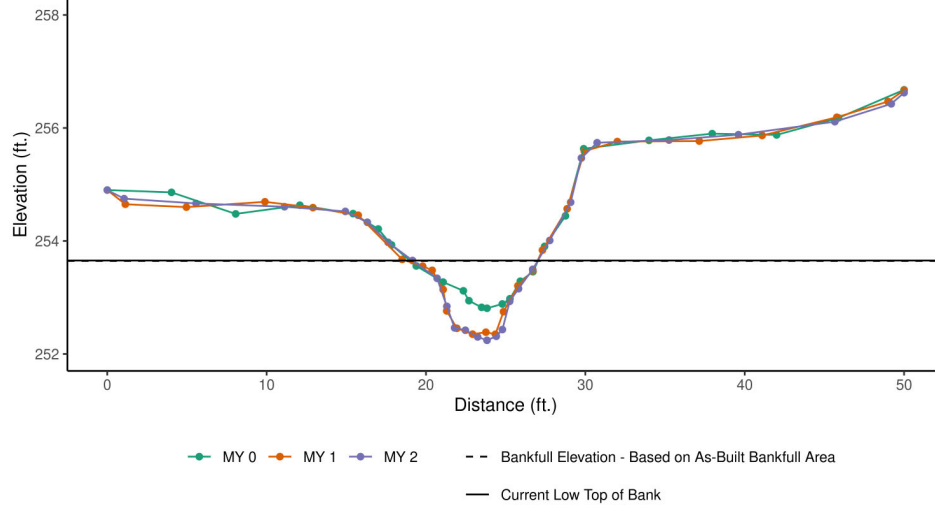
Cross-Section 3 (R2 - Riffle) MY2

MY0	MY1	MY2	MY3	MY4	MY5	MY6	MY7
Bankfull Elevation - Based on As-Built Bankfull Area	253.90	253.70	253.65					
Bank Height Ratio - Based on As-Built Bankfull Area	1.00	0.89	1.01					
Thalweg Elevation	252.81	252.35	252.24					
LTOB Elevation	253.90	253.55	253.65					
LTOB Max Depth	1.095	1.205	1.412					
LTOB Cross Sectional Area	6.03	5.00	6.10

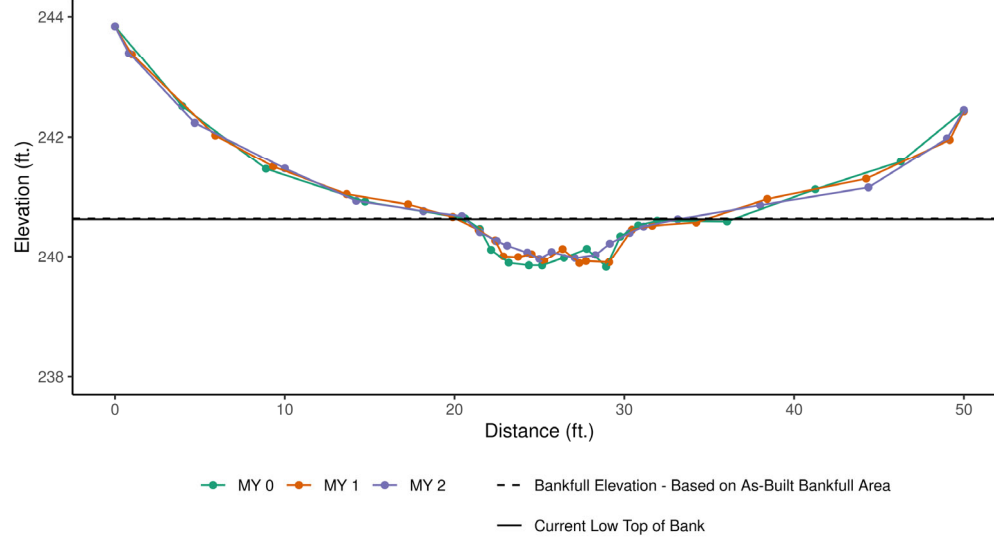
Cross-Section 4 (R3 - Riffle) MY2

MY0	MY1	MY2	MY3	MY4	MY5	MY6	MY7
Bankfull Elevation - Based on As-Built Bankfull Area	240.60	240.58	240.64					
Bank Height Ratio - Based on As-Built Bankfull Area	1.00	0.90	0.98					
Thalweg Elevation	239.85	239.89	239.96					
LTOB Elevation	240.60	240.52	240.63					
LTOB Max Depth	0.752	0.629	0.665					
LTOB Cross Sectional Area	4.90	4.18	4.73

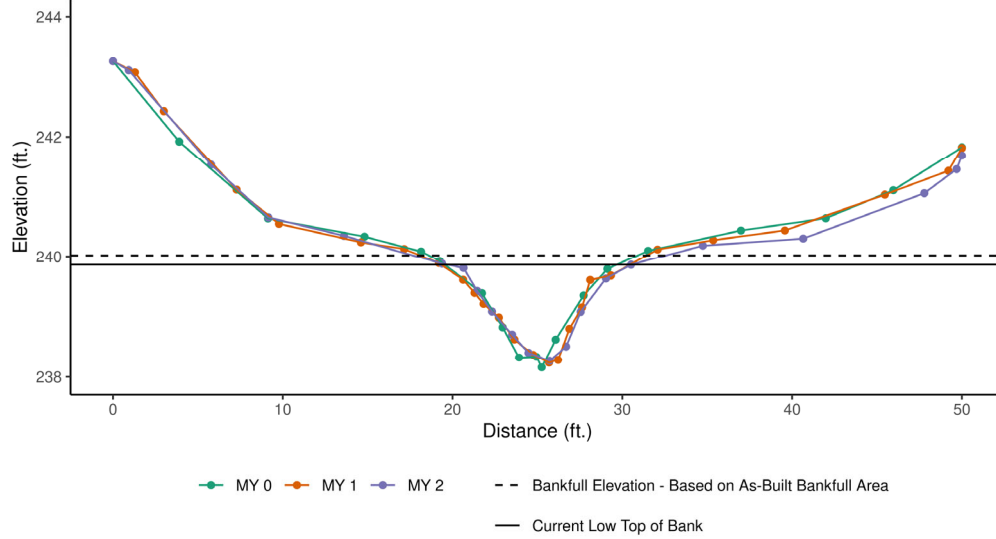
Cross-Section 5 (R3 - Pool) MY2

MY0	MY1	MY2	MY3	MY4	MY5	MY6	MY7
Bankfull Elevation - Based on As-Built Bankfull Area	240.09	240.00	240.02					
Bank Height Ratio - Based on As-Built Bankfull Area	1.00	1.07	0.91					
Thalweg Elevation	238.34	238.24	238.27					
LTOB Elevation	240.09	240.13	239.86					
LTOB Max Depth	1.749	1.892	1.591					
LTOB Cross Sectional Area	10.02	11.78	8.32

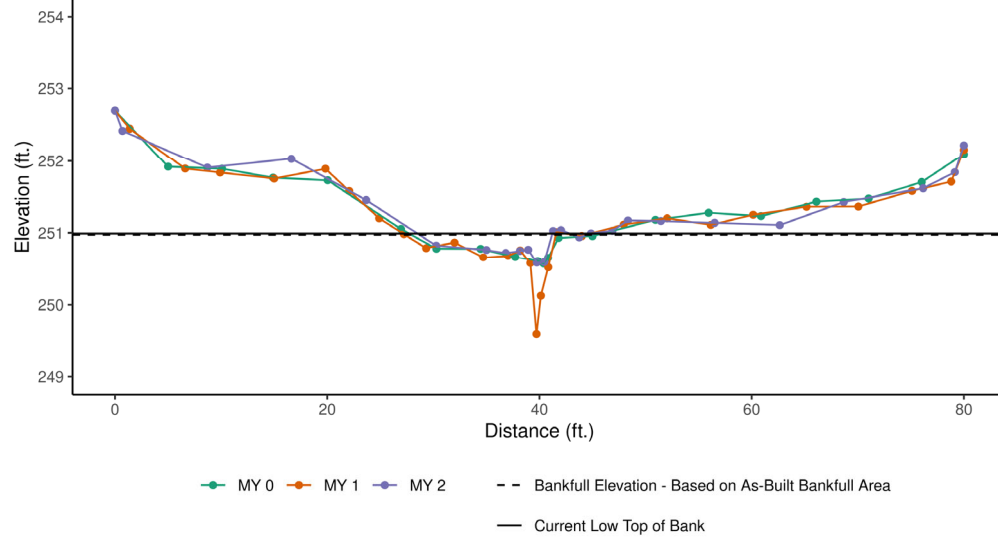
Cross-Section 6 (R5 - Headwater) MY2

MY0	MY1	MY2	MY3	MY4	MY5	MY6	MY7
Bankfull Elevation - Based on As-Built Bankfull Area	250.93	250.88	250.97					
Bank Height Ratio - Based on As-Built Bankfull Area	1.00	0.99	1.05					
Thalweg Elevation	250.57	249.60	250.58					
LTOB Elevation	250.93	250.87	250.99					
LTOB Max Depth	0.359	1.267	0.409					
LTOB Cross Sectional Area	2.55	2.46	2.78

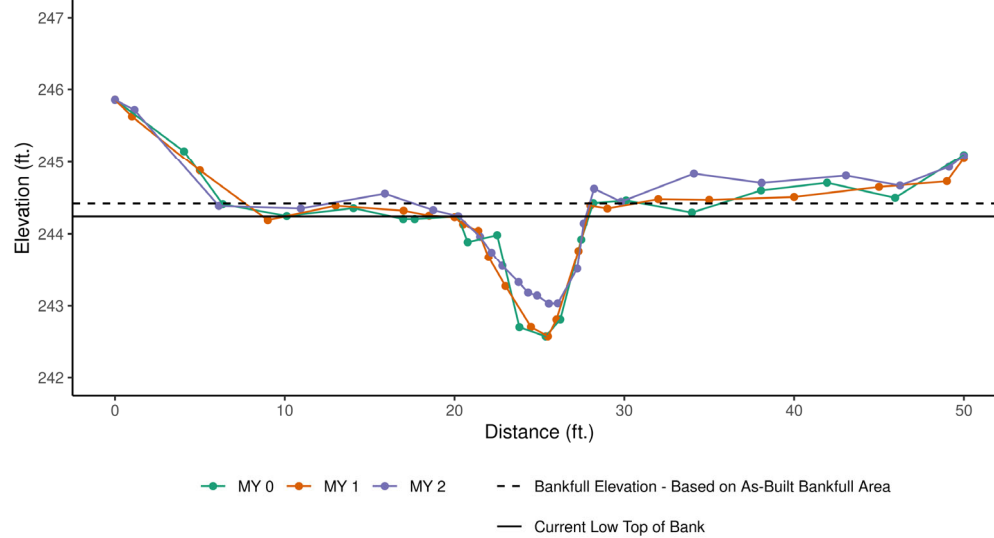
Cross-Section 7 (R6 - Pool) MY2

MY0	MY1	MY2	MY3	MY4	MY5	MY6	MY7
Bankfull Elevation - Based on As-Built Bankfull Area	244.24	244.24	244.42					
Bank Height Ratio - Based on As-Built Bankfull Area	1.00	0.99	0.87					
Thalweg Elevation	242.58	242.58	243.03					
LTOB Elevation	244.24	244.23	244.24					
LTOB Max Depth	1.663	1.65	1.212					
LTOB Cross Sectional Area	6.78	6.70	5.43

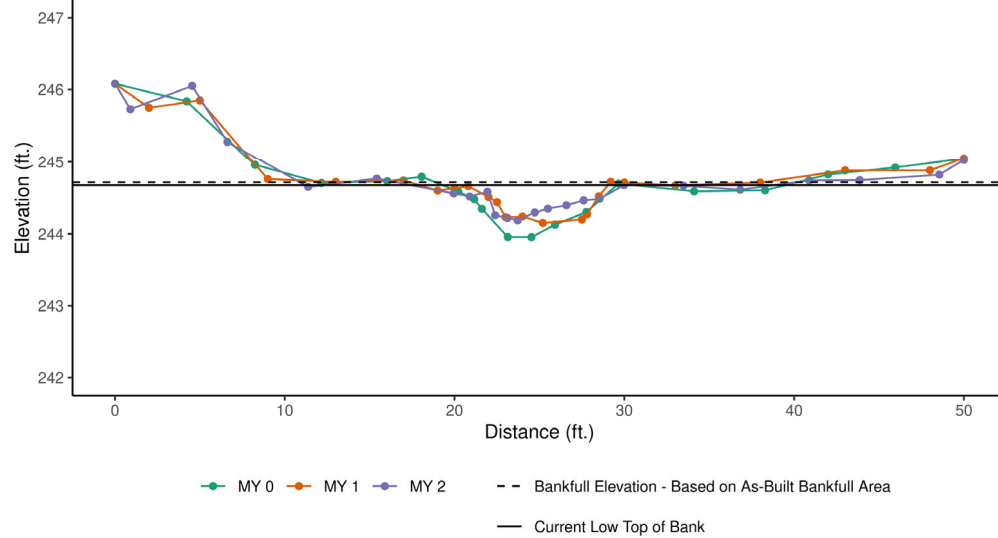
Cross-Section 8 (R6 - Riffle) MY2

MY0	MY1	MY2	MY3	MY4	MY5	MY6	MY7
Bankfull Elevation - Based on As-Built Bankfull Area	244.59	244.71	244.72					
Bank Height Ratio - Based on As-Built Bankfull Area	1.00	0.90	0.92					
Thalweg Elevation	243.96	244.15	244.19					
LTOB Elevation	244.59	244.66	244.67					
LTOB Max Depth	0.632	0.51	0.487					
LTOB Cross Sectional Area	3.23	2.79	2.72

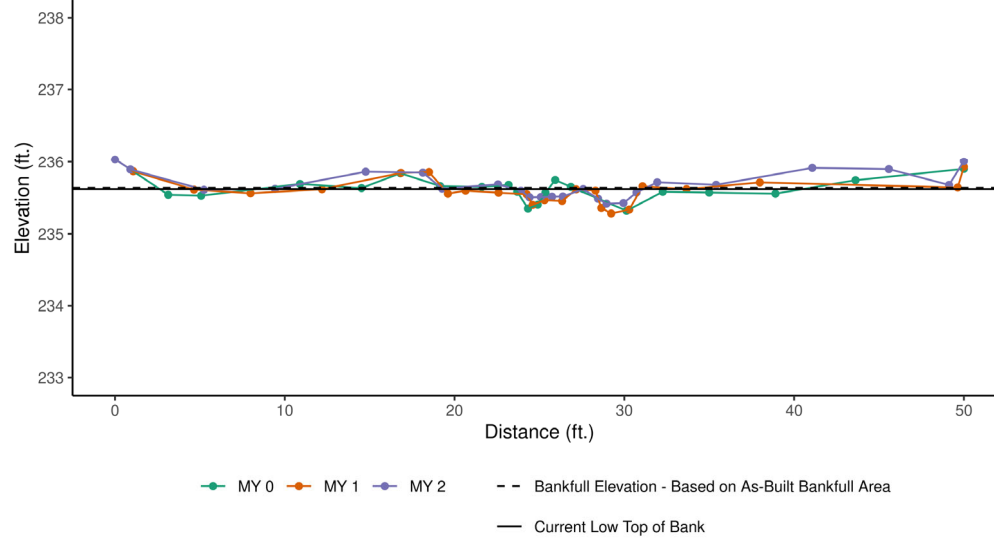
Cross-Section 9 (R7 upper - Riffle) MY2

MY0	MY1	MY2	MY3	MY4	MY5	MY6	MY7
Bankfull Elevation - Based on As-Built Bankfull Area	235.65	235.59	235.64					
Bank Height Ratio - Based on As-Built Bankfull Area	0.97	1.05	0.86					
Thalweg Elevation	235.35	235.40	235.51					
LTOB Elevation	235.65	235.60	235.62					
LTOB Max Depth	0.299	0.197	0.113					
LTOB Cross Sectional Area	0.39	0.45	0.31

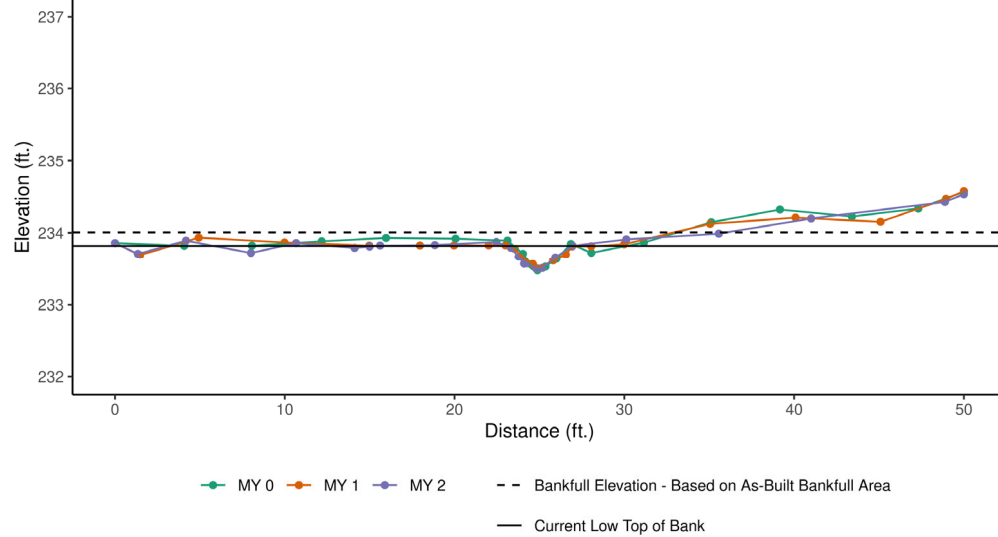
Cross-Section 10 (R7 upper - Pool) MY2

MY0	MY1	MY2	MY3	MY4	MY5	MY6	MY7
Bankfull Elevation - Based on As-Built Bankfull Area	233.89	233.99	234.01					
Bank Height Ratio - Based on As-Built Bankfull Area	0.68	0.64	0.57					
Thalweg Elevation	233.47	233.50	233.57					
LTOB Elevation	233.85	233.81	233.82					
LTOB Max Depth	0.371	0.316	0.25					
LTOB Cross Sectional Area	0.70	0.63	0.57

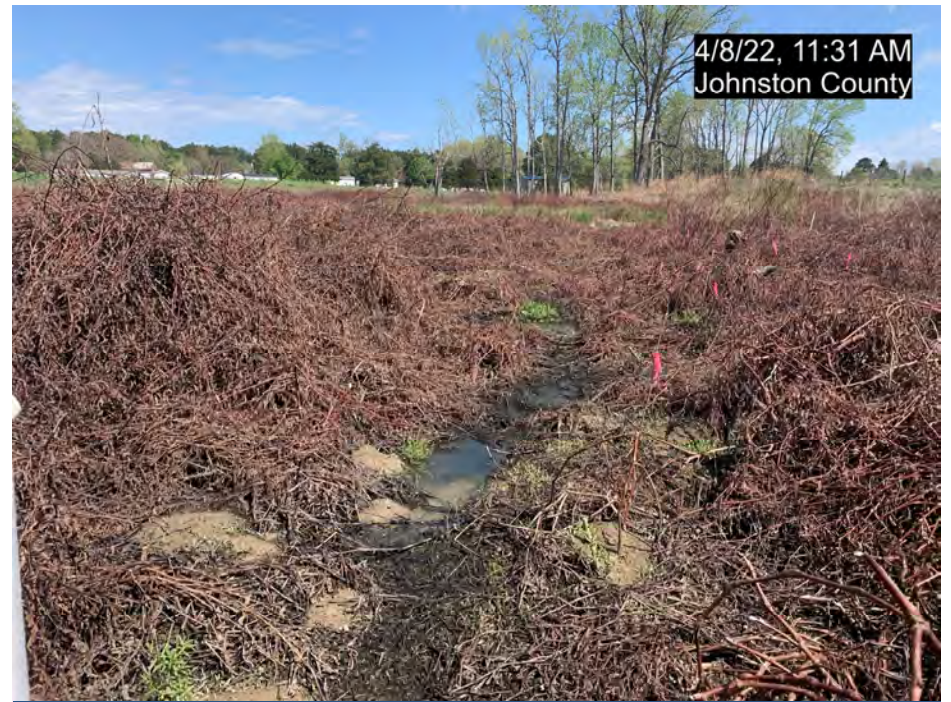
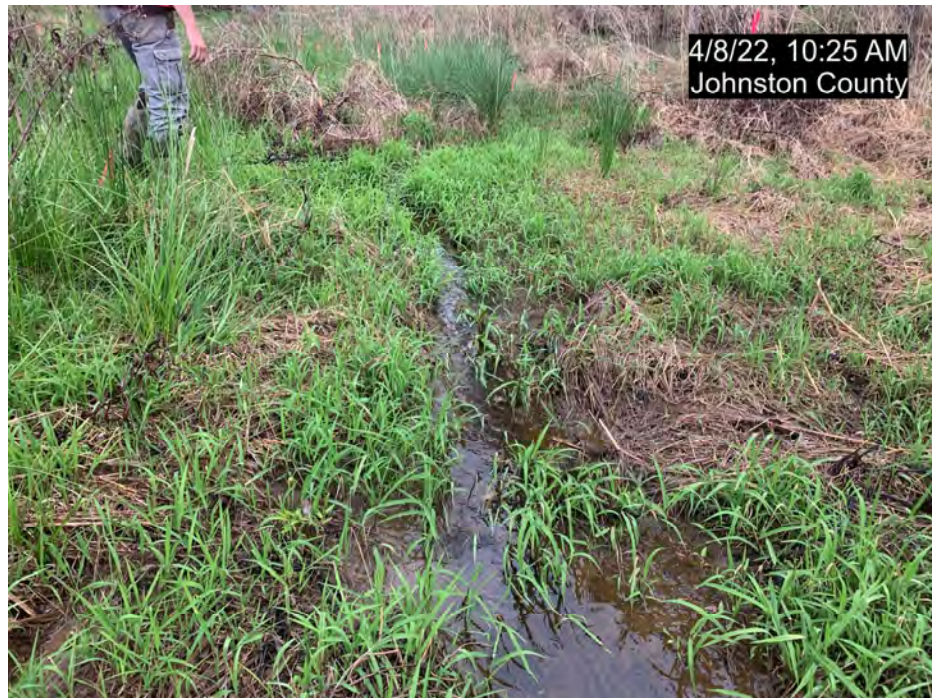
R1 Flow Documentation (MY-02)

Two pressure transducers (flow gauges), installed in March 2021 on reaches R1 and R5, documented that the stream exhibited surface flow for a minimum of 30 consecutive days throughout the monitoring year (Appendix E). An additional flow gauge (FG-3) was installed on December 16th, 2021, on R1 near the center of the old pond bed. FG-3 exhibit flow for a maximum of 18 consecutive days and failed to meet the 30-day criterium. WLS will continue to monitor FG-3 in Year 3 to determine if R1 is trending toward success. If needed, remedial actions will be planned following Year 3 data analysis. Additionally, to determine if rainfall amounts are normal for the given year, precipitation data was obtained from an onsite rain gauge and data is presented in Appendix D.

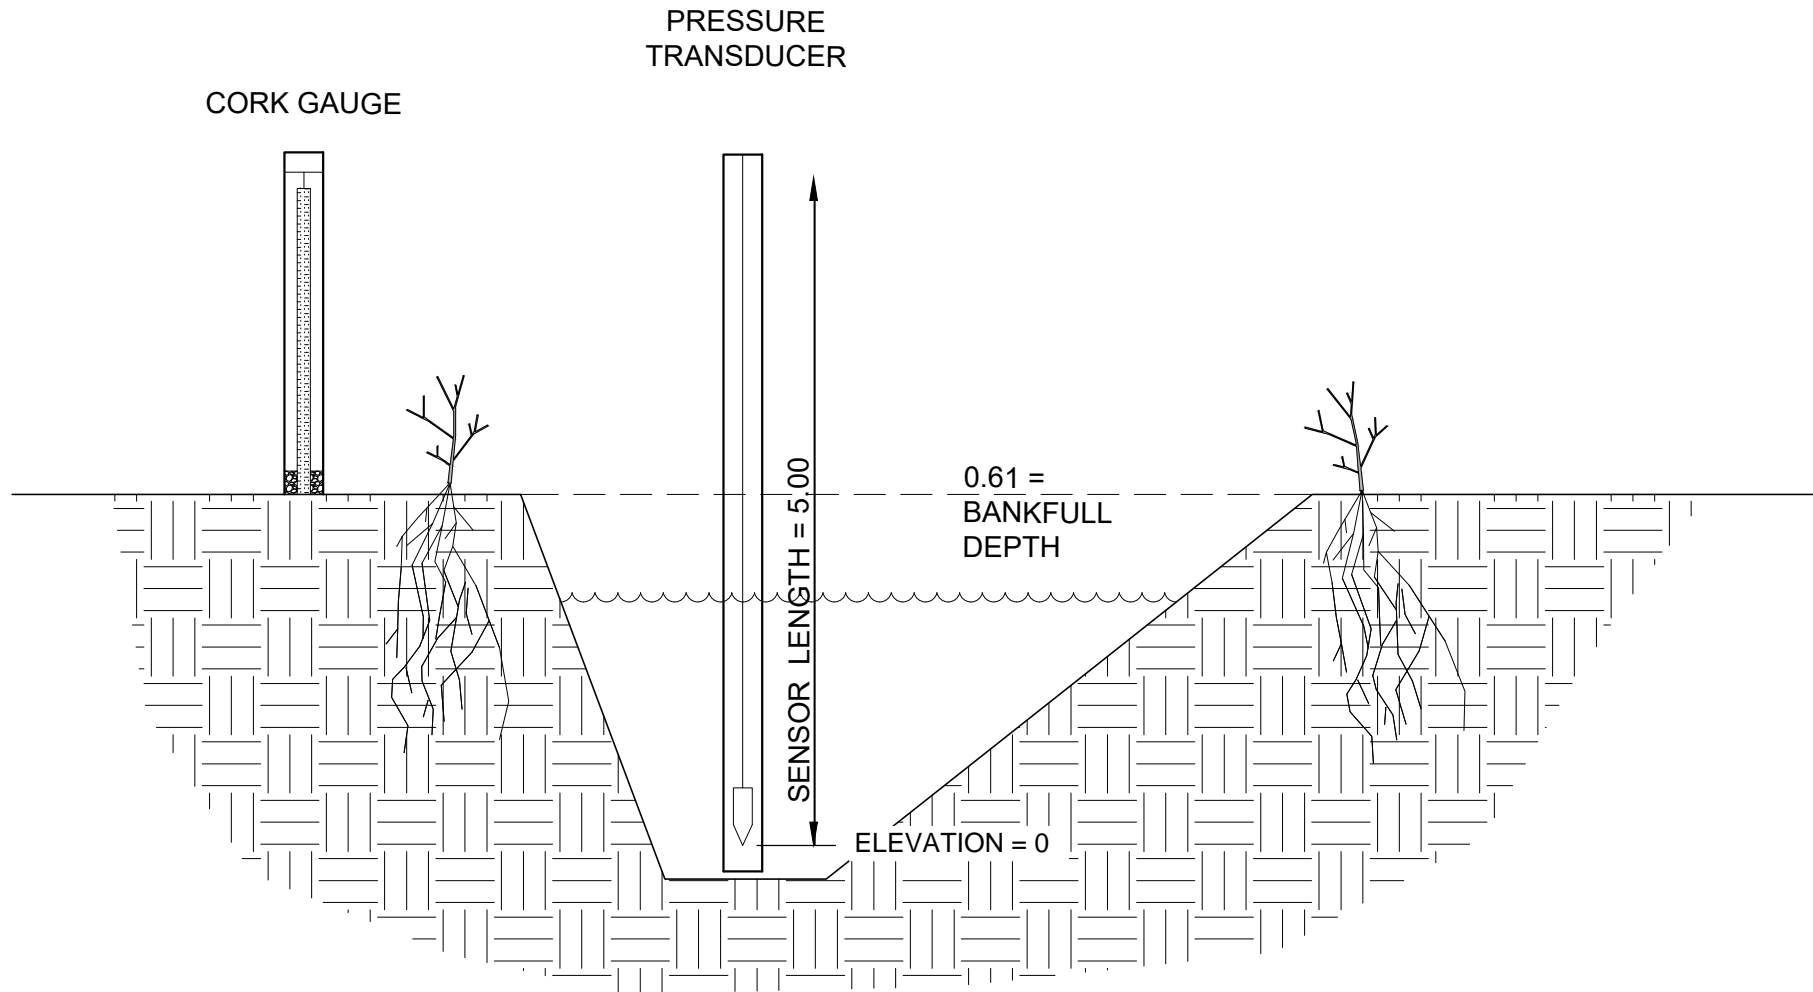
Crest Gauge CG-2 (R7 lower)

Bankfull Event Depth = 0.61 feet
