MY2 FINAL MONITORING REPORT Odell's House Buffer Mitigation Project Monitoring Year 2 Calendar Year of Data Collection: 2022

NCDEQ DMS Project Identification #100041 NCDEQ DMS Contract # 7420 Neuse River Basin (CU 03020201) DWR Project # 2018-0200 USACE Action ID Number: SAW-2018-00431 Johnston County, NC Data Collection Period: September 2022 Submission Date: November 2022

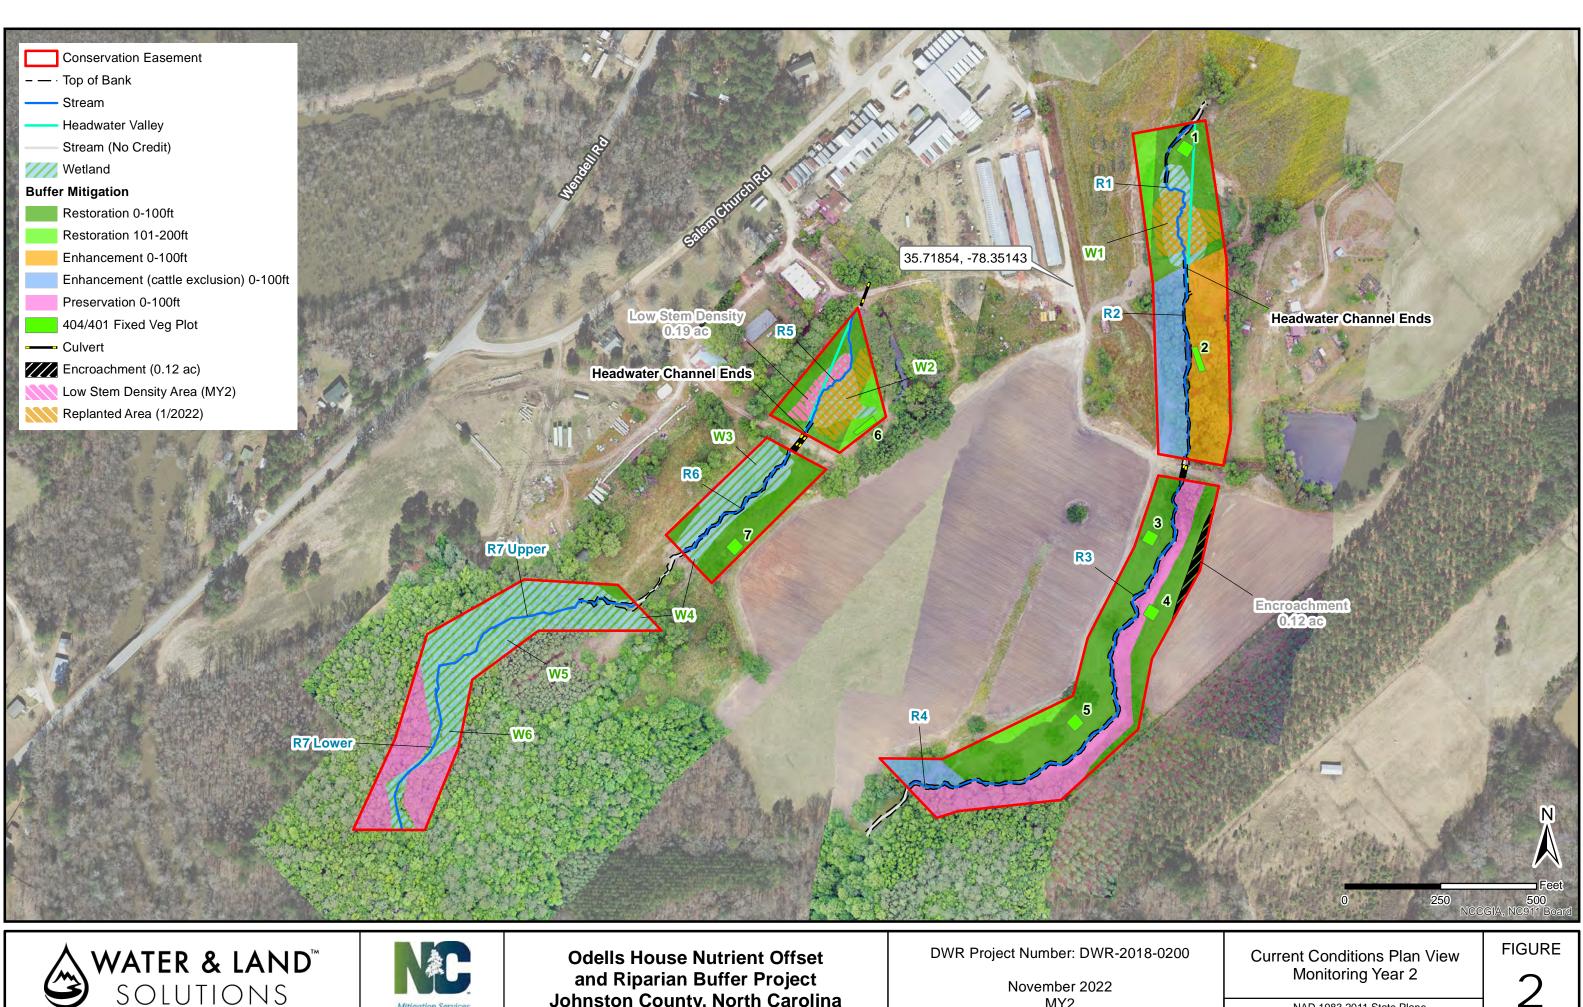
Figure 1: Site Location Map Figure 2: Current Condition Plan View

Visual assessment of vegetation outside of the monitoring plots indicates that the herbaceous vegetation is becoming well established throughout the project. One area of encroachment was noted in MY1 along R3 left bank slope (~0.12 acres). An active farm field along the easement has led to farm equipment encroachment. Prior to MY2, additional t-posts, string, and flagging was added to the easement (see photos in Appendix A). No trees were damaged from the encroachment, only herbaceous vegetation. No further encroachment in this area was noted in MY2.

Two areas of low stem density were observed in MY1. Low stem densities in these areas (~1.07 acres) are due to low planting densities at as-built, mortality due to high hydrology, and dense herbaceous vegetation. Extremely soft and wet soil conditions during construction and planting made areas of W1 and W2 unsafe for the contractor to plant bare roots. During MY2, both wetlands were re-planted with wet tolerant species from the approved mitigation plan on January 5th, 2022 (see Table 3 below). The low stem density area has been reduced to the right floodplain of R5 (0.19 acres). W2 has a low stem density in MY2 due to difficulty finding trees in dense herbaceous vegetation.
