MY3 FINAL MONITORING REPORT

Odell's House Mitigation Project

DMS Project # 100041

Calendar Year of Data Collection: 2023

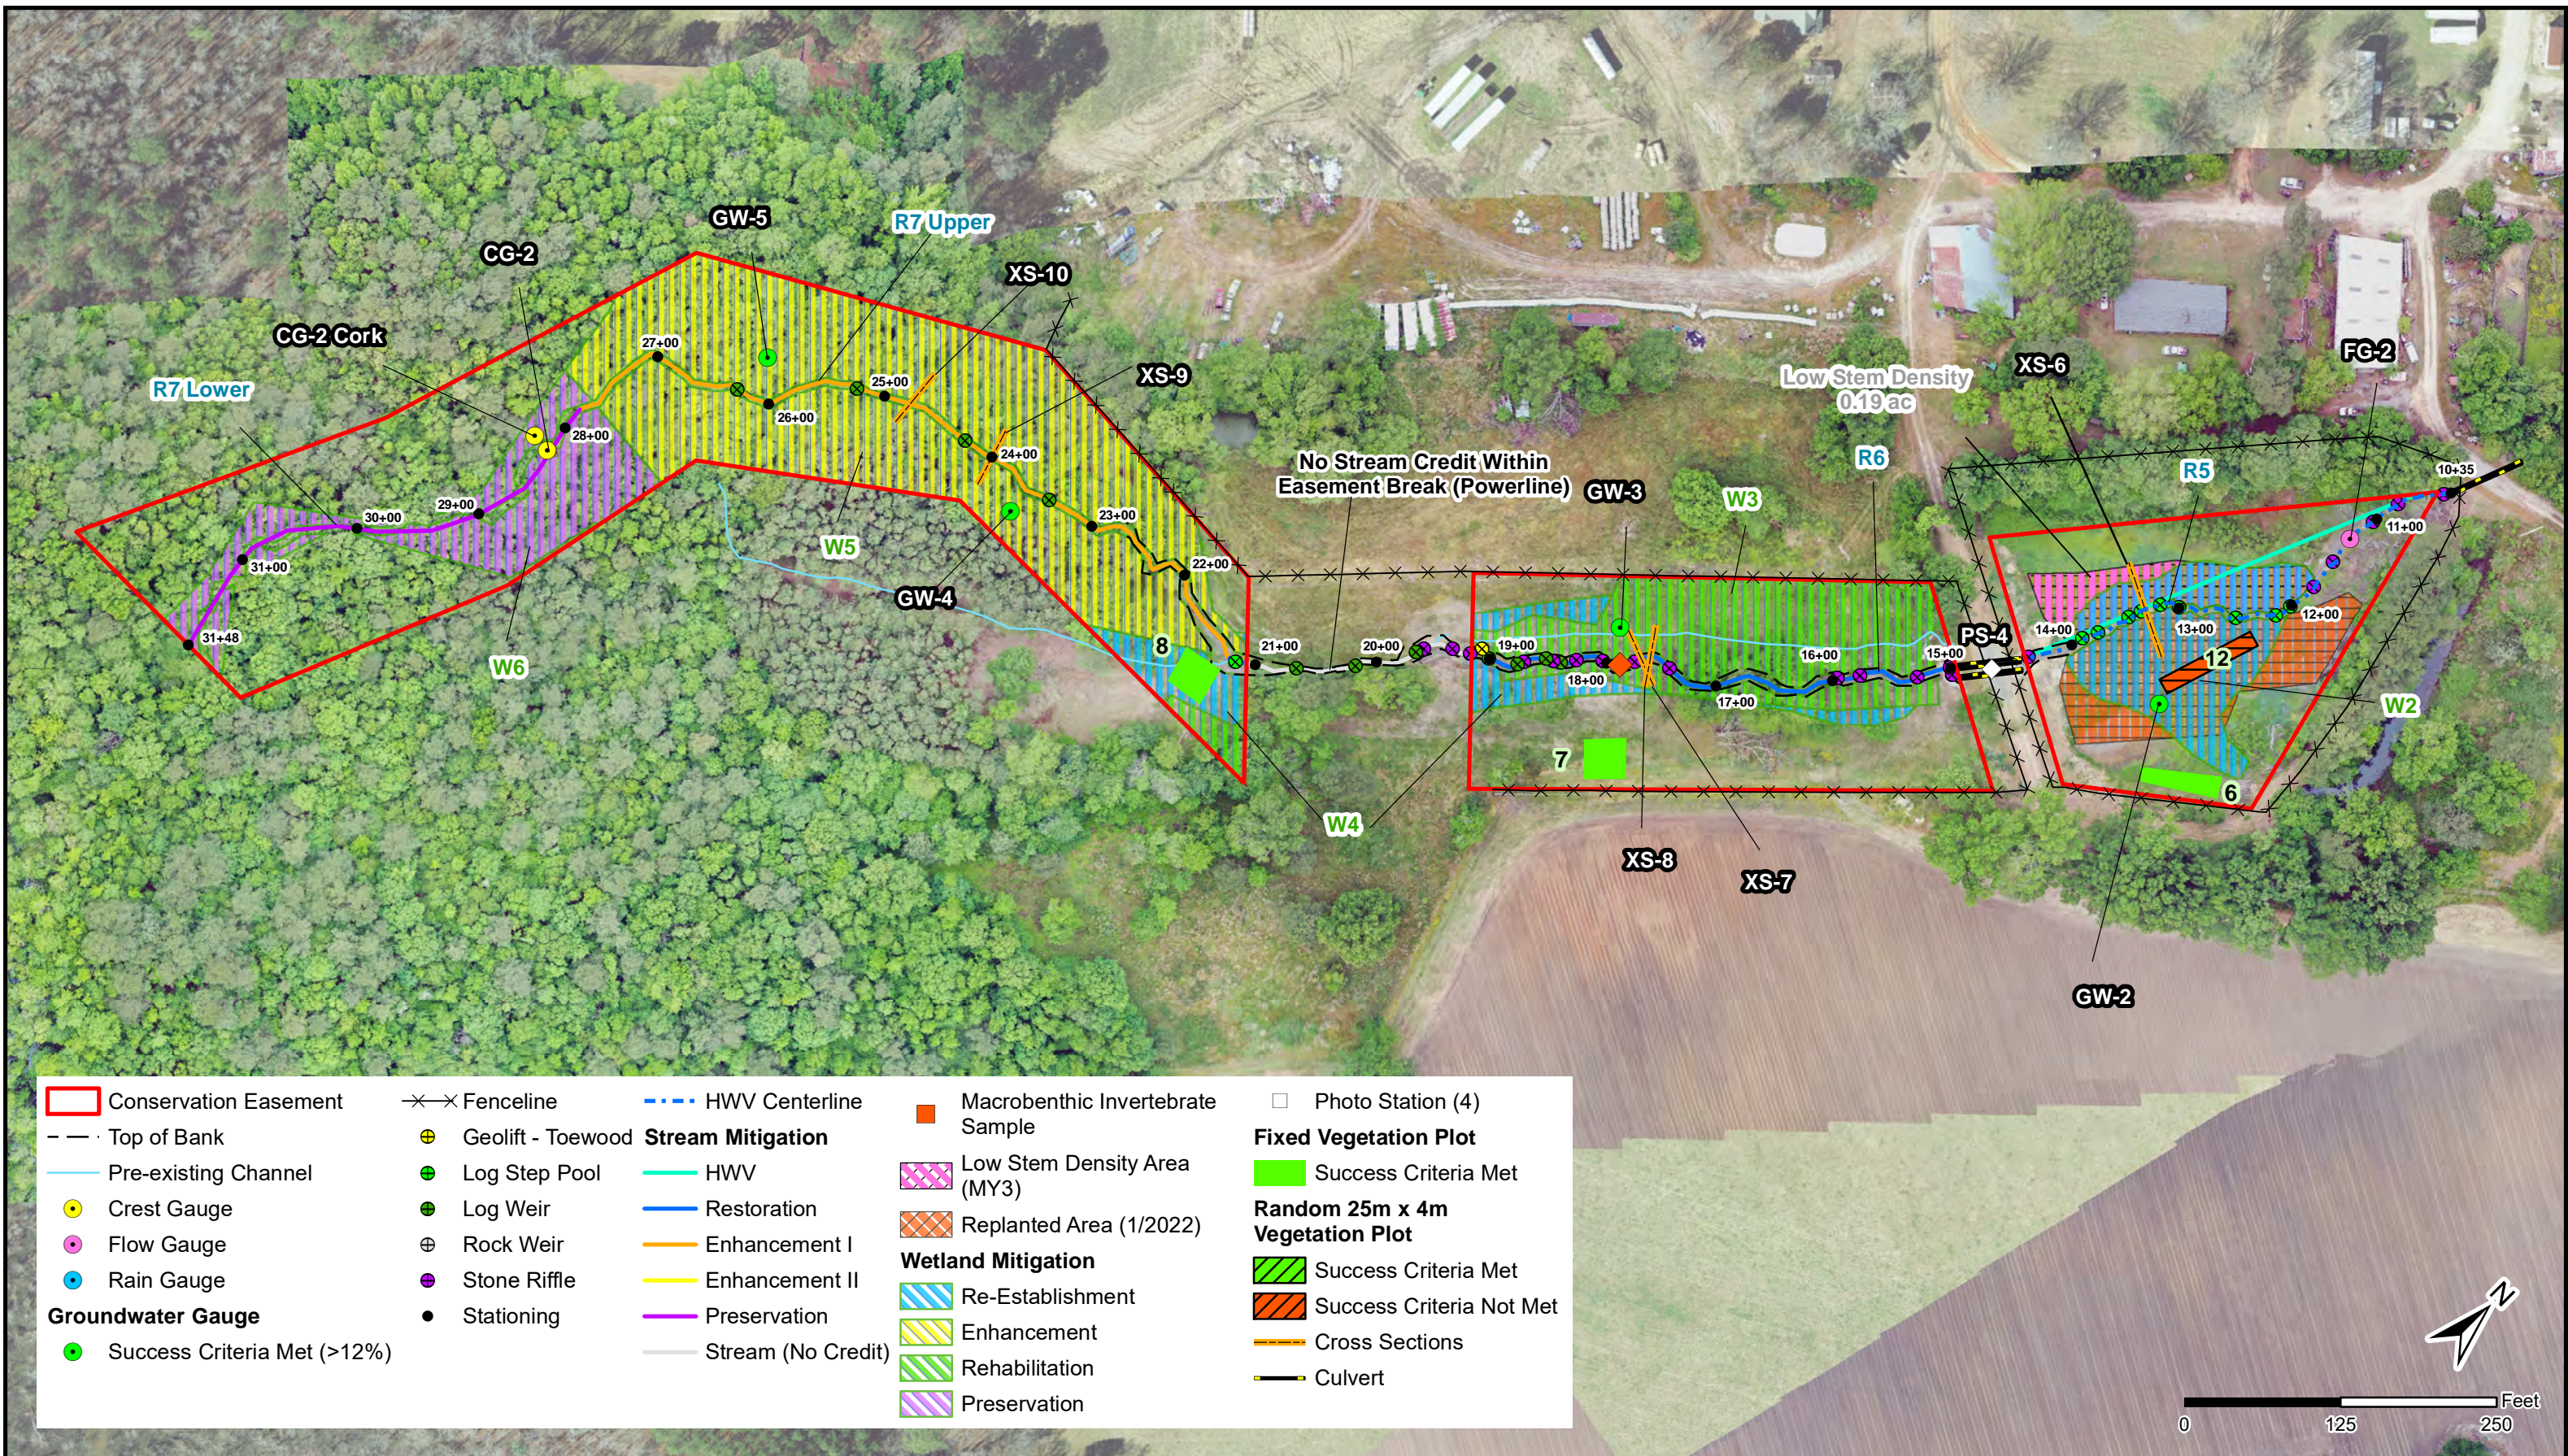
FIGURE
1b

1. **Figure 1b: Add date to replanted area in legend (1/2022).** WLS Response: The date has been added to the replanted area in the Figure 1b legend.
2. **Figure 1b: Is the low stem density area the same as it was in MY2? Indicate if this is true by adding MY3 in legend.** WLS Response: The low stem density area is the same as it was in MY2 and the legend on Figure 1b and c have been updated accordingly.
3. **Appendix A, Vegetation Condition Assessment Table: Update low stem acreage to 0.33 acres.** WLS Response: The low stem acreage has been updated to the correct acreage in the Appendix A, Vegetation Condition Assessment Table.

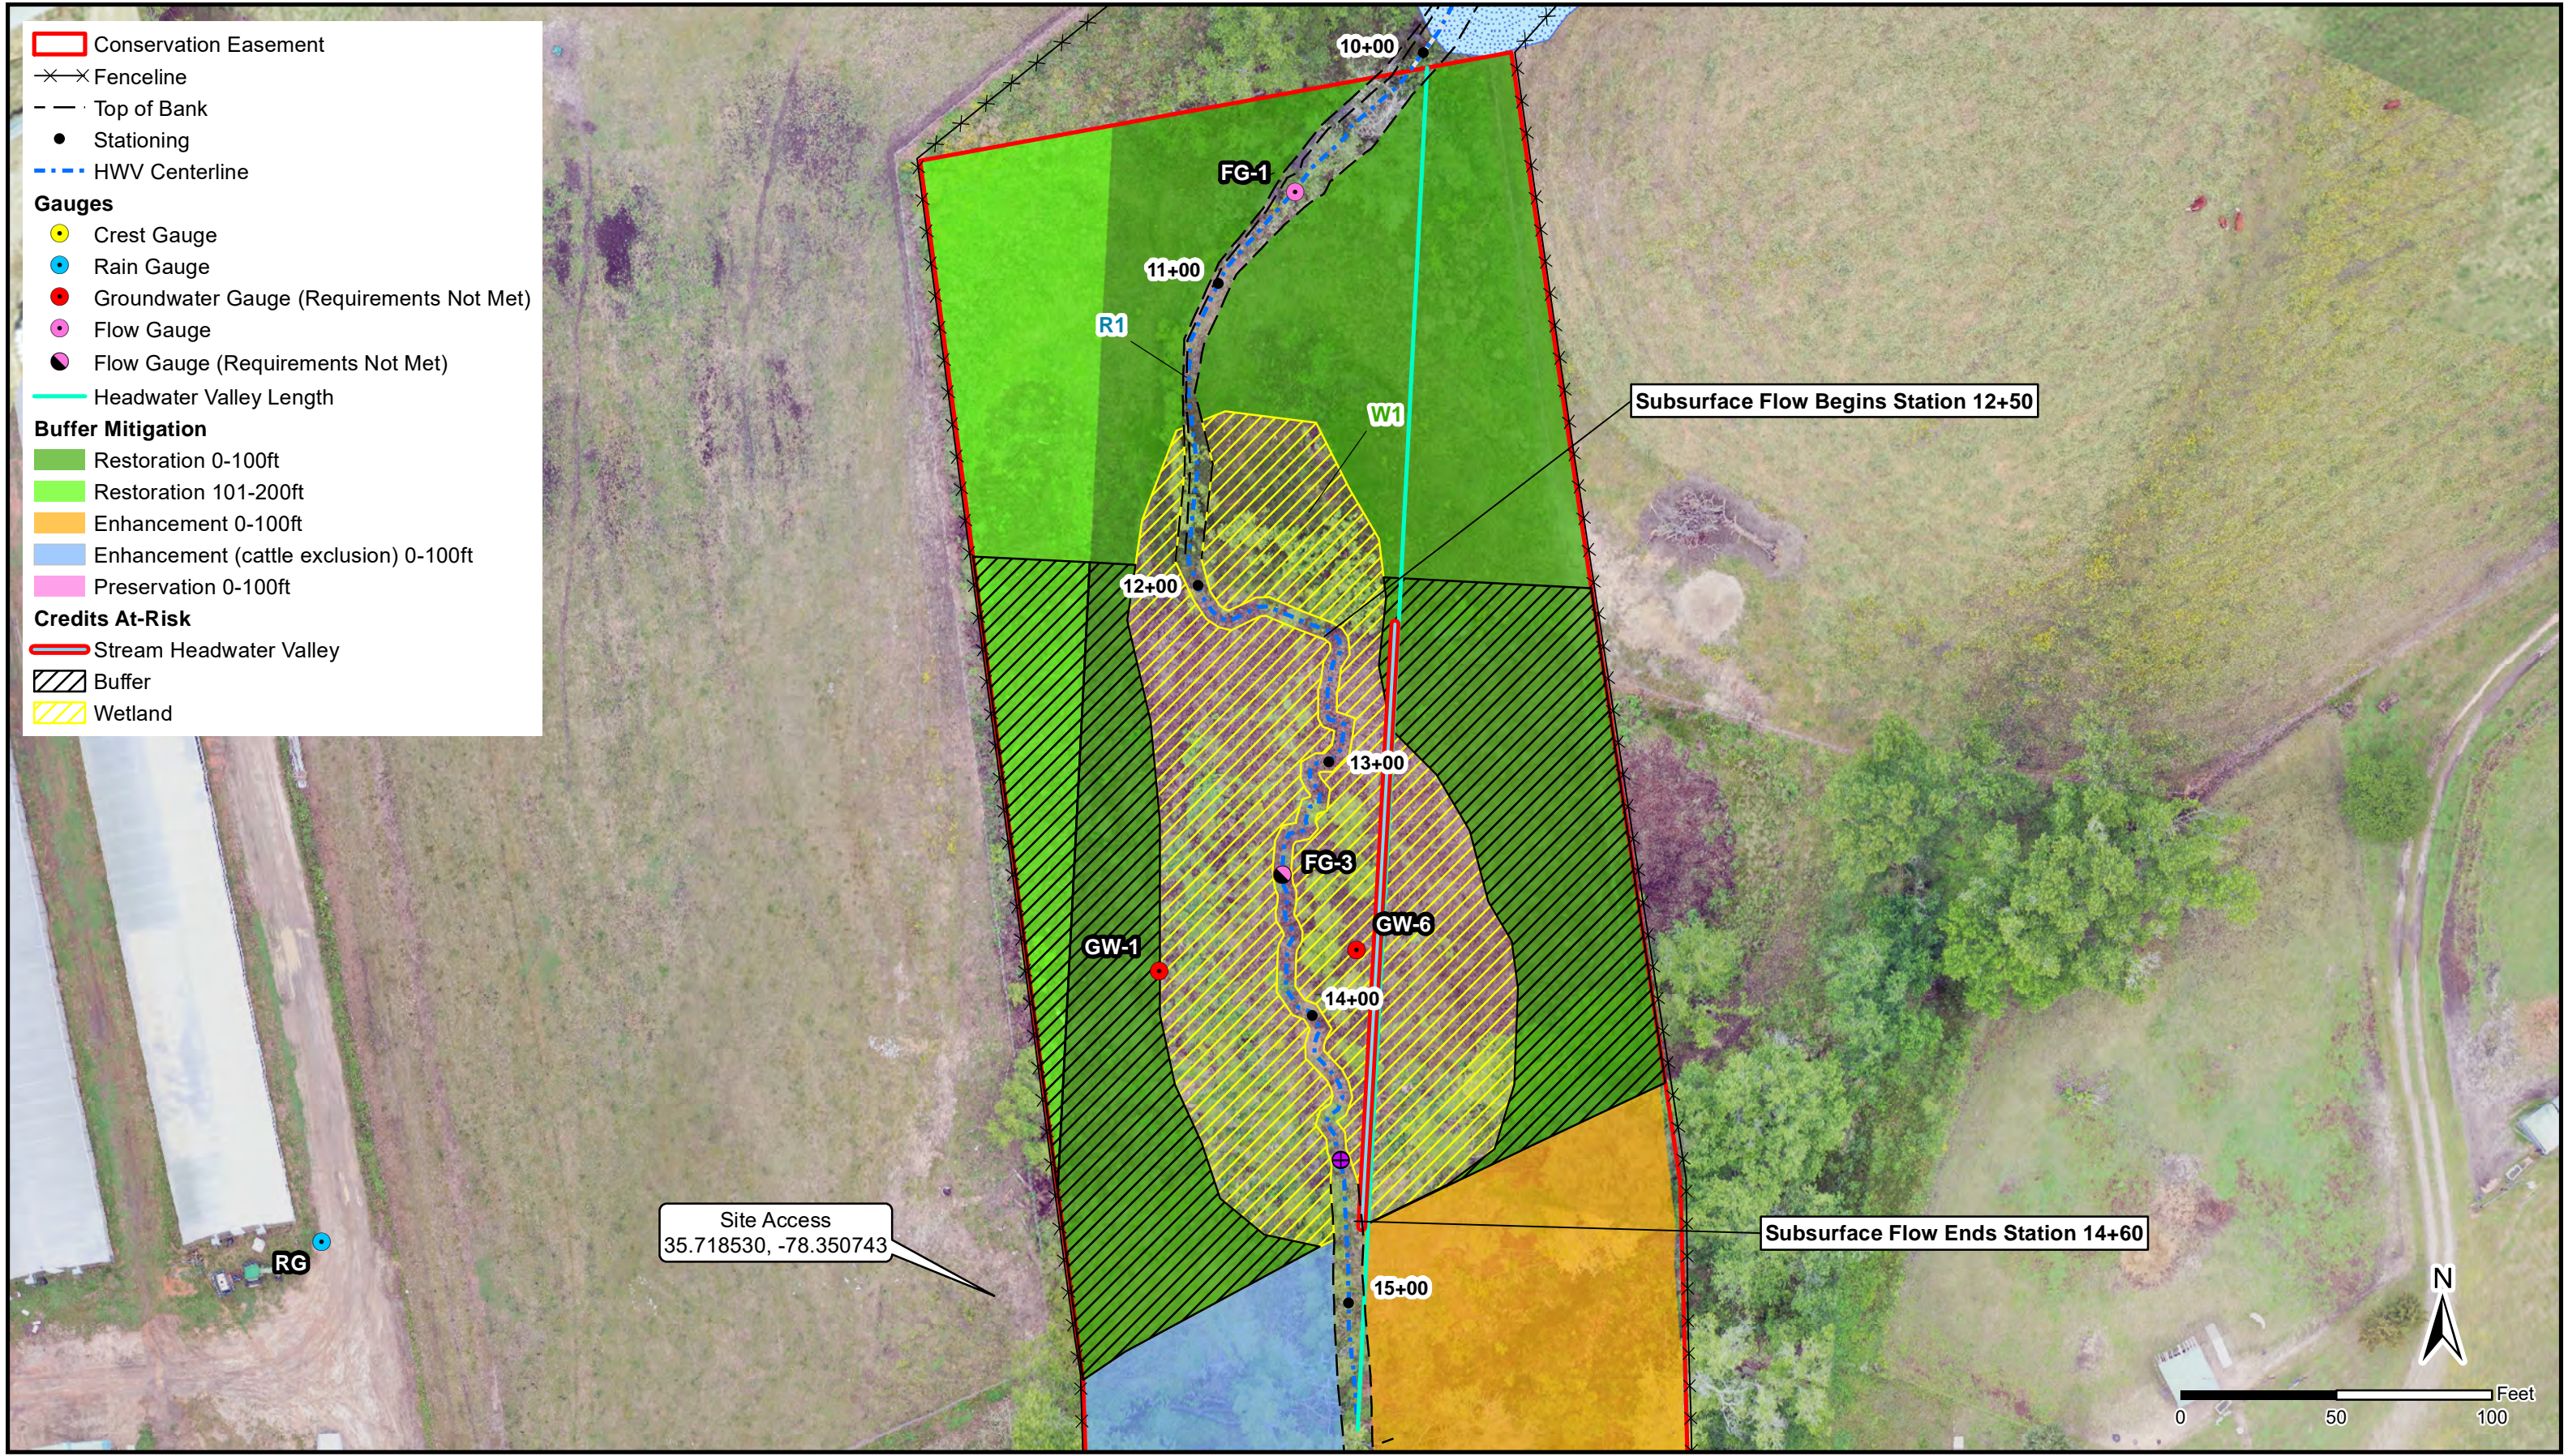
FIGURE
1d

Subsurface Flow Begins Station 12+50

Subsurface Flow Ends Station 14+60

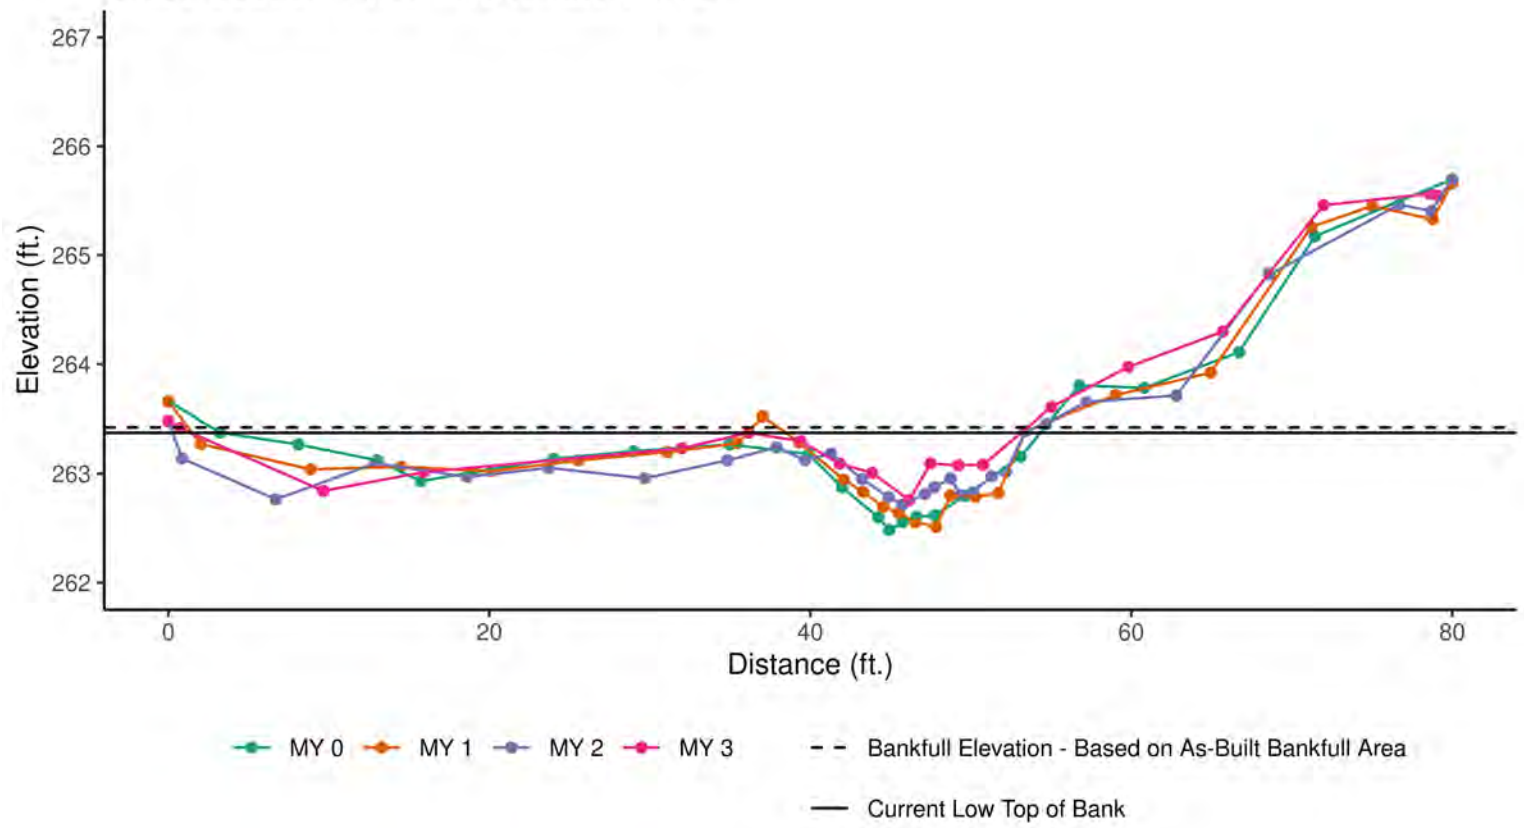
Cross-Section 1 (R1 - Headwater) MY2

MY0	MY1	MY2	MY3	MY4	MY5	MY6	MY7
Bankfull Elevation - Based on As-Built Bankfull Area	263.18	263.20	263.31	263.42				
Bank Height Ratio - Based on As-Built Bankfull Area	0.96	1.13	0.89	0.93				
Thalweg Elevation	262.48	262.51	262.72	262.76				
LTOB Elevation	263.16	263.29	263.24	263.38				
LTOB Max Depth	0.674	0.778	0.527	0.617				
LTOB Cross Sectional Area	4.77	6.27	4.11	4.26

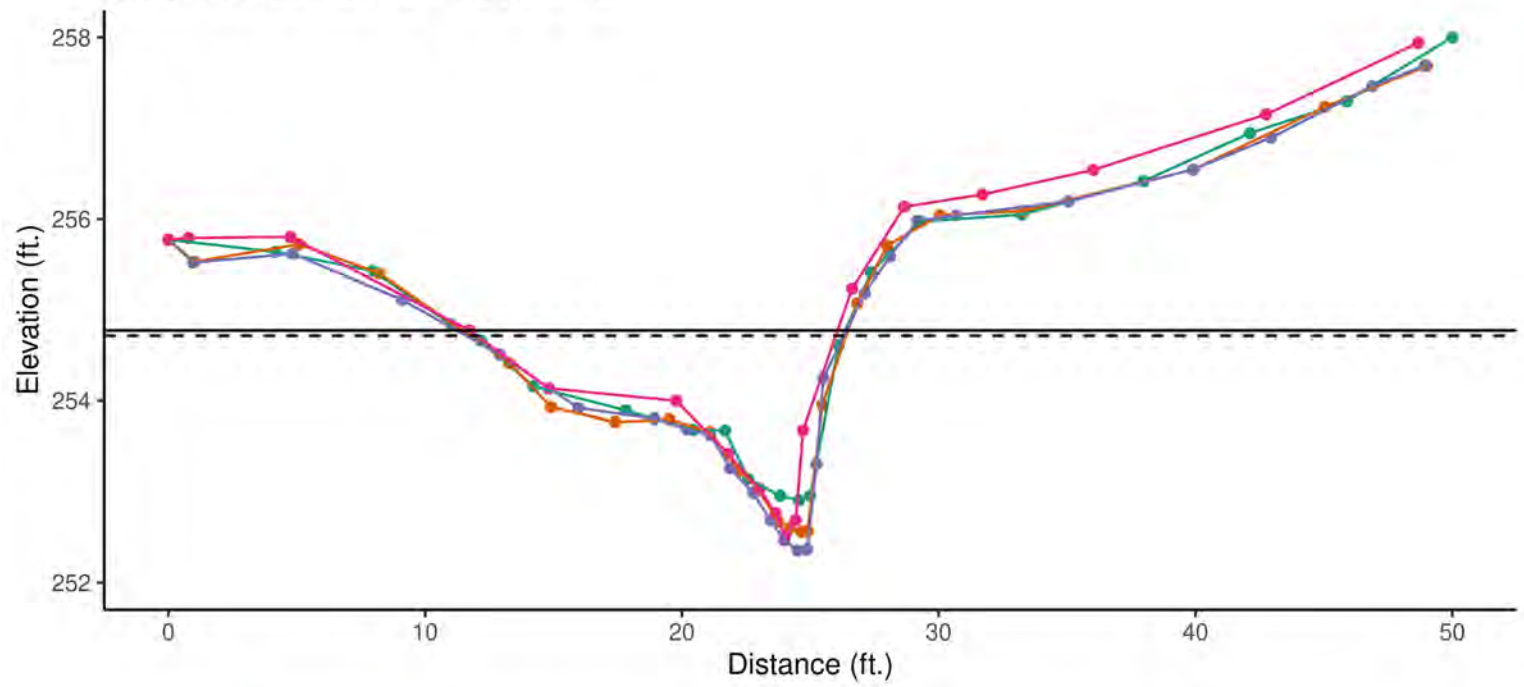
Cross-Section 2 (R2 - Pool) MY2

MY0	MY1	MY2	MY3	MY4	MY5	MY6	MY7
Bankfull Elevation - Based on As-Built Bankfull Area	254.61	254.52	254.53	254.71				
Bank Height Ratio - Based on As-Built Bankfull Area	1.00	0.94	0.99	1.03				
Thalweg Elevation	252.91	252.56	252.35	252.51				
LTOB Elevation	254.61	254.41	254.51	254.77				
LTOB Max Depth	1.704	1.852	2.155	2.258				
LTOB Cross Sectional Area	11.76	10.33	11.53	12.59

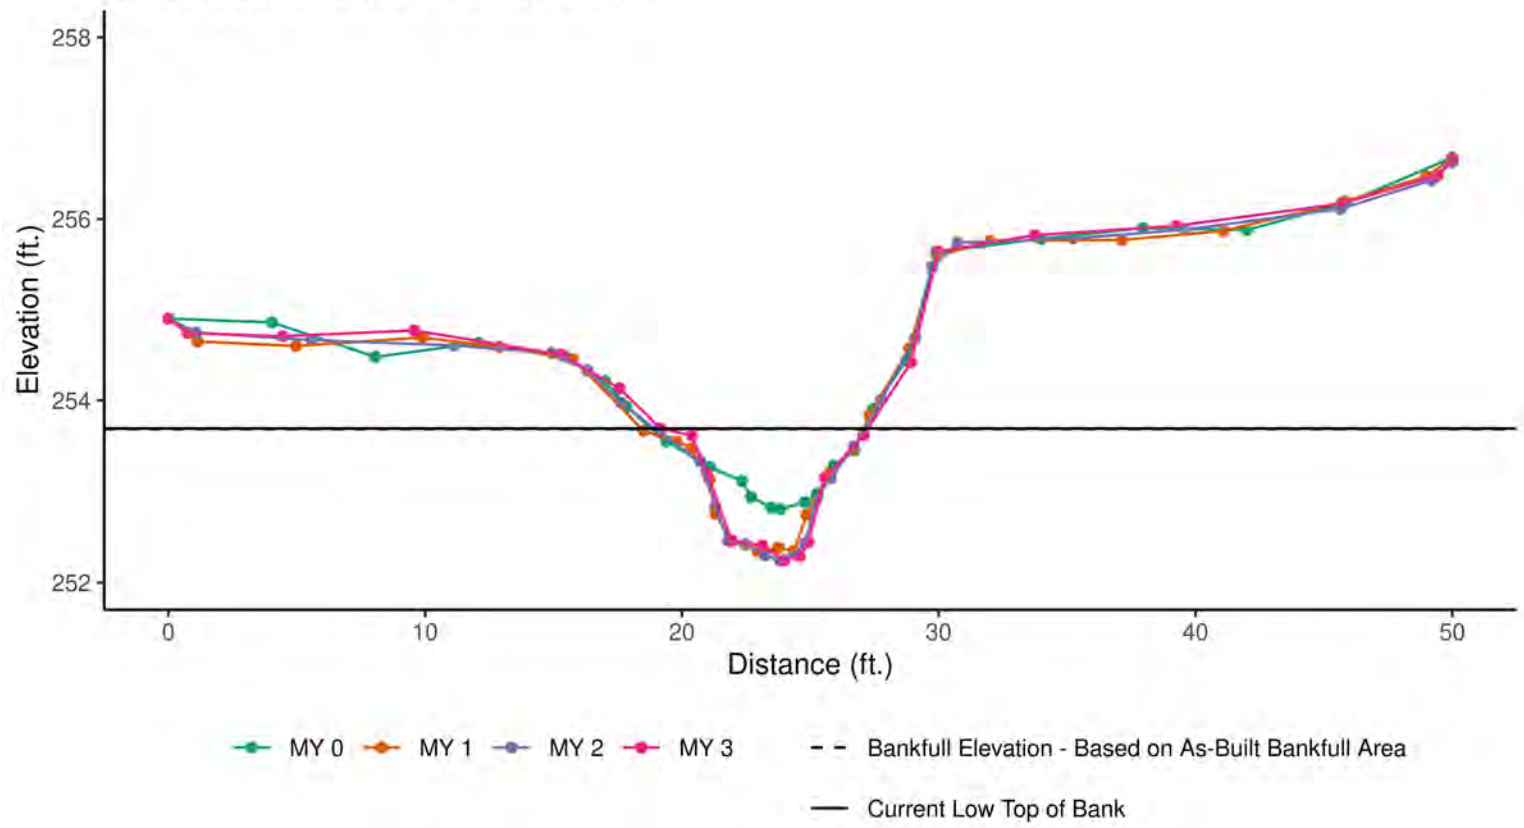
Cross-Section 3 (R2 - Riffle) MY2

MY0	MY1	MY2	MY3	MY4	MY5	MY6	MY7
Bankfull Elevation - Based on As-Built Bankfull Area	253.90	253.70	253.65	253.69				
Bank Height Ratio - Based on As-Built Bankfull Area	1.00	0.89	1.01	1.00				
Thalweg Elevation	252.81	252.35	252.24	252.25				
LTOB Elevation	253.90	253.55	253.65	253.70				
LTOB Max Depth	1.095	1.205	1.412	1.453				
LTOB Cross Sectional Area	6.03	5.00	6.10	6.08

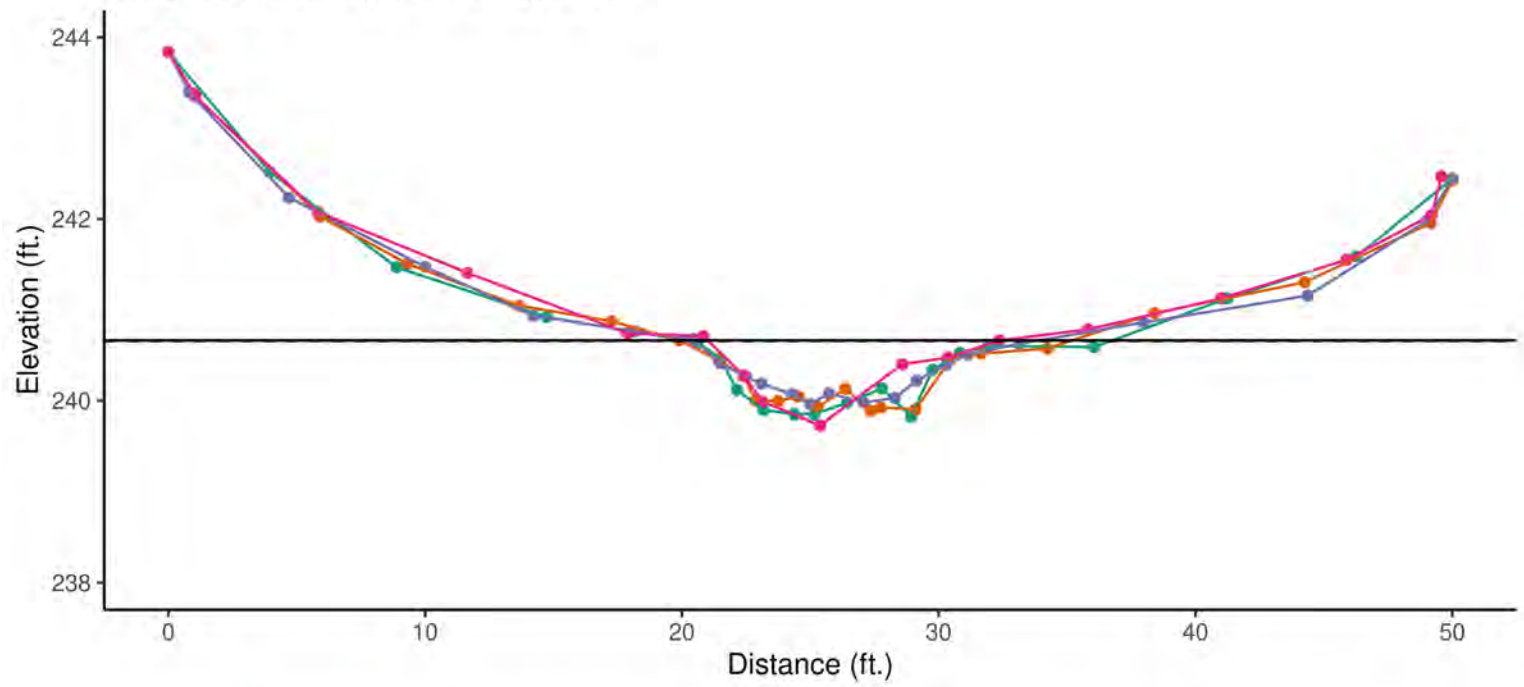
Cross-Section 4 (R3 - Riffle) MY2

MY0	MY1	MY2	MY3	MY4	MY5	MY6	MY7
Bankfull Elevation - Based on As-Built Bankfull Area	240.60	240.58	240.64	240.66				
Bank Height Ratio - Based on As-Built Bankfull Area	1.00	0.90	0.98	1.01				
Thalweg Elevation	239.85	239.89	239.96	239.73				
LTOB Elevation	240.60	240.52	240.63	240.66				
LTOB Max Depth	0.752	0.629	0.665	0.931				
LTOB Cross Sectional Area	4.90	4.18	4.73	4.96

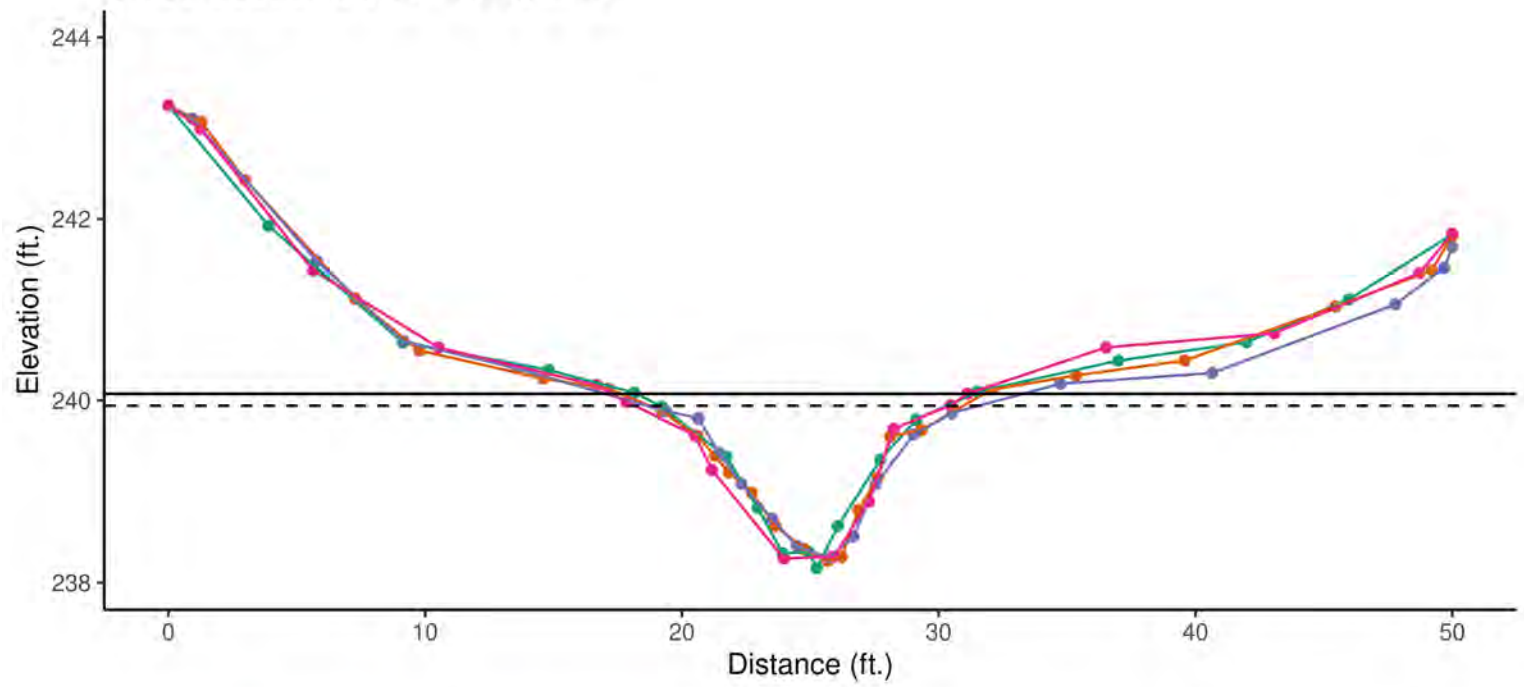
Cross-Section 5 (R3 - Pool) MY2

MY0	MY1	MY2	MY3	MY4	MY5	MY6	MY7
Bankfull Elevation - Based on As-Built Bankfull Area	240.09	240.00	240.02	239.94				
Bank Height Ratio - Based on As-Built Bankfull Area	1.00	1.07	0.91	1.08				
Thalweg Elevation	238.34	238.24	238.27	238.27				
LTOB Elevation	240.09	240.13	239.86	240.07				
LTOB Max Depth	1.749	1.892	1.591	1.807				
LTOB Cross Sectional Area	10.02	11.78	8.32	11.75

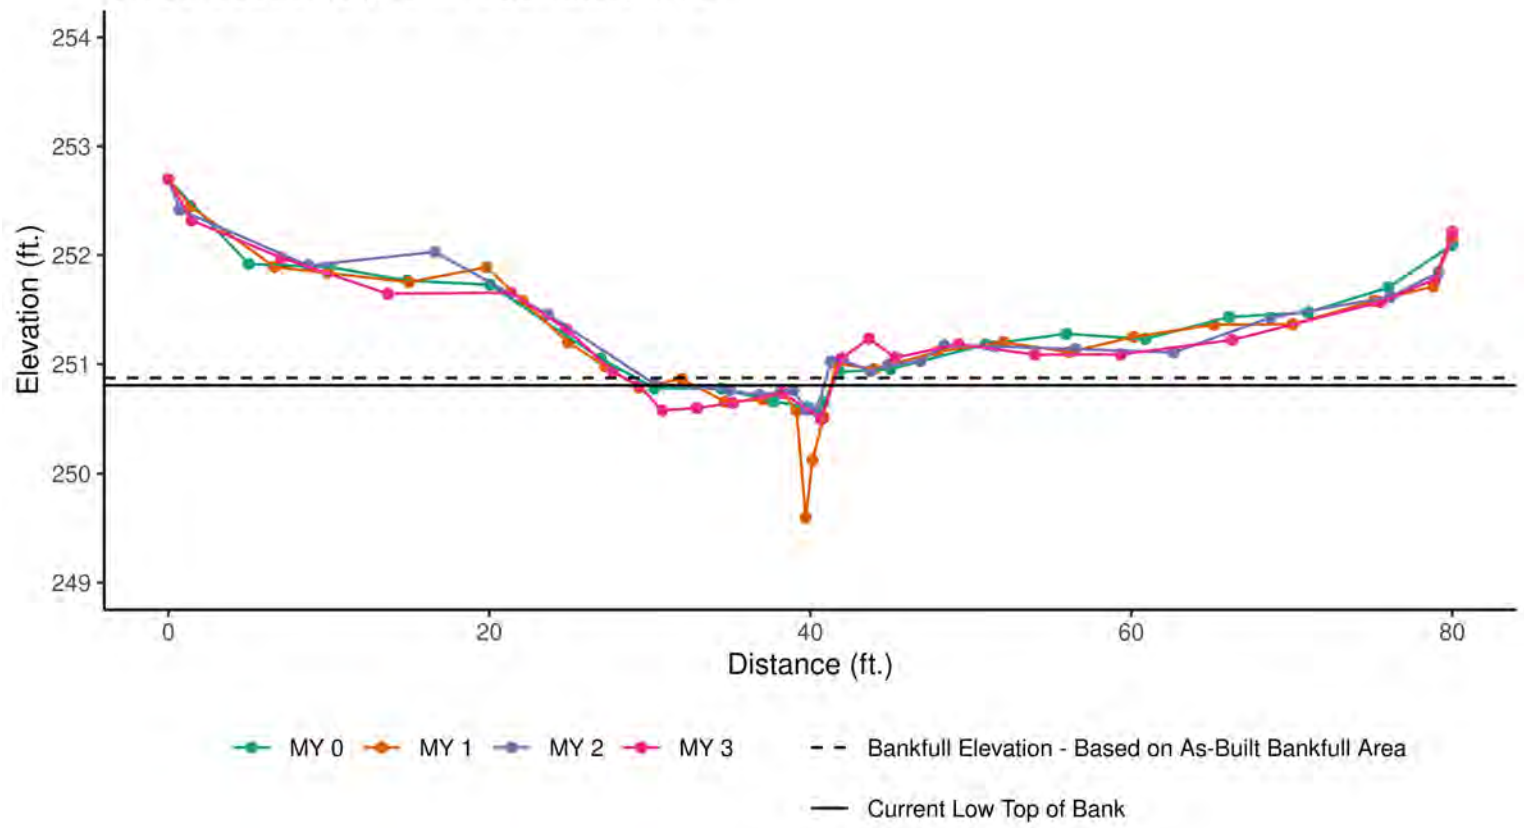
Cross-Section 6 (R5 - Headwater) MY2

MY0	MY1	MY2	MY3	MY4	MY5	MY6	MY7
Bankfull Elevation - Based on As-Built Bankfull Area	250.93	250.88	250.97	250.87				
Bank Height Ratio - Based on As-Built Bankfull Area	1.00	0.99	1.05	0.82				
Thalweg Elevation	250.57	249.60	250.58	250.50				
LTOB Elevation	250.93	250.87	250.99	250.81				
LTOB Max Depth	0.359	1.267	0.409	0.304				
LTOB Cross Sectional Area	2.55	2.46	2.78	1.98

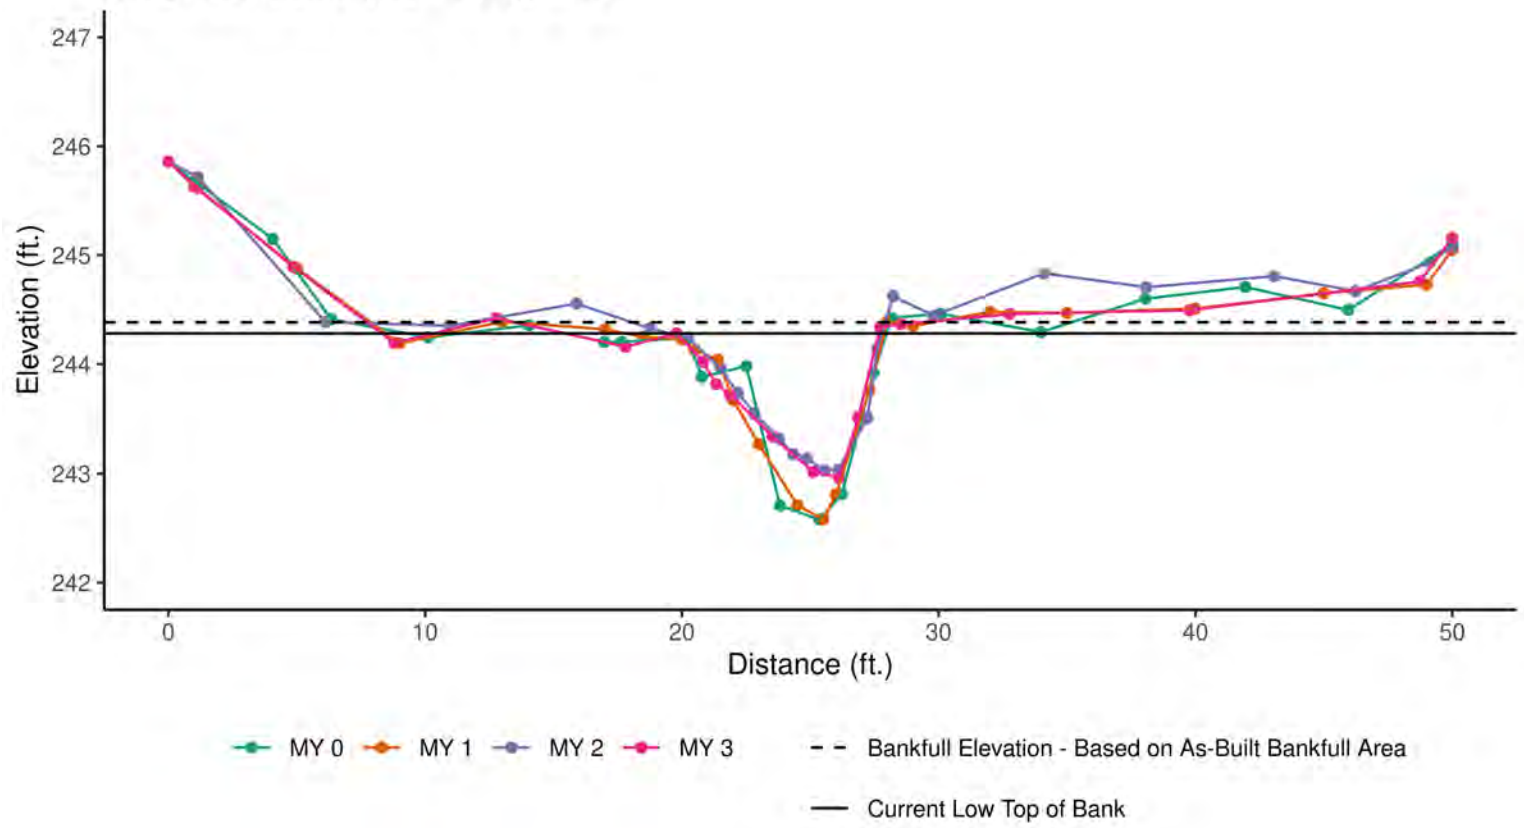
Cross-Section 7 (R6 - Pool) MY2

MY0	MY1	MY2	MY3	MY4	MY5	MY6	MY7
Bankfull Elevation - Based on As-Built Bankfull Area	244.24	244.24	244.42	244.38				
Bank Height Ratio - Based on As-Built Bankfull Area	1.00	0.99	0.87	0.93				
Thalweg Elevation	242.58	242.58	243.03	242.96				
LTOB Elevation	244.24	244.23	244.24	244.28				
LTOB Max Depth	1.663	1.65	1.212	1.321				
LTOB Cross Sectional Area	6.78	6.70	5.43	5.98

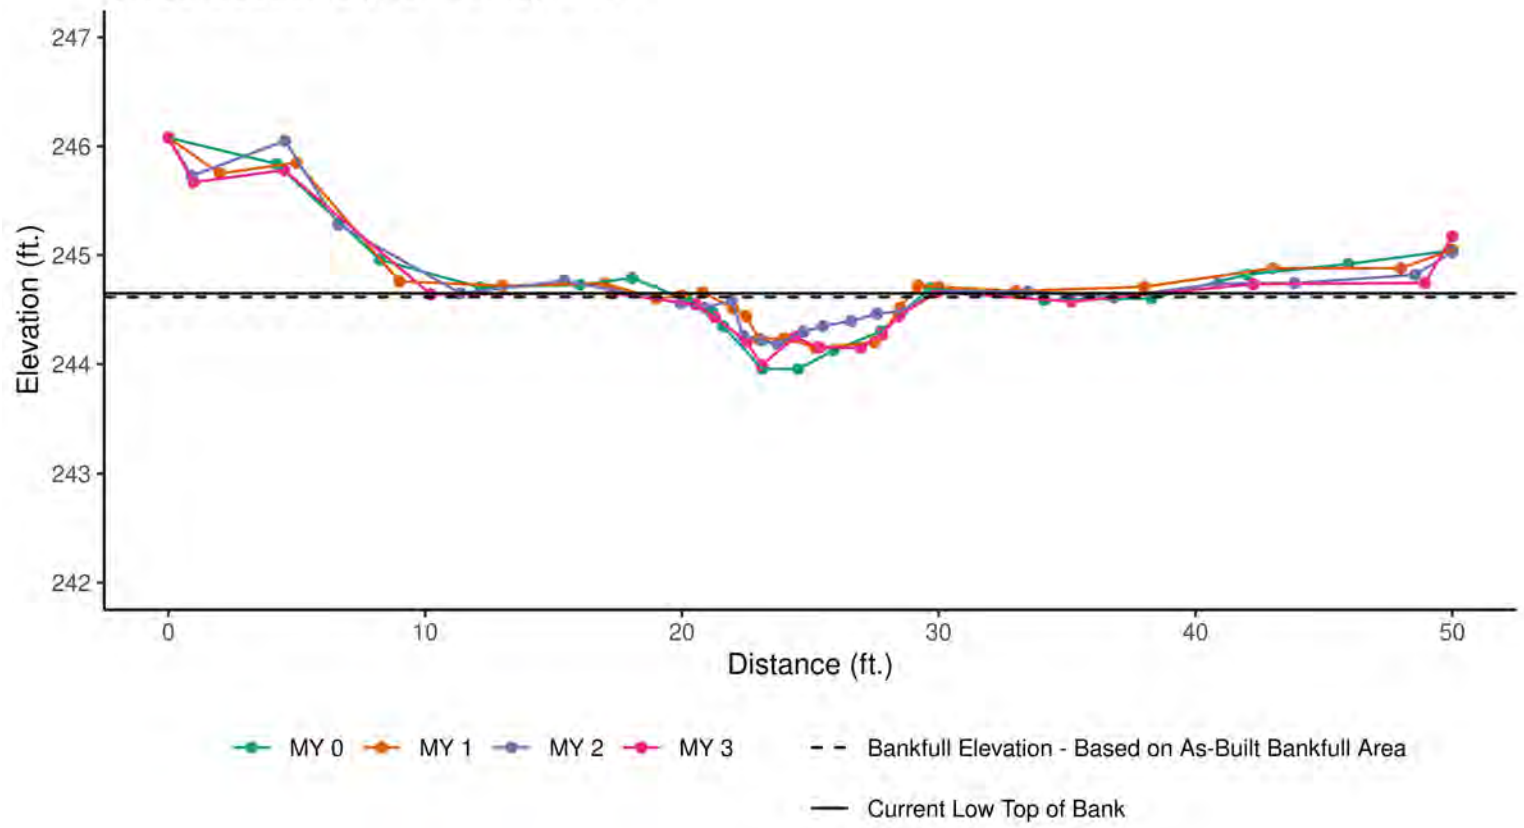
Cross-Section 8 (R6 - Riffle) MY2

MY0	MY1	MY2	MY3	MY4	MY5	MY6	MY7
Bankfull Elevation - Based on As-Built Bankfull Area	244.59	244.71	244.72	244.62				
Bank Height Ratio - Based on As-Built Bankfull Area	1.00	0.90	0.92	1.05				
Thalweg Elevation	243.96	244.15	244.19	243.99				
LTOB Elevation	244.59	244.66	244.67	244.65				
LTOB Max Depth	0.632	0.51	0.487	0.66				
LTOB Cross Sectional Area	3.23	2.79	2.72	3.64

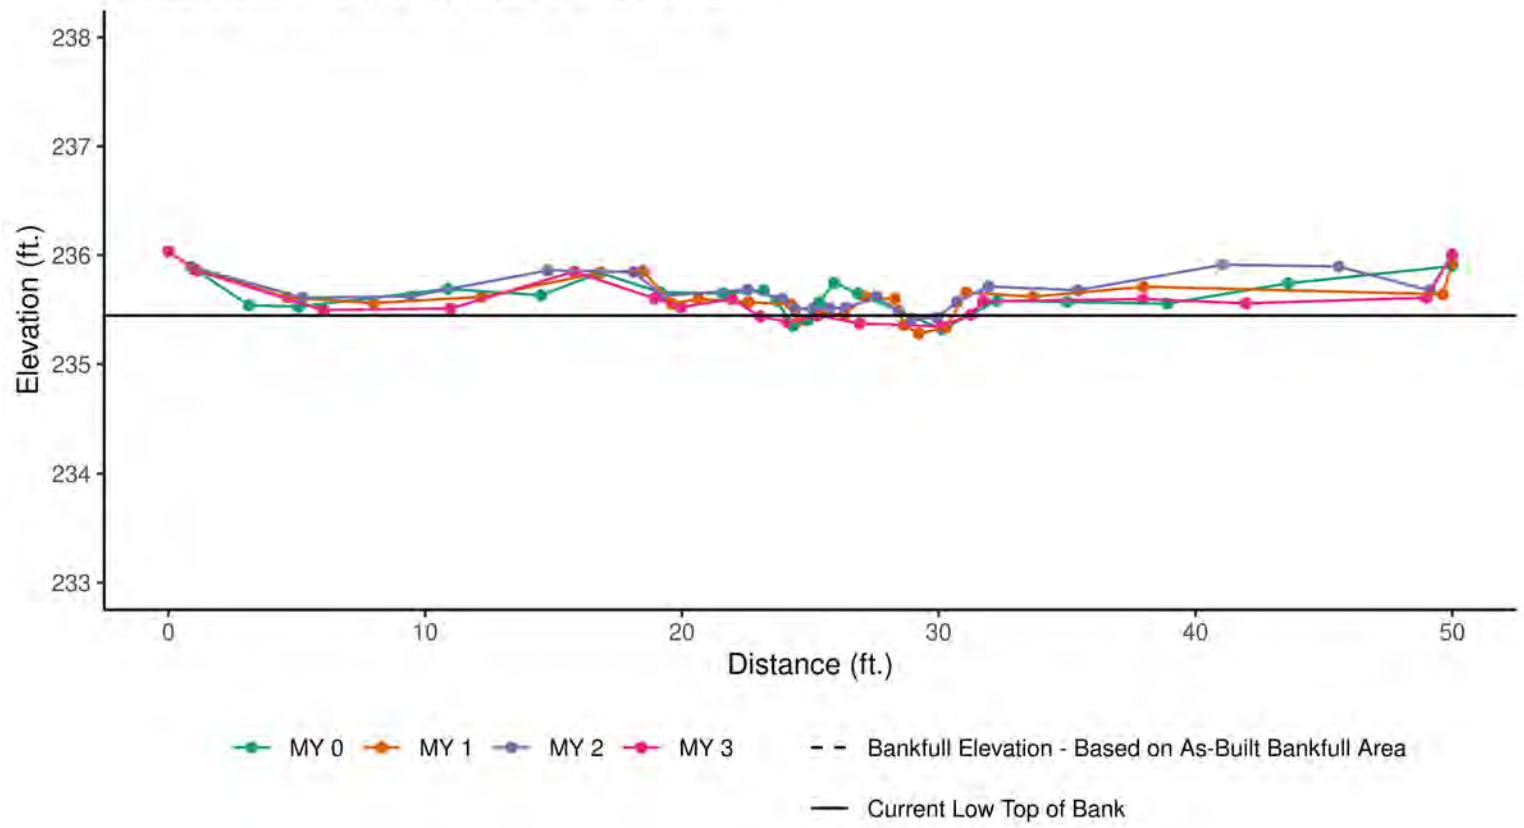
Cross-Section 9 (R7 upper - Riffle) MY2

MY0	MY1	MY2	MY3	MY4	MY5	MY6	MY7
Bankfull Elevation - Based on As-Built Bankfull Area	235.65	235.59	235.64	235.45				
Bank Height Ratio - Based on As-Built Bankfull Area	0.97	1.05	0.86	1.01				
Thalweg Elevation	235.35	235.40	235.51	235.35				
LTOB Elevation	235.65	235.60	235.62	235.45				
LTOB Max Depth	0.299	0.197	0.113	0.101				
LTOB Cross Sectional Area	0.39	0.45	0.31	0.39

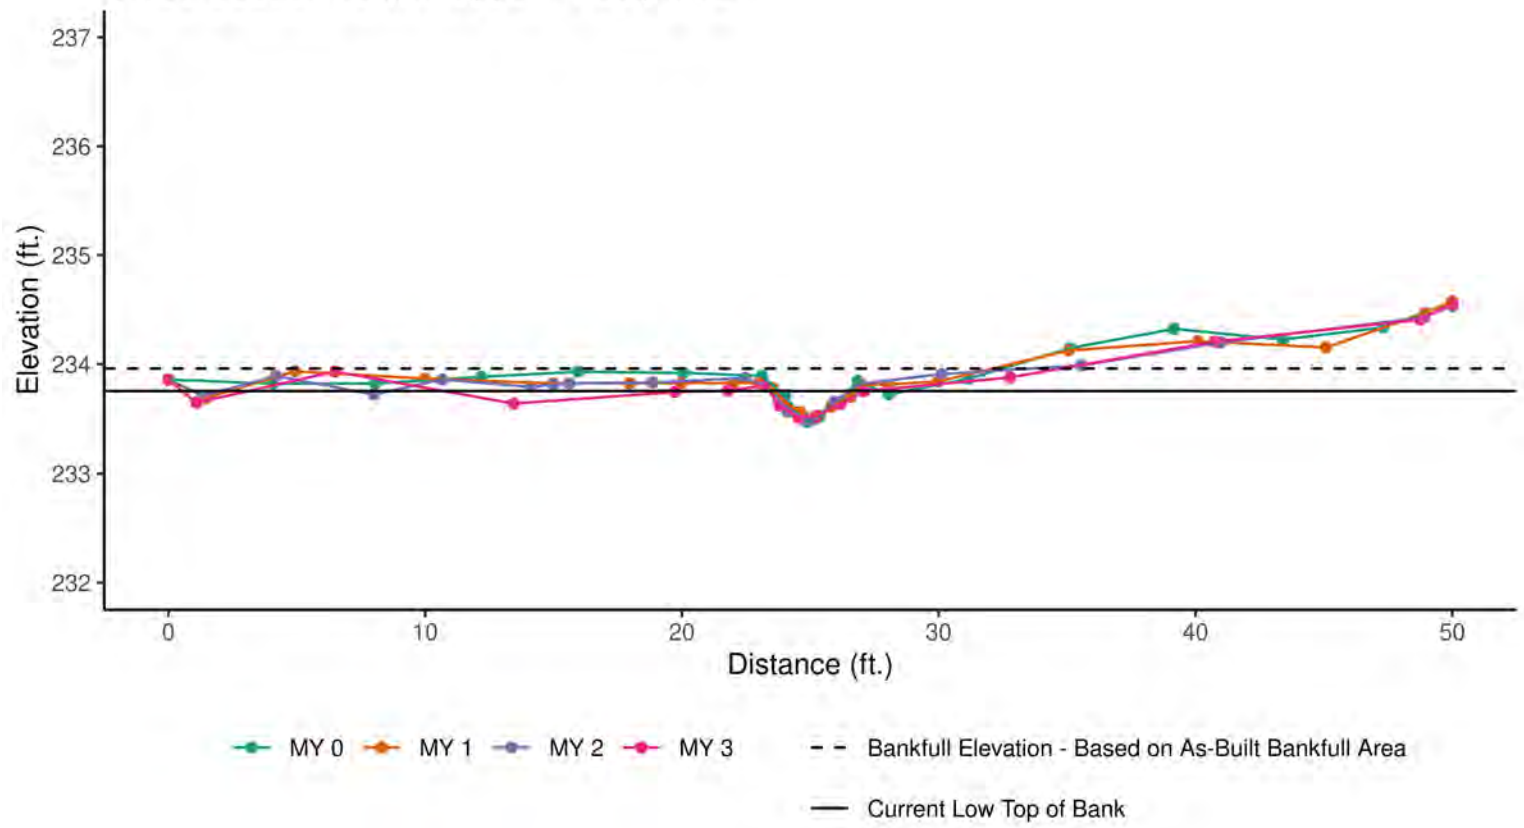
Cross-Section 10 (R7 upper - Pool) MY2

MY0	MY1	MY2	MY3	MY4	MY5	MY6	MY7
Bankfull Elevation - Based on As-Built Bankfull Area	233.89	233.99	234.01	233.96				
Bank Height Ratio - Based on As-Built Bankfull Area	0.68	0.64	0.57	0.54				
Thalweg Elevation	233.47	233.50	233.57	233.51				
LTOB Elevation	233.85	233.81	233.82	233.75				
LTOB Max Depth	0.371	0.316	0.25	0.239				
LTOB Cross Sectional Area	0.70	0.63	0.57	0.54

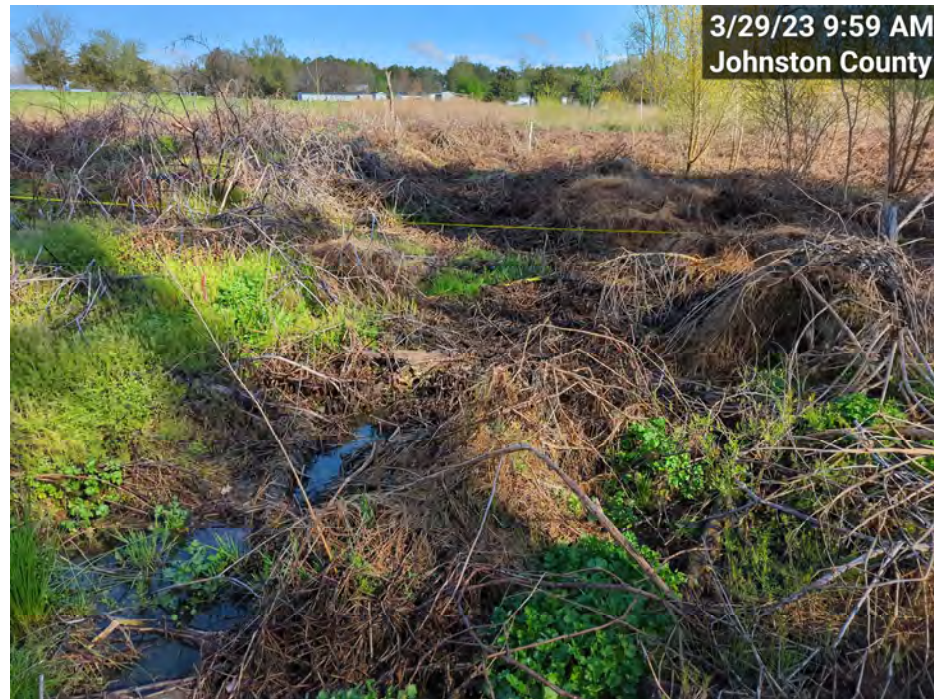
R1 Documentation – XS-1 Upstream View (MY-03)

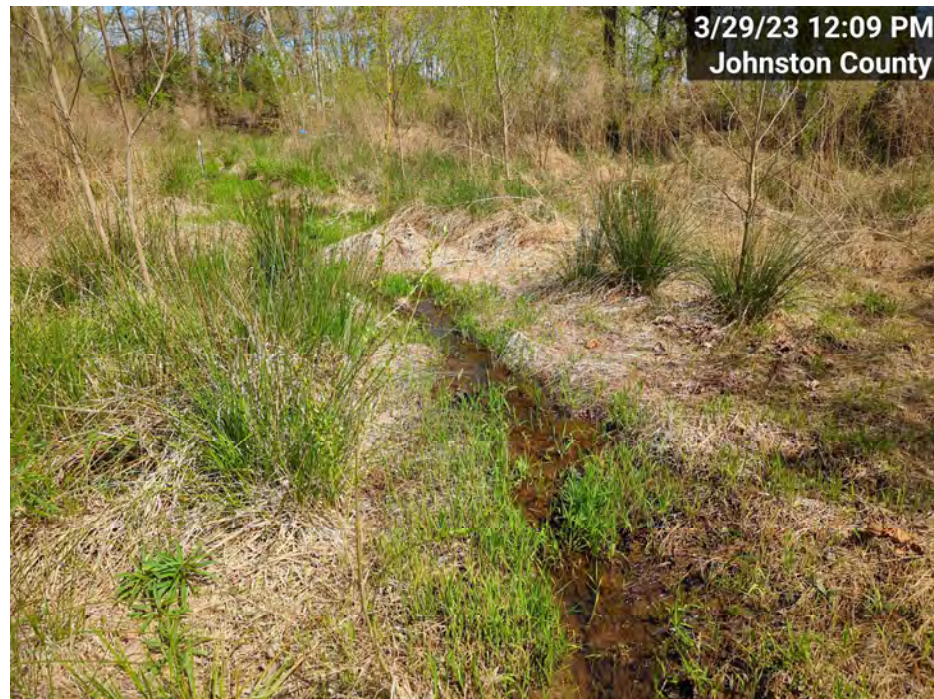
R5 Flow Documentation (MY-03)

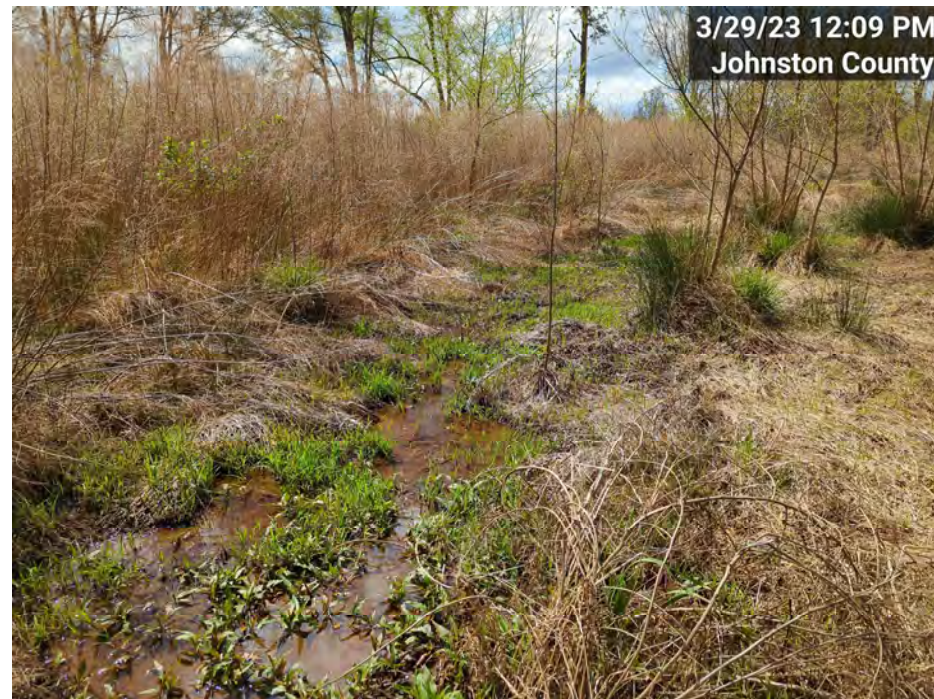
R5 Looking Downstream at FG-2 (MY-03)
