MY3 FINAL MONITORING REPORT

Odell's House Mitigation Project

DMS Project # 100041

Calendar Year of Data Collection: 2023

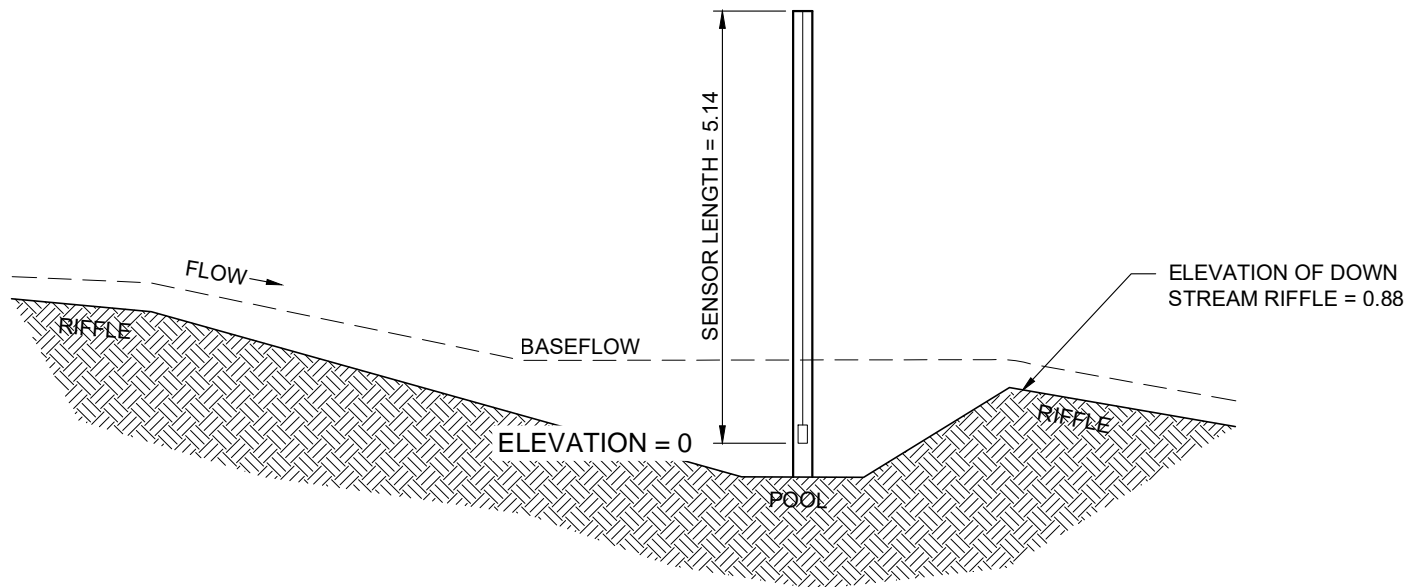
FLOW GAUGE #3 - R1

R1 has experienced continued subsurface flow through a portion of the old pond bottom. This length is not functioning as intended and is not meeting stream criteria. R1 will continue to be monitored in MY4 as flow is present above and below the old pond bottom. More information can be found in Section 4.6.

Flow Depth = 0.88 feet

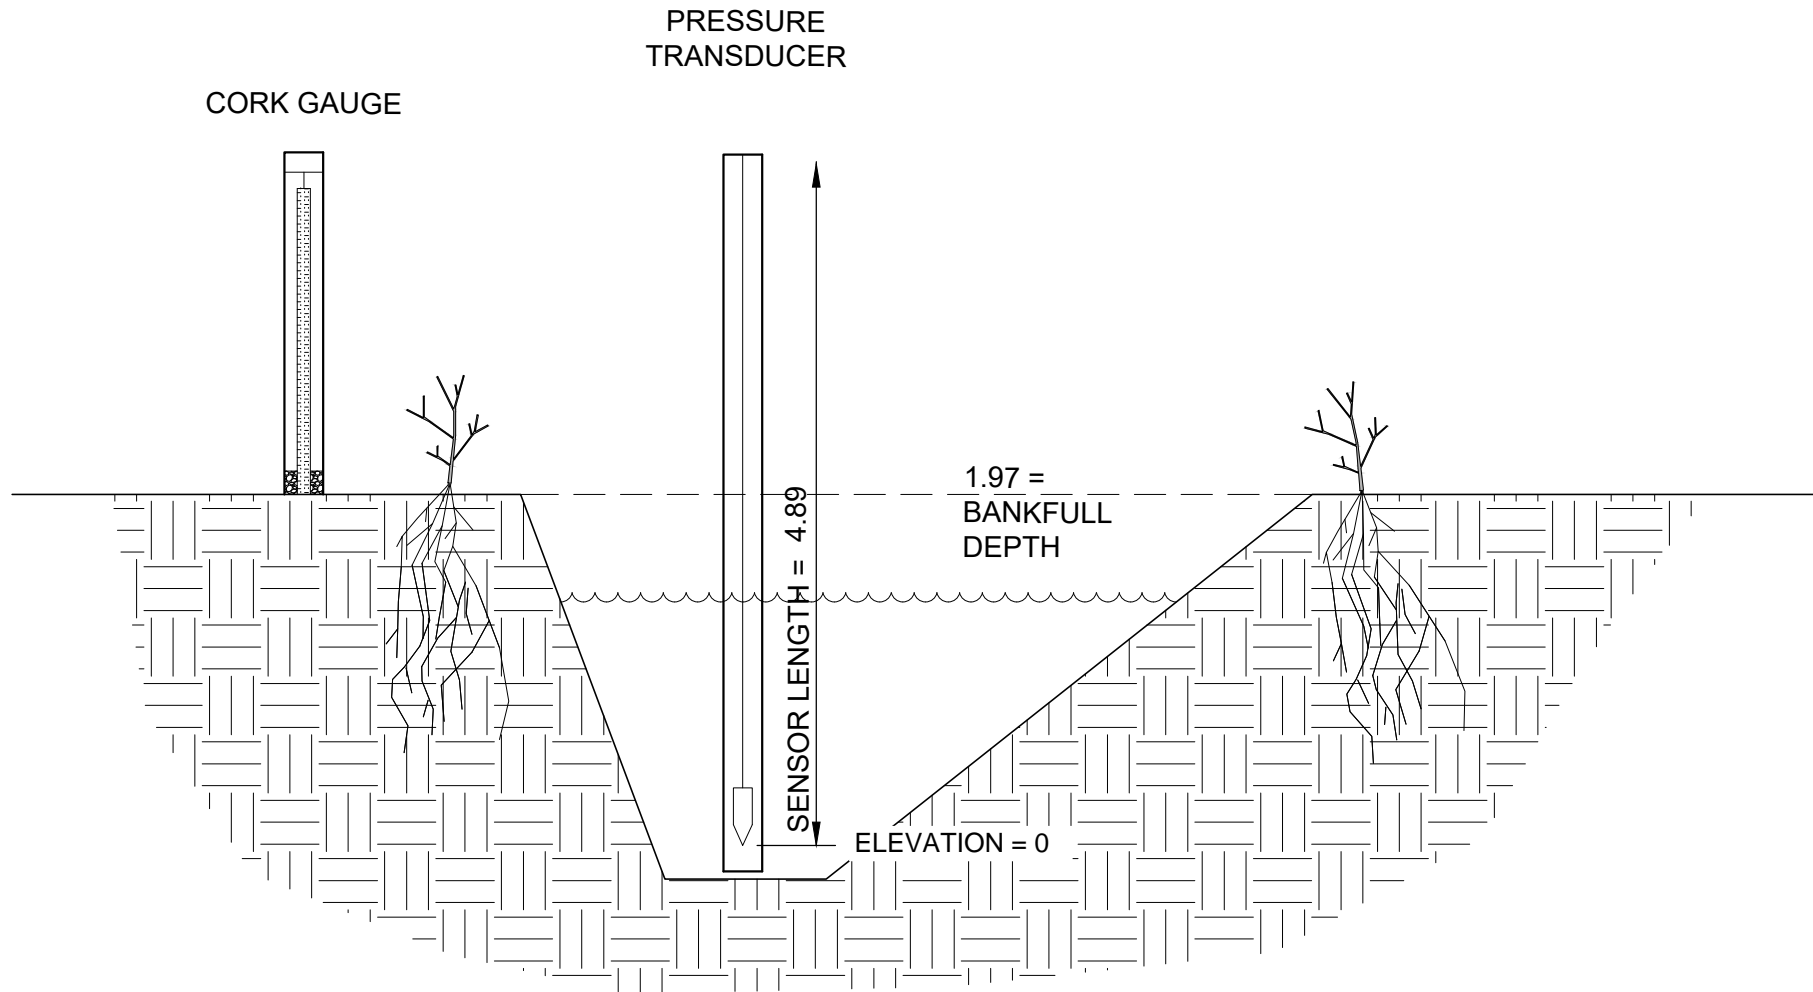
Crest Gauge CG-1 (R3)

Bankfull Event Depth = 1.81 feet

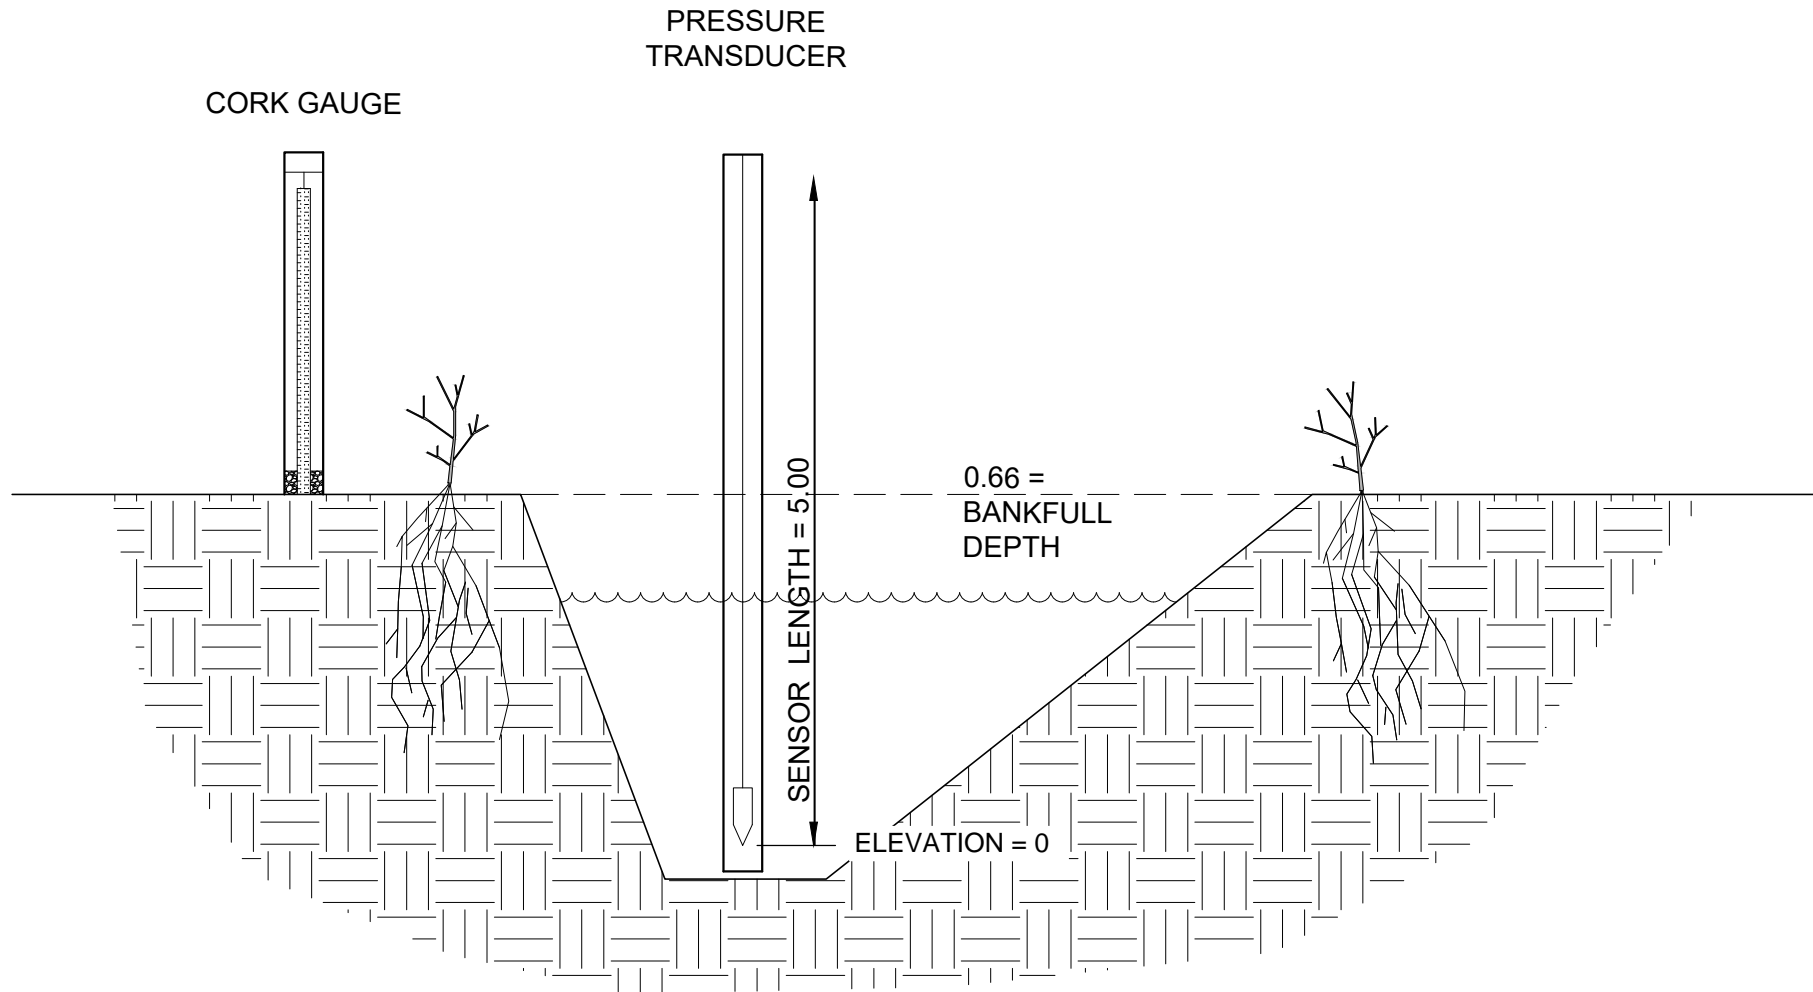
Crest Gauge CG-2 (R7 lower)

Bankfull Event Depth = 0.61 feet

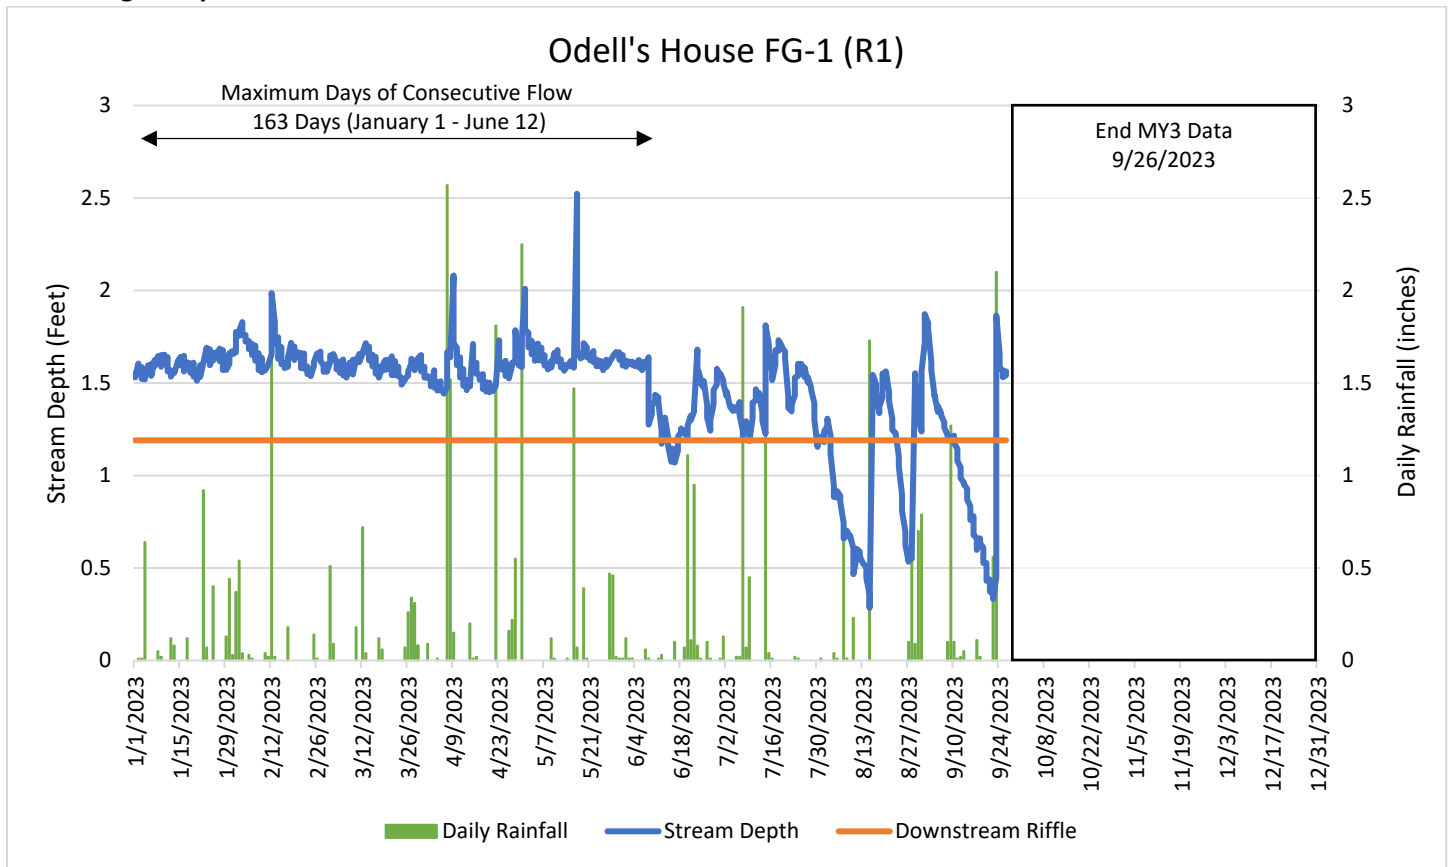
***FG-1:** 233 days total of Cumulative Flow, 37 days of no flow.

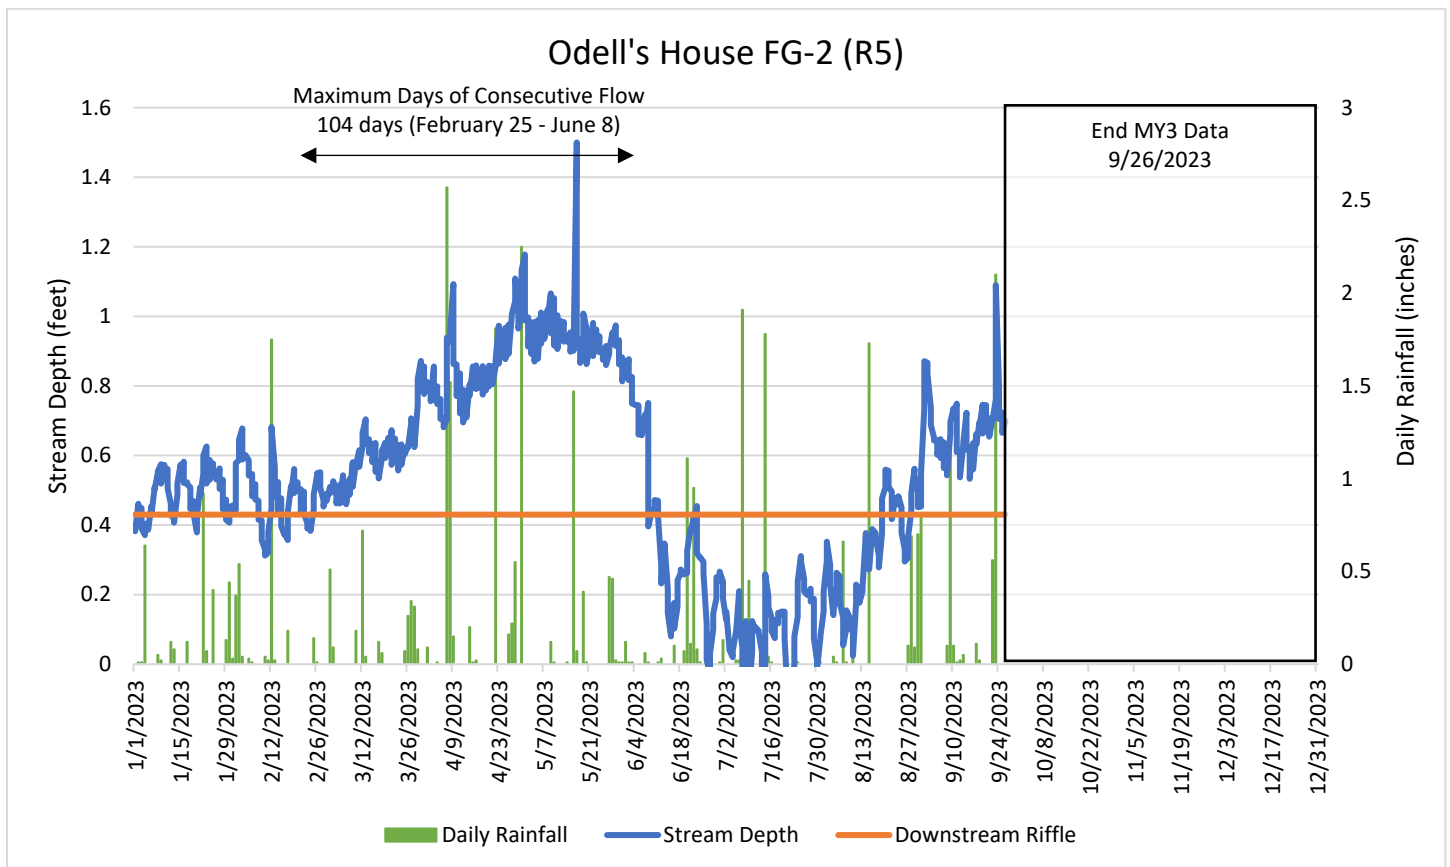
***FG-2:** 182 days of Cumulative Flow, 88 days of no flow.

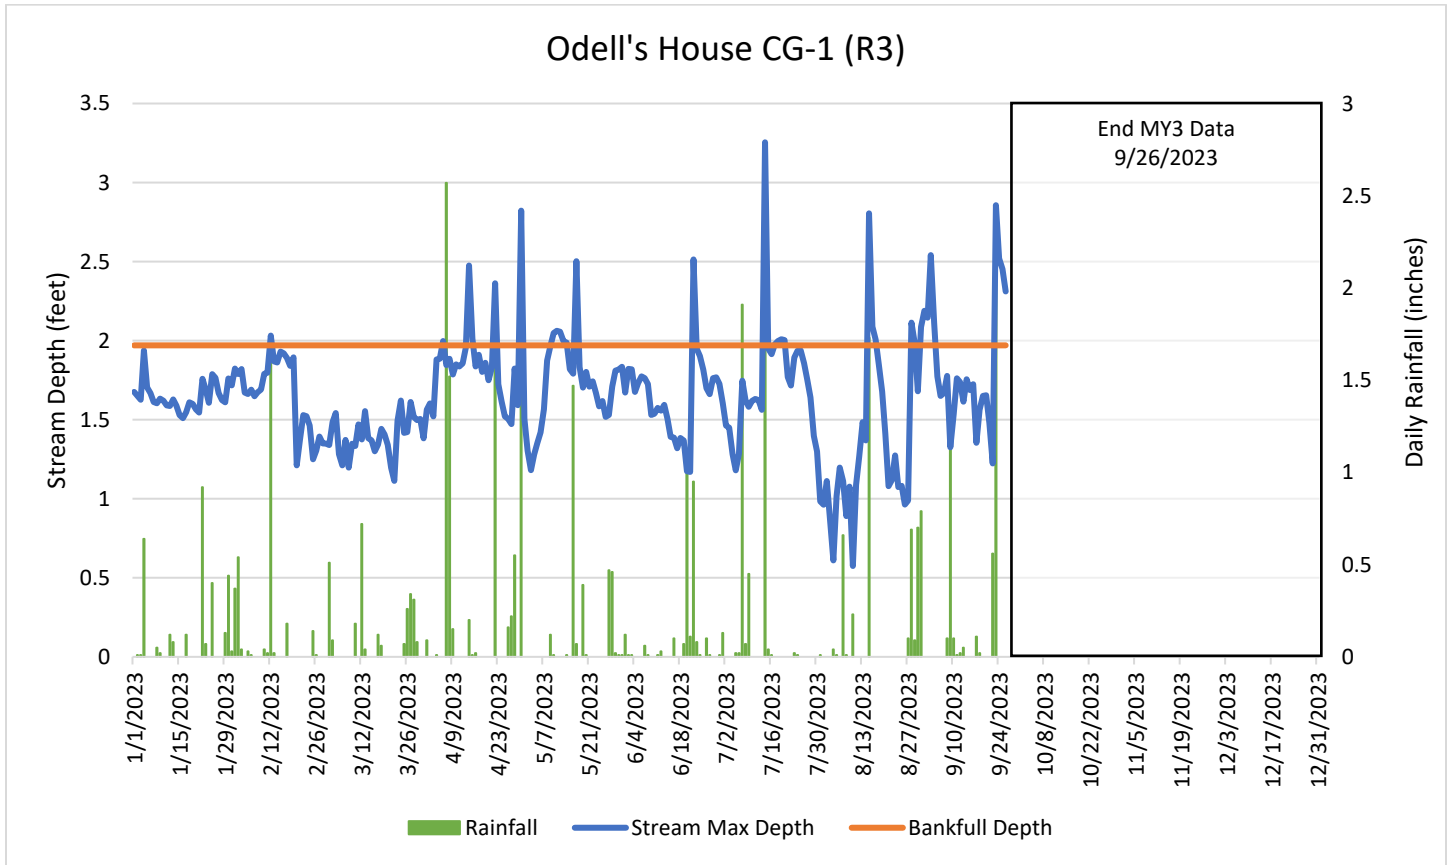
*CG-1: 14 bankfull events with a maximum 1.285' above bankfull on July 14th

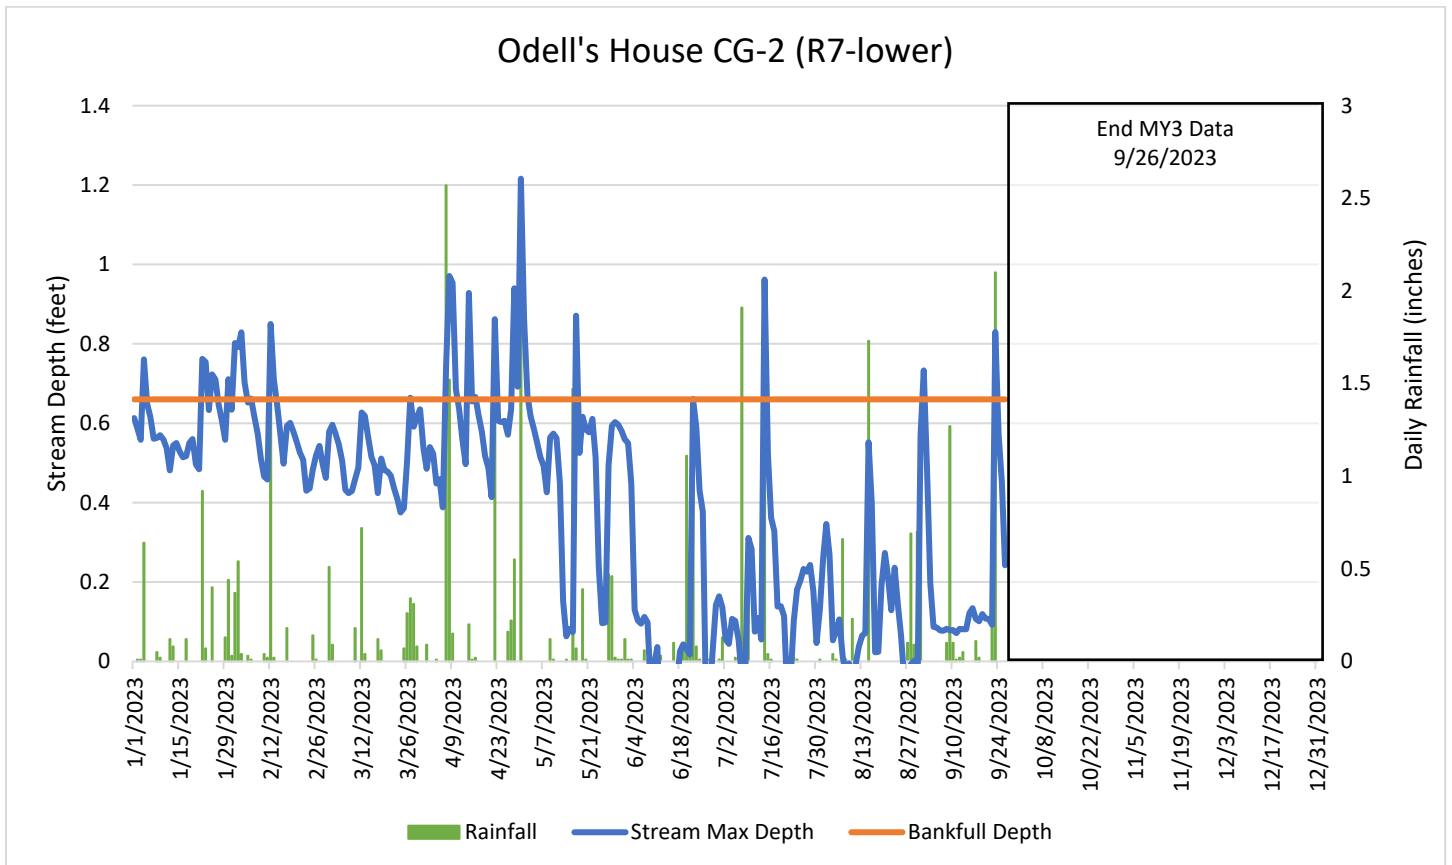
*CG-2: 11 bankfull events with a maximum 0.56' above bankfull on April 30th

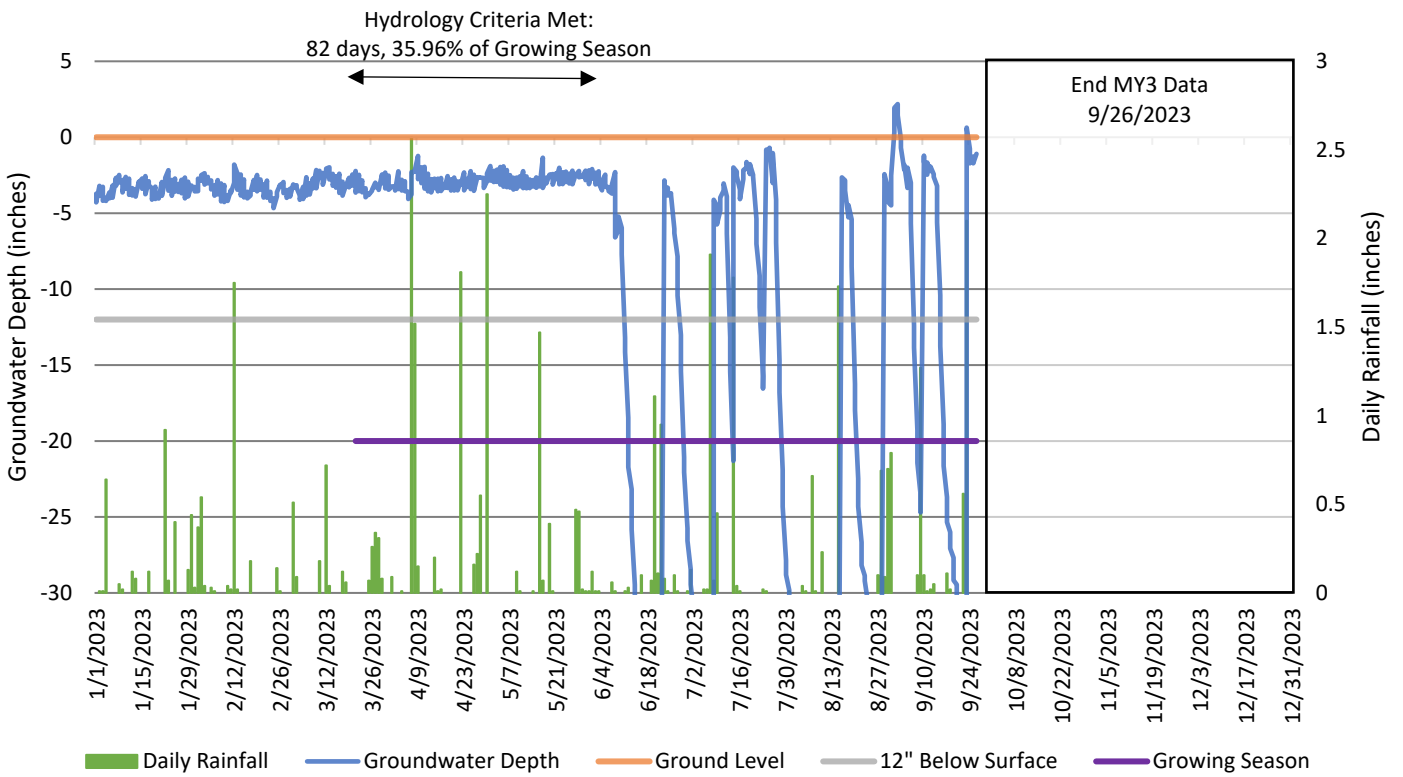
Odells House GW-5

Hydrology Criteria Met:
54 days, 23.68% of Growing Season

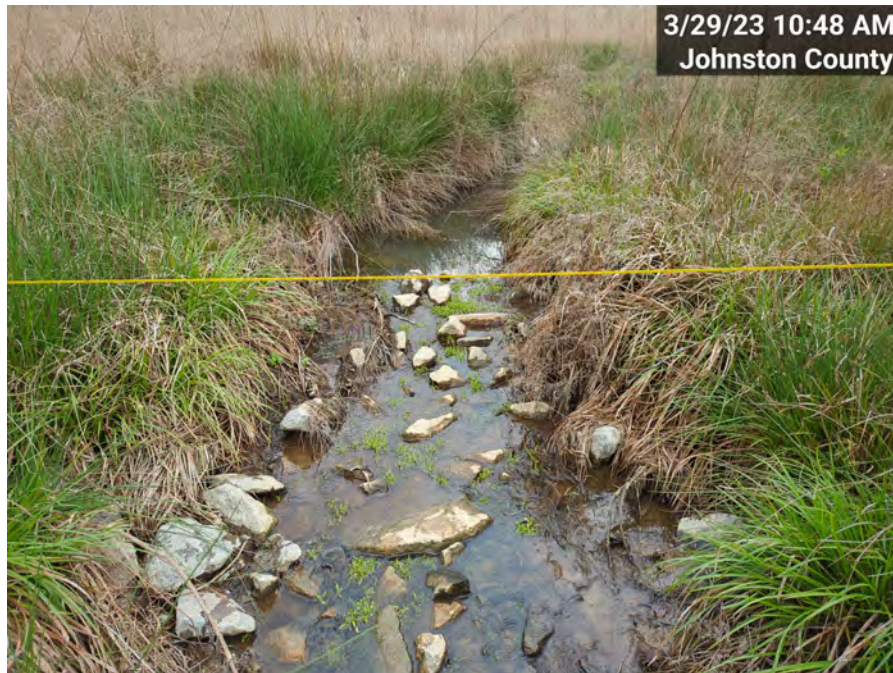
View Upstream

R3 - Odell's House Mitigation Site			
Monitoring Year	MY0	MY3	
Biotic Index Score	NA*	8.32	
Water Quality Level	NA*	Poor

**No benthics were collected during sampling*

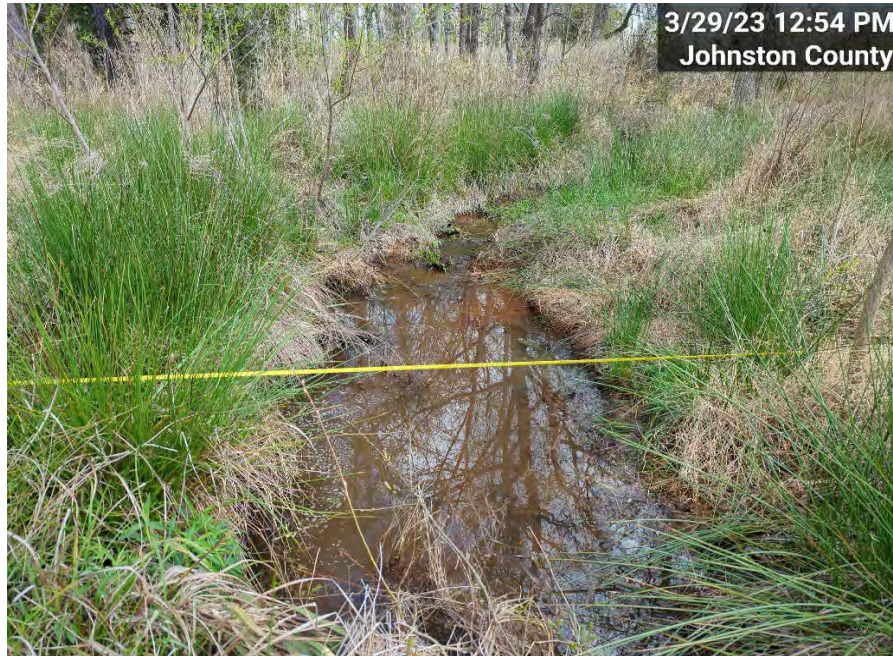
View Upstream

R6 - Odell's House Mitigation Site			
Monitoring Year	MY0	MY3	
Biotic Index Score	NA*	7.87	
Water Quality Level	NA*	Poor

**Sampling reach adjusted*
