**Open Springs Mitigation Project  
Randolph County, North Carolina**

**Year 3 Monitoring Report**

**November 2007**

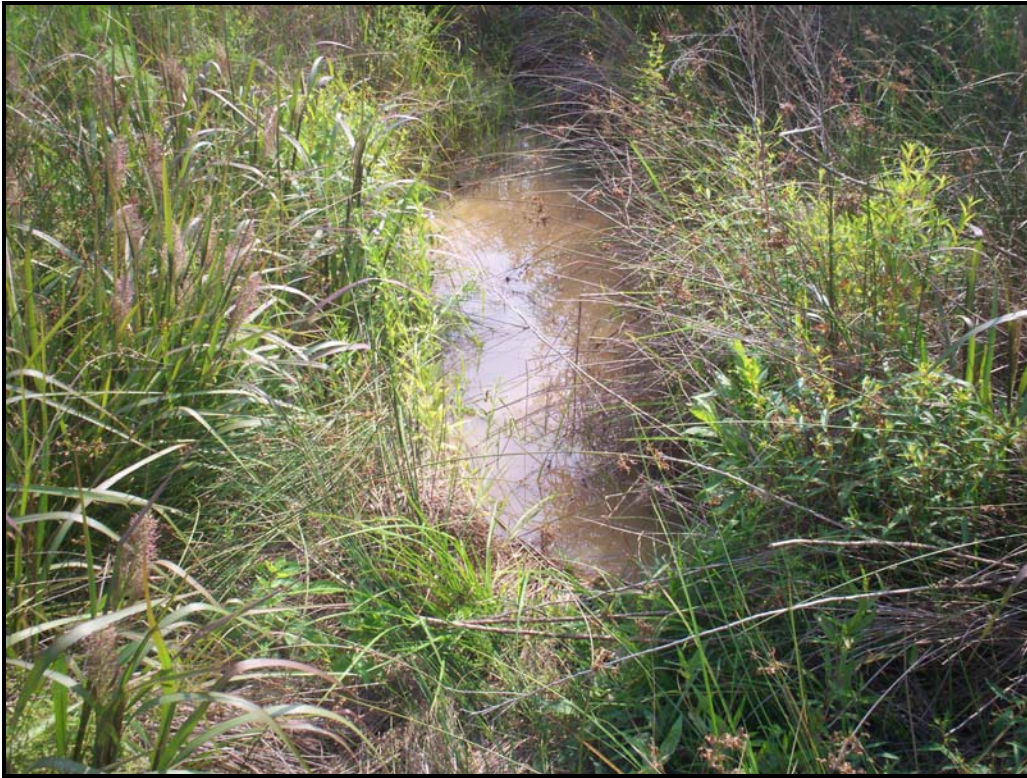
**Photo 1. Rock cross vane - looking downstream at STA 31+50.**

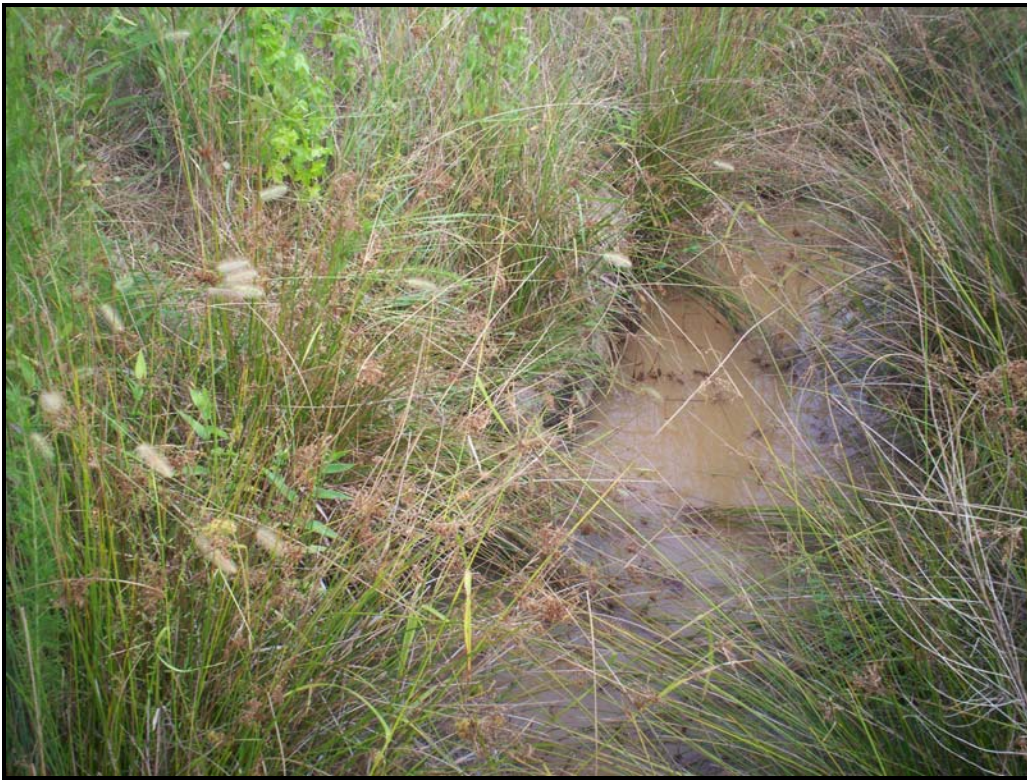
**Photo 2. Log vane on left bank at STA 30+00 - looking downstream.**

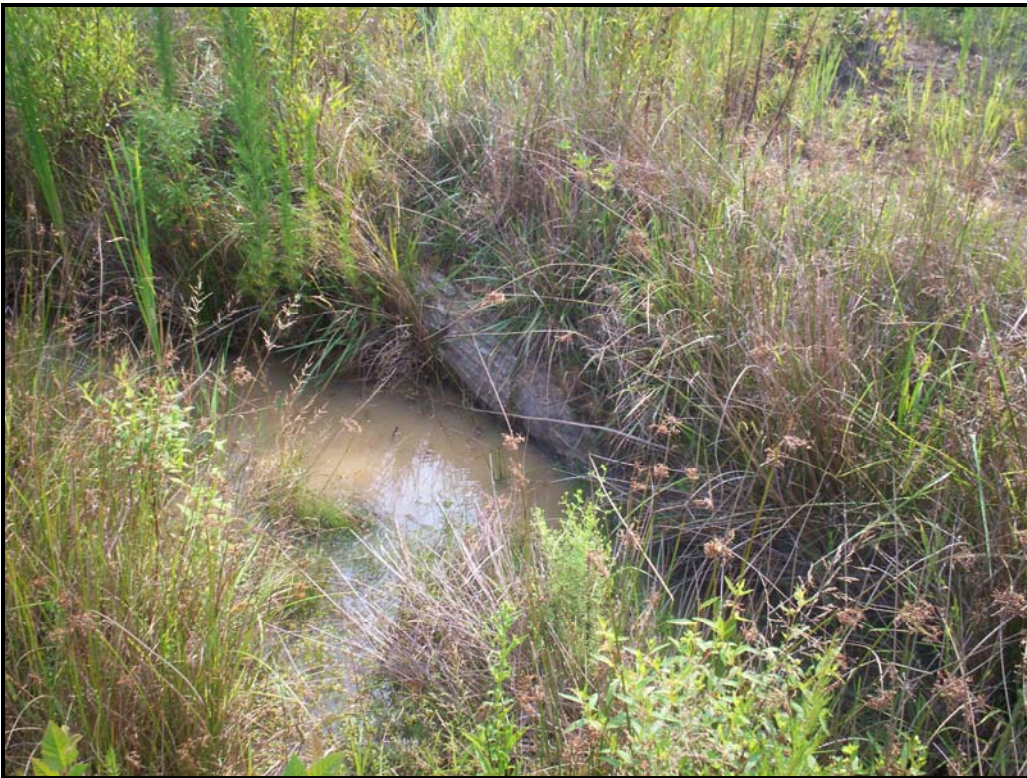
**Photo 4. Log vane on right bank at STA 28+00 - looking downstream.**

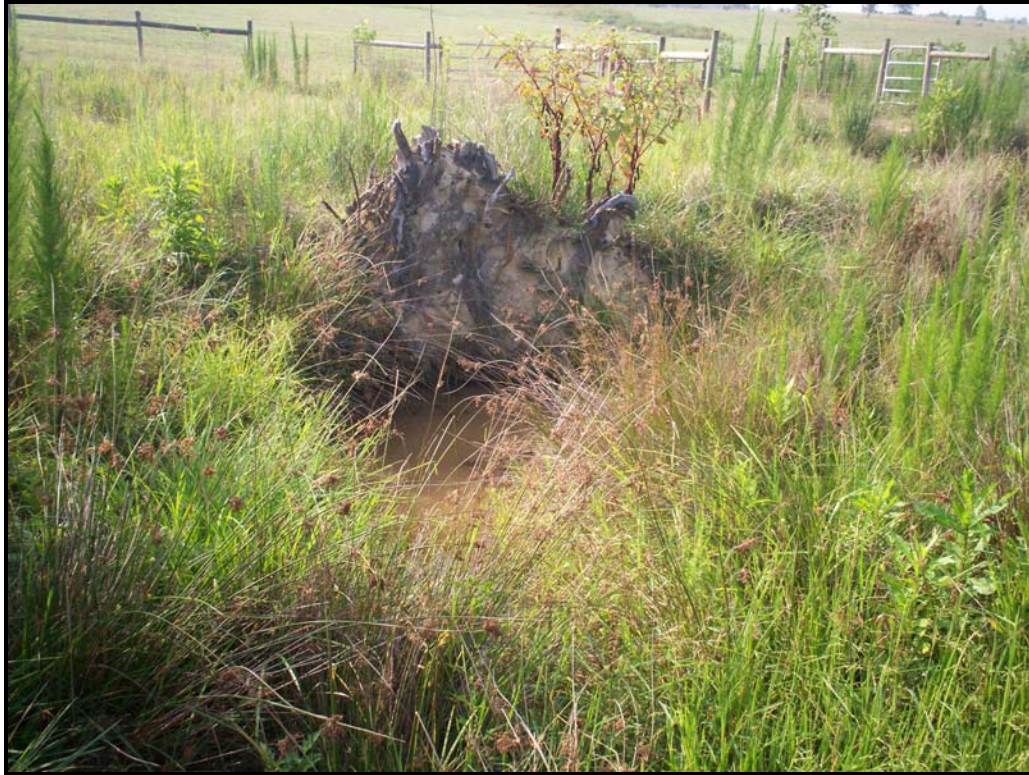
**Photo 5. Root wad on left bank at STA 21+00 - looking downstream.**

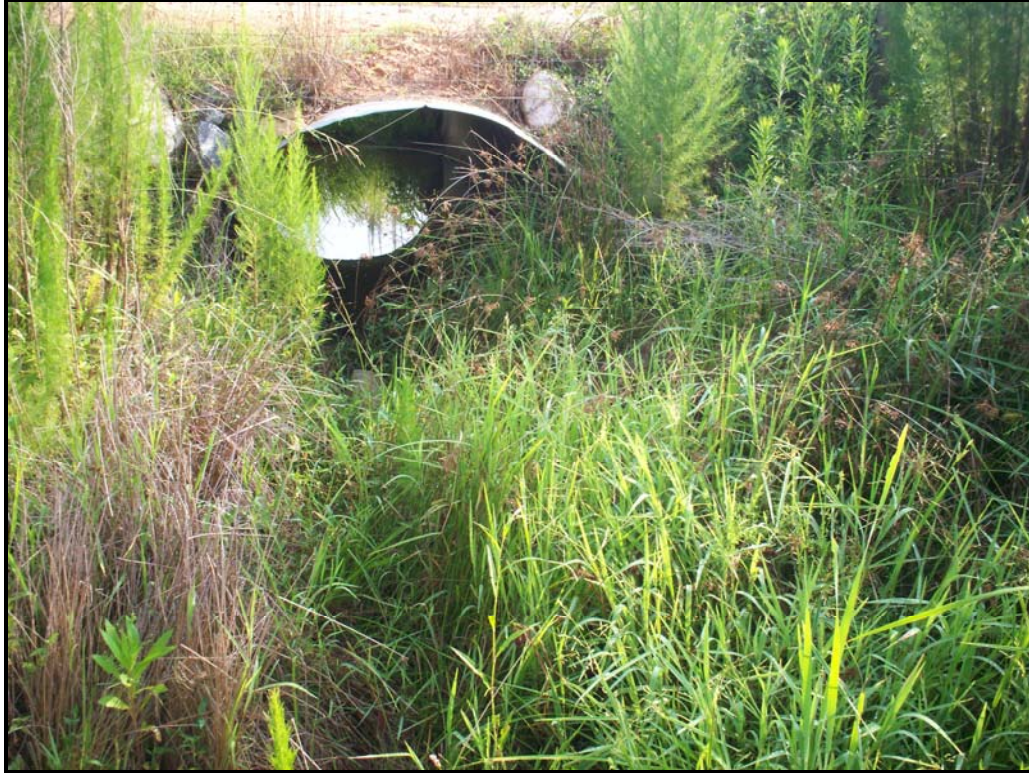
**Photo 7. Culvert at STA 20+60 - looking upstream.**

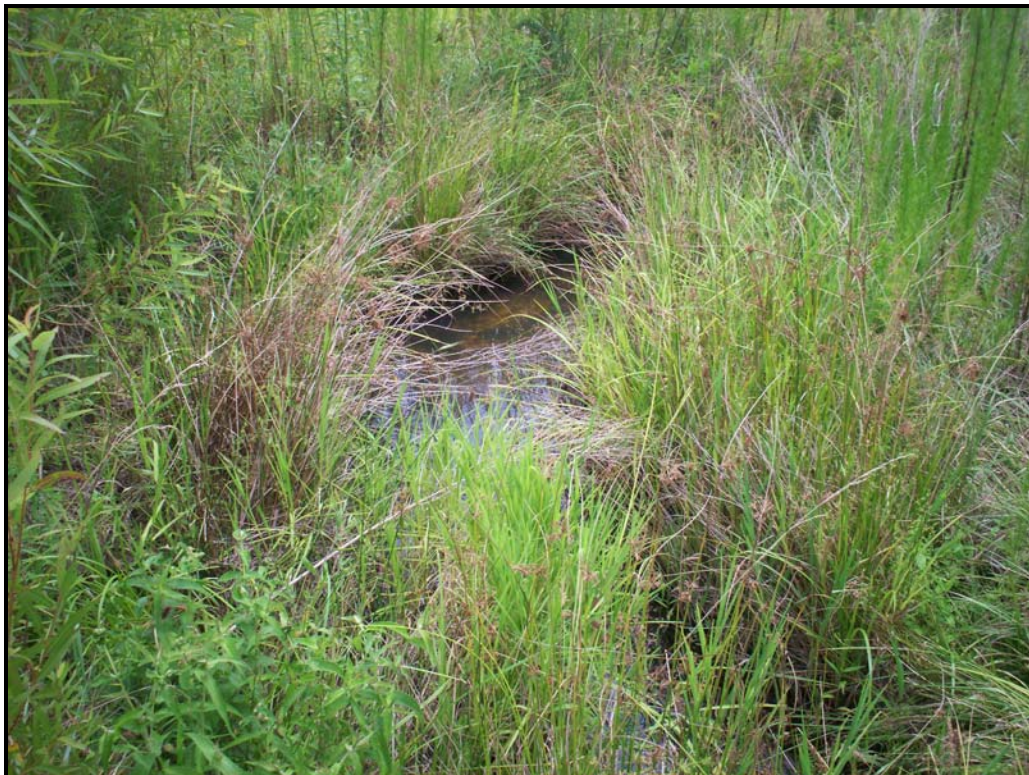
**Photo 8. Grade control structure with well vegetated banks at STA 3+40 - looking downstream.**
