**Open Springs Mitigation Project  
Randolph County, North Carolina**

**Year 4 Monitoring Report**

**November 2008**

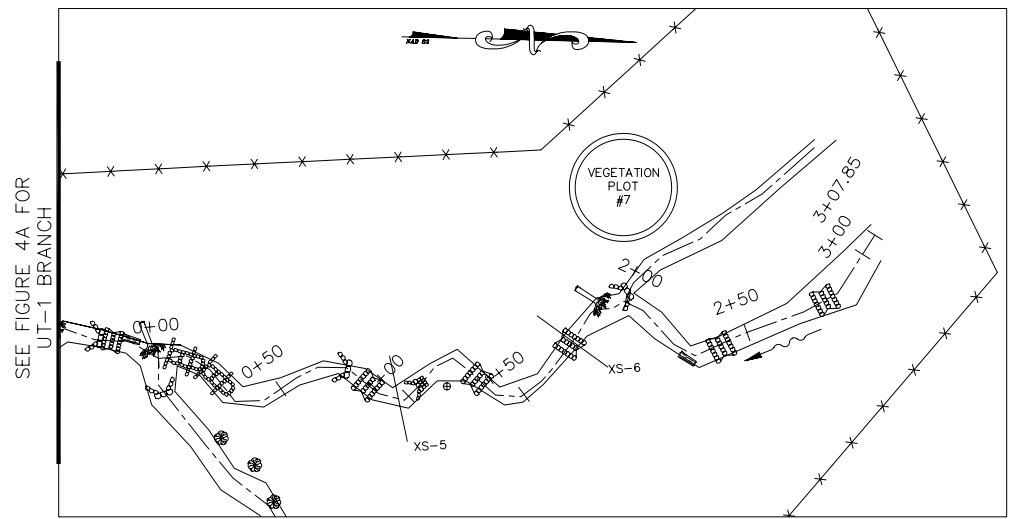
Open Springs  
Stream Problem Areas

Photographs were taken throughout the monitoring season to document the evolution of the restored stream channel (see **Appendix C**). Herbaceous vegetation is moderately dense along the restored stream. Pools have maintained a variety of depths and habitat qualities, depending on the location and type of scour features (logs, root wads, transplants, etc.). Throughout the monitoring season, both reaches had a steady flow. Very few problems with stream morphology were observed during the monitoring field visit. Throughout the project, many riffle structures were covered with vegetation. Many of the riffle features are collecting small gravel, as expected. Some minor siltation was observed, especially in the pool features, along UT-1. **Table 9** lists stream areas requiring further observation, as well as the station and description of the noted areas. Photographs of each area requiring observation can be found in **Appendix C**.
