MY2 Monitoring Report

Owen Farms Mitigation Site
Transylvania County, NC

NCDMS Project No. 100064
NCDMS Contract No. 7532
NCDMS RFP No. 16-007334
(Issued 9/8/2017)

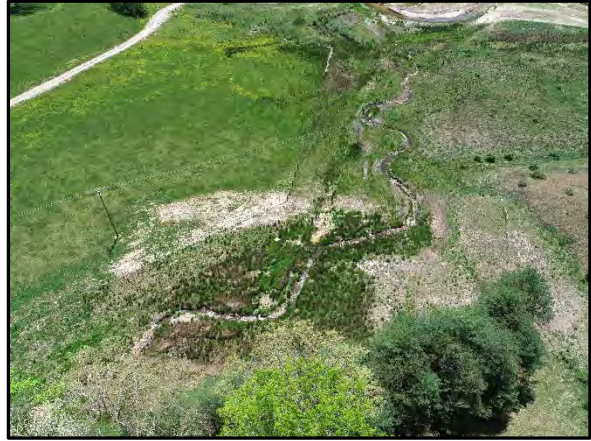
3.26 Aerial overview of UT5 looking downstream, 5/10/2022

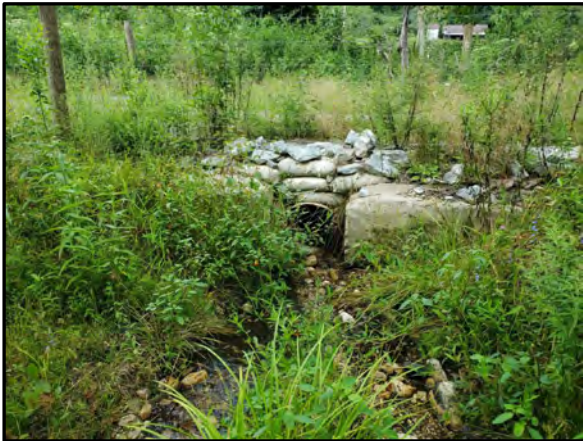
3.27 UT1 Culvert looking downstream, 8/15/2022

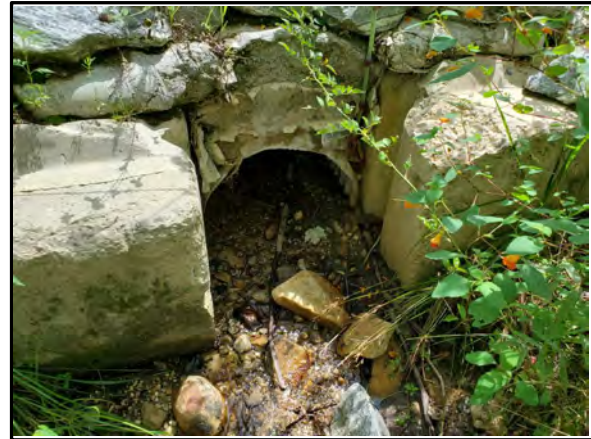
3.28 UT1 Culvert looking upstream, 8/15/2022

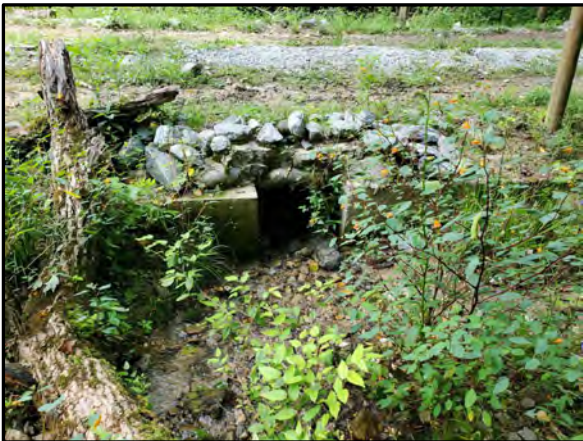
3.29 UT2A Culvert looking downstream, 8/15/2022

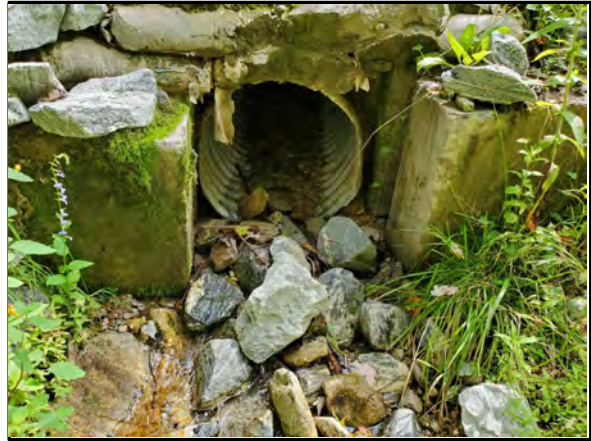
3.30 UT2A Culvert looking upstream, 8/15/2022

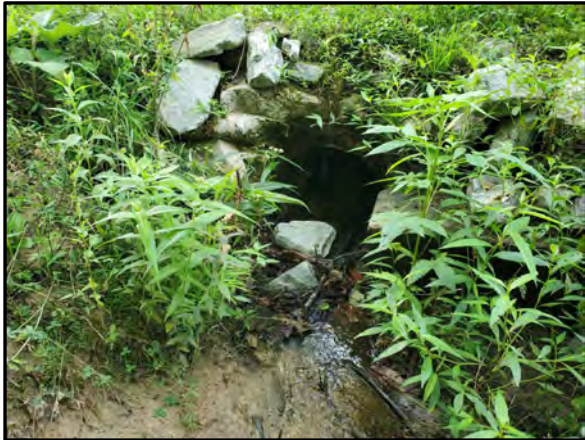
**3.31 UT2 Culvert looking downstream,
8/15/2022**

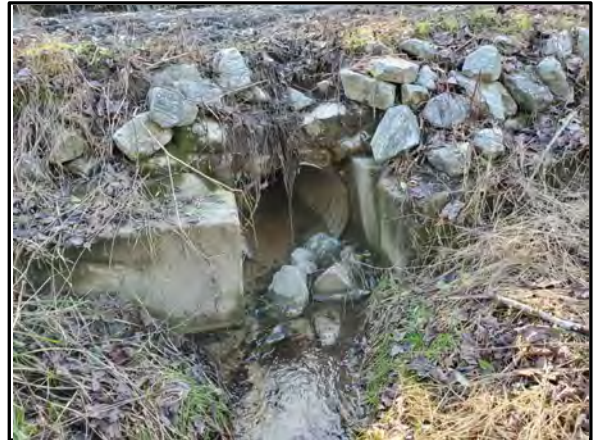
**3.32 UT2 Culvert looking upstream,
1/20/2023**

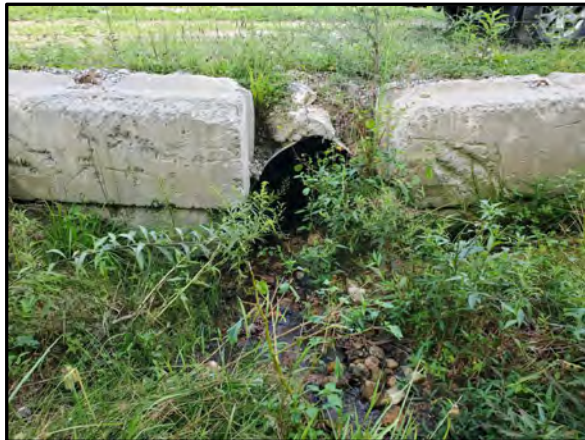
**3.33 UT4 Culvert looking downstream,
8/15/2022**

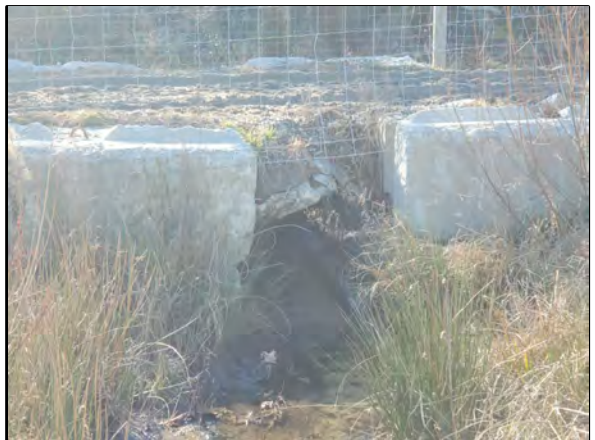
**3.34 UT4 Culvert looking upstream,
1/20/2023**
