MY3 Monitoring Report

Owen Farms Mitigation Site
Transylvania County, NC

NCDMS Project No. 100064
NCDMS Contract No. 7532
NCDMS RFP No. 16-007334
(Issued 9/8/2017)

Data Collected: March and August 2023

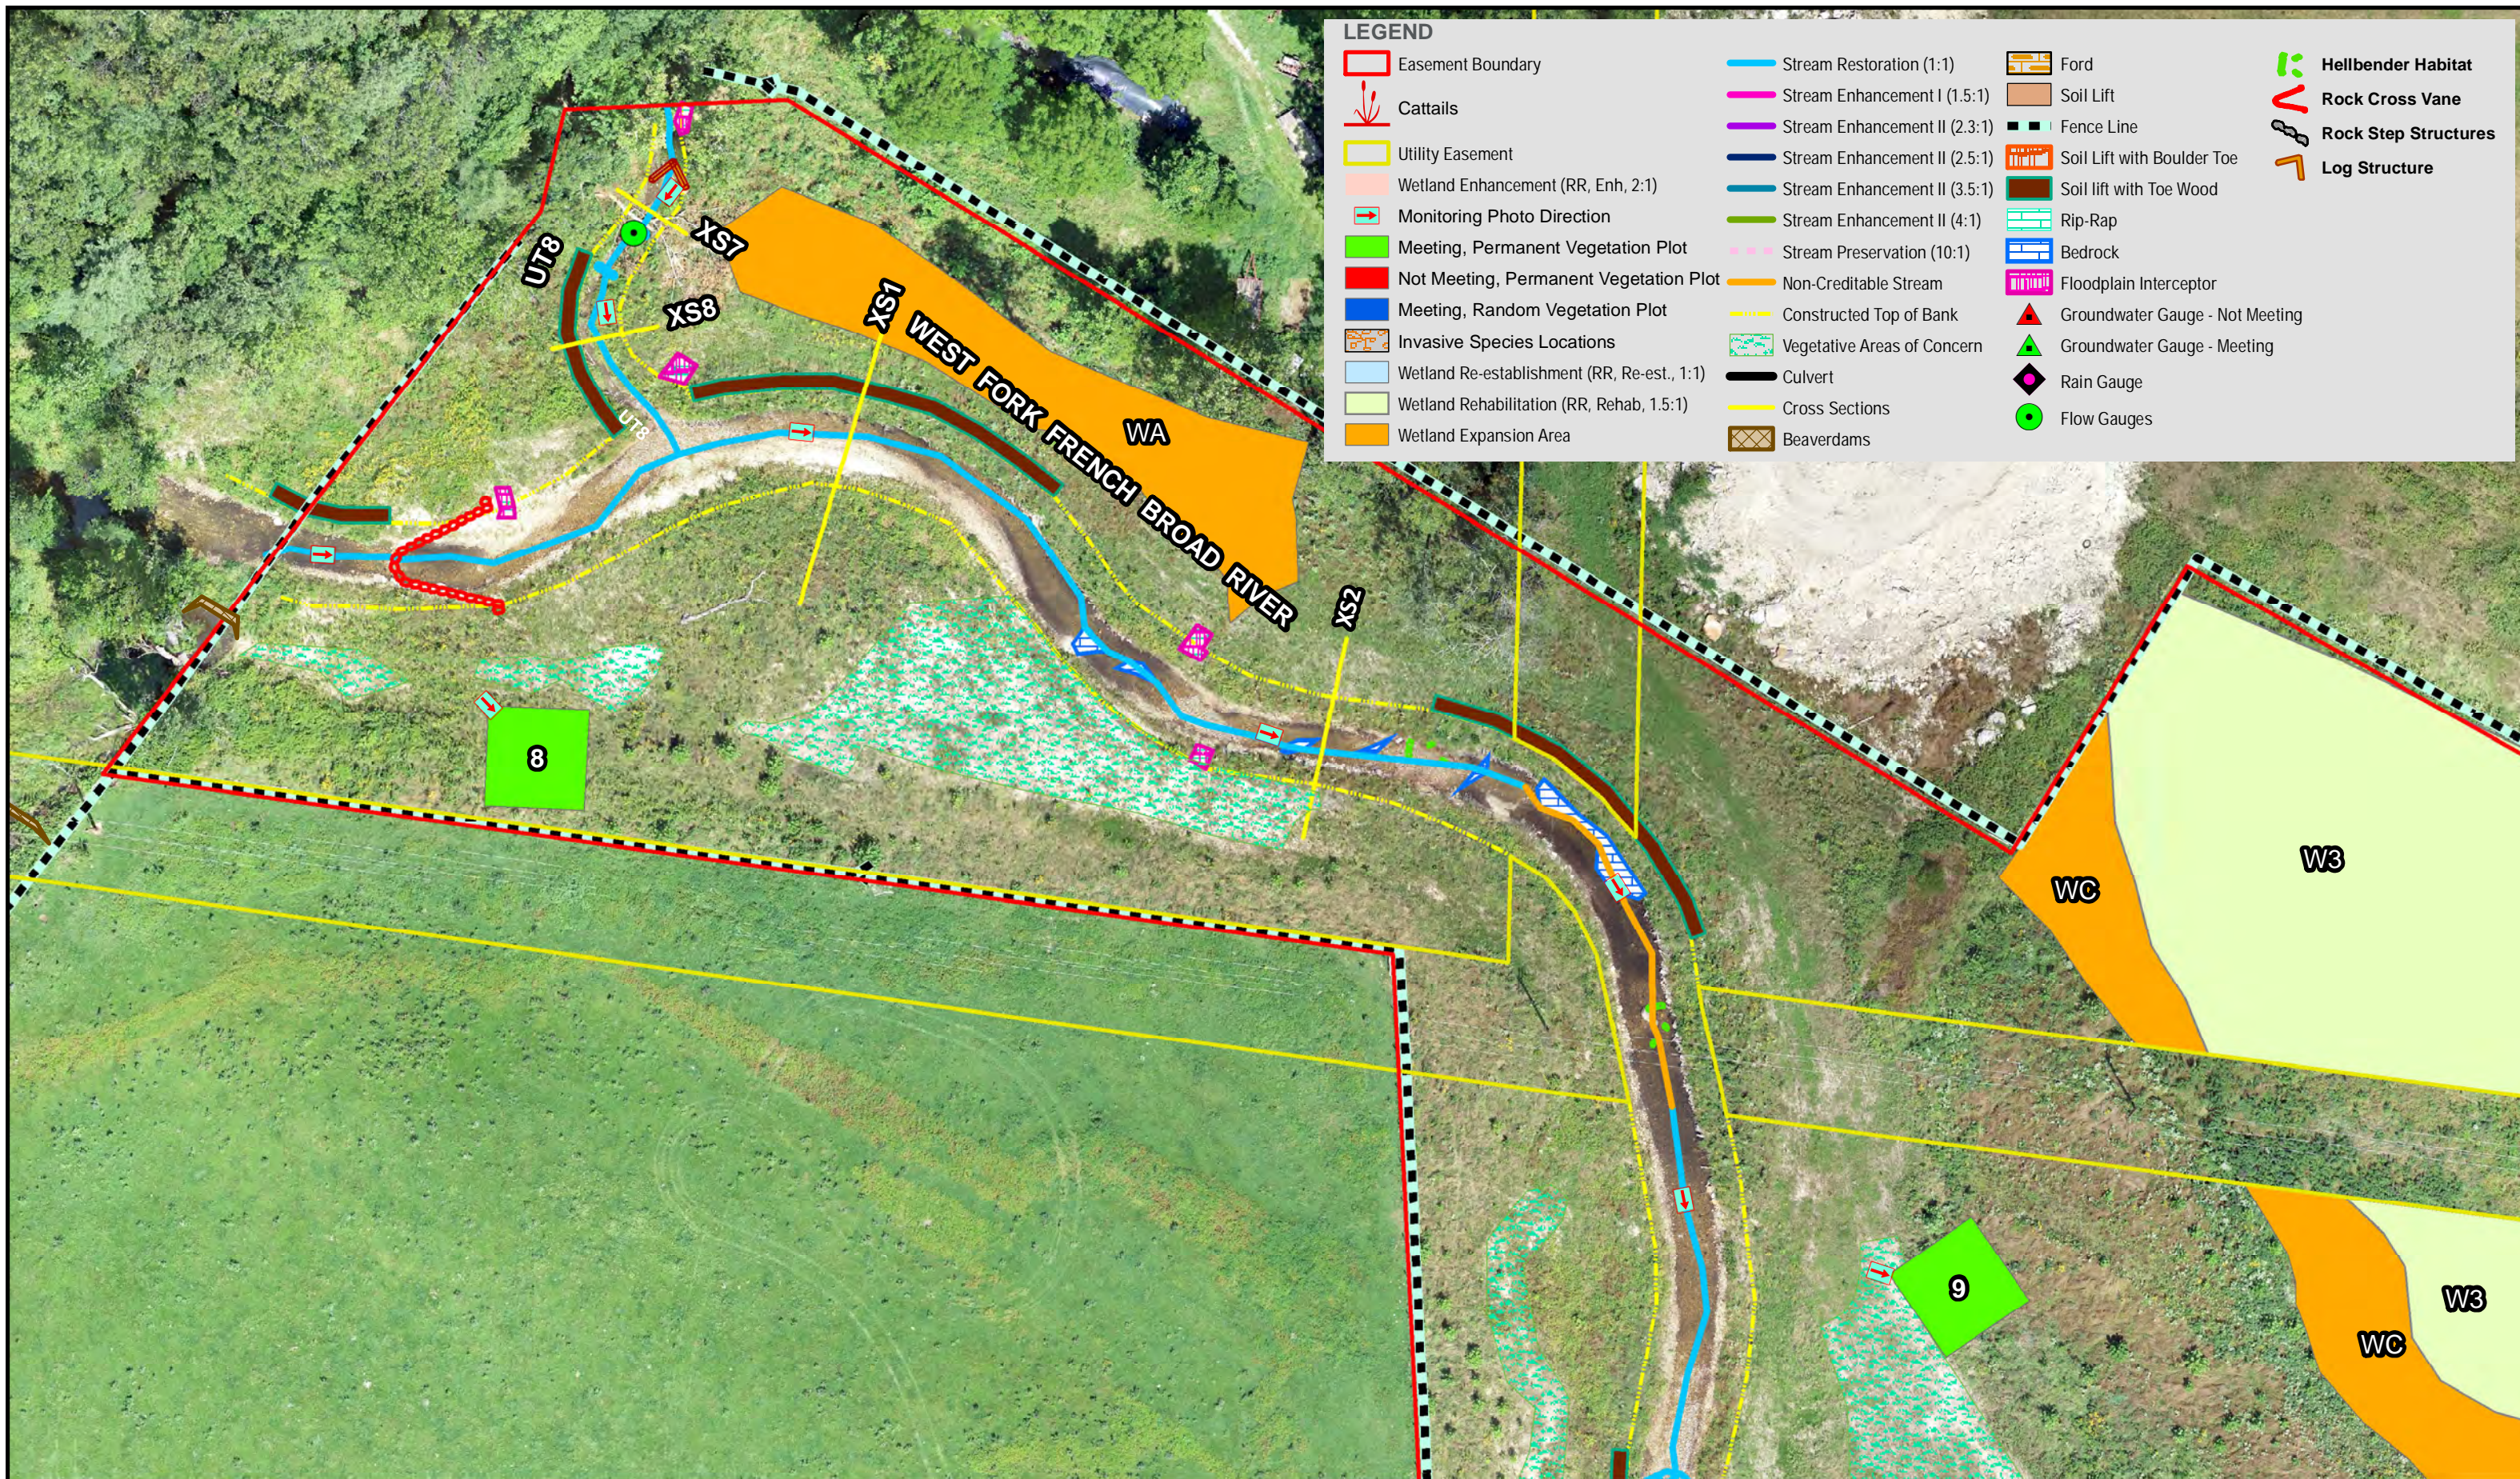
CURRENT CONDITIONS PLAN VIEW
OWEN FARMS MITIGATION SITE
 FIGURE 2.2

7. IRT noted that Figure 2.2 of the CCPV was not accurate (it is a duplicate of Figure 2.3), and requested that HDR correct for MY3 report.

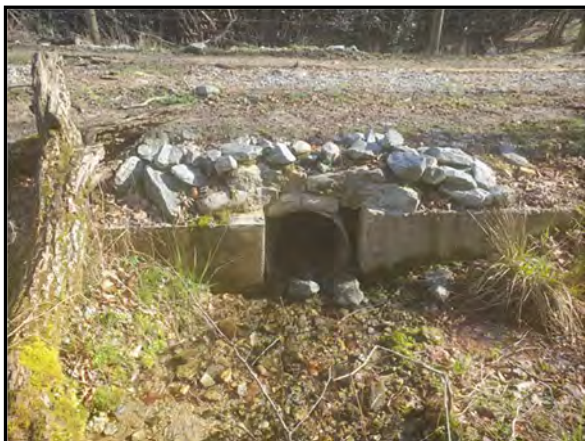
**3.29 UT2A Culvert looking downstream,
3/30/2023**

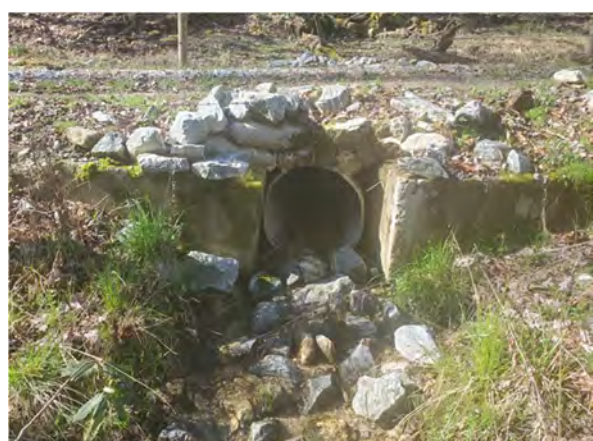
**3.30 UT2A Culvert looking upstream:
3/30/2023**

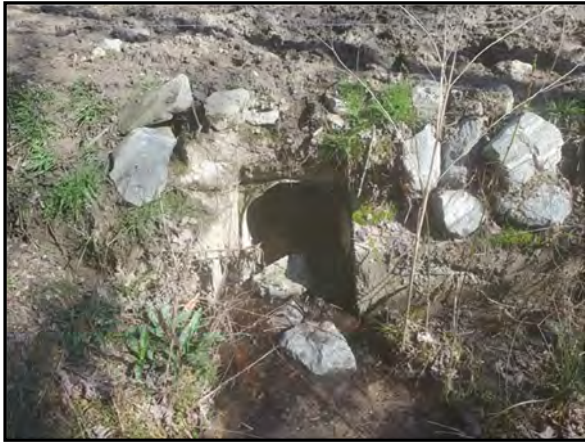
**3.31 UT2 Culvert looking downstream:
3/30/2023**

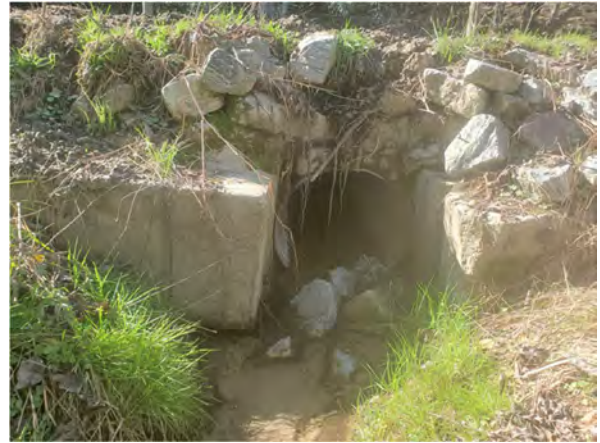
**3.32 UT2 Culvert looking upstream:
3/30/2023**

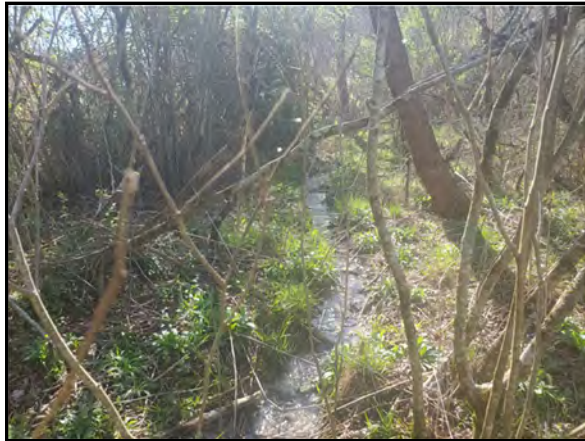
3.33 UT2 Single Thread Channel: 3/30/2023

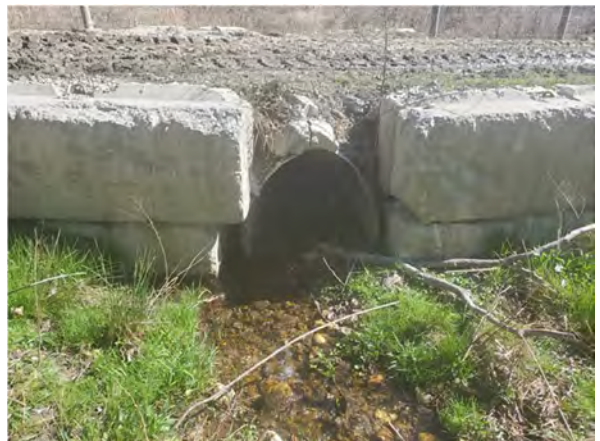
**3.34 UT4 Culvert looking downstream:
3/30/2023**

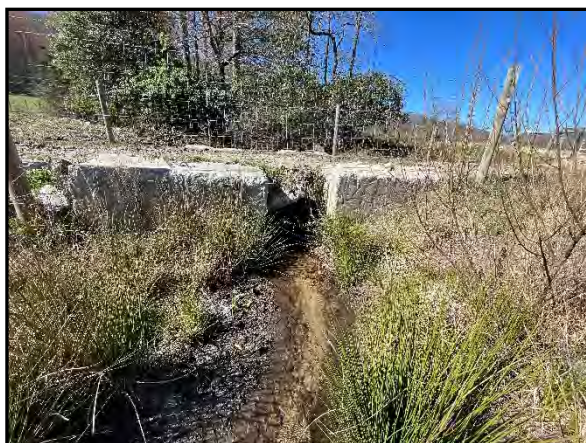
**3.35 UT4 Culvert Crossing looking upstream:
3/30/2023**

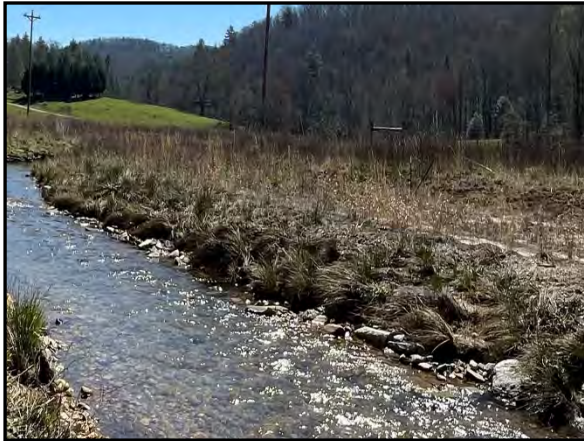
**3.43 Juncus sod mat between STA 13+90
- 14+50: 8/23/2023**

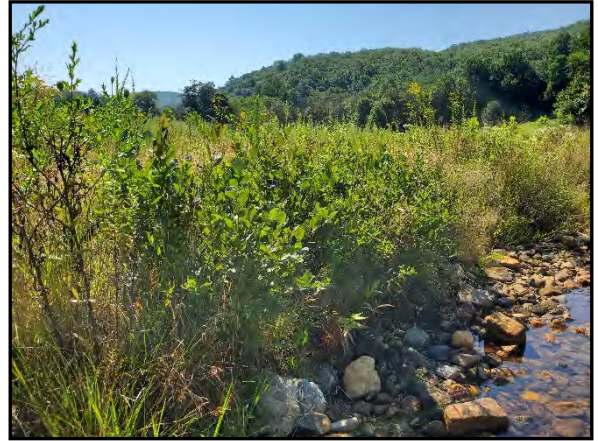
**3.44 Woody vegetation along WFFBR at STA
15+25: 8/23/2023**

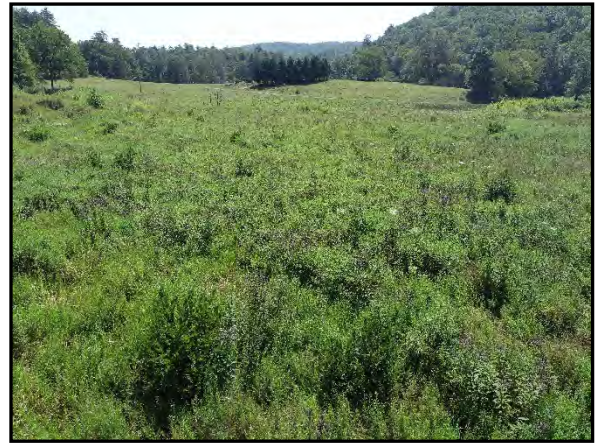
*Low stem densities observed only in Swamp Bog complex. See section 2.2.2 for details

**3.46 Aerial photo of Swamp Bog Complex:
8/24/2023**

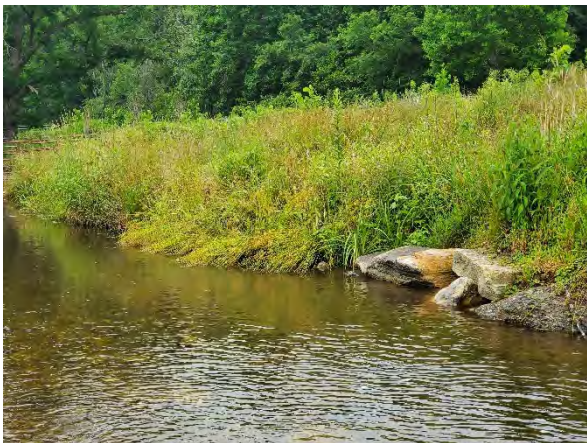
**3.47 Juncus sod mat repair at STA 22+35
6/30/2023**

Areas that were repaired in November 2022 were replanted in January 2023. All repaired areas showed increased amounts of herbaceous and woody vegetation during the Year 3 monitoring period. DRG does not anticipate the need for any repairs on WFFBR in Year 4.

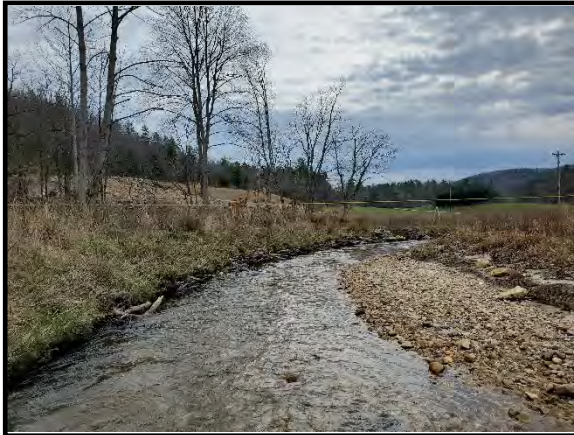
**4.1 West Fork French Broad Cross
Section 1: 3/30/2023**

Cross section geometry along WFFBR has remained consistent with the As-Built condition. Repaired areas have remained stable over the course of MY3 monitoring period. Visual observation of stream banks indicates that WFFBR has stabilized after repairs in November 2022. Herbaceous and woody stream bank vegetation has significantly increased during the MY3 monitoring period. Evidence of stream stability can be seen in Figures 4.1-4.14 and Figures 5.1-5.14.

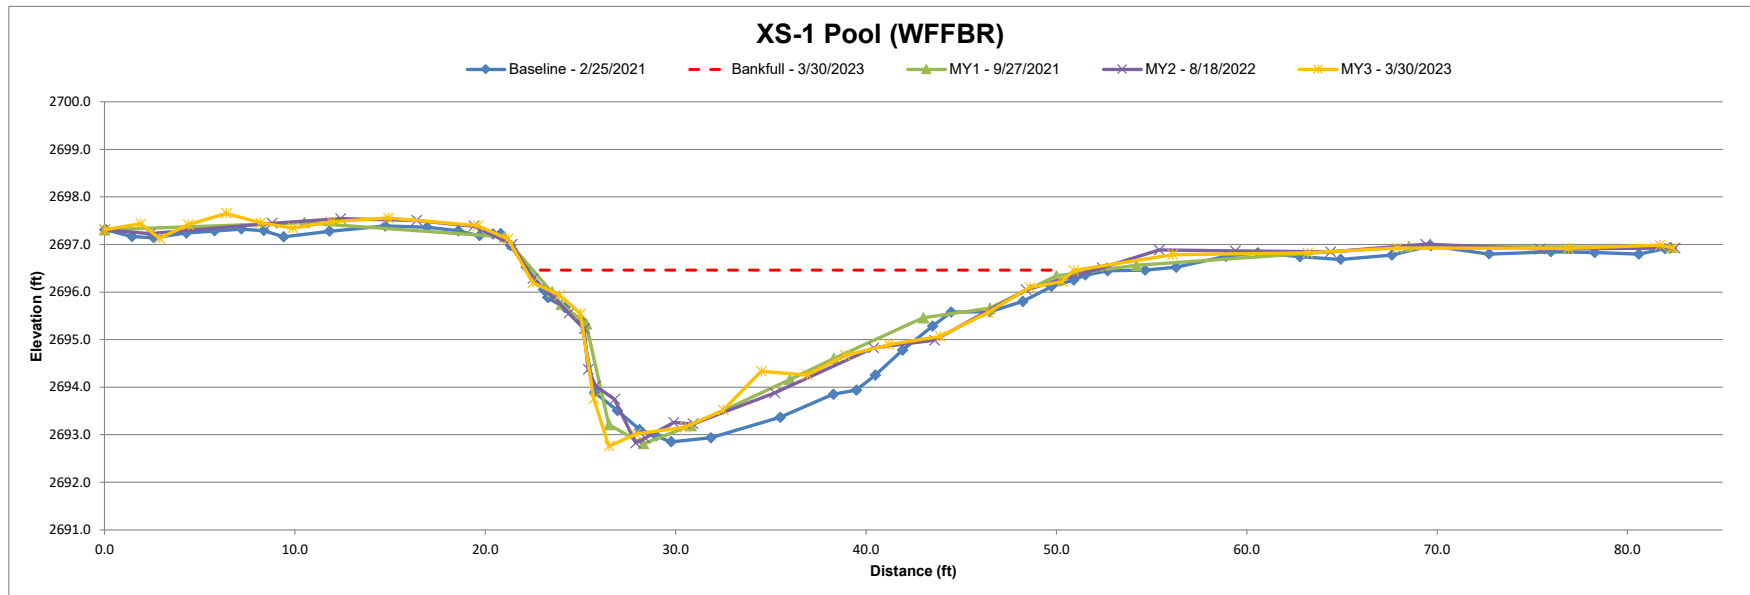
Figure 5.1 Cross Section 1

Dimensions	Cross Section 1 (Pool)					
	Base	MY1	MY2	MY3	MY4	MY5
Bankfull Elevation (ft) - Based on As Built-Bankfull Area	--	--	--	--		
Bank Height Ratio	--	--	--	--		
Thalweg Elevation	2692.85	2692.81	2692.83	2692.76		
Low Top Of Bank Elevation	2696.45	2696.34	2696.51	2696.46		
Low Top of Bank Max Depth (ft)	3.60	3.53	3.68	3.70		
Low Top Of Bank Cross Sectional Area (ft ²)	58.72	46.68	54.47	52.20

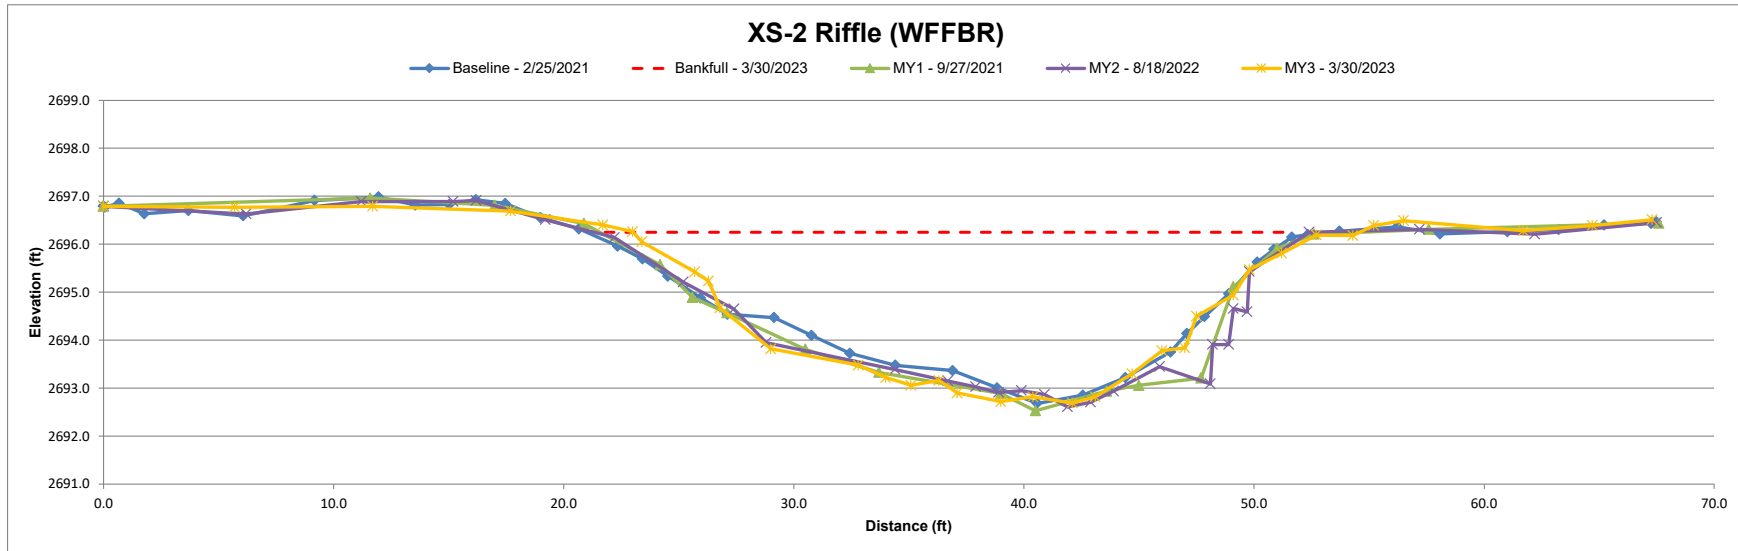
Figure 5.2 Cross Section 2

Dimensions	Cross Section 2 (Riffle)					
	Base	MY1	MY2	MY3	MY4	MY5
Bankfull Elevation (ft) - Based on As Built-Bankfull Area	2696.15	2695.96	2696.25	2696.18		
Bank Height Ratio	1.00	1.07	1.00	1.00		
Thalweg Elevation	2692.68	2692.53	2692.61	2692.69		
Low Top Of Bank Elevation	2696.15	2696.21	2696.25	2696.18		
Low Top of Bank Max Depth (ft)	3.47	3.68	3.54	3.54		
Low Top Of Bank Cross Sectional Area (ft ²)	61.32	69.39	70.16	65.25

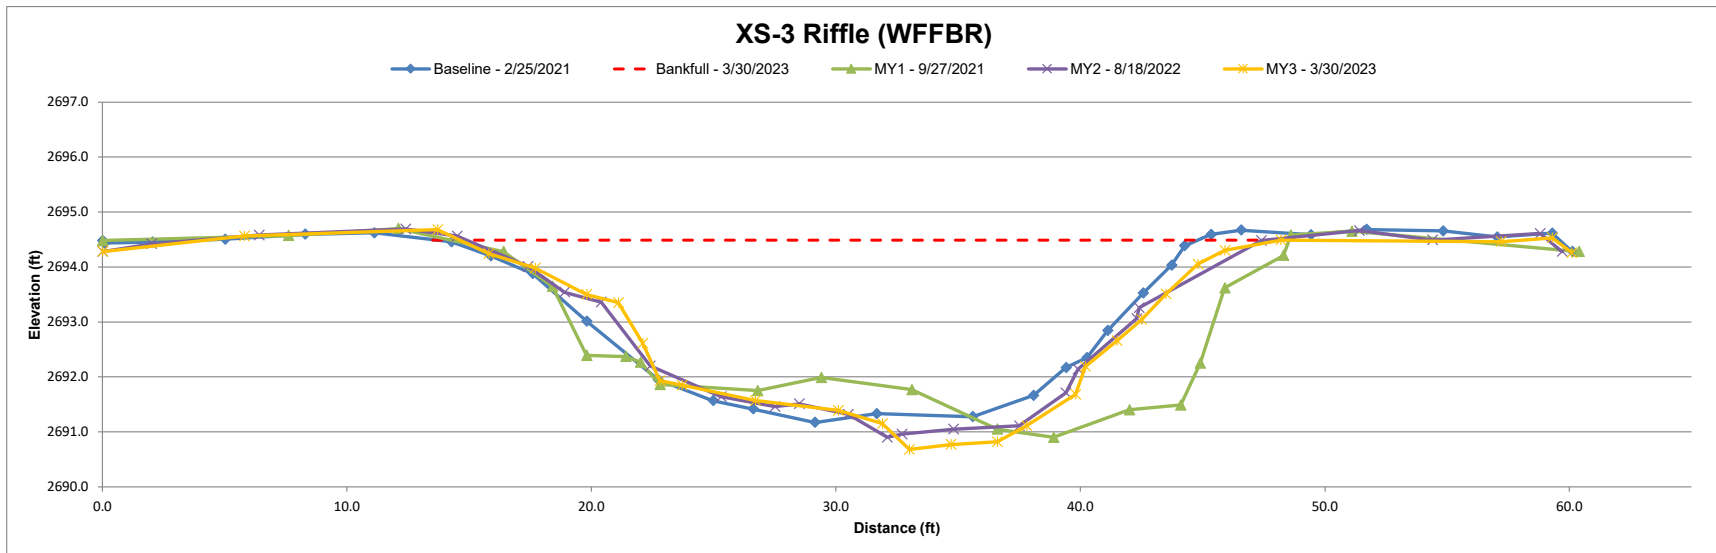
Figure 5.3 Cross Section 3

Dimensions	Cross Section 3 (Riffle)					
	Base	MY1	MY2	MY3	MY4	MY5
Bankfull Elevation (ft) - Based on As Built-Bankfull Area	2694.46	2694.11	2694.48	2694.49		
Bank Height Ratio	1.00	1.15	1.00	1.00		
Thalweg Elevation	2691.17	2690.90	2690.90	2690.68		
Low Top Of Bank Elevation	2694.46	2694.58	2694.48	2694.49		
Low Top of Bank Max Depth (ft)	3.29	3.68	3.58	3.81		
Low Top Of Bank Cross Sectional Area (ft ²)	65.45	80.97	68.38	69.43

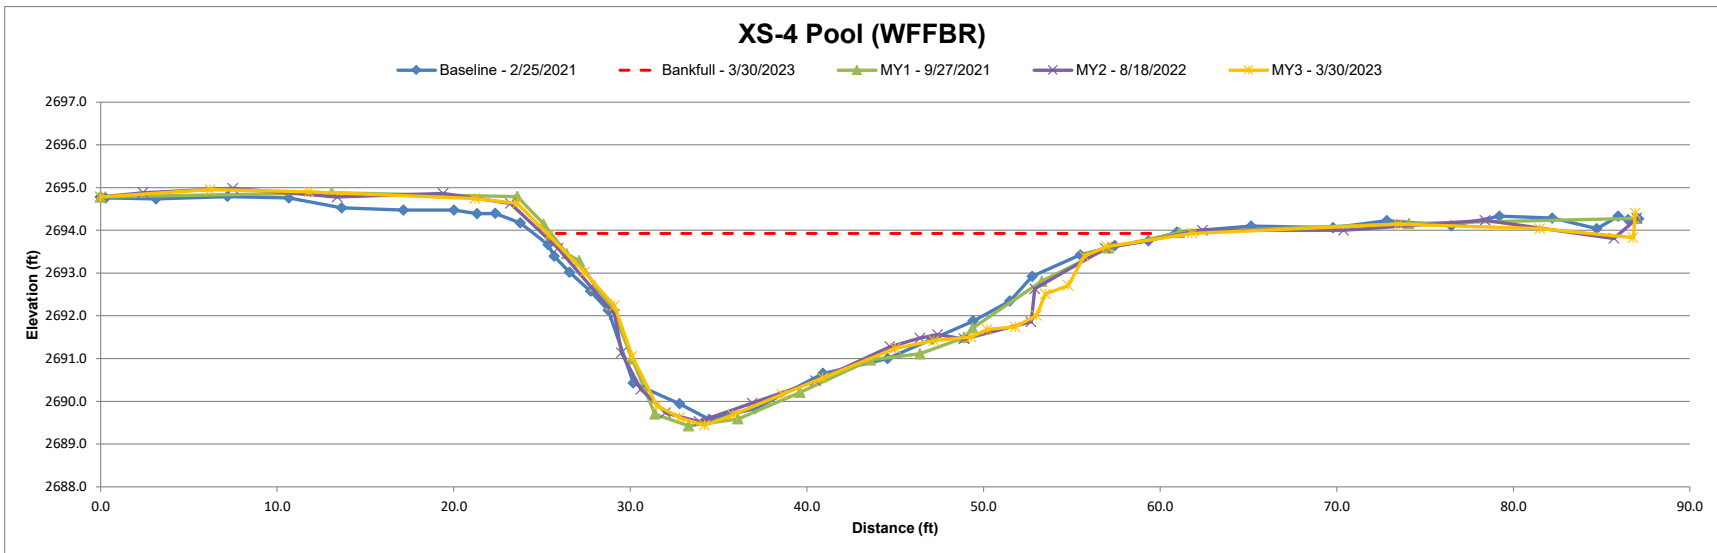
Figure 5.4 Cross Section 4

Dimensions	Cross Section 4 (Pool)					
	Base	MY1	MY2	MY3	MY4	MY5
Bankfull Elevation (ft) - Based on As Built-Bankfull Area	--	--	--	--		
Bank Height Ratio	--	--	--	--		
Thalweg Elevation	2689.58	2689.43	2689.53	2689.44		
Low Top Of Bank Elevation	2693.64	2693.95	2693.95	2693.93		
Low Top of Bank Max Depth (ft)	4.06	4.52	4.42	4.49		
Low Top Of Bank Cross Sectional Area (ft ²)	71.83	84.77	84.93	84.40

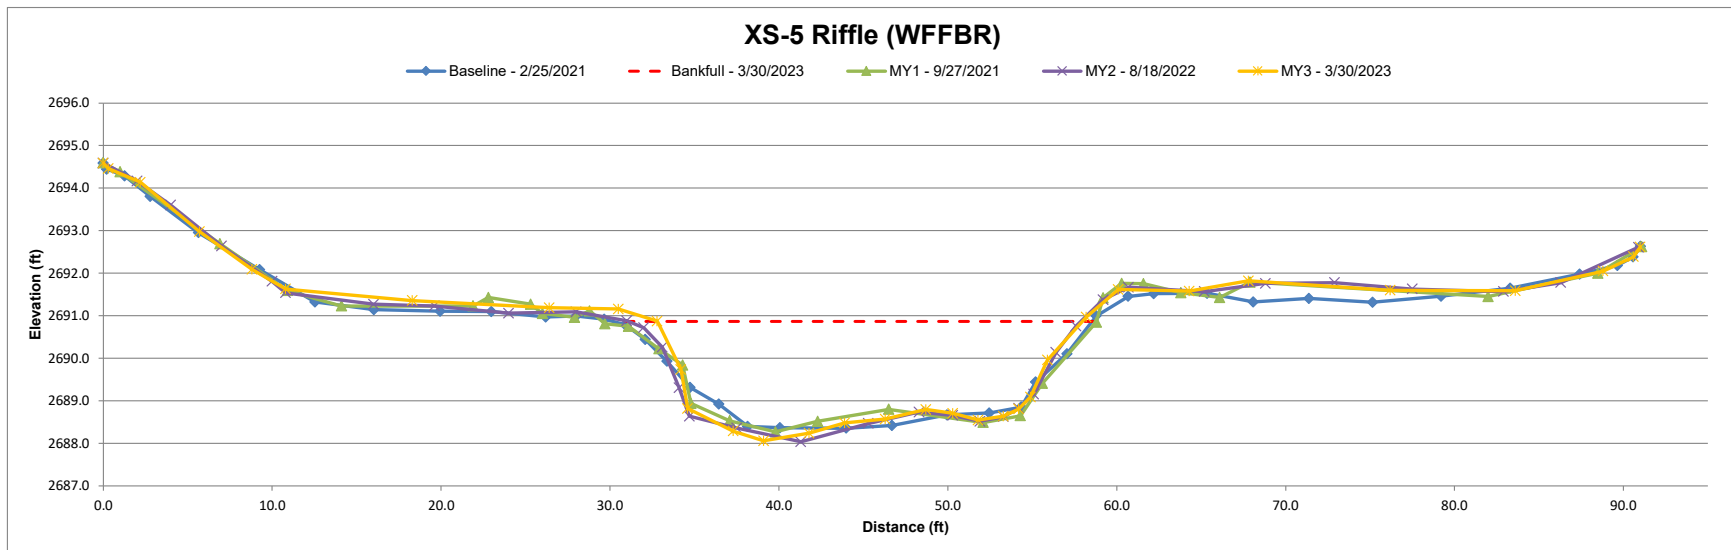
Figure 5.5 Cross Section 5

Dimensions	Cross Section 5 (Riffle)					
	Base	MY1	MY2	MY3	MY4	MY5
Bankfull Elevation (ft) - Based on As Built-Bankfull Area	2690.79	2690.79	2690.88	2690.87		
Bank Height Ratio	1.00	1.01	1.00	1.00		
Thalweg Elevation	2688.36	2688.27	2688.04	2688.06		
Low Top Of Bank Elevation	2690.79	2690.81	2690.88	2690.87		
Low Top of Bank Max Depth (ft)	2.43	2.54	2.84	2.81		
Low Top Of Bank Cross Sectional Area (ft ²)	49.82	50.32	53.99	51.8

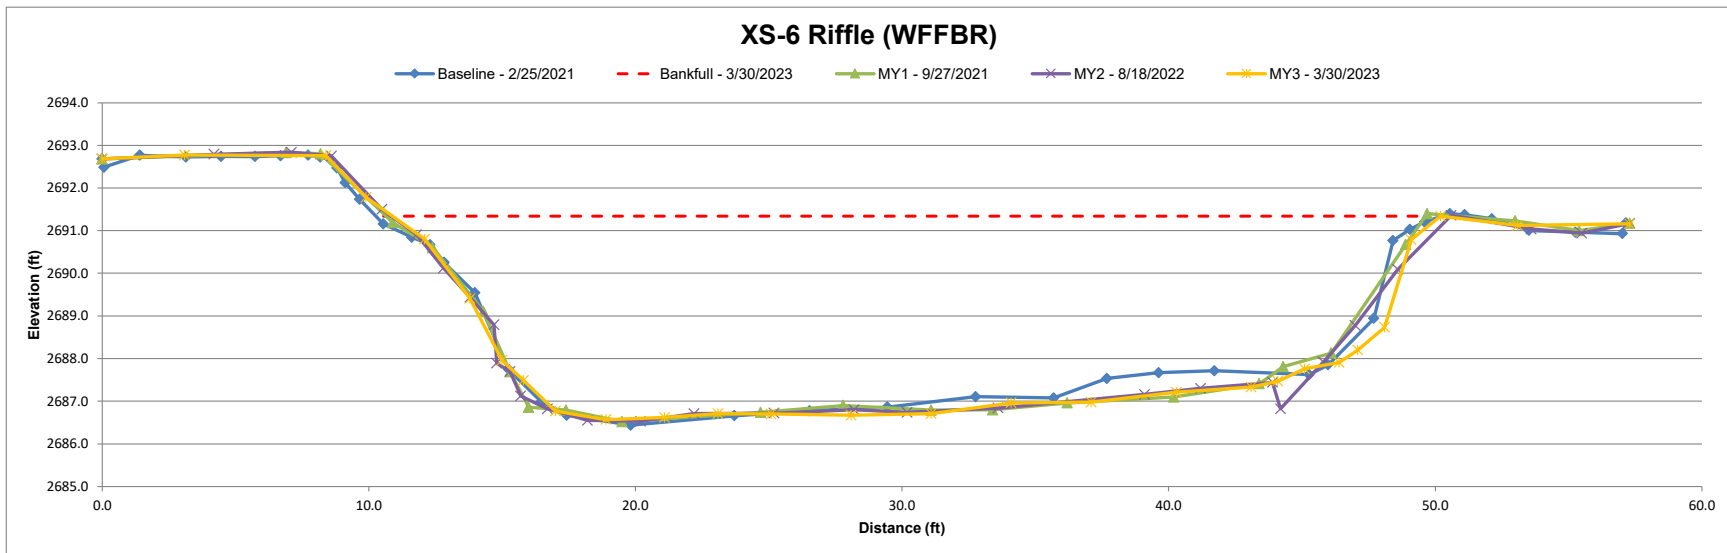
Figure 5.6 Cross Section 6

Dimensions	Cross Section 6 (Riffle)					
	Base	MY1	MY2	MY3	MY4	MY5
Bankfull Elevation (ft) - Based on As Built-Bankfull Area	2691.20	2691.11	2691.36	2691.33		
Bank Height Ratio	1.00	1.06	1.00	1.00		
Thalweg Elevation	2686.44	2686.52	2686.53	2686.57		
Low Top Of Bank Elevation	2691.20	2691.40	2691.36	2691.34		
Low Top of Bank Max Depth (ft)	4.76	4.88	4.83	4.77		
Low Top Of Bank Cross Sectional Area (ft ²)	138.26	149.49	150.40	150.30

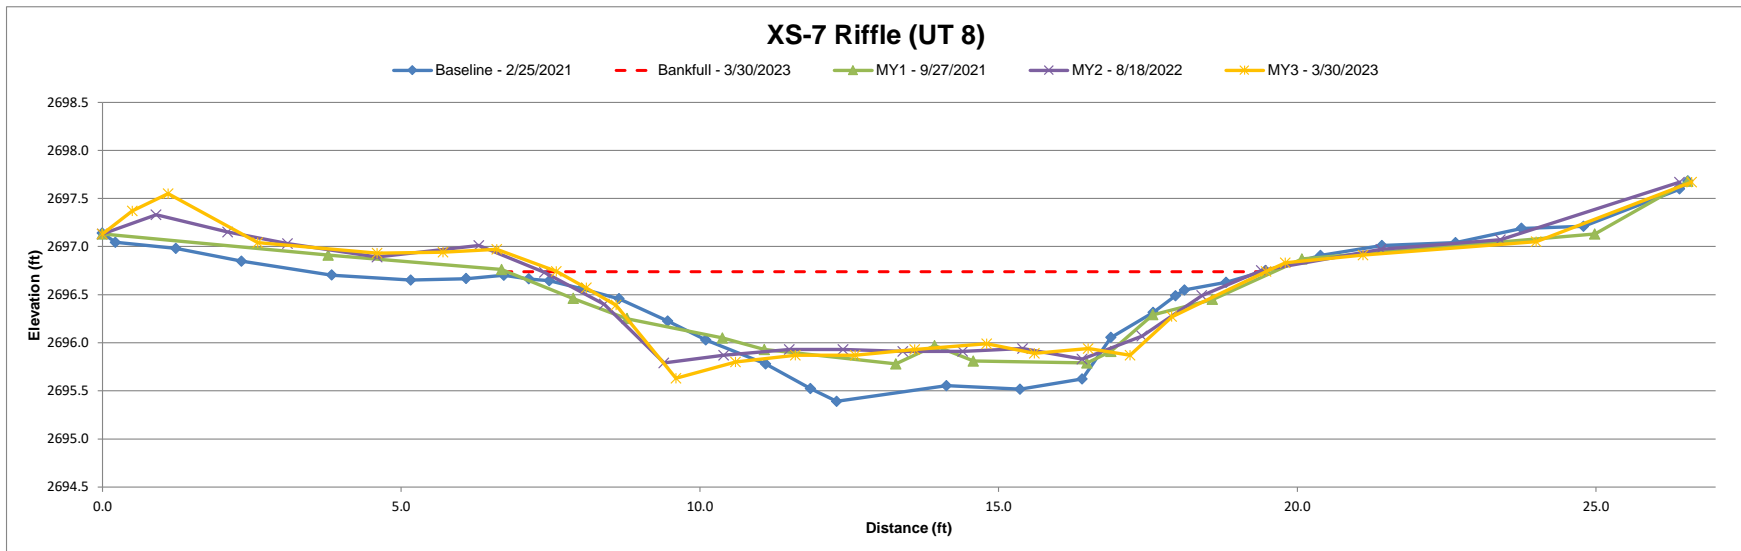
Figure 5.7 Cross Section 7

Dimensions	Cross Section 7 (Riffle)					
	Base	MY1	MY2	MY3	MY4	MY5
Bankfull Elevation (ft) - Based on As Built-Bankfull Area	2696.64	2696.74	2696.75	2696.74		
Bank Height Ratio	1.00	1.02	1.00	1.00		
Thalweg Elevation	2695.39	2695.78	2695.79	2695.63		
Low Top Of Bank Elevation	2696.64	2696.76	2696.75	2696.74		
Low Top of Bank Max Depth (ft)	1.25	0.98	0.96	1.11		
Low Top Of Bank Cross Sectional Area (ft ²)	8.14	8.40	8.19	8.43

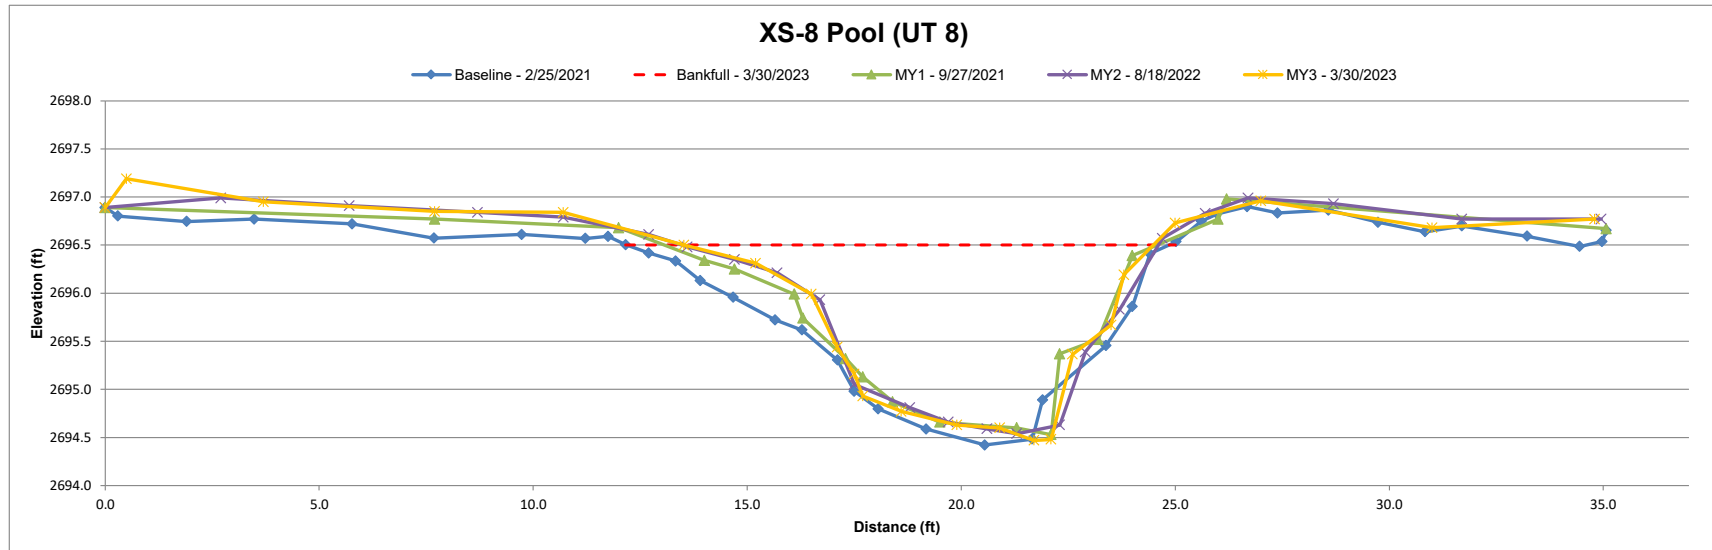
Figure 5.8 Cross Section 8

Dimensions	Cross Section 8 (Pool)					
	Base	MY1	MY2	MY3	MY4	MY5
Bankfull Elevation (ft) - Based on As Built-Bankfull Area	--	--	--	--		
Bank Height Ratio	--	--	--	--		
Thalweg Elevation	2694.42	2694.53	2694.54	2694.5		
Low Top Of Bank Elevation	2696.50	2696.68	2696.51	2696.5		
Low Top of Bank Max Depth (ft)	2.08	1.97	1.97	2.03		
Low Top Of Bank Cross Sectional Area (ft ²)	14.19	11.96	11.94	11.9

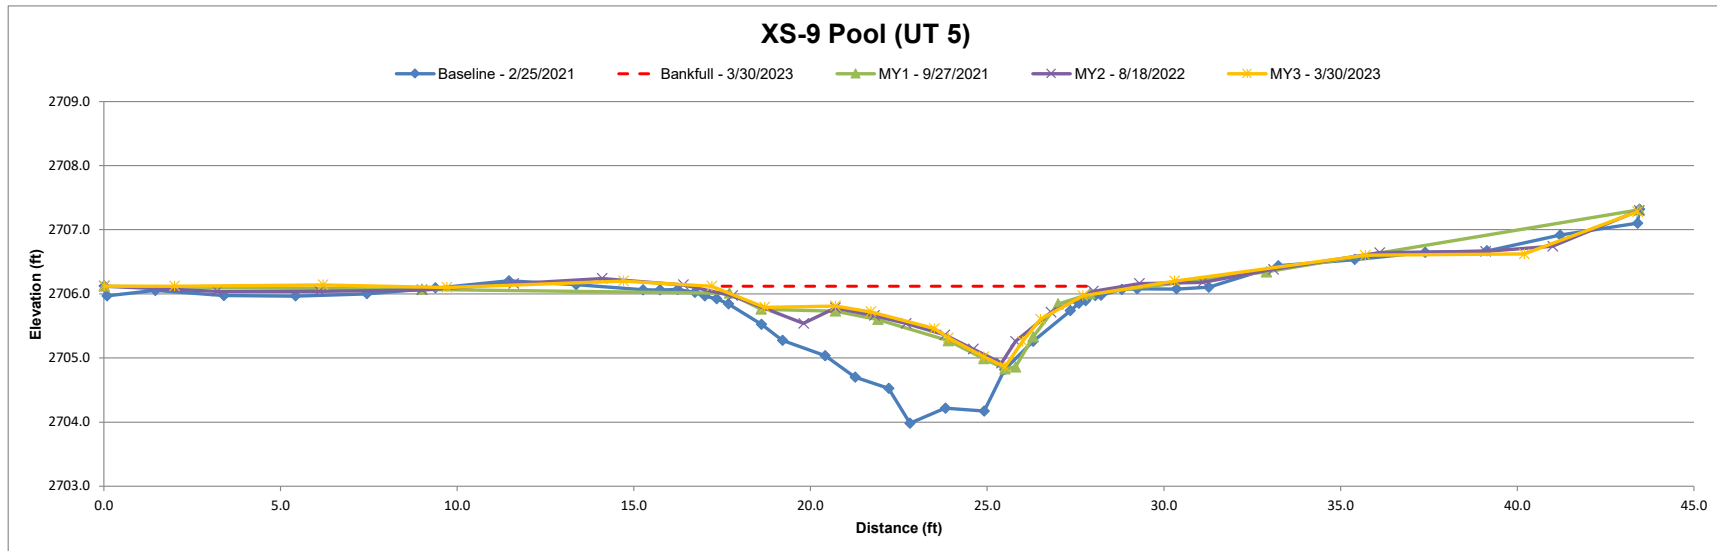
Figure 5.9 Cross Section 9

Dimensions	Cross Section 9 (Pool)					
	Base	MY1	MY2	MY3	MY4	MY5
Bankfull Elevation (ft) - Based on As Built-Bankfull Area	--	--	--	--		
Bank Height Ratio	--	--	--	--		
Thalweg Elevation	2703.98	2704.83	2704.92	2704.86		
Low Top Of Bank Elevation	2705.97	2706.01	2706.04	2706.12		
Low Top of Bank Max Depth (ft)	1.99	1.18	1.12	1.26		
Low Top Of Bank Cross Sectional Area (ft ²)	10.89	4.96	4.90	5.55

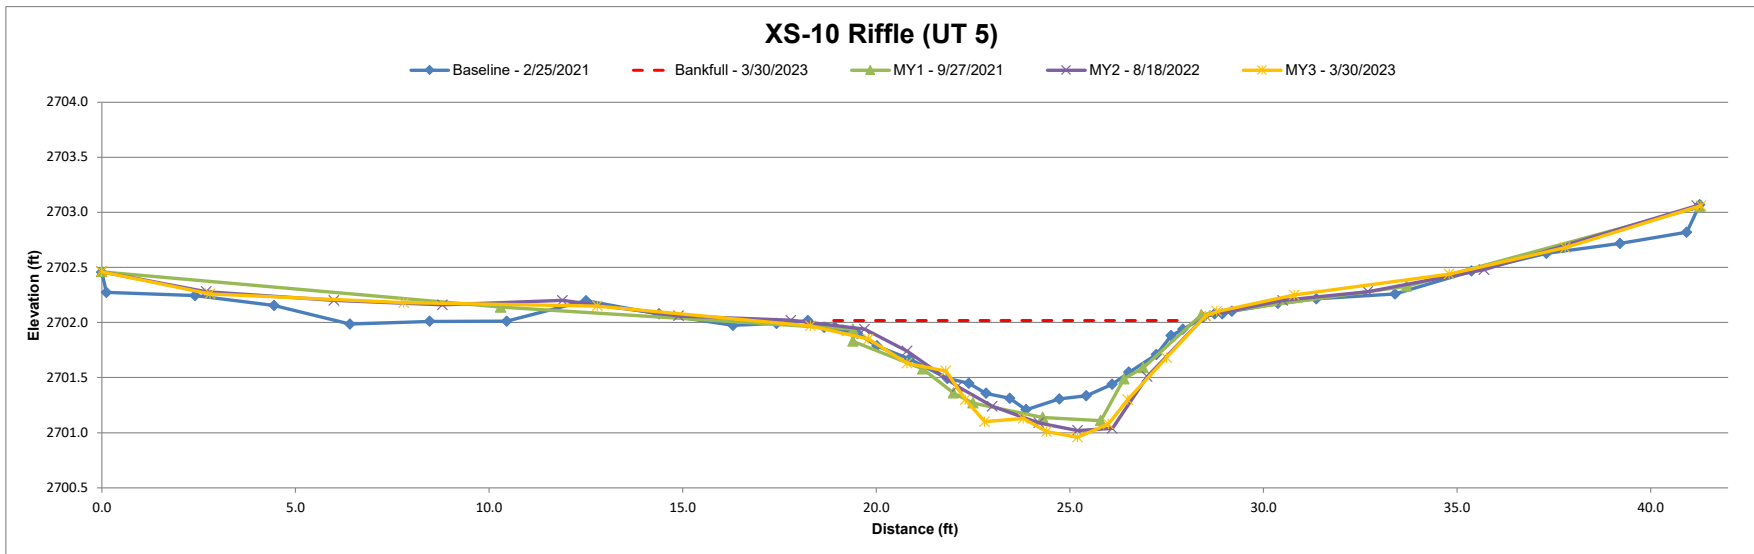
Figure 5.10 Cross Section 10

Dimensions	Cross Section 10 (Riffle)					
	Base	MY1	MY2	MY3	MY4	MY5
Bankfull Elevation (ft) - Based on As Built-Bankfull Area	2702.02	2701.93	2702.02	2701.97		
Bank Height Ratio	1.00	1.01	1.00	1.00		
Thalweg Elevation	2701.21	2701.11	2701.02	2700.96		
Low Top Of Bank Elevation	2702.02	2701.94	2702.02	2701.97		
Low Top of Bank Max Depth (ft)	0.81	0.83	1.00	1.01		
Low Top Of Bank Cross Sectional Area (ft ²)	4.37	4.43	5.37	5.27

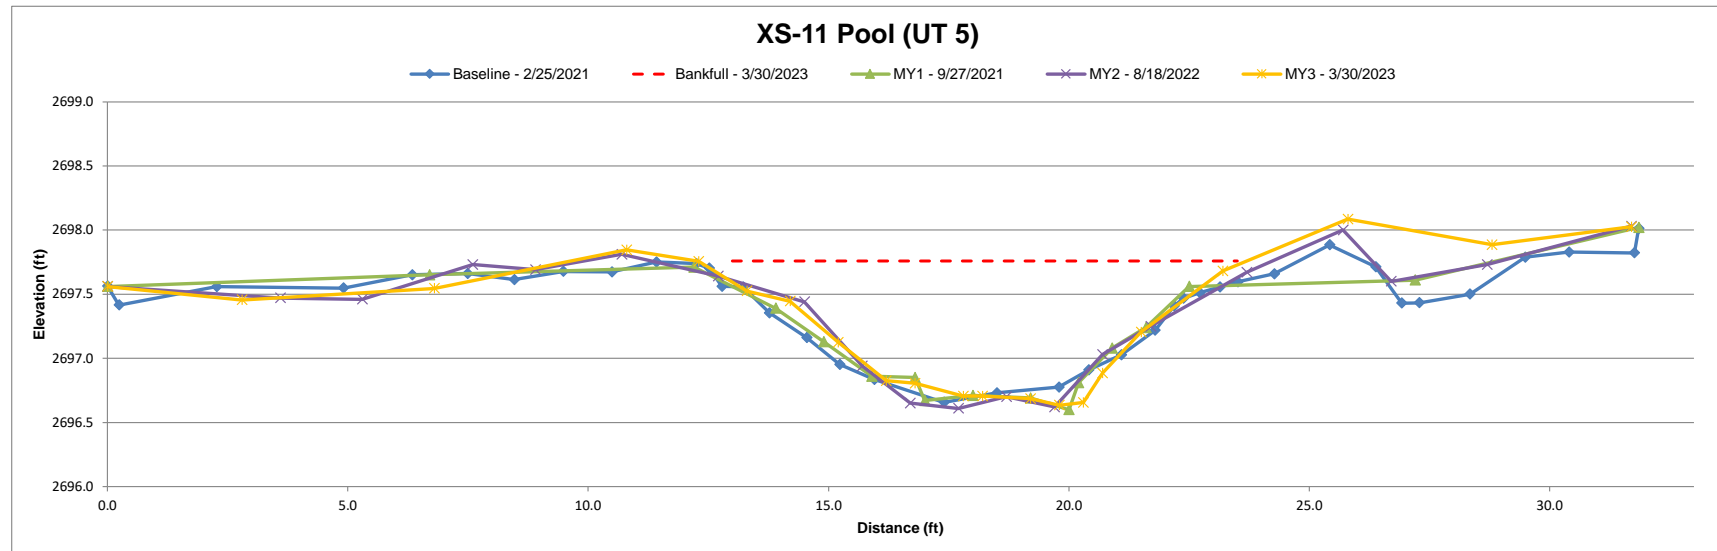
Figure 5.11 Cross Section 11

Dimensions	Cross Section 11 (Pool)					
	Base	MY1	MY2	MY3	MY4	MY5
Bankfull Elevation (ft) - Based on As Built-Bankfull Area	--	--	--	--		
Bank Height Ratio	--	--	--	--		
Thalweg Elevation	2696.66	2996.60	2696.61	2696.64		
Low Top Of Bank Elevation	2697.47	2697.56	2697.67	2697.76		
Low Top of Bank Max Depth (ft)	0.81	0.96	1.06	1.13		
Low Top Of Bank Cross Sectional Area (ft ²)	4.75	5.40	6.55	7.32

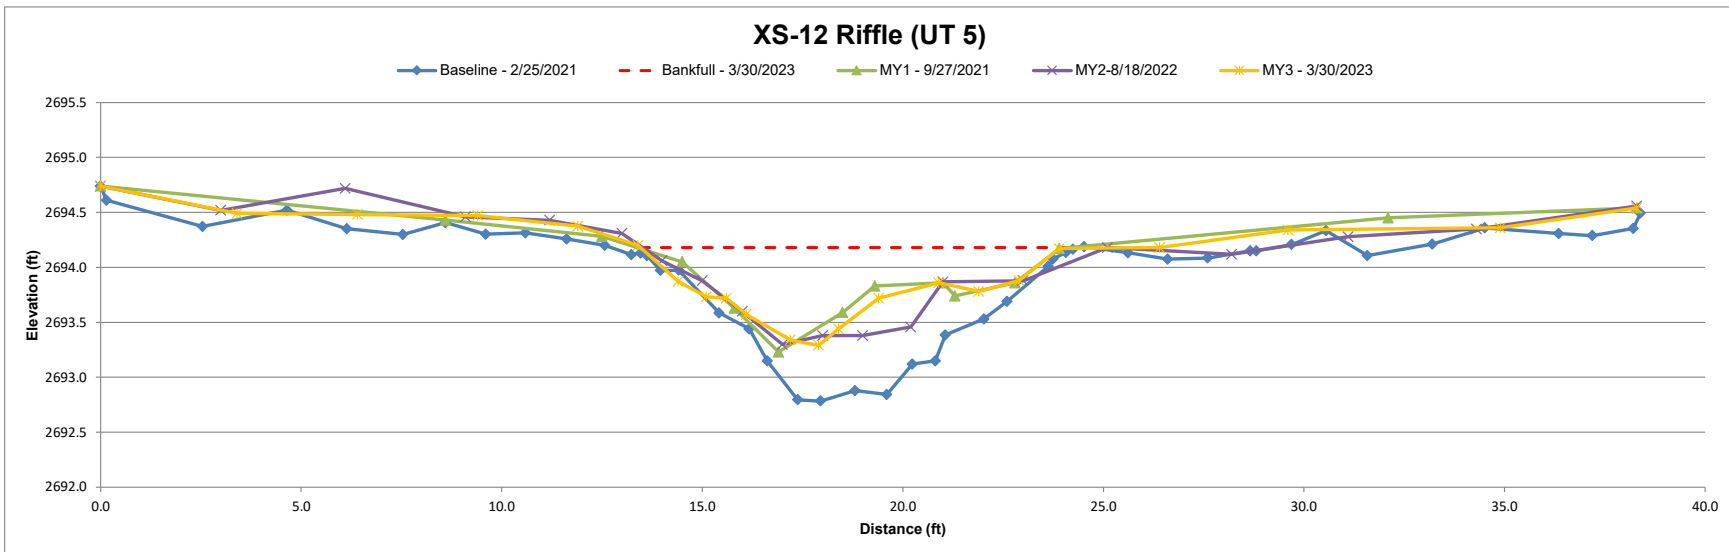
Figure 5.12 Cross Section 12

Dimensions	Cross Section 12 (Riffle)					
	Base	MY1	MY2	MY3	MY4	MY5
Bankfull Elevation (ft) - Based on As Built-Bankfull Area	2694.13	2694.49	2694.18	2694.17		
Bank Height Ratio	1.00	0.75	1.00	1.00		
Thalweg Elevation	2692.78	2693.23	2693.30	2693.29		
Low Top Of Bank Elevation	2694.13	2694.17	2694.18	2694.17		
Low Top of Bank Max Depth (ft)	1.35	0.95	0.88	0.88		
Low Top Of Bank Cross Sectional Area (ft ²)	7.83	4.28	5.30	4.66

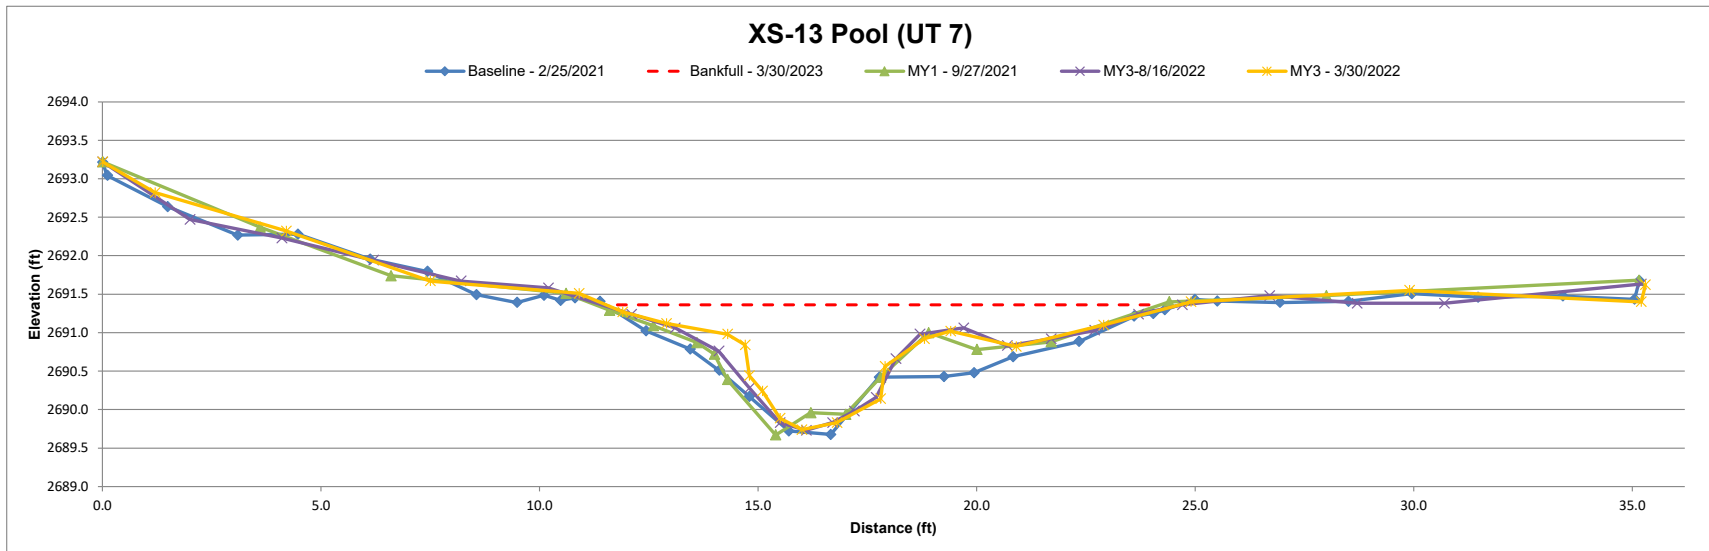
Figure 5.13 Cross Section 13

Dimensions	Cross Section 13 (Pool)					
	Base	MY1	MY2	MY3	MY4	MY5
Bankfull Elevation (ft) - Based on As Built-Bankfull Area	--	--	--	--		
Bank Height Ratio	--	--	--	--		
Thalweg Elevation	2689.68	2689.67	2689.73	2689.74		
Low Top Of Bank Elevation	2691.25	2691.40	2691.36	2691.4		
Low Top of Bank Max Depth (ft)	1.57	1.73	1.63	1.66		
Low Top Of Bank Cross Sectional Area (ft ²)	8.77	9.06	8.10	8.21

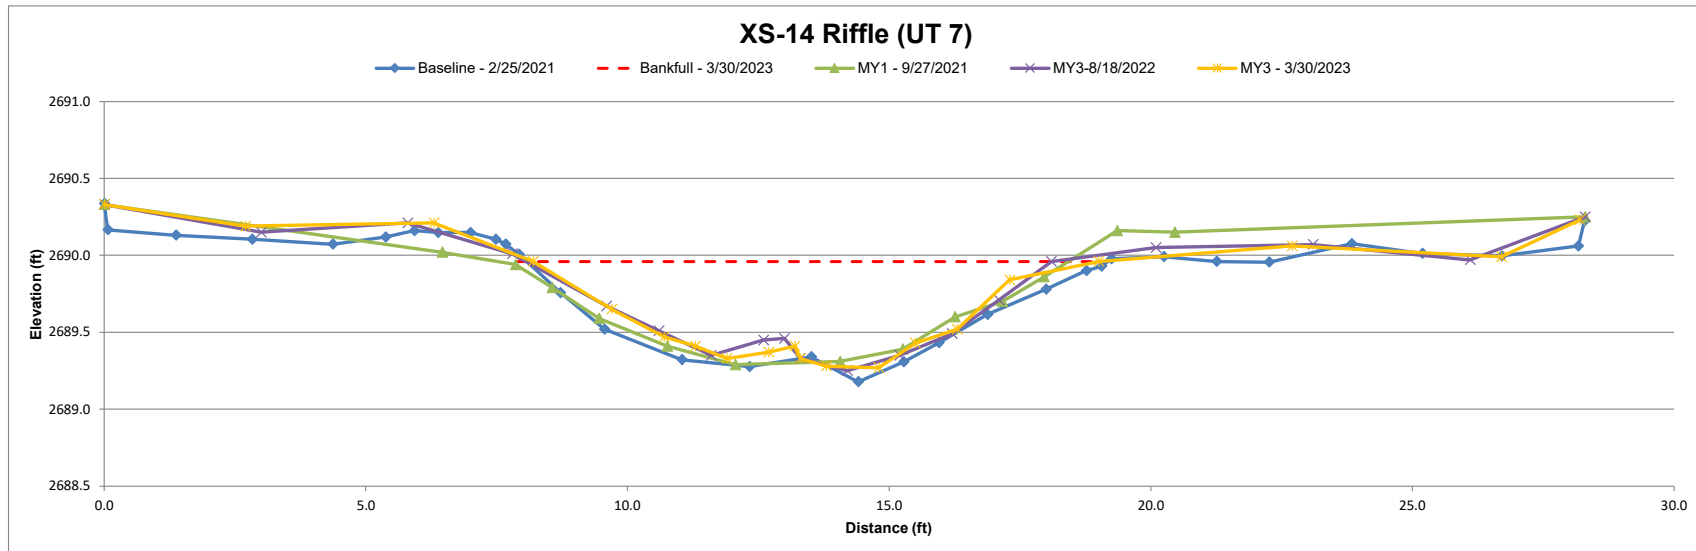
Figure 5.14 Cross Section 14

Dimensions	Cross Section 14 (Riffle)					
	Base	MY1	MY2	MY3	MY4	MY5
Bankfull Elevation (ft) - Based on As Built-Bankfull Area	2689.90	2689.95	2689.96	2689.96		
Bank Height Ratio	1.00	0.98	1.00	1.00		
Thalweg Elevation	2689.18	2689.29	2689.25	2689.27		
Low Top Of Bank Elevation	2689.90	2689.94	2689.96	2689.96		
Low Top of Bank Max Depth (ft)	0.72	0.65	0.71	0.69		
Low Top Of Bank Cross Sectional Area (ft ²)	4.56	4.45	4.31	4.34
