MY3 Monitoring Report

Owen Farms Mitigation Site
Transylvania County, NC

NCDMS Project No. 100064
NCDMS Contract No. 7532
NCDMS RFP No. 16-007334
(Issued 9/8/2017)

Data Collected: March and August 2023

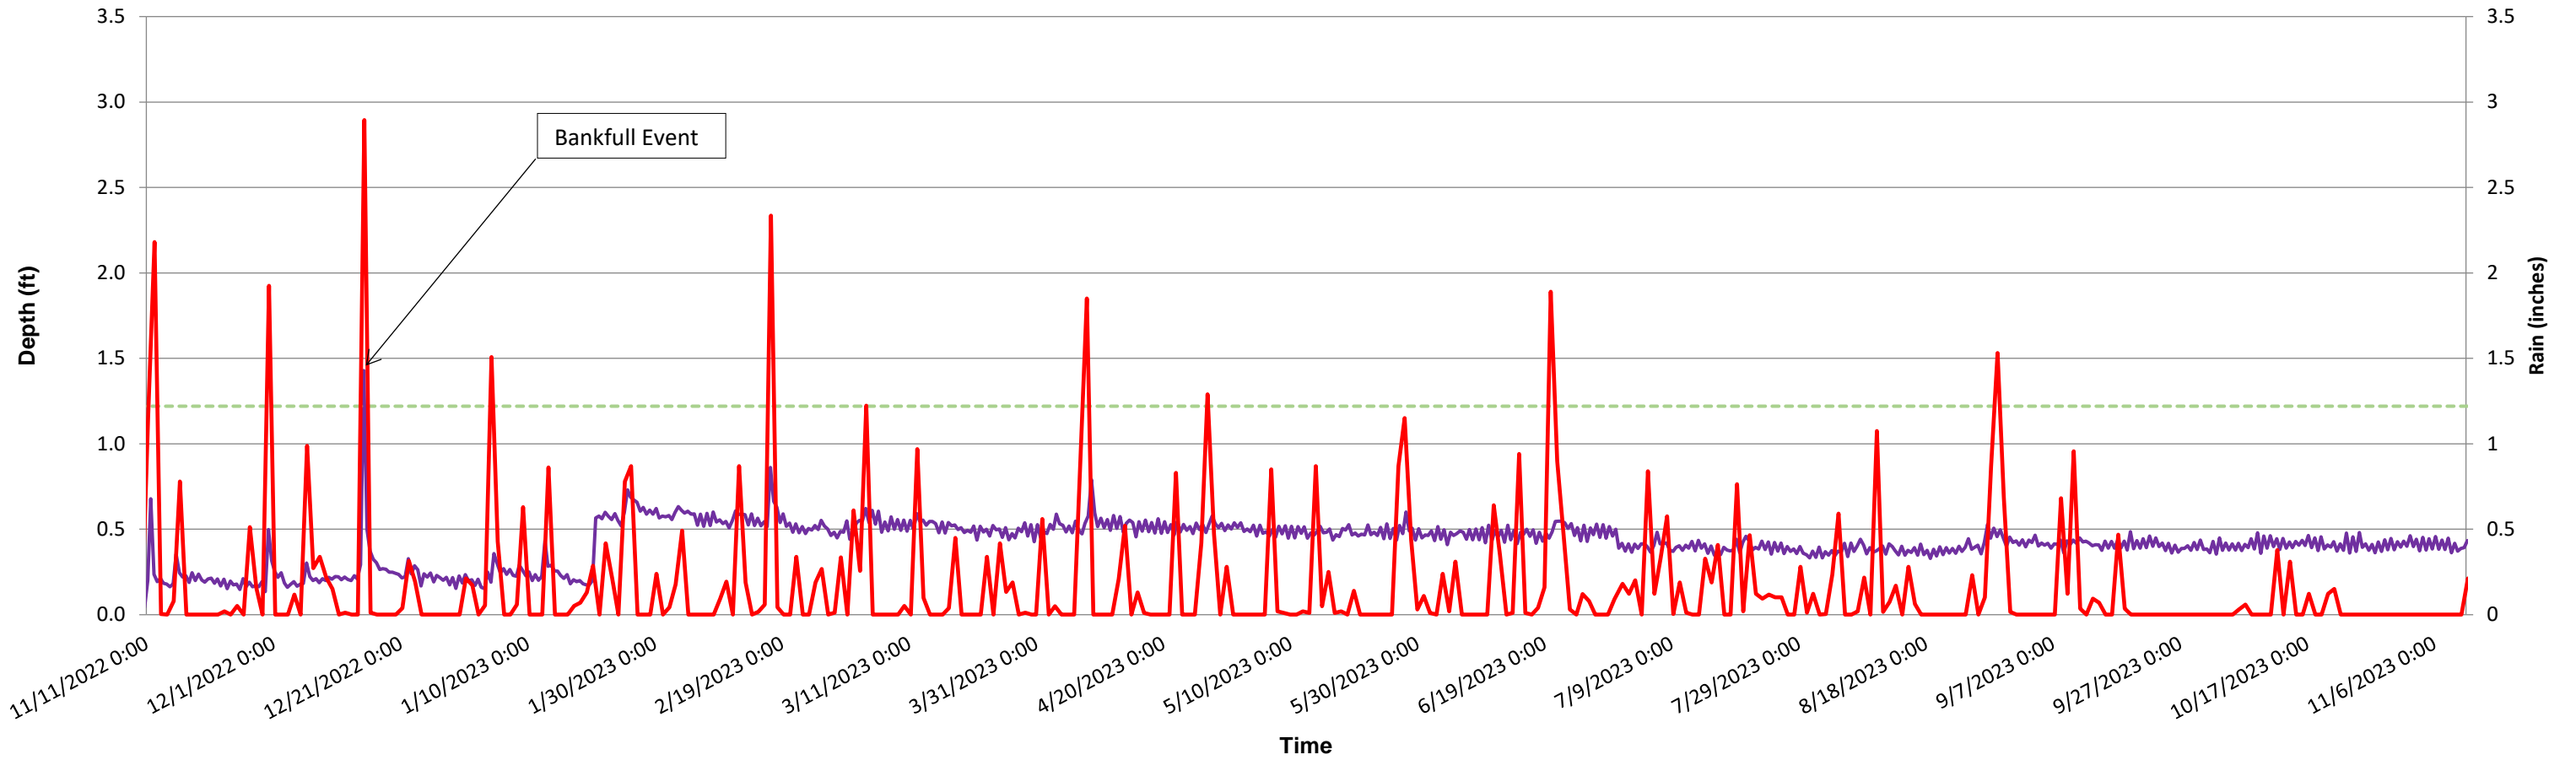
Figure 7.4 UT 8 Flow Depth

7: Figure 7.4: Please update the “Daily Rainfall Totals” line in the graph legend. It currently reads “Series1”. *Graph legend title has been updated.*

All monitored streams have experienced continuous flow within tributaries and has been documented for at least 30 consecutive days. To date, stream flow gauge data indicates that the site did not experience a bankfull event during Year 3; however, UT8 recorded a bankfull event December 15, 2022, which was not reported in the MY2 report. Hydrologic data for UT7 indicates a spike in water depth around June 14, 2023 that show water levels to at or above bankfull: this is indicative of the time when beaver dams were constructed and is a false representation of a bankfull event. Stream hydrologic data between November 10, 2022 and November 23, 2023 can be seen in Figures 7.1 - 7.4 (Appendix E).

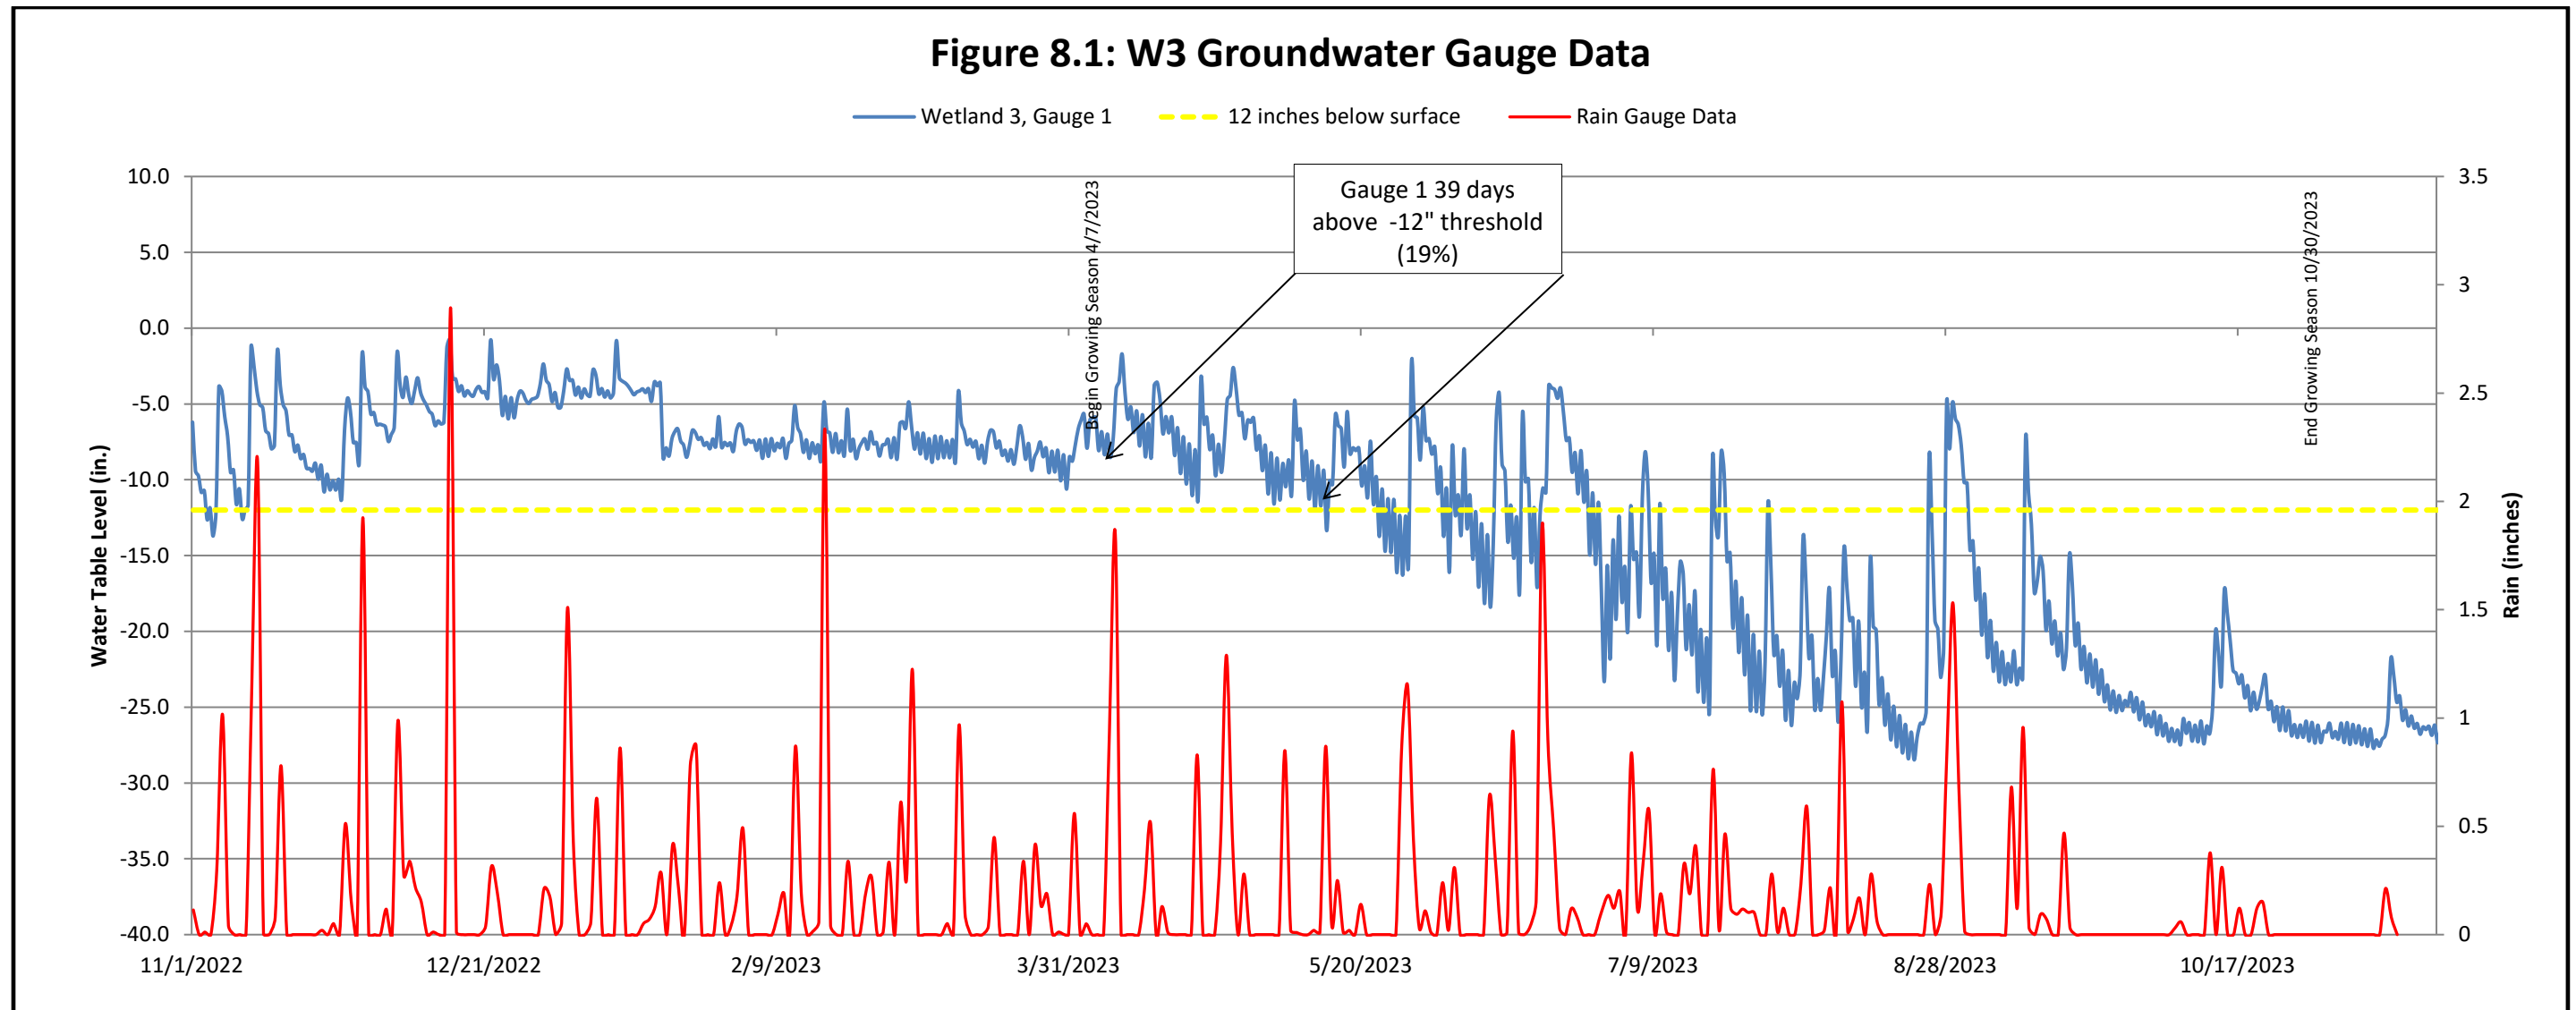
10: Figures 8.1 – 8.6 Groundwater gauge data graphs: Please review and confirm that the data reported is accurate and the graph callouts are correct. As an example, the Gauge 1 (Figure 8.1) callout shows occurrences of the groundwater line well below the “12 inches below surface” line. Please also be consistent with the graph colors utilized. Figure 8.6 has a green “Wetlands 5, Gauge 5 line”. Please review and update the report and graphs accordingly. *Graph data has been reviewed and updated for accuracy and callouts have been updated accordingly.*

Wetland W3 re-establishment are exceeding success criteria, experiencing groundwater levels within 12 inches of the soil surface for at least 23% of the growing season, or 47 consecutive days over the Year 3 monitoring period (Figures 8.1-8.3, Appendix E).

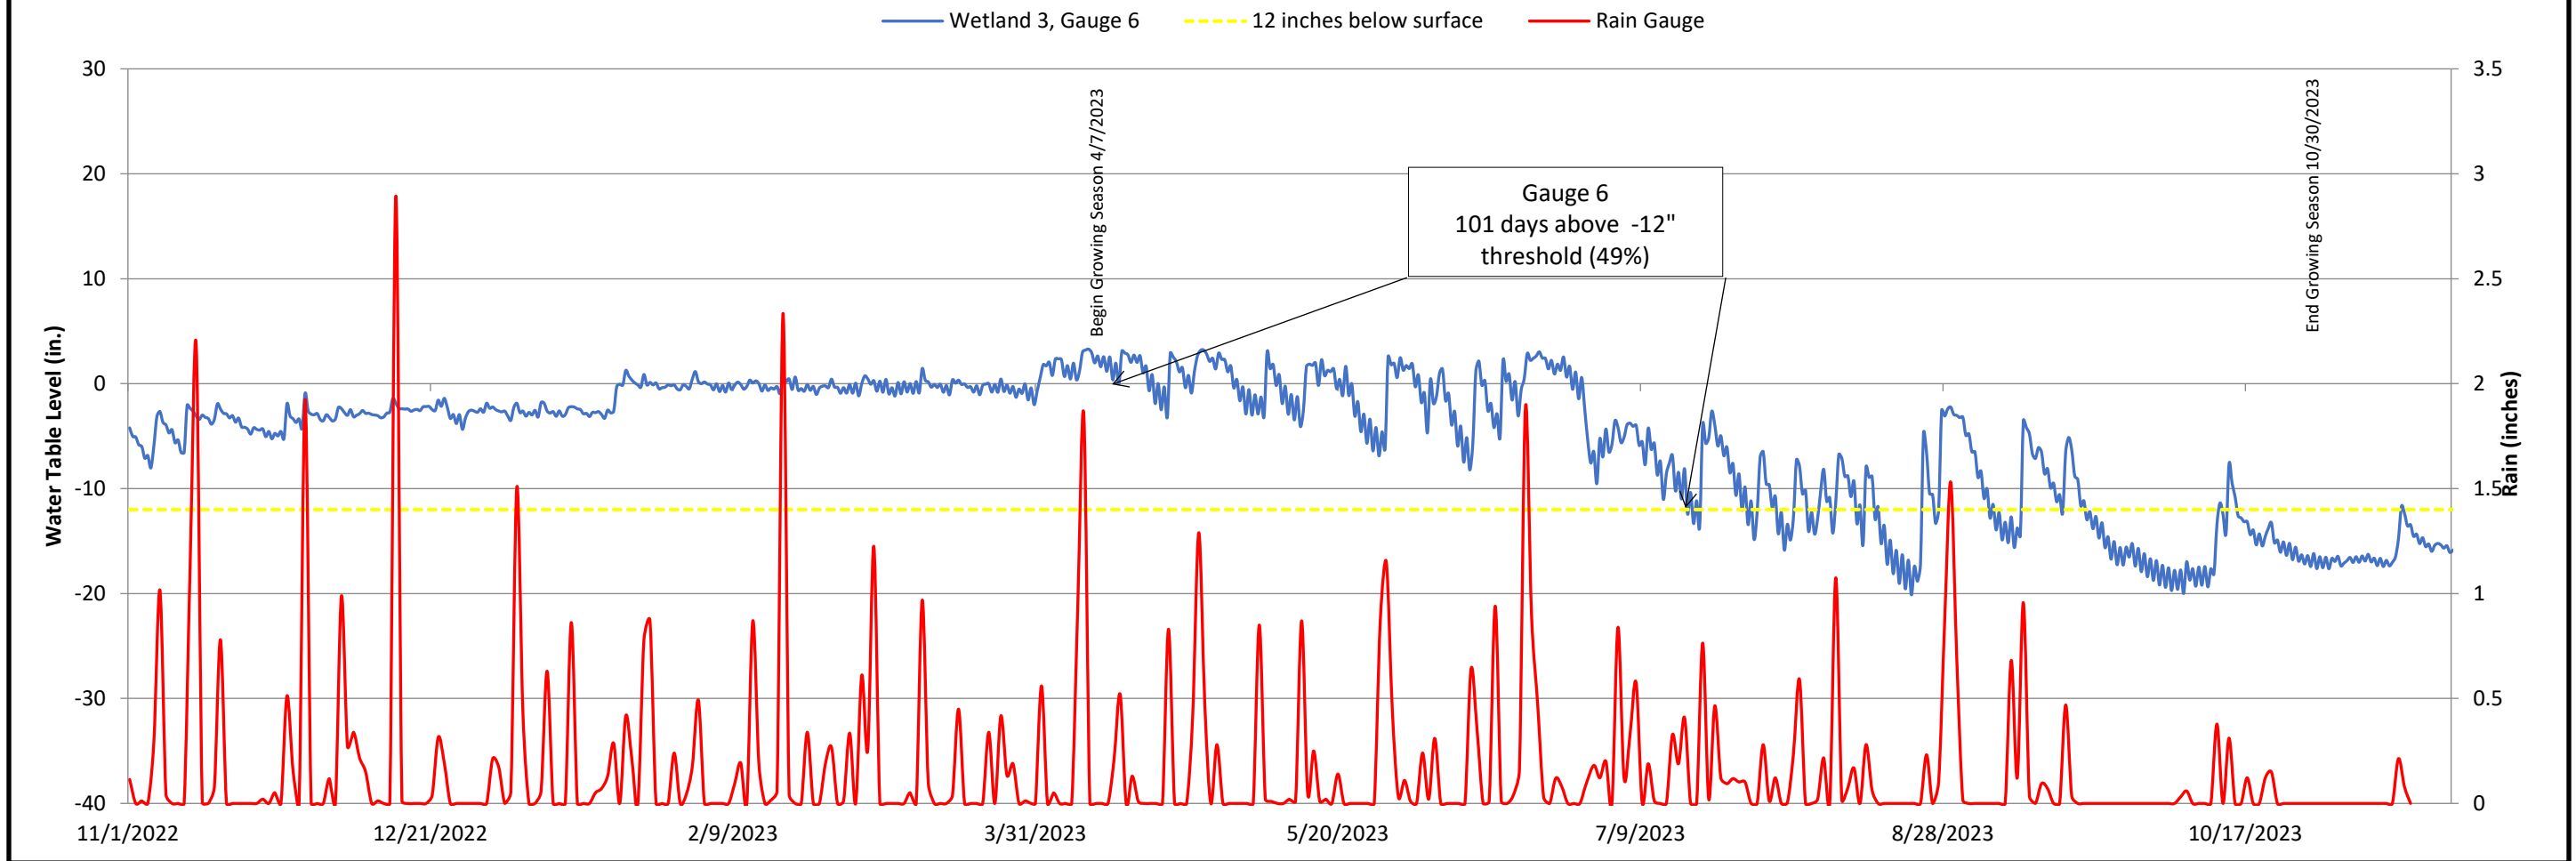
Figure 8.4: W3 Groundwater Gauge Data

Gauge data indicate that ground water within the wetland rehabilitation area has remained within 12 inches of the soil surface for 49% of the growing season, or 102 consecutive days over the Year 3 monitoring period (Figure 8.4, Appendix E) in the wetland expansion areas depicted on the CCPV Figures in Appendix B.

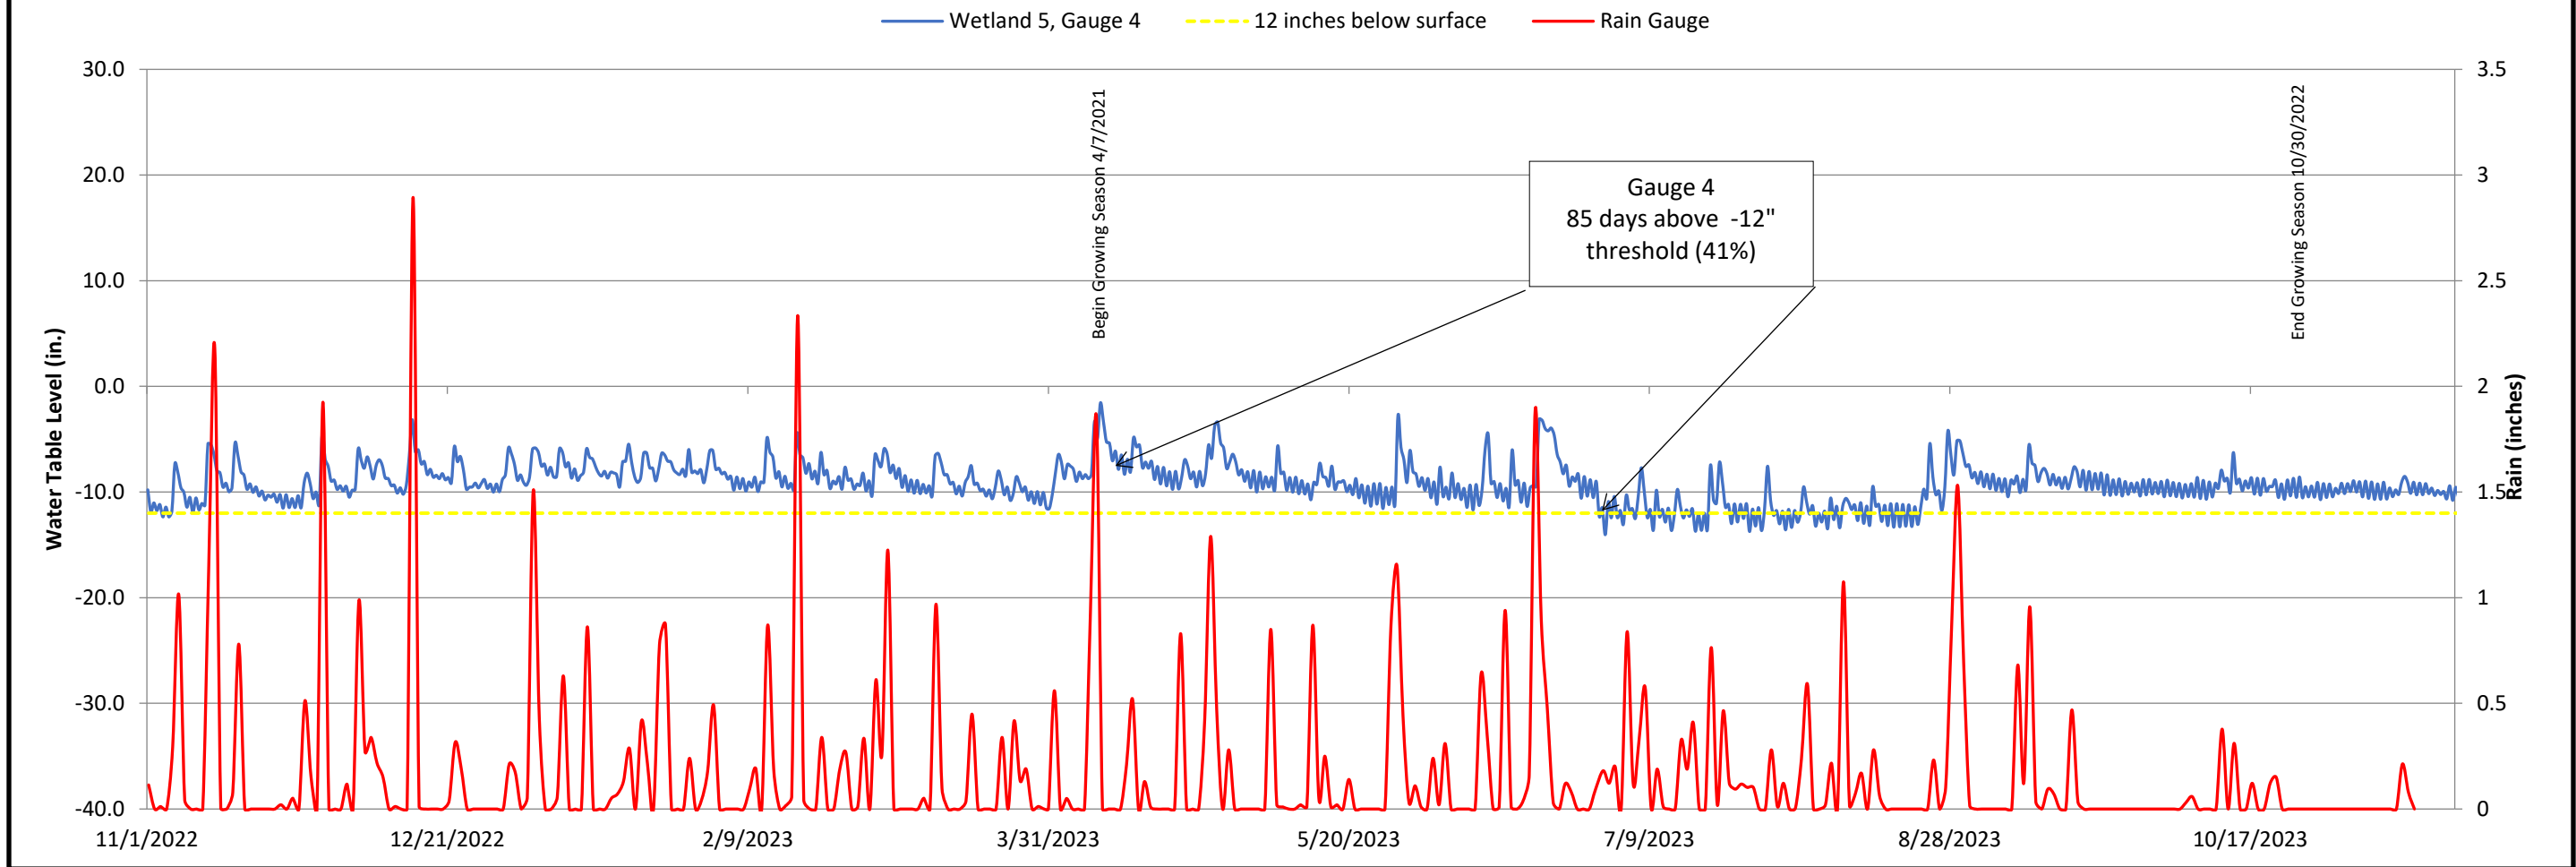
Figure 8.5: W5 Groundwater Gauge Data (Reference)

Gauge 4, located within the enhancement area of W5, shows water levels within 12 inches of the soil surface for 41% of the growing season, or 85 consecutive days during the Year 3 monitoring period (Figure 8.5, Appendix E). Data from Gauge 5, located in the re-establishment area of W5, shows groundwater levels within 12 inches of the soil surface for approximately 32% of the growing season, or 65 consecutive days over the Year 3 monitoring period (Figure 8.6, Appendix E).
