MONITORING YEAR 7 ANNUAL/CLOSEOUT REPORT

OWL'S DEN MITIGATION SITE

Lincoln County, NC
DEQ Contract 005150
DMS Project Number 95808
DWR No. 14-0153
USACE Action ID No. SAW-2013-00717
Catawba River Basin
HUC 03050102

Data Collection Period: March - November 2022
Submitted: January, 2023

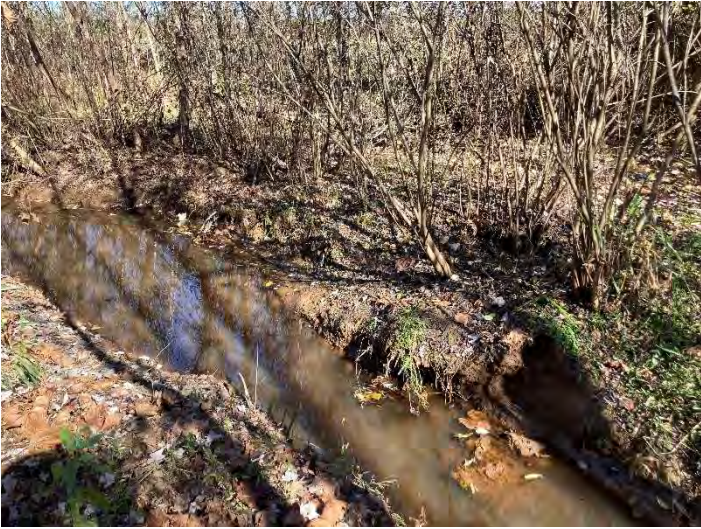
HC1 Reach 2, station 116+15 – Bank scour (11/8/2022)

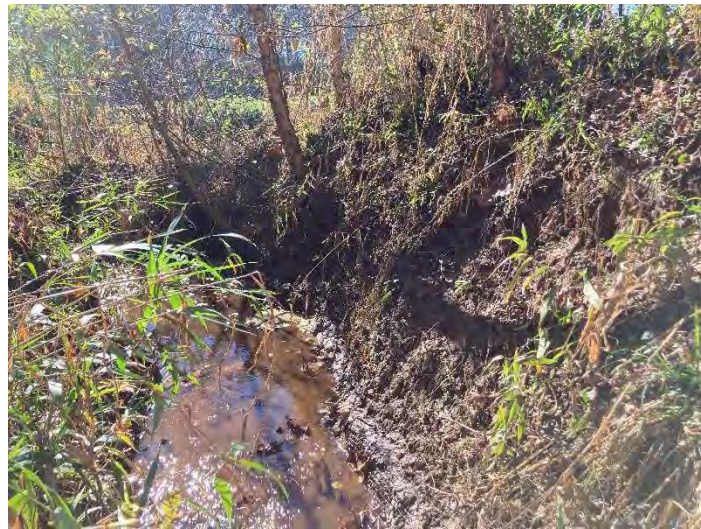
HC1 Reach 2, station 117+50 to 117+79 – Bank scour (11/8/2022)

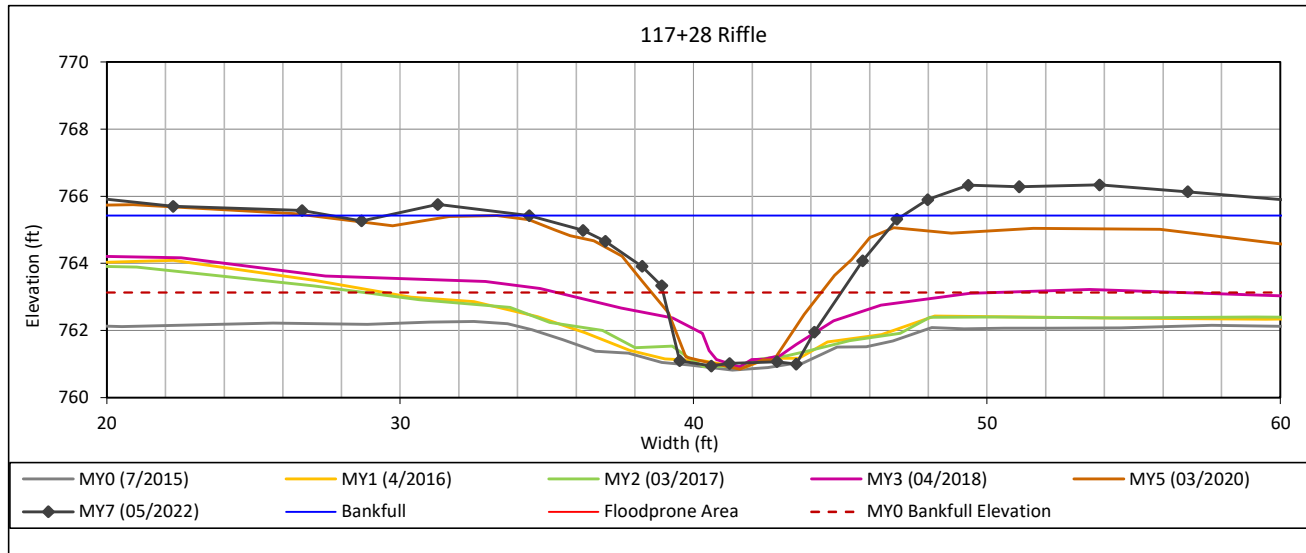
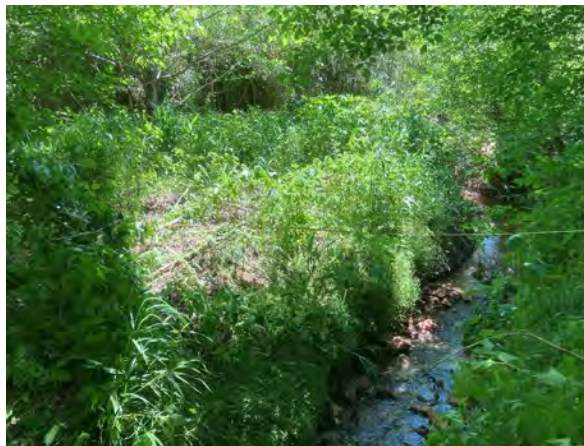
Cross Section 8, HC1 Reach 2

Wildlands' Response: Wildlands conducted a review of the MY7 XS8 data and found the correct BHR to be 2.0. Table 11 has been updated accordingly.

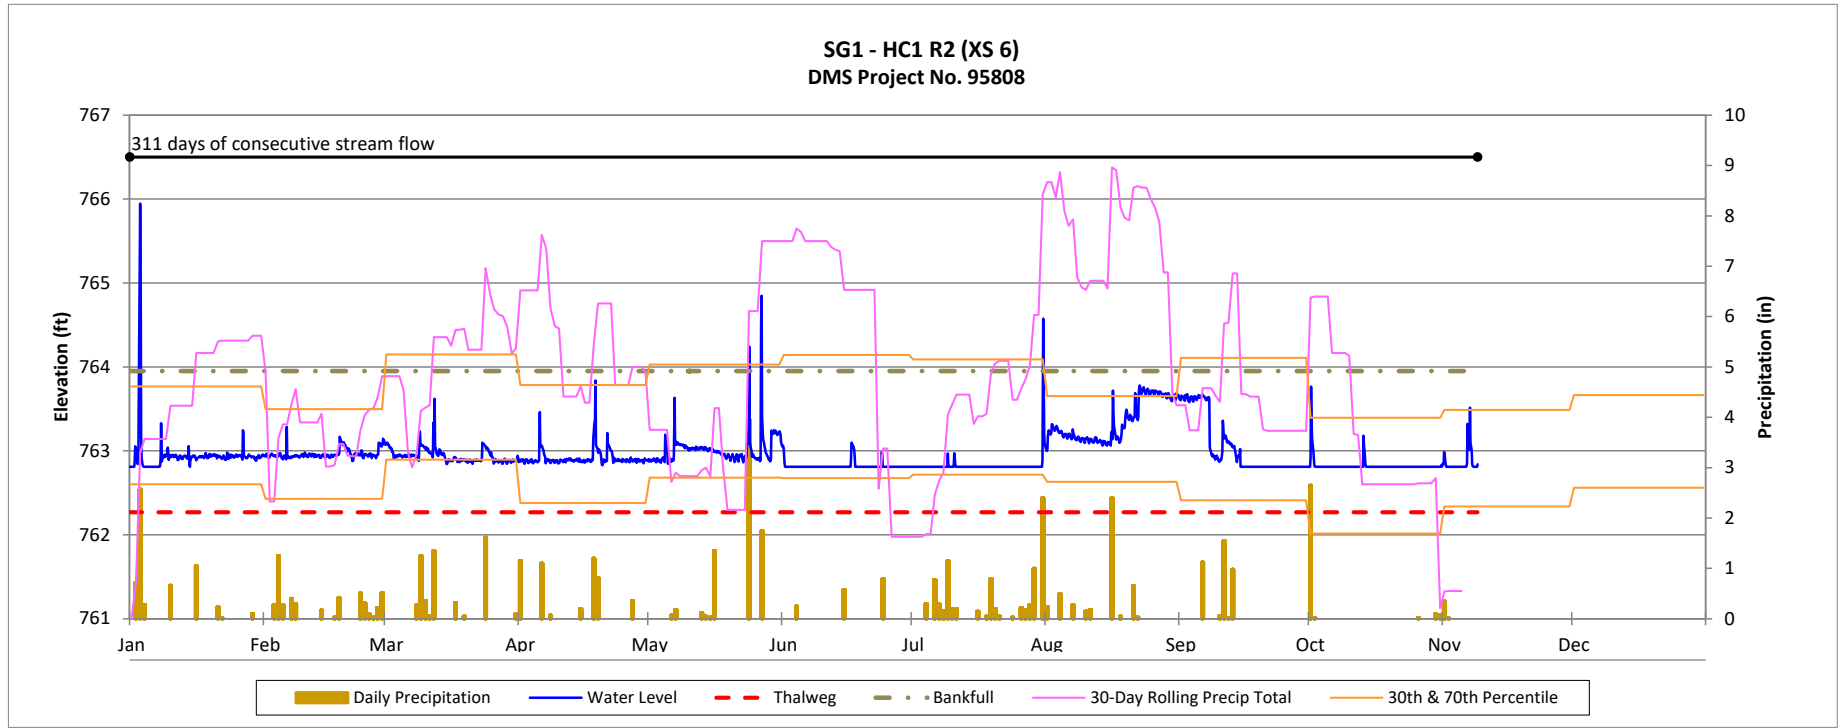
In May of 2022, the barotroll malfunctioned and could not be downloaded for the remainder of the year; therefore, pressure data from May to November was calibrated from the Wyant Lands Mitigation Site located approximately 3.5 miles north of the Owl's Den Mitigation.

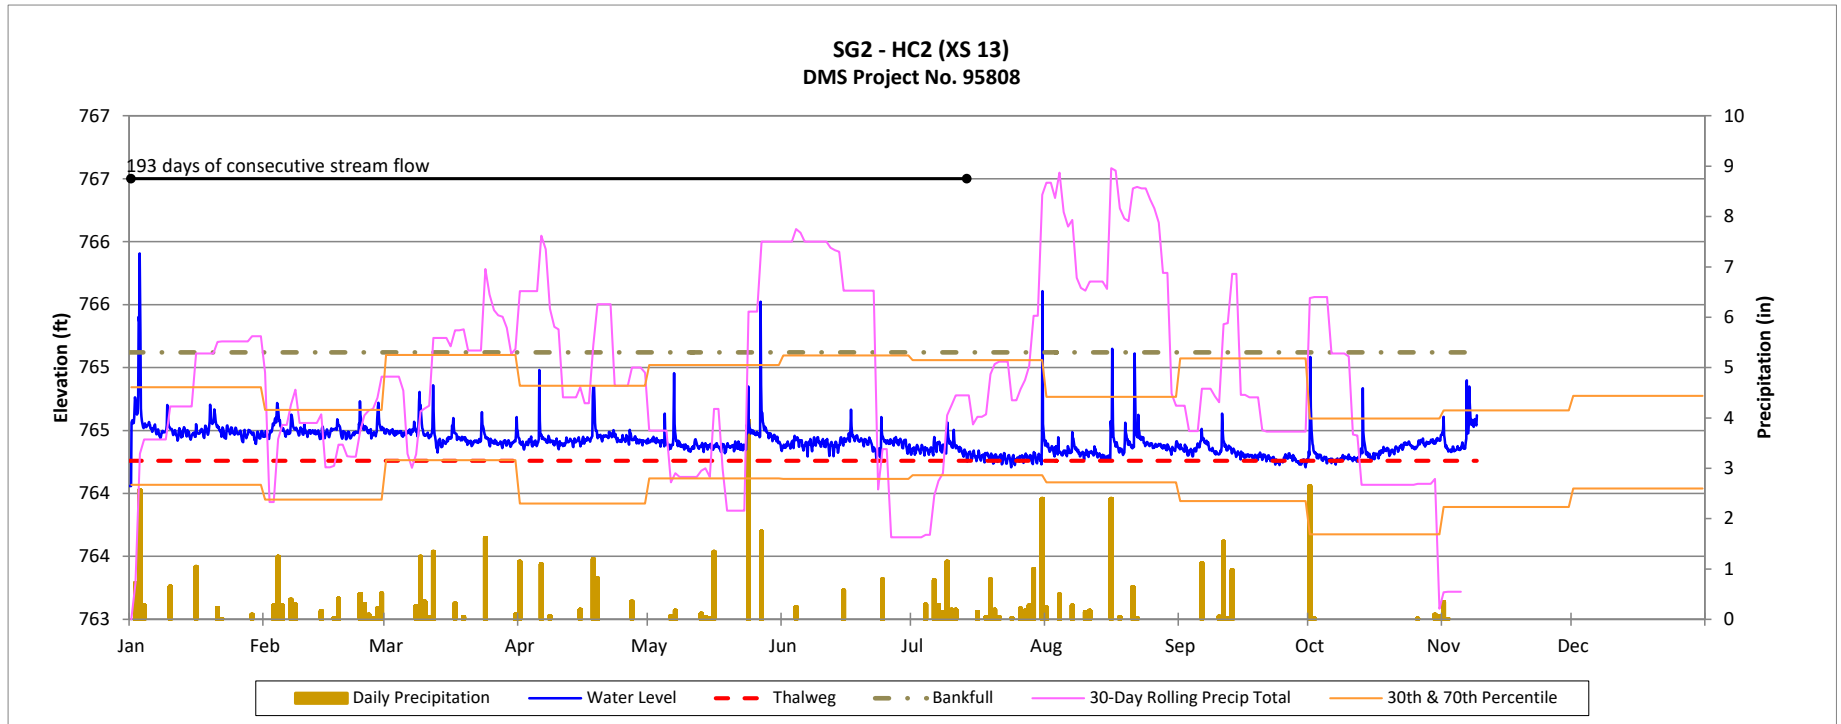
In May of 2022, the barotroll malfunctioned and could not be downloaded for the remainder of the year; therefore, pressure data from May to November was calibrated from the Wyant Lands Mitigation Site located approximately 3.5 miles north of the Owl's Den Mitigation.

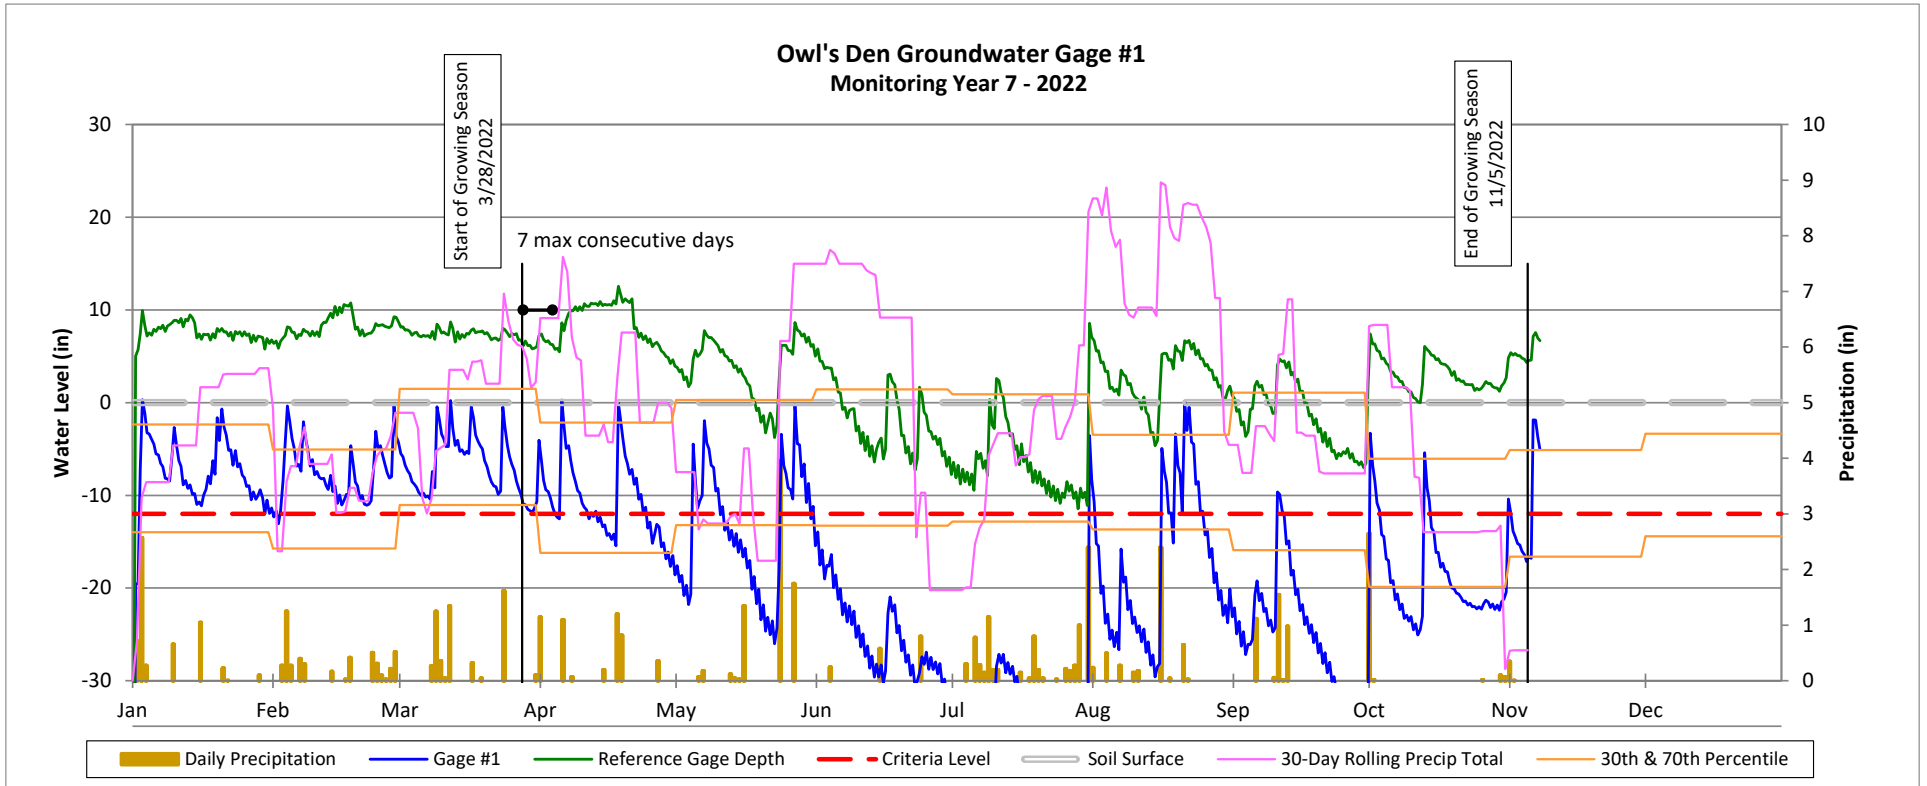
In May of 2022, the barotroll malfunctioned and could not be downloaded for the remainder of the year; therefore, pressure data from May to November was calibrated from the Wyant Lands Mitigation Site located approximately 3.5 miles north of the Owl's Den Mitigation Site.

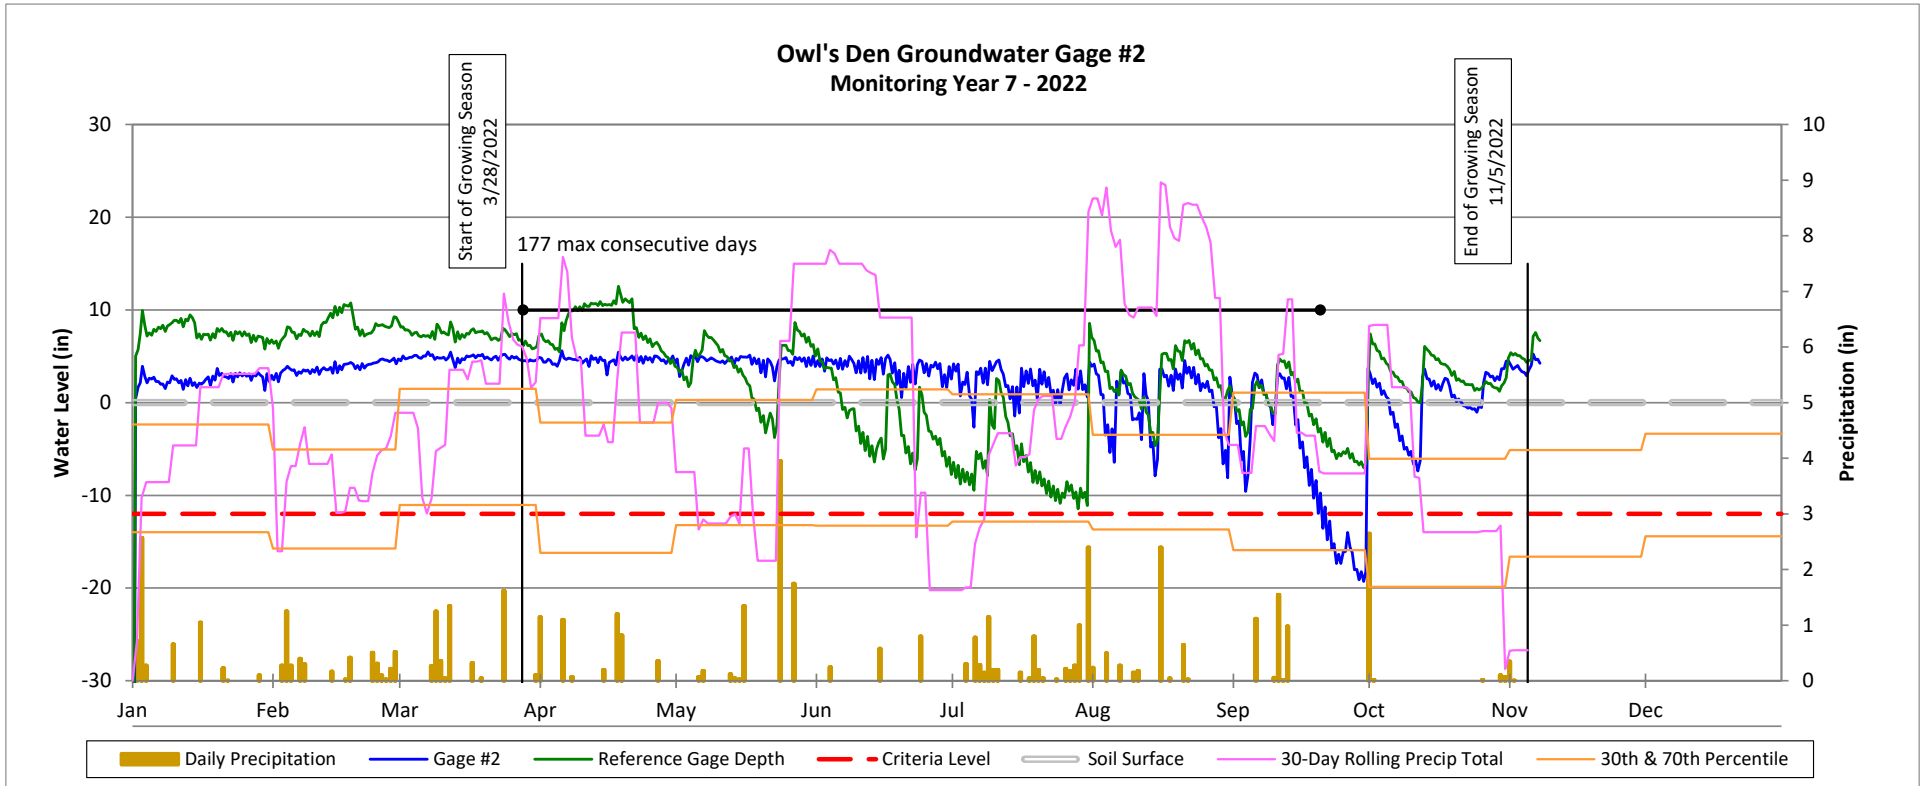
In May of 2022, the barotroll malfunctioned and could not be downloaded for the remainder of the year; therefore, pressure data from May to November was calibrated from the Wyant Lands Mitigation Site located approximately 3.5 miles north of the Owl's Den Mitigation Site.

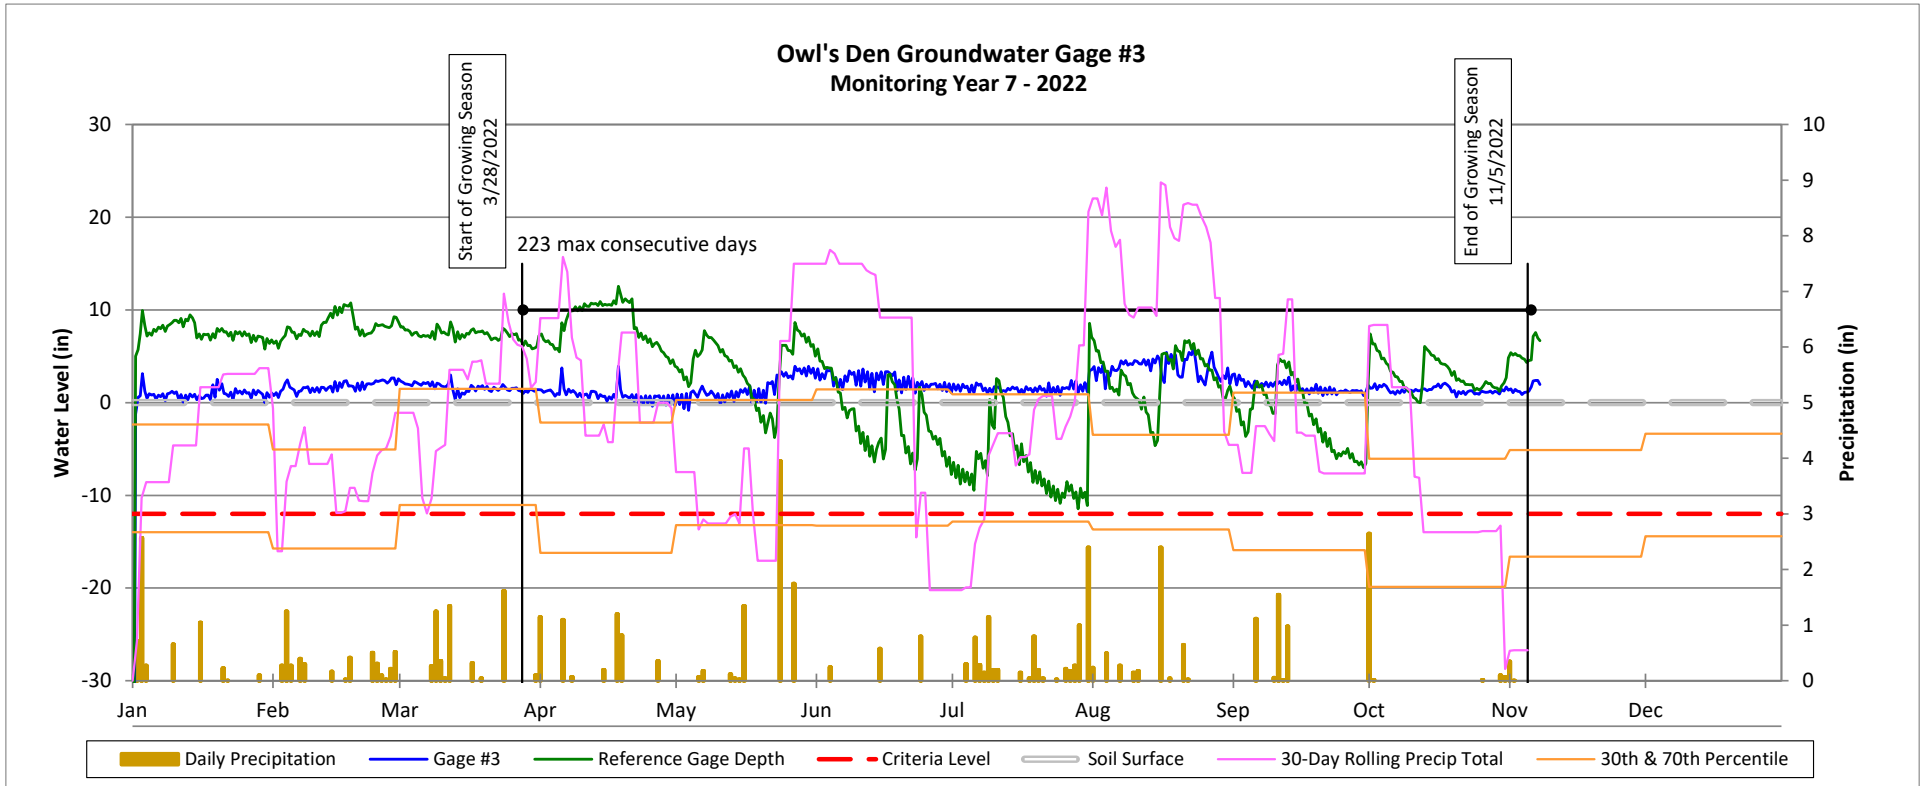
In May of 2022, the barotroll malfunctioned and could not be downloaded for the remainder of the year; therefore, pressure data from May to November was calibrated from the Wyant Lands Mitigation Site located approximately 3.5 miles north of the Owl's Den Mitigation Site.

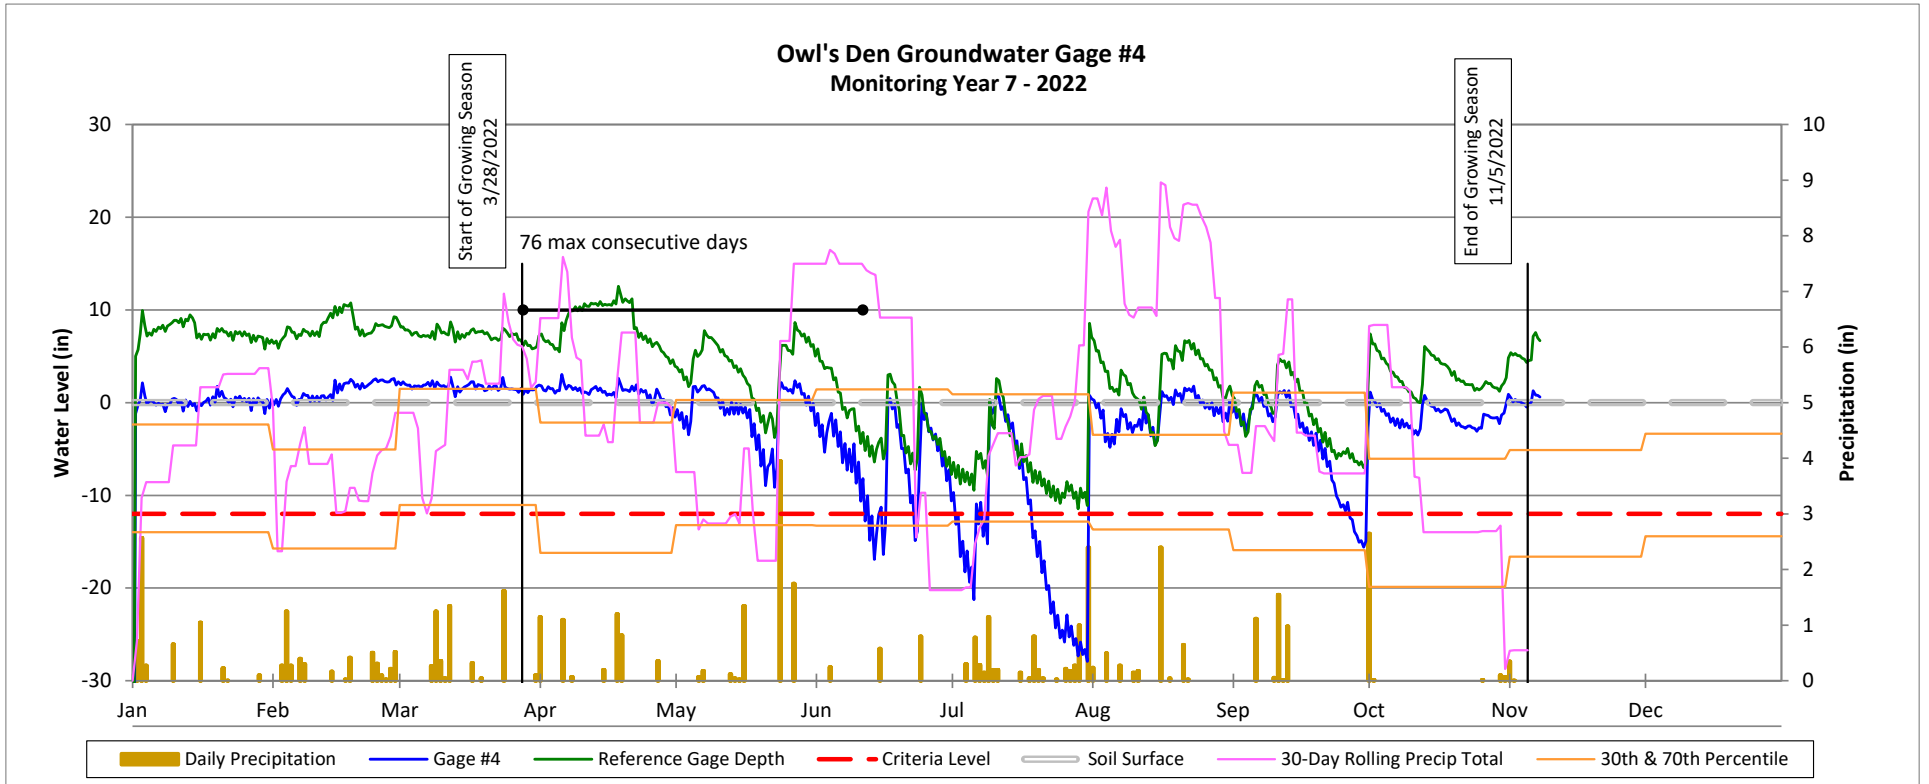
In May of 2022, the barotroll malfunctioned and could not be downloaded for the remainder of the year; therefore, pressure data from May to November was calibrated from the Wyant Lands Mitigation Site located approximately 3.5 miles north of the Owl's Den Mitigation Site.
