MONITORING YEAR 7 ANNUAL/CLOSEOUT REPORT

OWL'S DEN MITIGATION SITE

Lincoln County, NC
DEQ Contract 005150
DMS Project Number 95808
DWR No. 14-0153
USACE Action ID No. SAW-2013-00717
Catawba River Basin
HUC 03050102

Data Collection Period: March - November 2022
Submitted: January, 2023

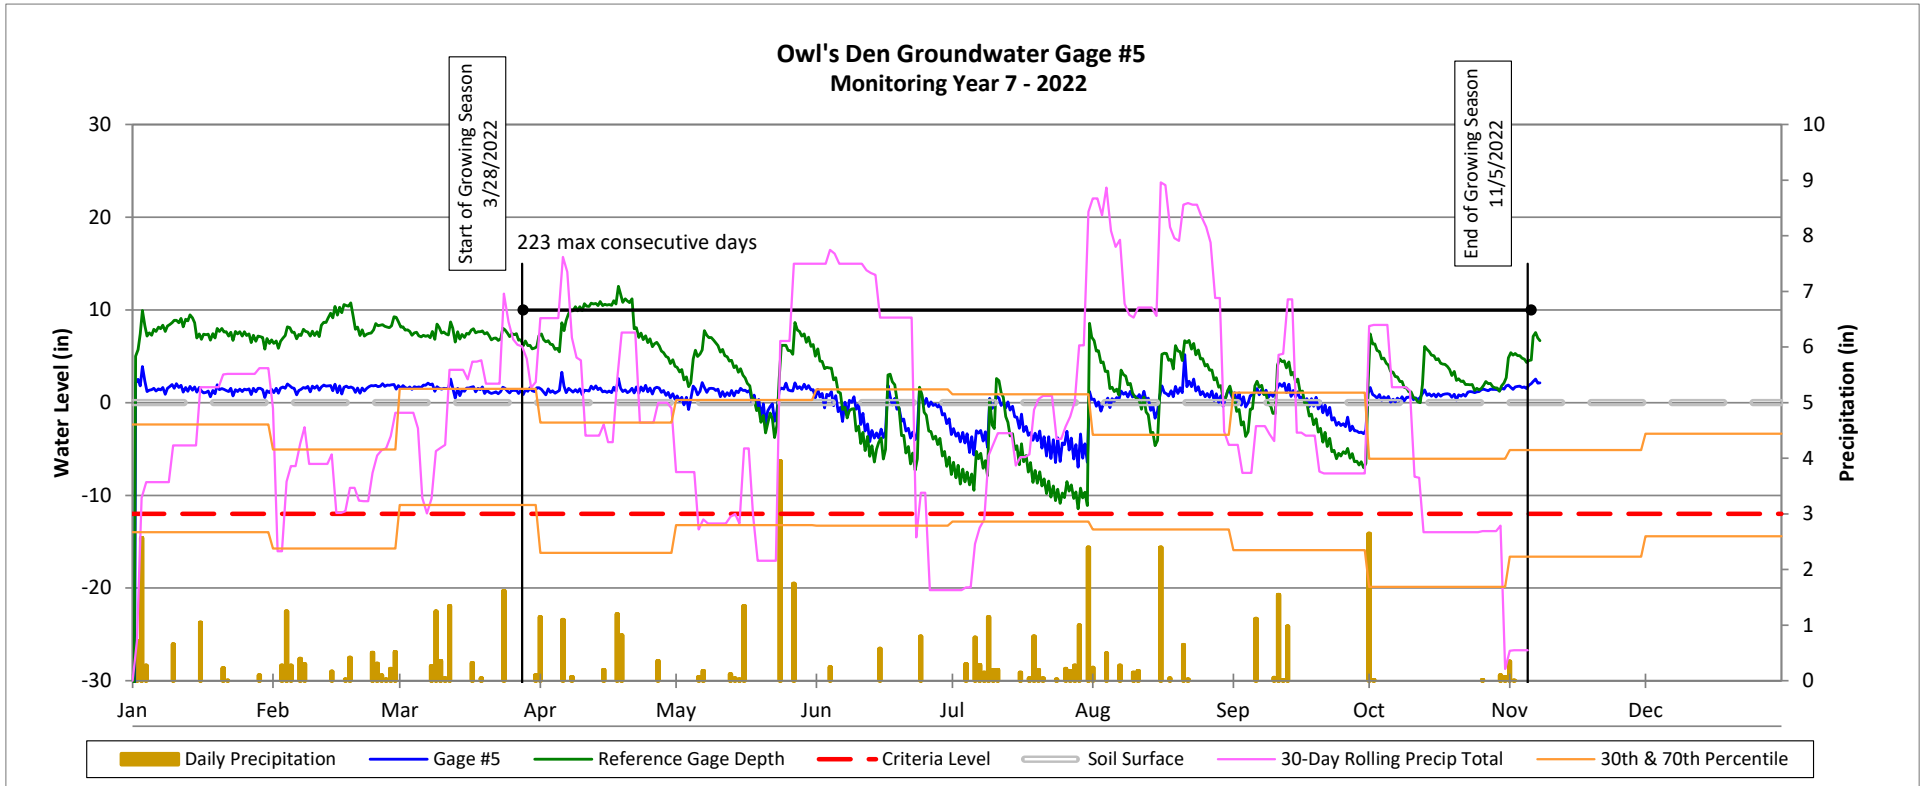
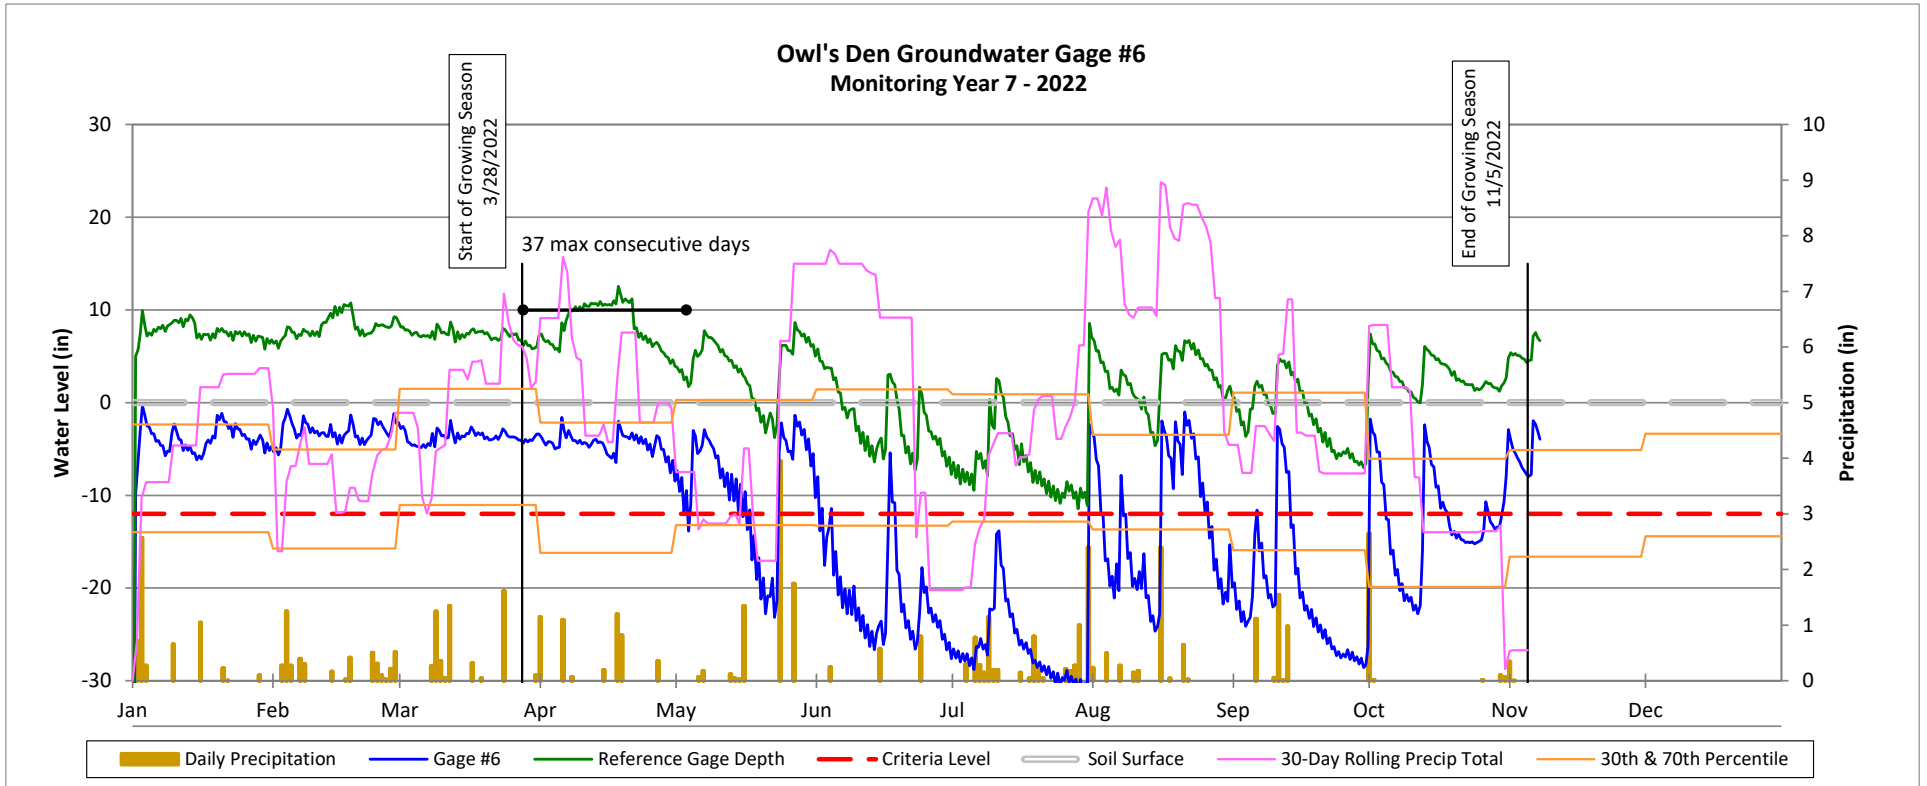
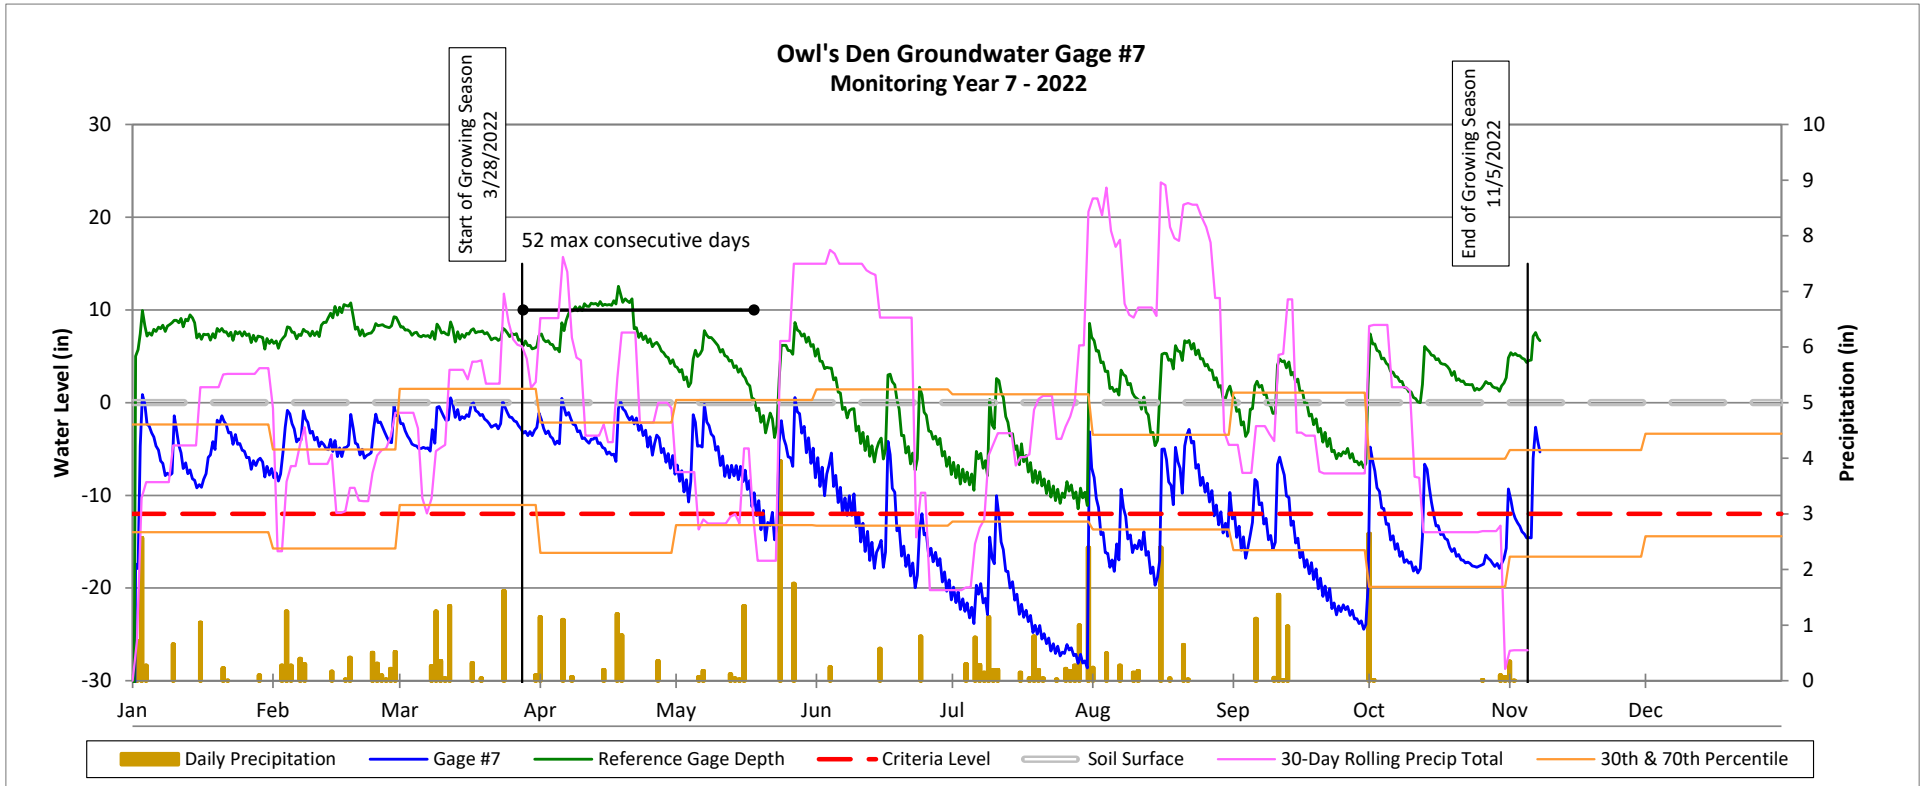
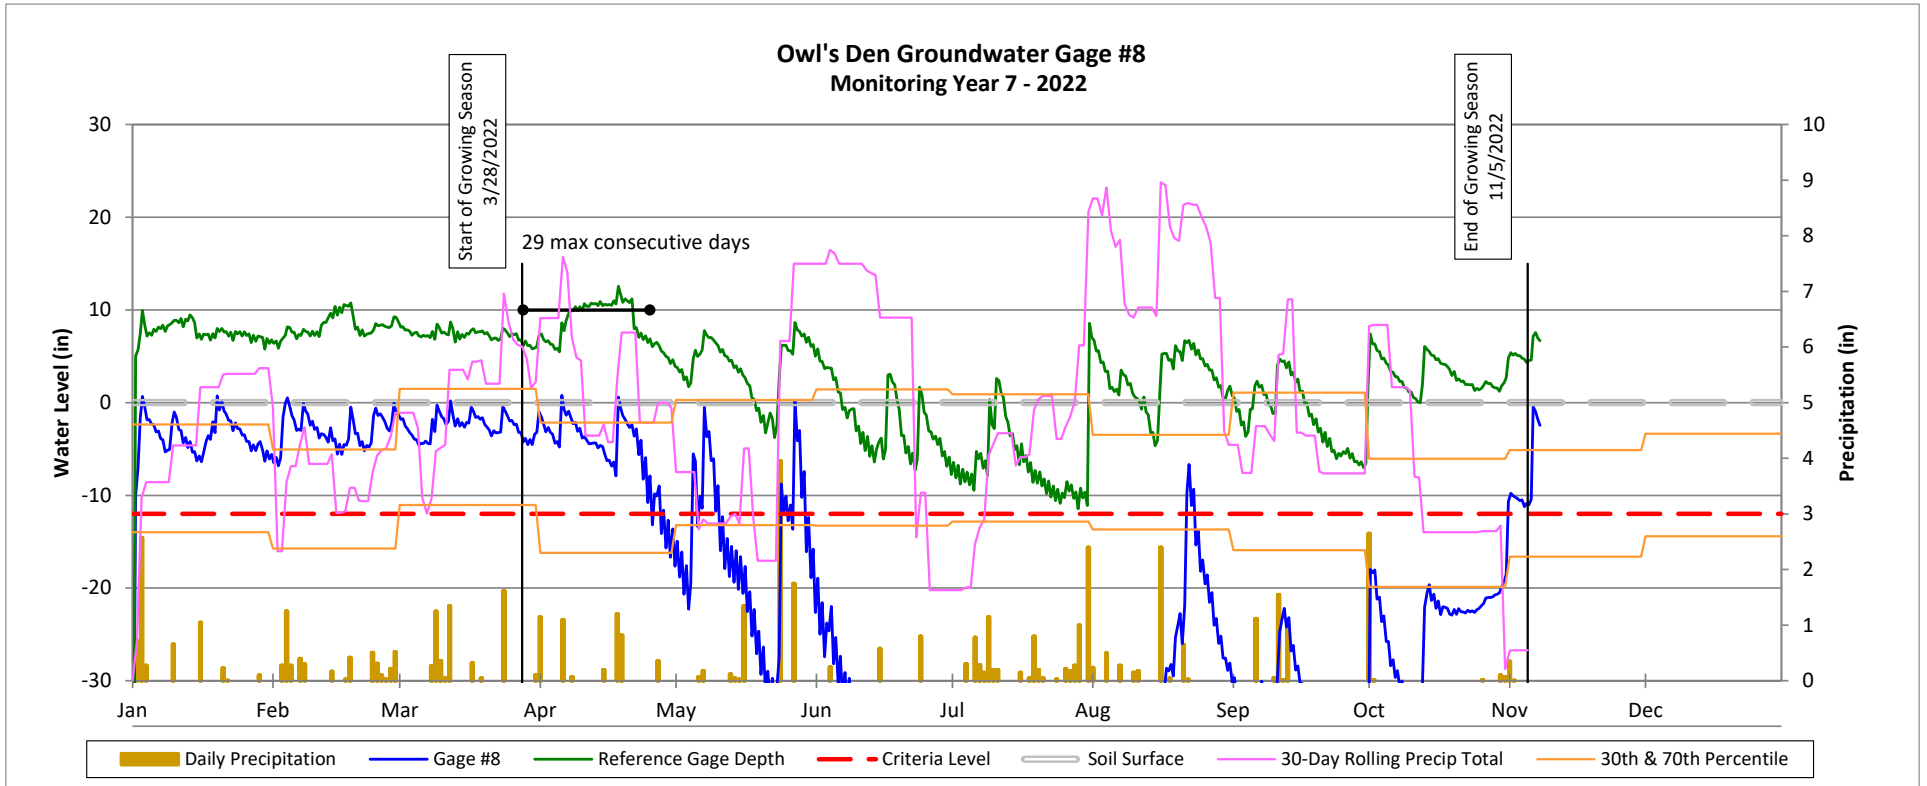
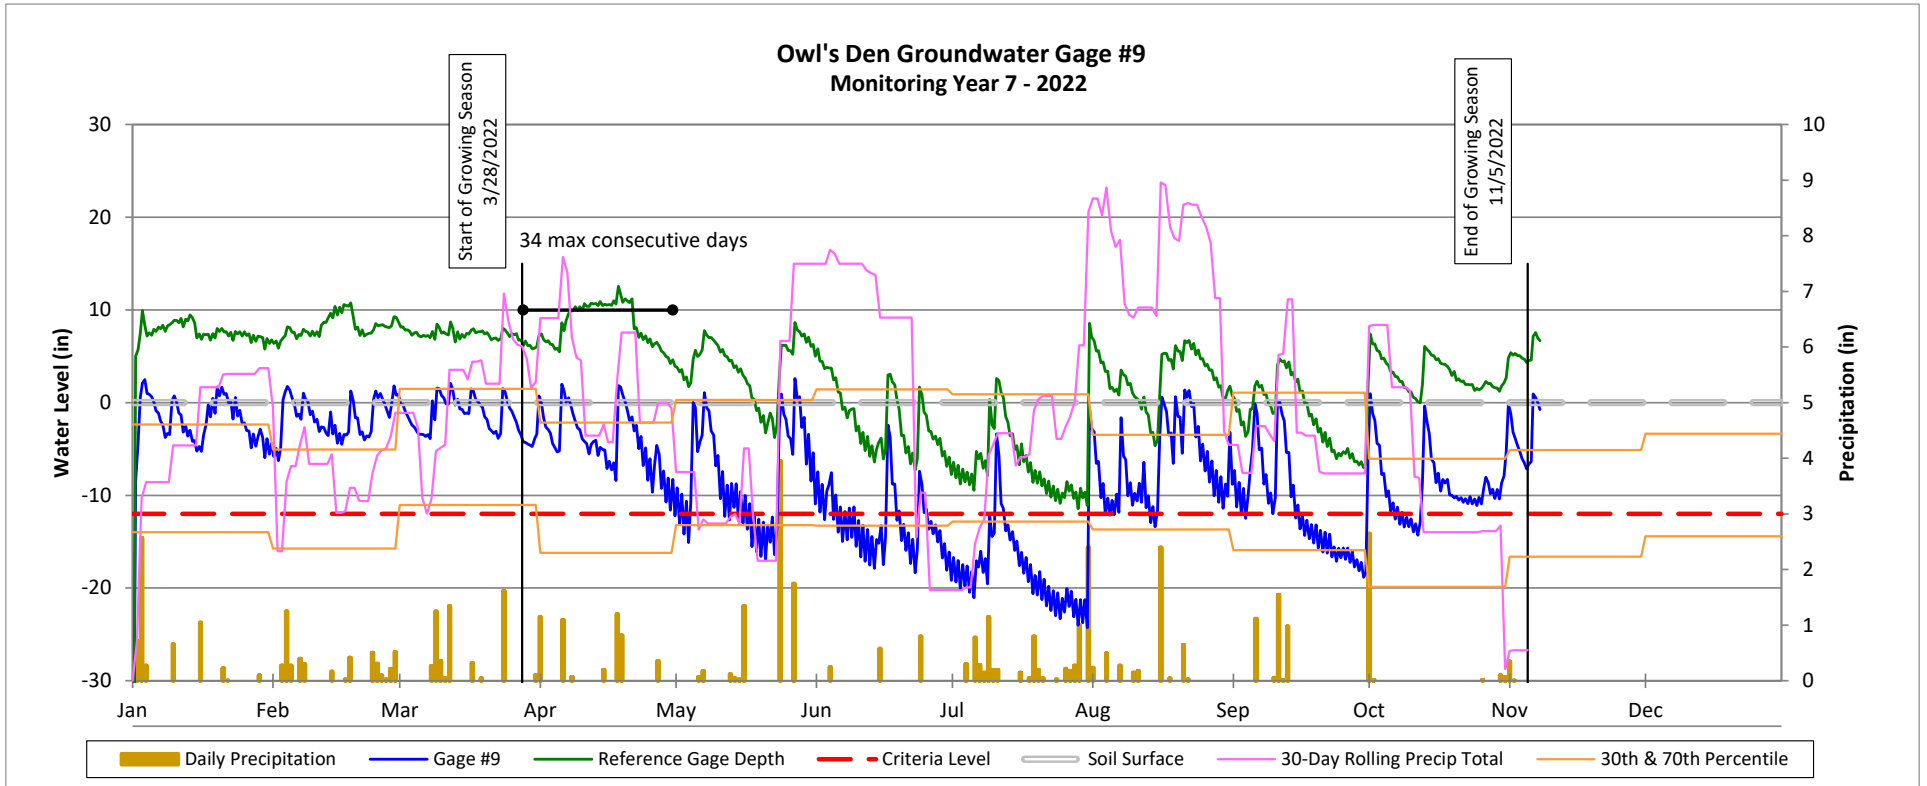
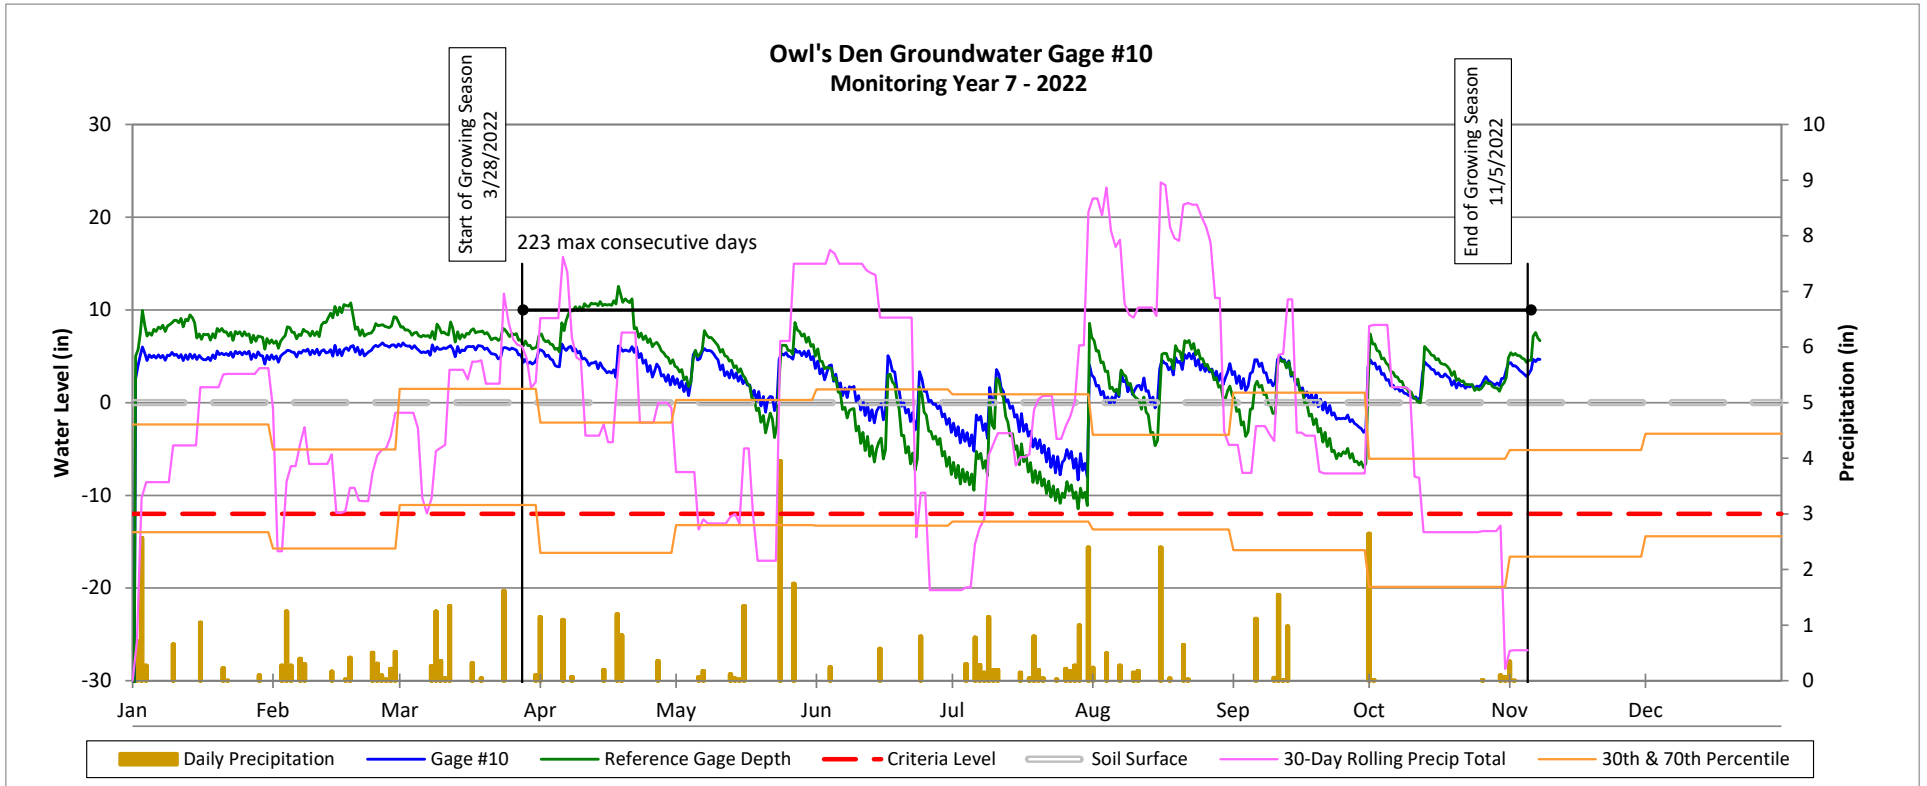
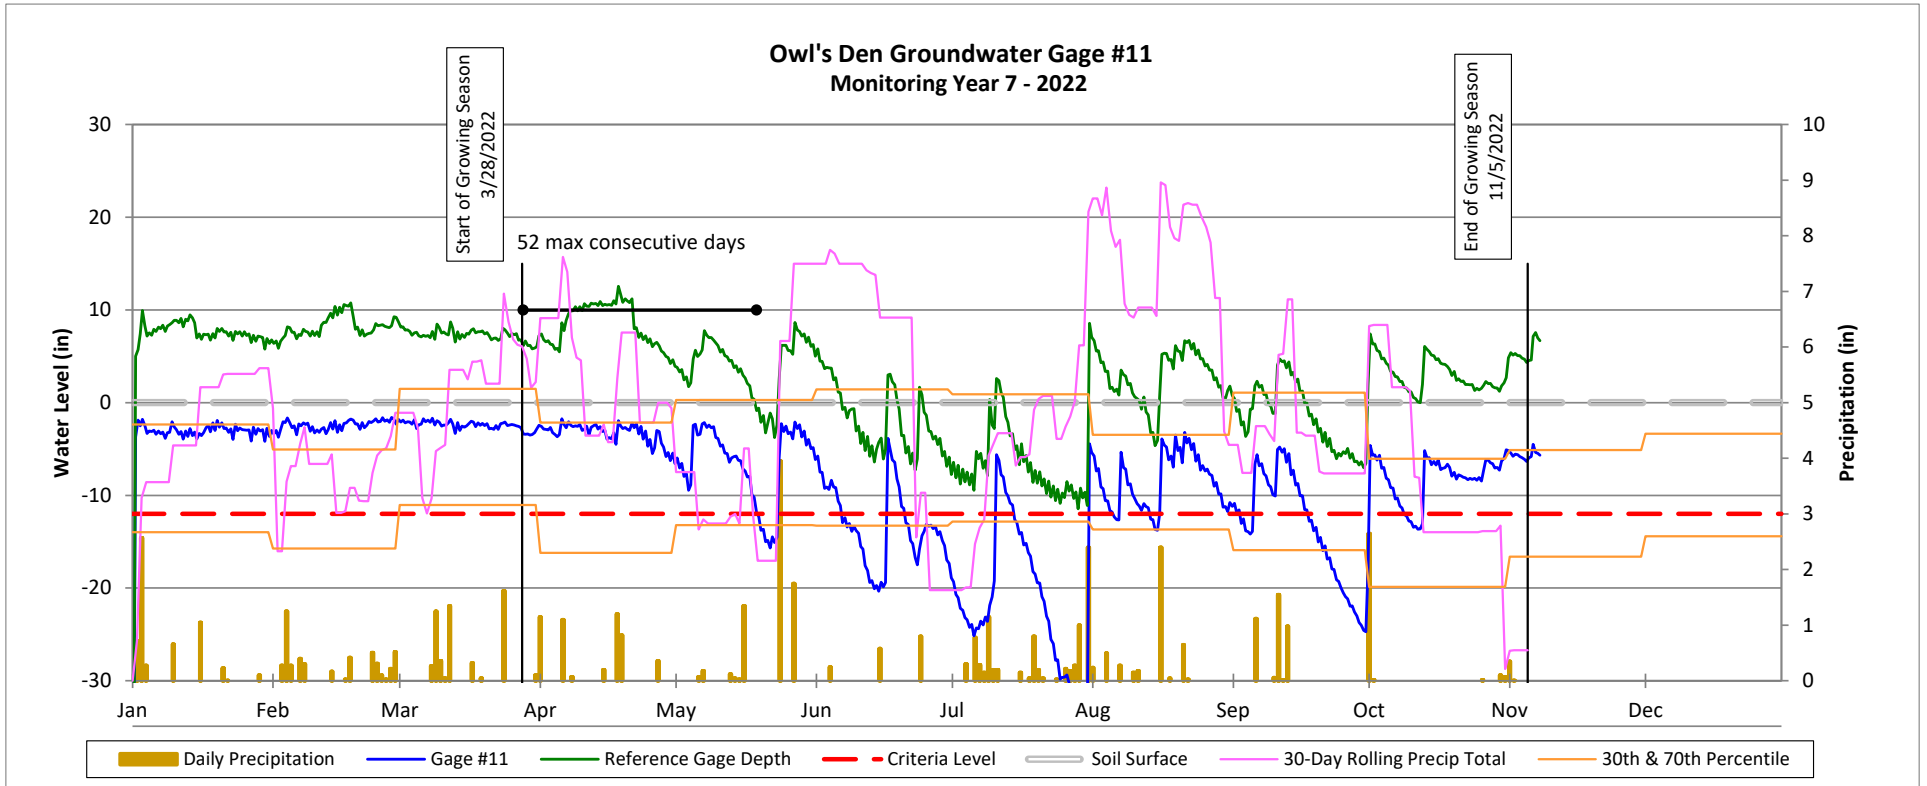
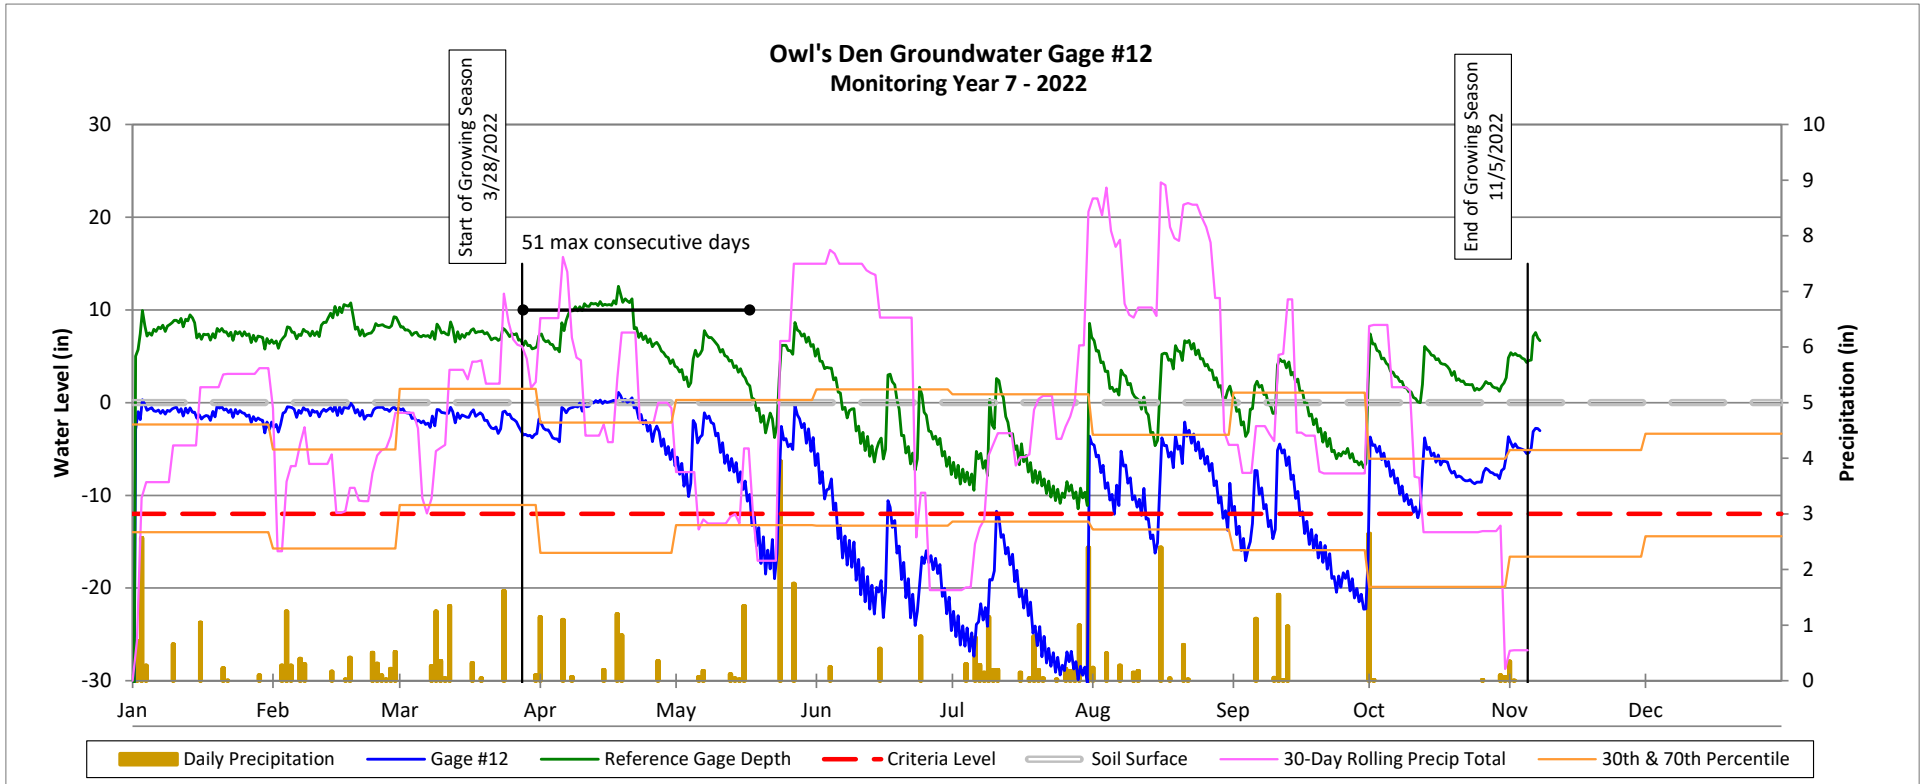
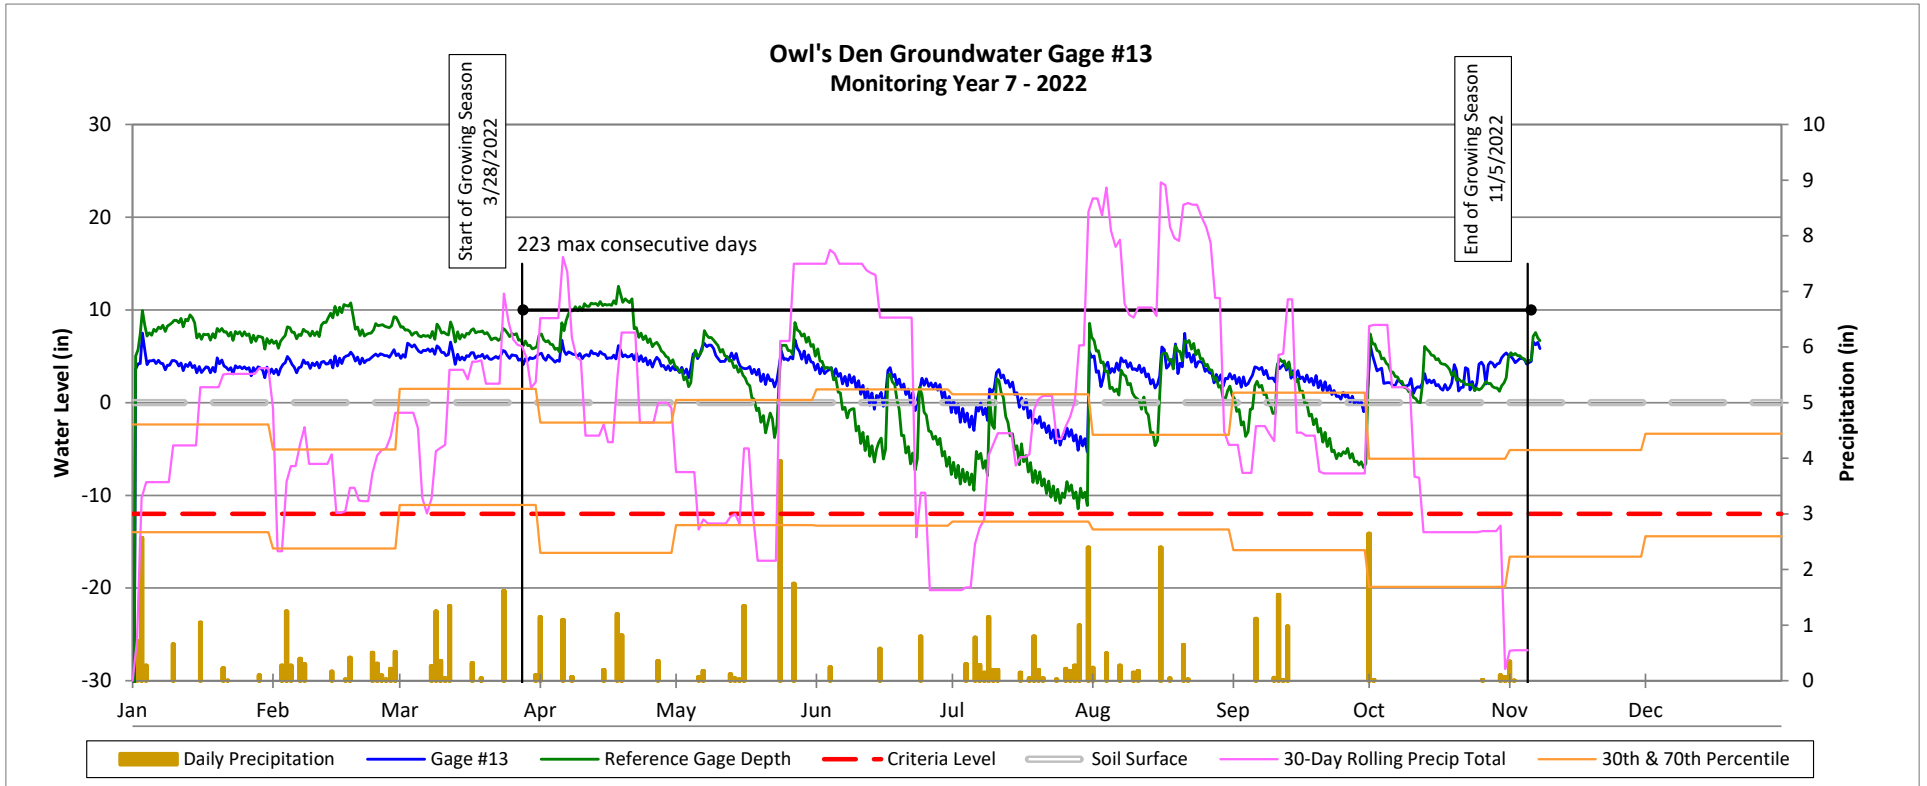
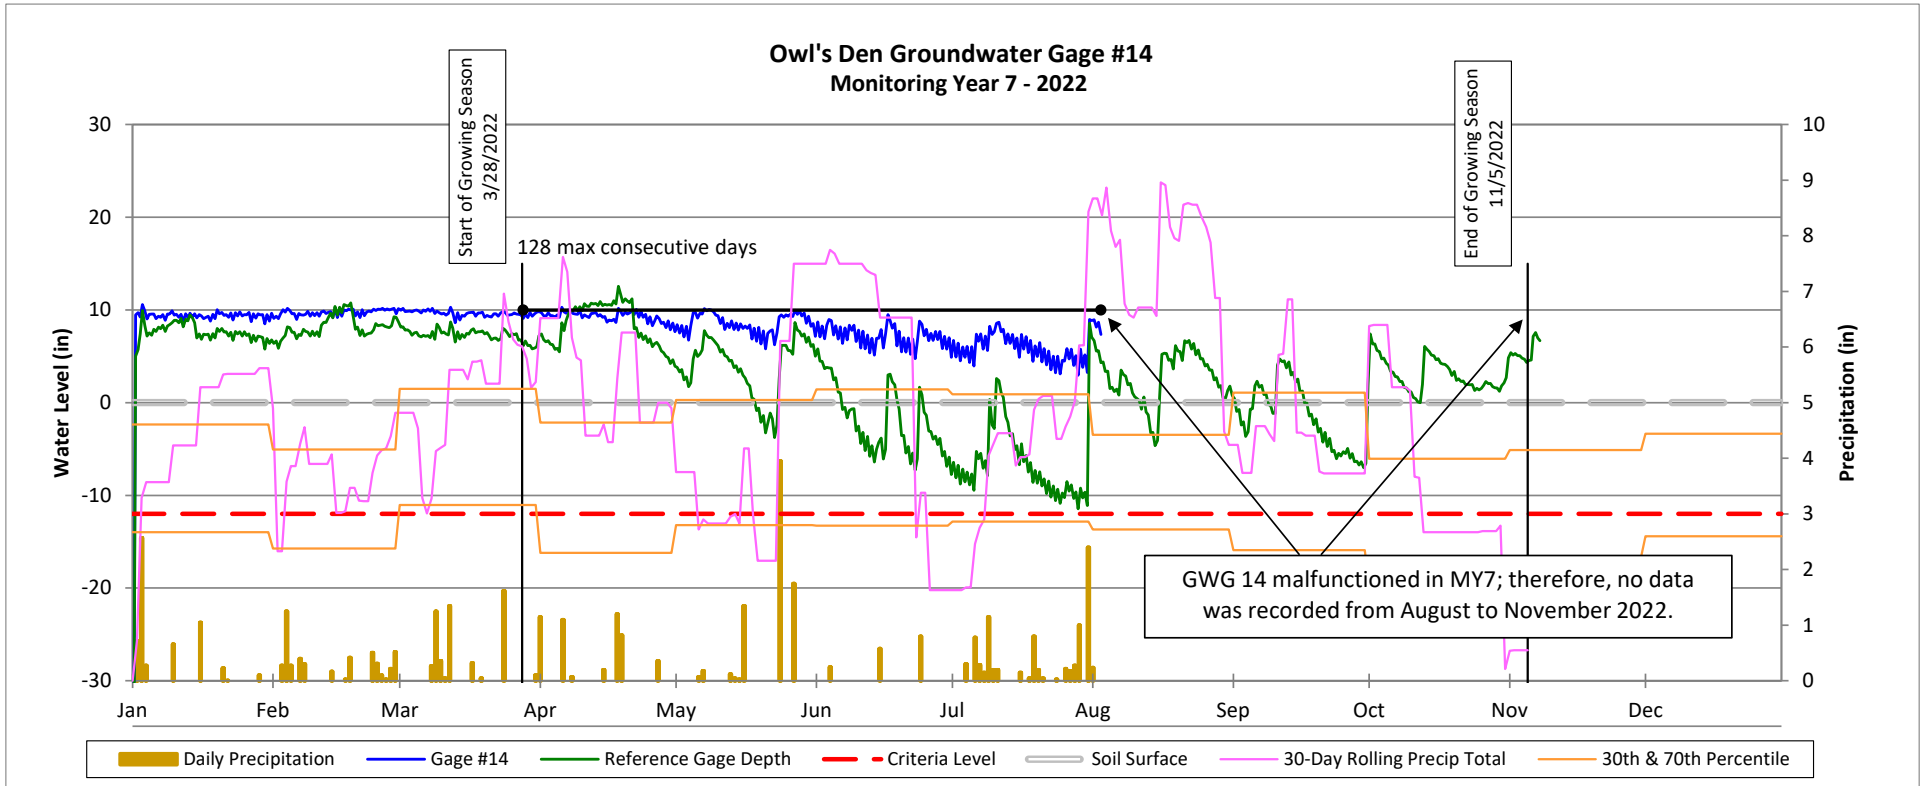
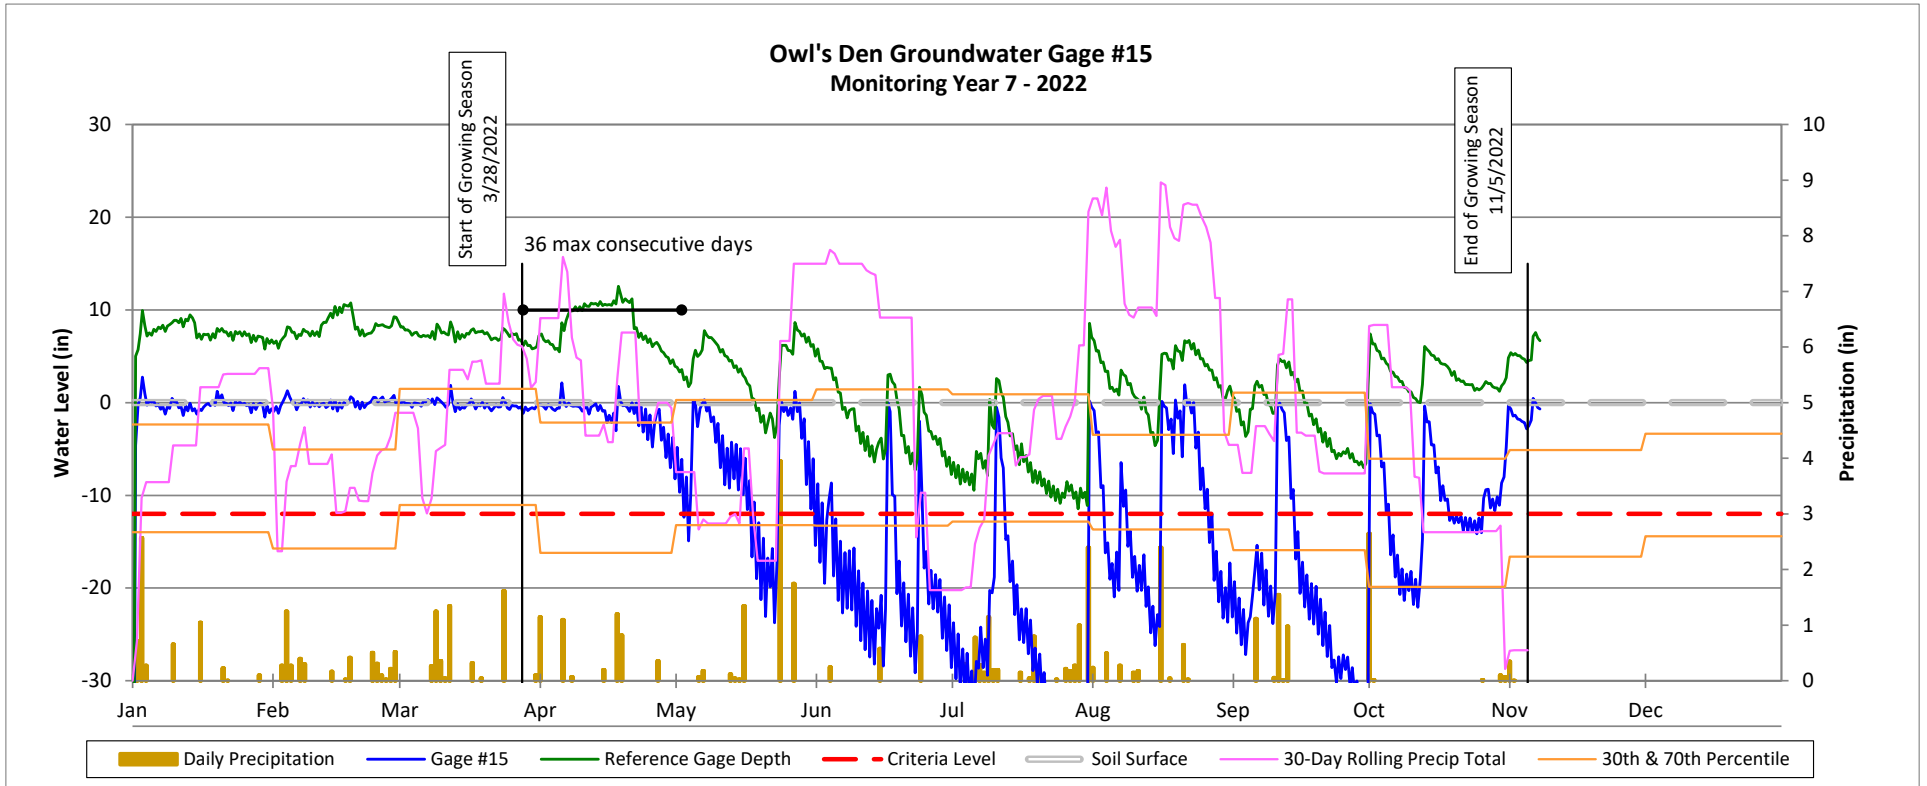
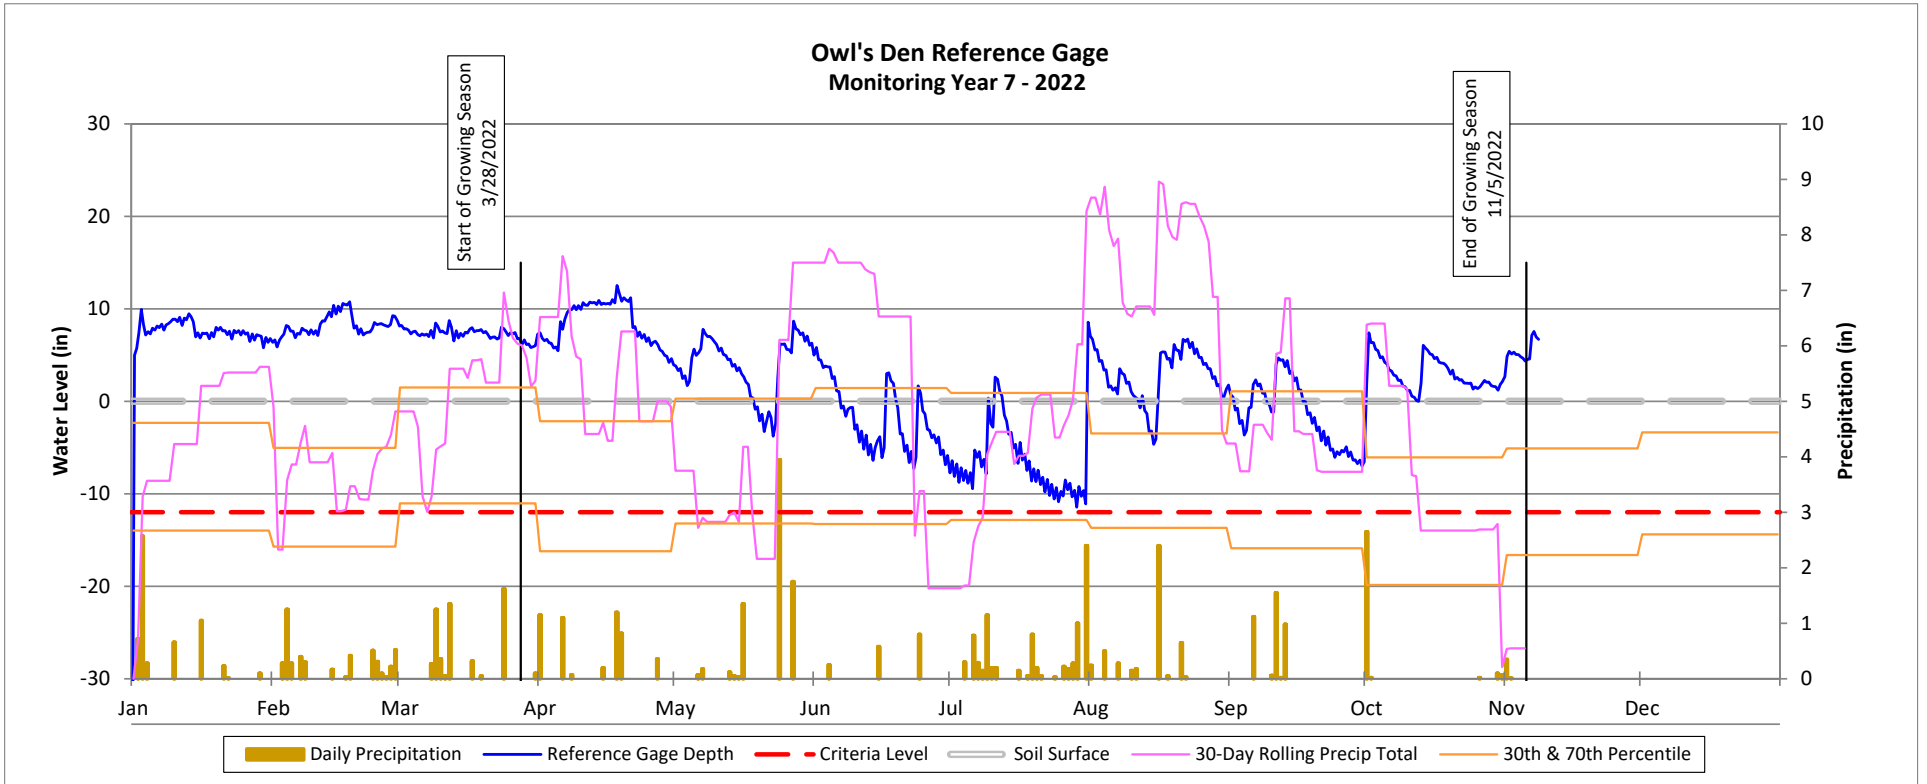
In May of 2022, the barotroll malfunctioned and could not be downloaded for the remainder of the year; therefore, pressure data from May to November was calibrated from the Wyant Lands Mitigation Site located approximately 3.5 miles north of the Owl's Den Mitigation Site.

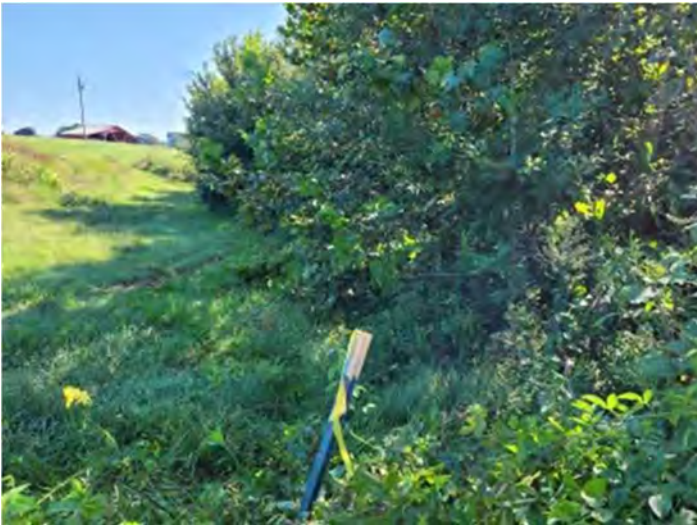
- Corner markers and in-line markers were difficult to spot due to vegetation overgrowth. Flagging was added to improve visibility.
- Corner markers consisted of U-Channel with signs. The post and sign located at Mowed Area 1 was bent/damaged.
- Five stamped aluminum monument caps were field verified and consistent the plat.
- In-line T-Post markers were adequately spaced, multiple signs were missing from posts.
- Mowed Area 3 was previously marked with flagging.
- No fencing was present.
- Crossing was in good condition.

Easement AOC 1 – Mowed and bent sign (9/14/2022)

- Upgrade marking at the three mowed areas with supplemental posts and horse tape, notify landowner of new posts.
- Repair damaged corner marker and sign at Mowed Area 1 and add tall PVC for visibility in this high traffic area.
- Trim vegetation blocking view of marker posts.
- Add missing signs to in-line markers (optional but recommended for consistency).

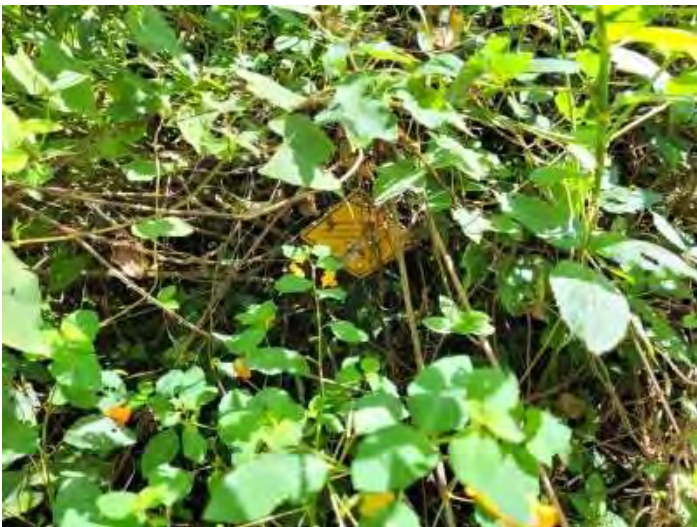
Easement AOC 5 – Vegetation covering sign (9/14/2022)

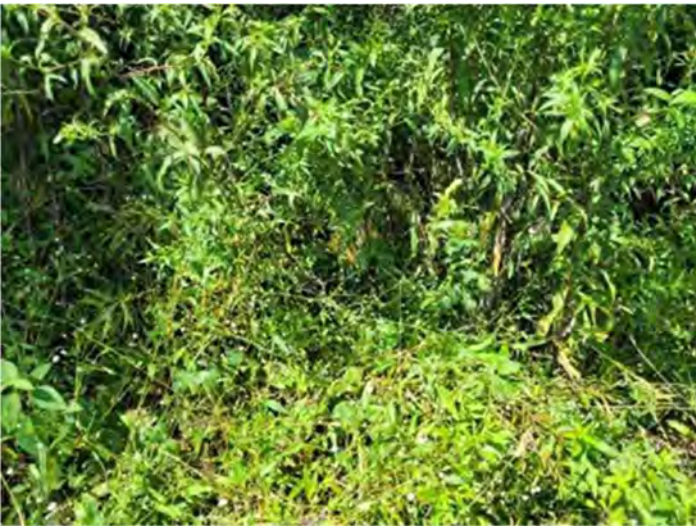
Easement AOC 9 – Vegetation covering sign (9/14/2022)
