## **MONITORING YEAR 3 ANNUAL REPORT**

### **OWL'S DEN MITIGATION SITE**

Lincoln County, NC  
DEQ Contract 005150  
DMS Project Number 95808

Data Collection Period: March - November 2018  
Submission Date: November 9, 2018

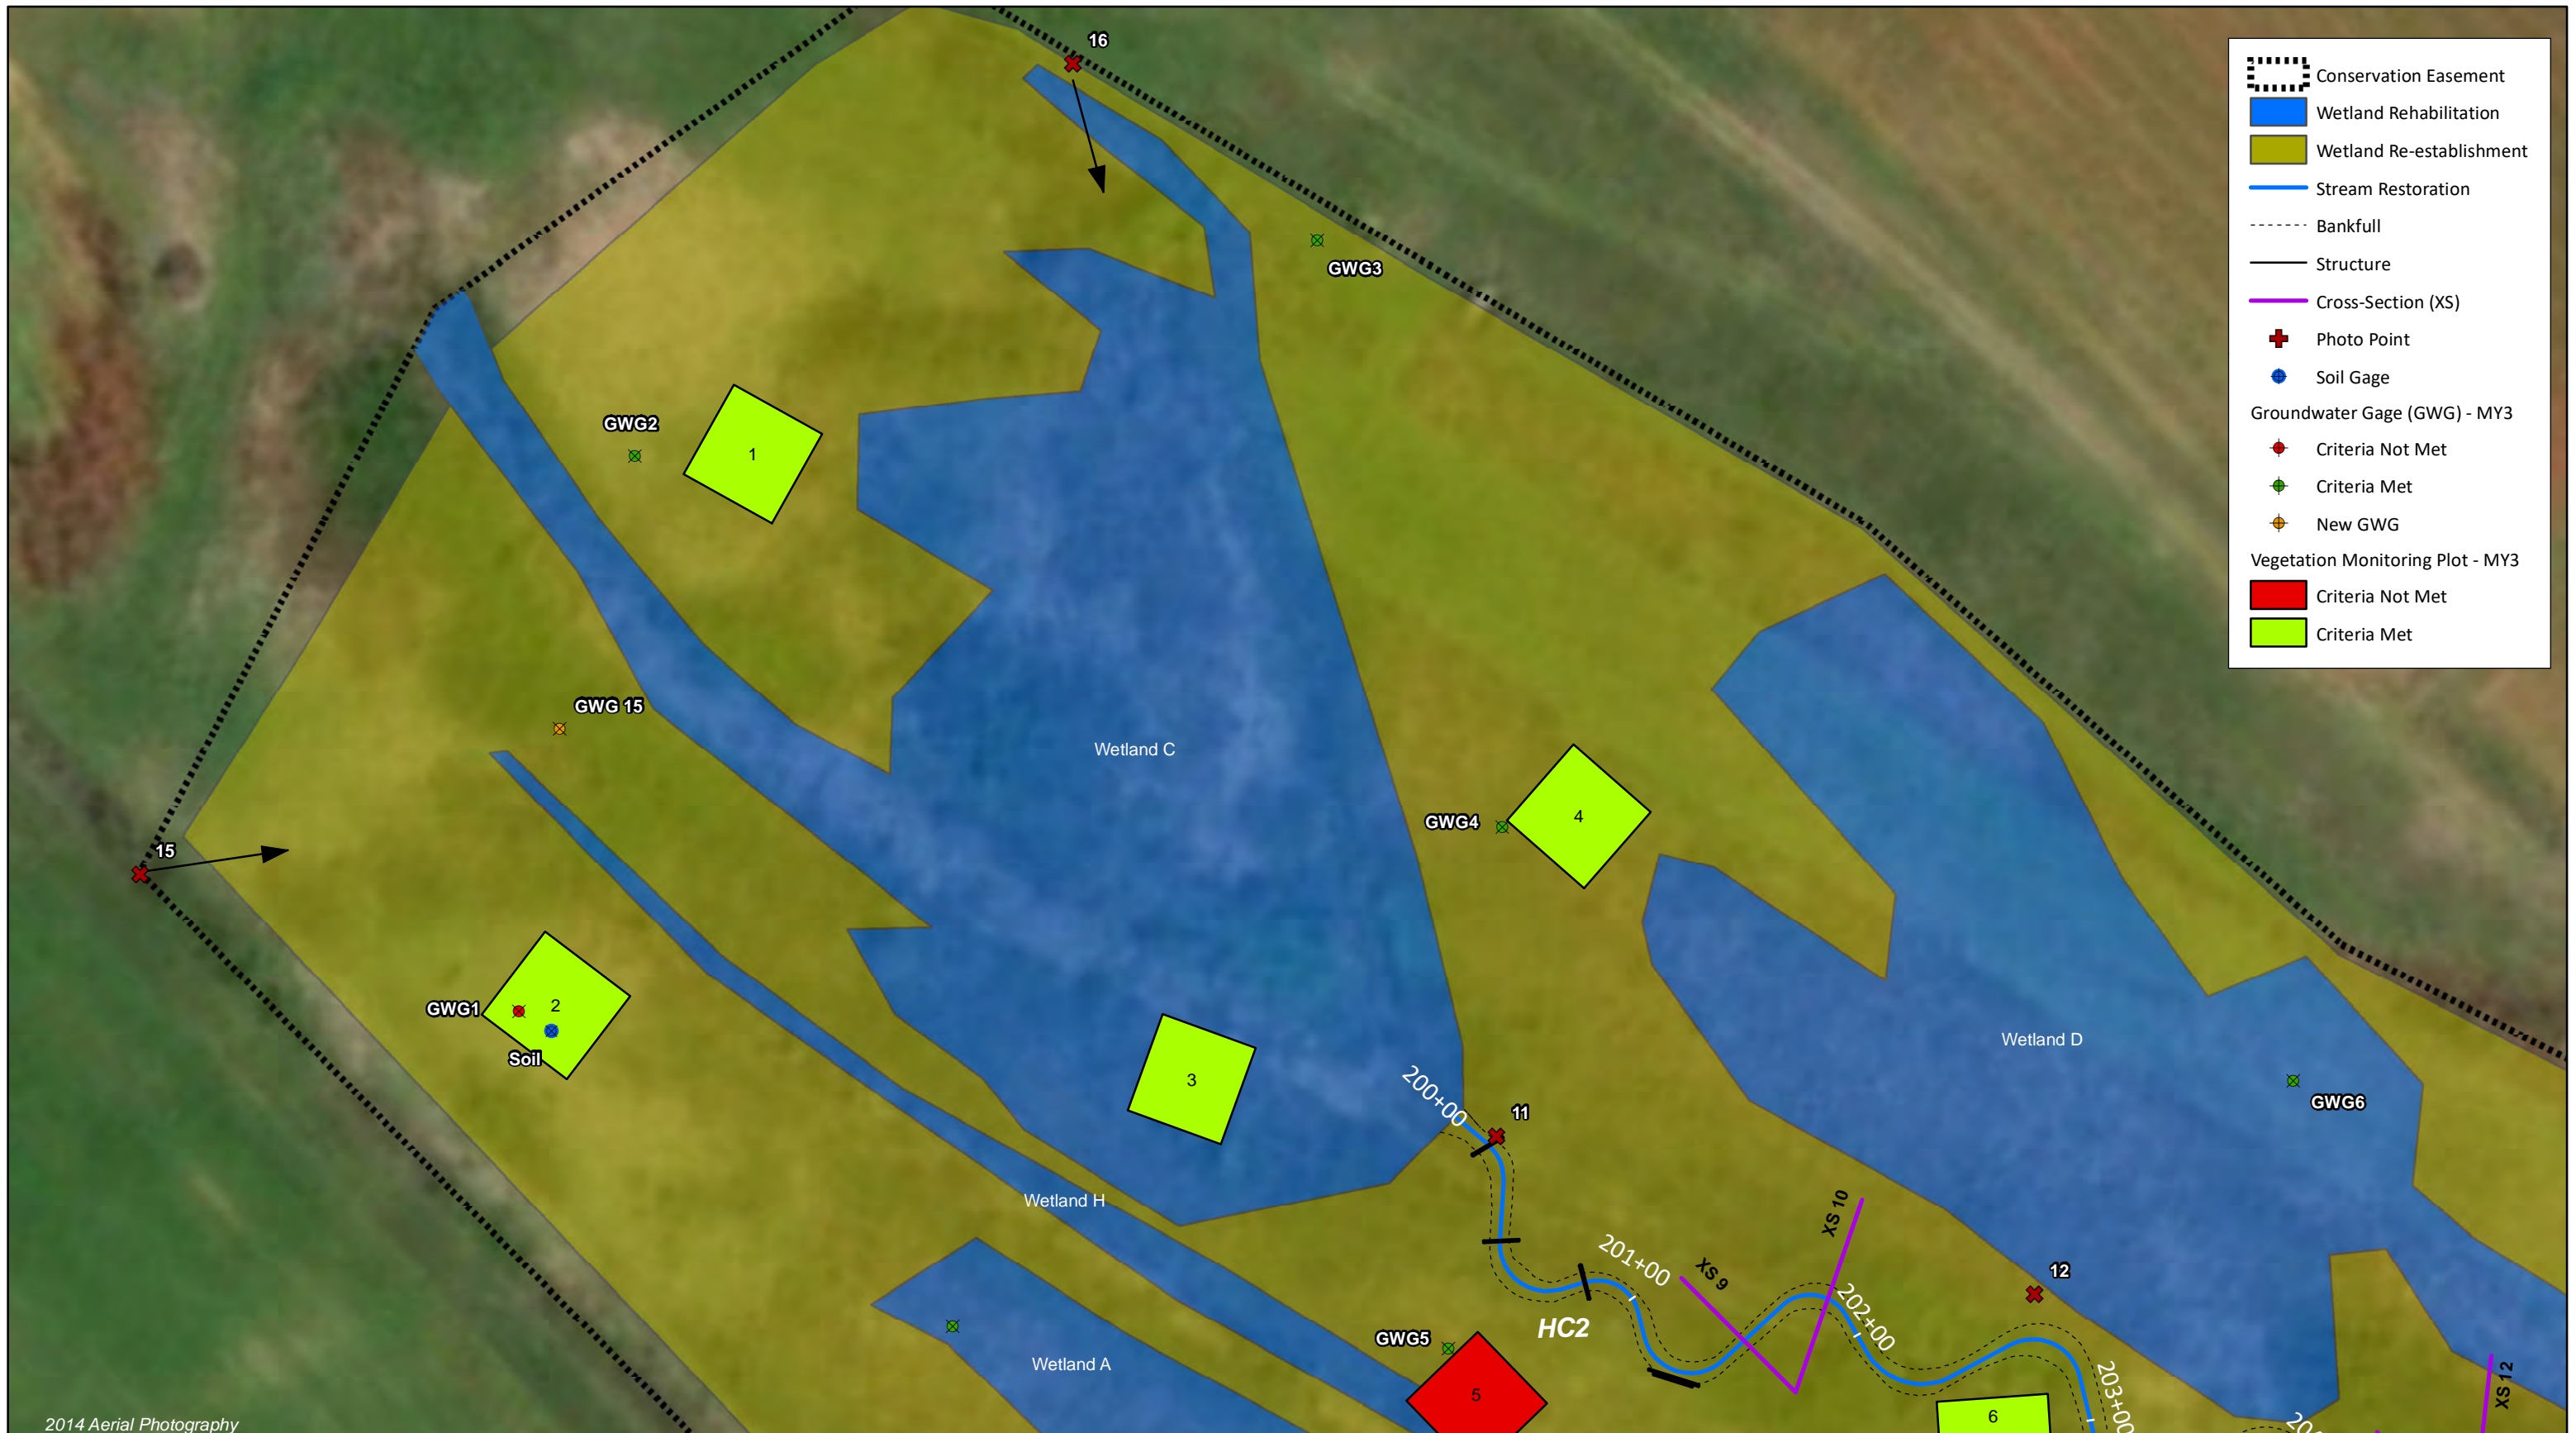
Figure 3.0 Integrated Current Condition Plan View (Key)  
 Owl's Den Mitigation Site  
 DMS Project No. 95808  
 Monitoring Year 3- 2018  
 Lincoln County, NC

Stream areas of concern are minimal. Floodplain deposition noted in MY1 at the downstream extent of HC1 Reach 2 will continue to be monitored for impacts to flood storage capacity and stream stability within the reach and an adaptive management plan will be established if deemed necessary. As of MY3, deposition has not adversely affected stream stability or conveyance in this reach. Nutrients from the deposition may be a contributing factor to the substantial vegetation growth that has occurred in this area of the Site.

In addition, there are a few, small areas in which the herbaceous layer has not fully established (<1% of the planted acreage). While these areas have improved with additional seeding and fertilization, these areas will require another application. In MY3, a small area (0.1 acres) in and around plot 11 was noted as having low planted woody stem densities. These areas are minimal in size and under the threshold for mapping but will continue to be closely monitored. Refer to Appendix 2 for the vegetation condition assessment table and Integrated Current Condition Plan View (CCPV).

Wildlands will continue to monitor the extent of invasive species and the small areas noted with poor herbaceous growth within the Site. As needed herbicide applications will be applied in accordance with state regulations to control these invasive species in future monitoring years. The isolated area in and around plot 11 with low planted stem densities will continue to be monitored for woody stem recruitment. A supplemental planting of 1-3 gallon stems will be warranted if woody vegetation recruitment does not become established within this area. These stems would be planted no later than the fall of 2019.
