# MONITORING YEAR 5 ANNUAL REPORT

## OWL'S DEN MITIGATION SITE

Lincoln County, NC  
DEQ Contract 005150  
DMS Project Number 95808  
DWR No. 14-0153  
USACE Action ID No. SAW-2010-00717  
Catawba River Basin  
HUC 03050102

Data Collection Period: March - November 2020  
Submission Date: December 21, 2020

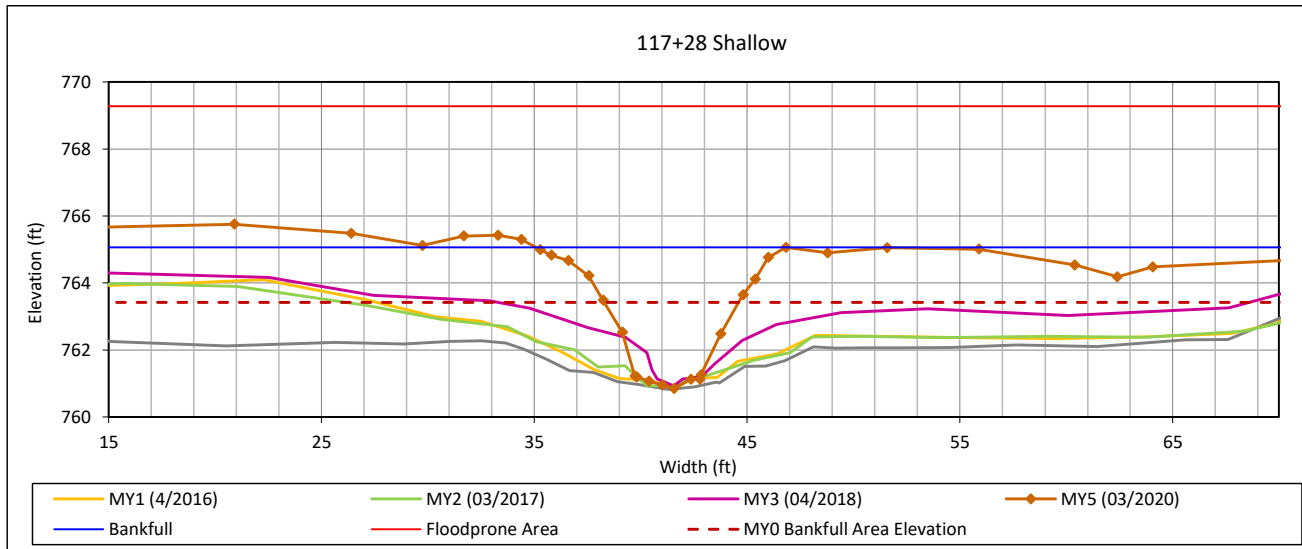
**Cross Section 8, HC1 Reach 2**

The downstream pools along tributary HC1 have aggraded and reduced cross-sectional area in MY5. XS5 had a 37% reduction in cross-sectional area from 24.9 ft<sup>2</sup> in MY0 to 15.5 ft<sup>2</sup> in MY5. XS7 had a 40% reduction in cross-sectional area from 13.9 ft<sup>2</sup> in MY0 to 8.1 ft<sup>2</sup> in MY5. The aggradation observed is probably due to aggradation from Howards Creek backwater at the downstream end of HC1. At the time of survey, these downstream pools most likely had not been flushed or scoured by a large rain event.

24.3	x-section area (ft.sq.)
11.7	width (ft)
2.1	mean depth (ft)
4.2	max depth (ft)
15.3	wetted parimeter (ft)
1.6	hyd radi (ft)
5.7	width-depth ratio
79.6	W flood prone area (ft)
6.8	entrenchment ratio
1.6	low bank height ratio
