# MONITORING YEAR 6 ANNUAL REPORT

## OWL'S DEN MITIGATION SITE

Lincoln County, NC  
DEQ Contract 005150  
DMS Project Number 95808  
DWR No. 14-0153  
USACE Action ID No. SAW-2010-00717  
Catawba River Basin  
HUC 03050102

Submission Date: January 3, 2022

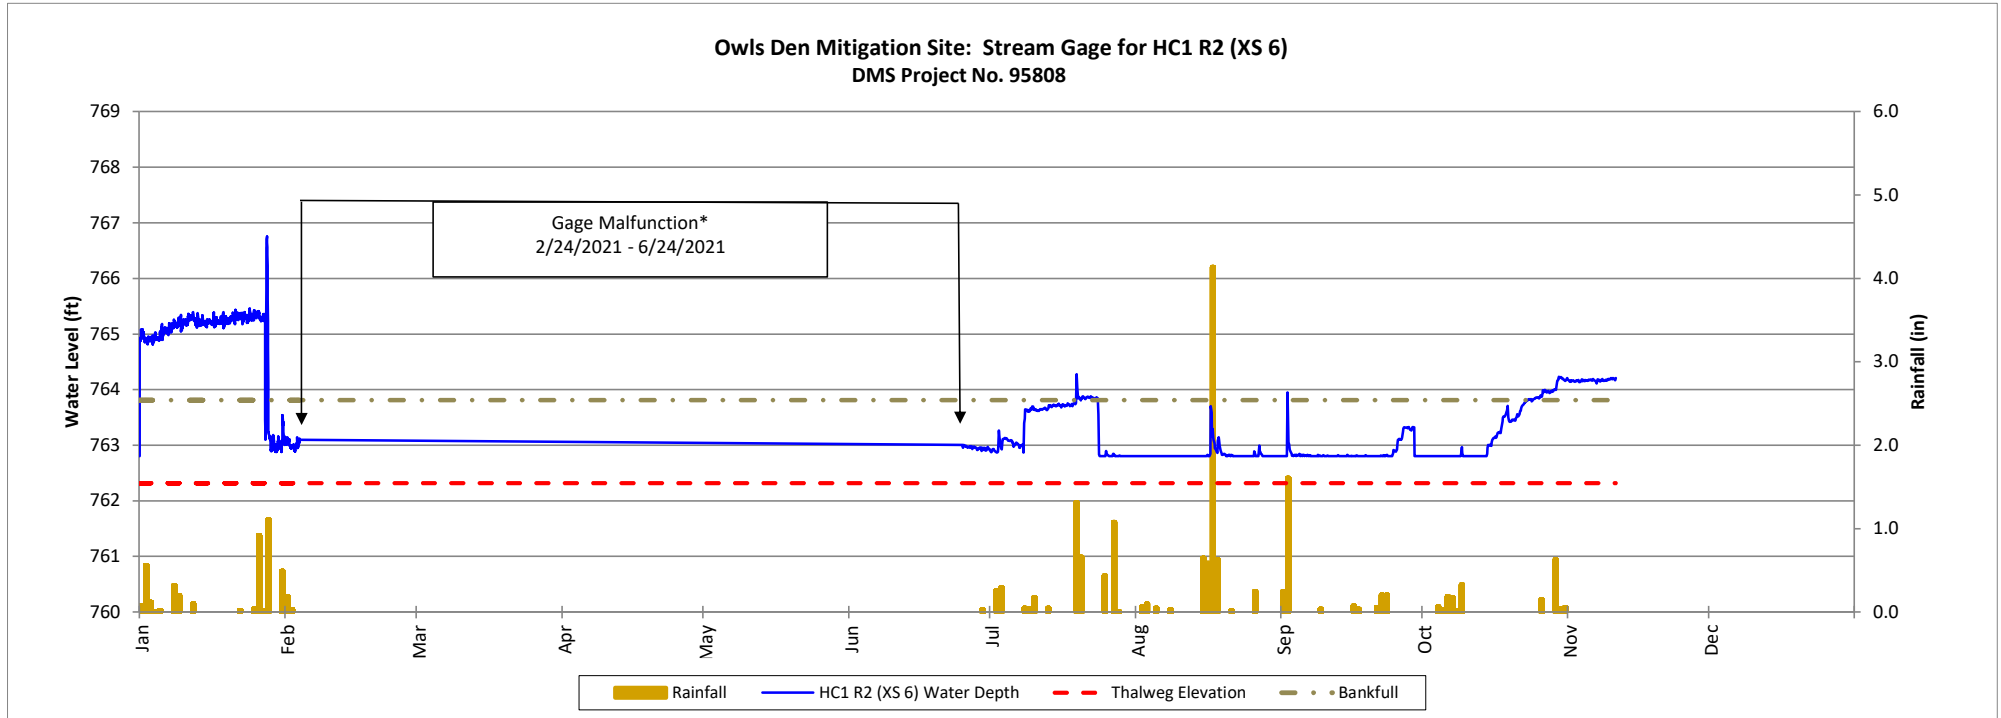
The Barotroll malfunctioned from 7/3/2021 to 7/17/2021 and 10/10/2021 to 11/10/2021; therefore, data for these ranges was calibrated from the Henry Fork Mitigation Site which is located in Lincoln County, approximately 15 miles from the Owl's Den Mitigation Site.

\* Gage replaced on 6/24/2021

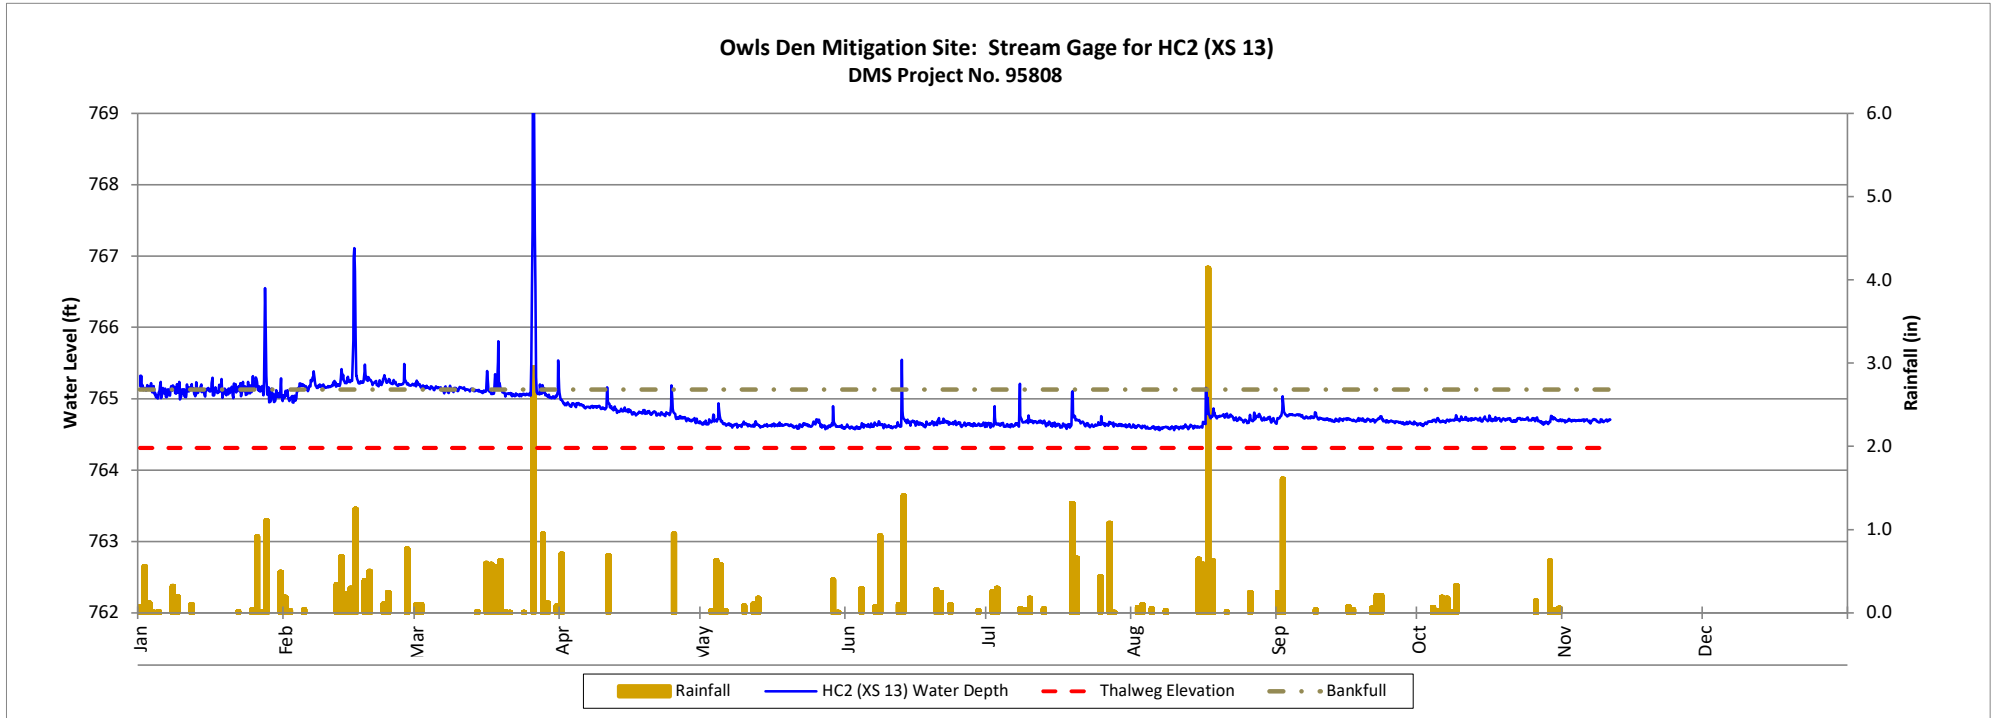
The Barotroll malfunctioned from 7/3/2021 to 7/17/2021 and 10/10/2021 to 11/10/2021; therefore, data for these ranges was calibrated from the Henry Fork Mitigation Site which is located in Catawba County, approximately 15 miles from the Owl's Den Mitigation Site.

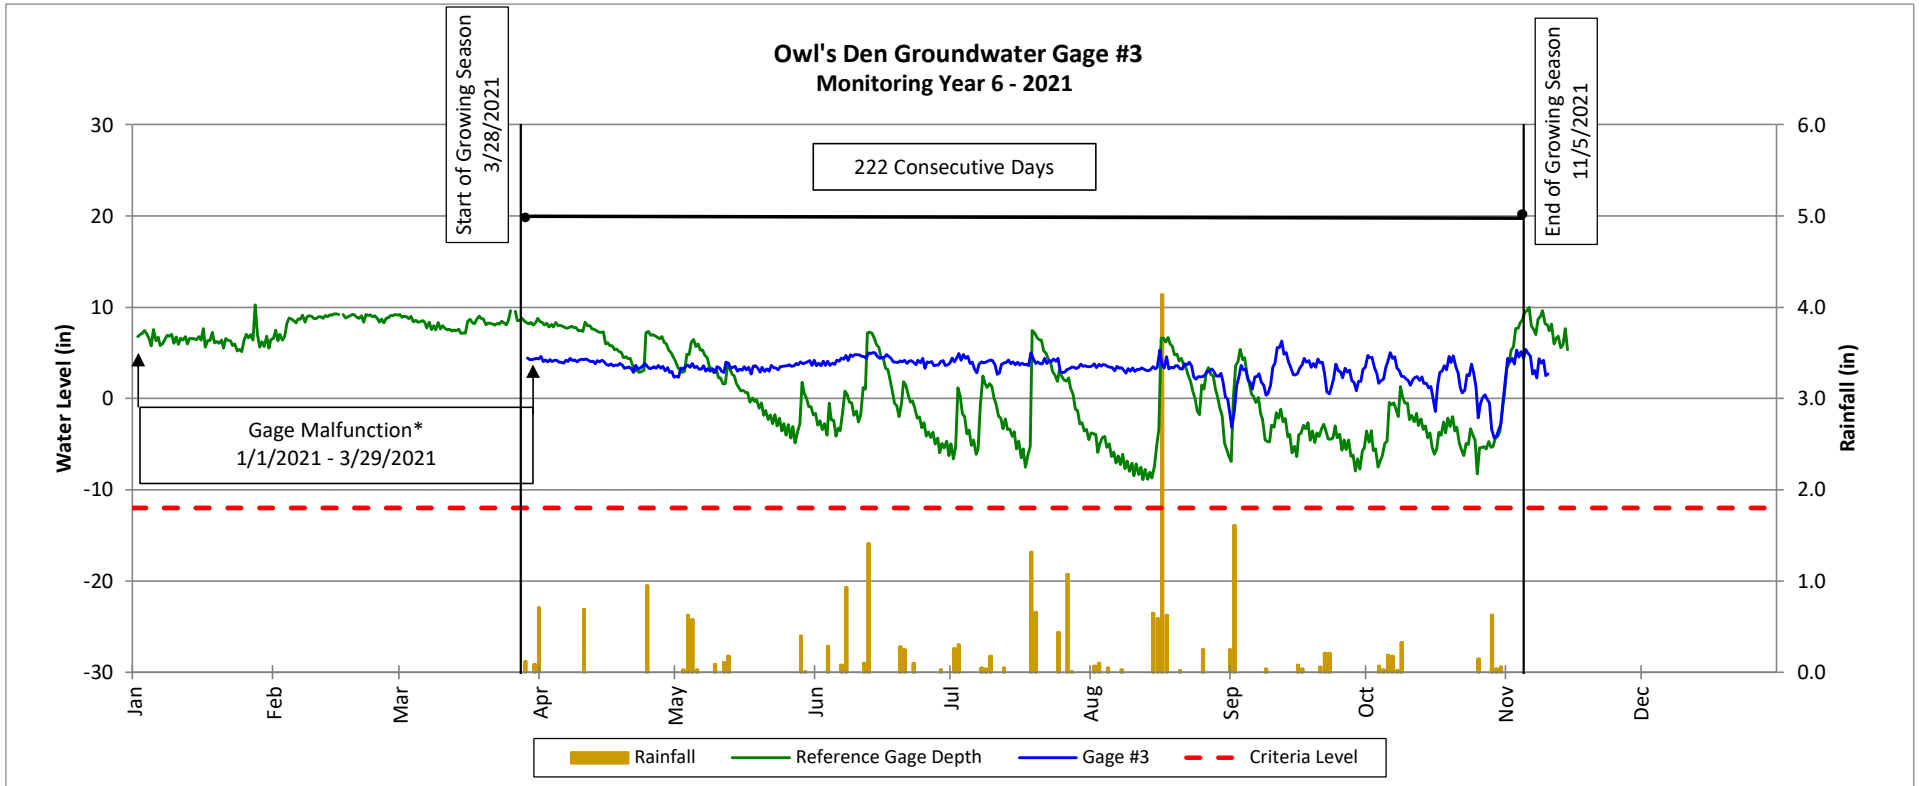
The Barotroll malfunctioned from 7/3/2021 to 7/17/2021 and 10/10/2021 to 11/10/2021; therefore, data for these ranges was calibrated from the Henry Fork Mitigation Site which is located in Catawba County, approximately 15 miles from the Owl's Den Mitigation Site.

\*Gage replaced on 3/29/2021

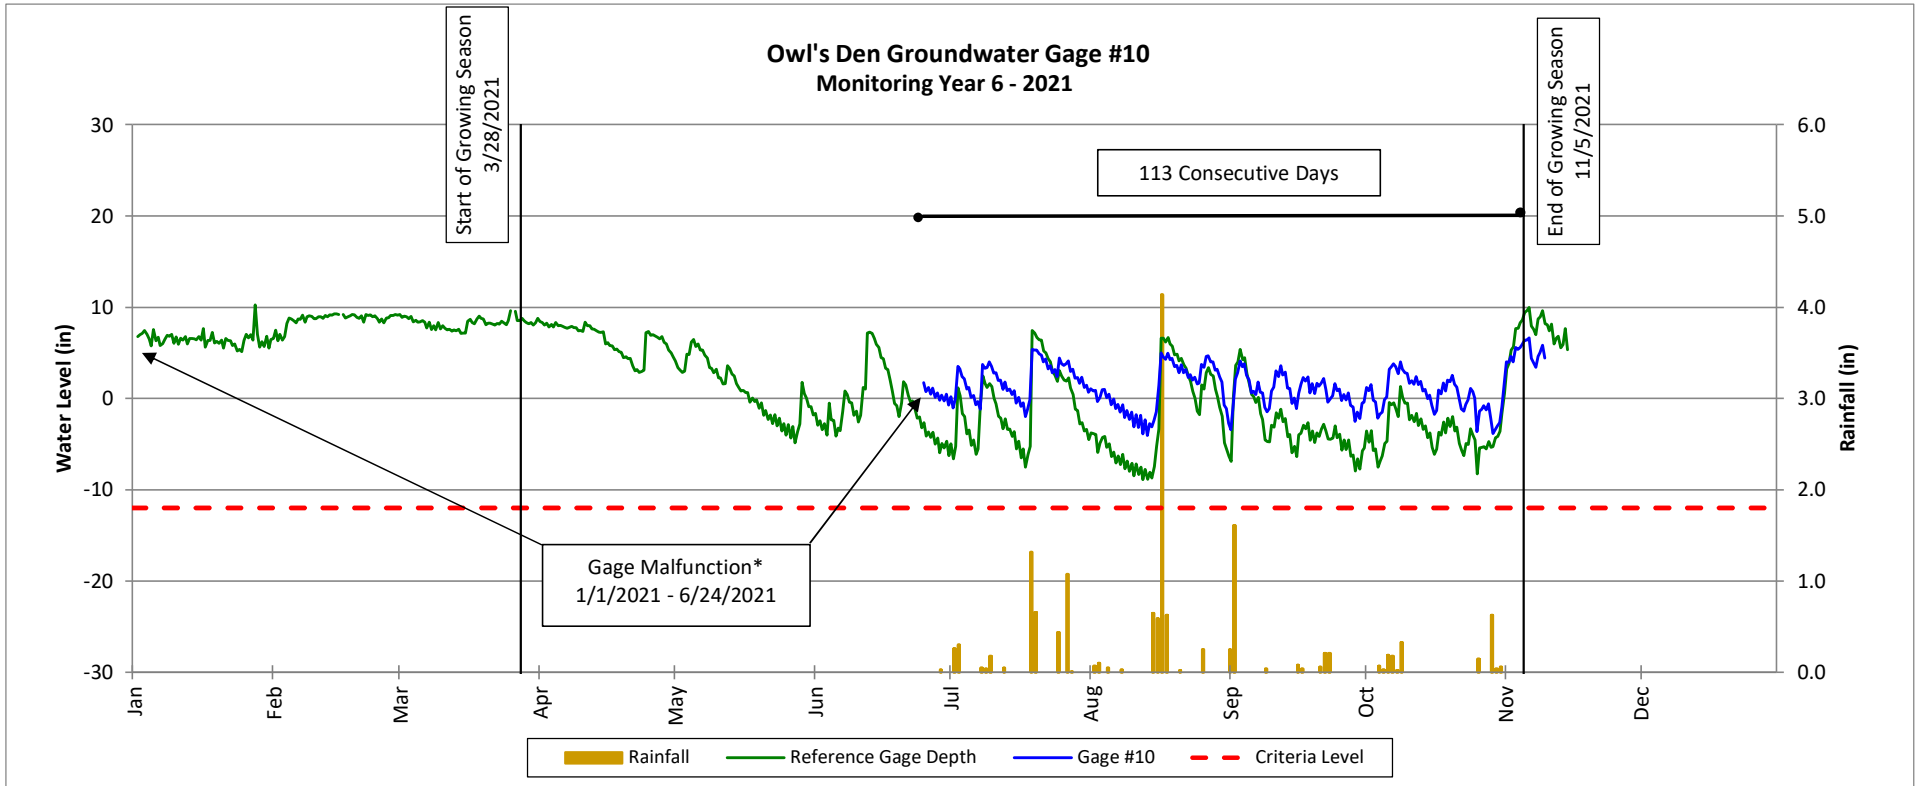
The Barotroll malfunctioned from 7/3/2021 to 7/17/2021 and 10/10/2021 to 11/10/2021; therefore, data for these ranges was calibrated from the Henry Fork Mitigation Site which is located in Catawba County, approximately 15 miles from the Owl's Den Mitigation Site.

\*Gage Malfunction. Gage replaced on 6/24/2021

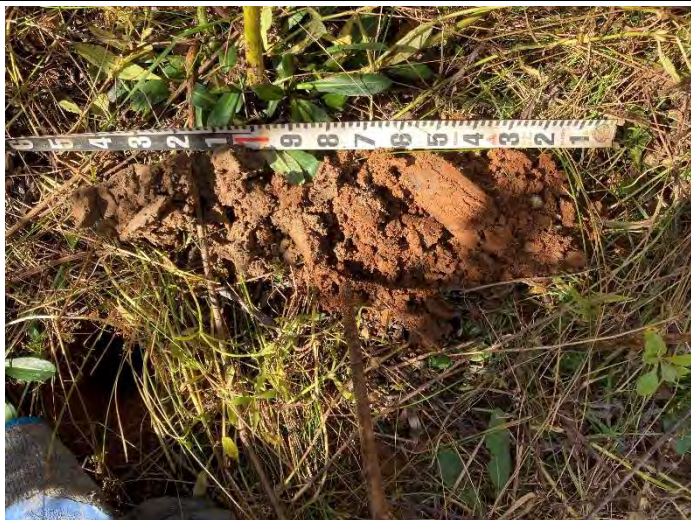
Core 1 - Hydric Soil Profile

0" - 9" - 5YR 4/6 (90%) 7.5YR 6/1 (10%)  
9" - 17" - 10YR 5/1 (80%) 7.5YR 5/6 (20%)

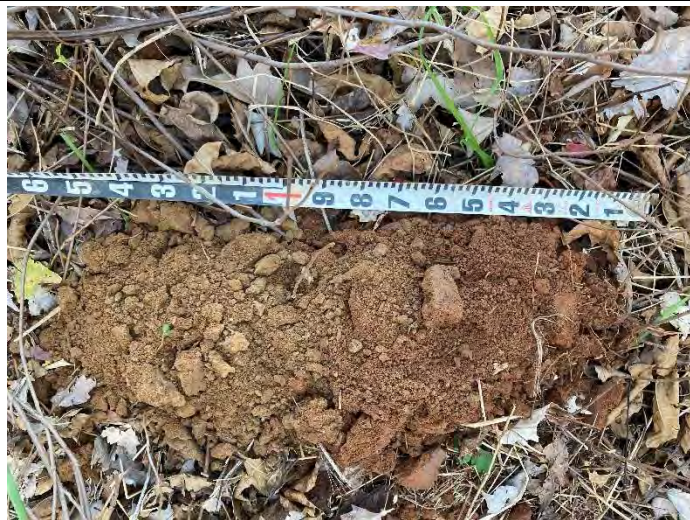
Core 2 - Non-hydric Soil Profile

0" - 11" - 5YR 4/6 (95%) 7.5YR 5/2 (5%)  
11" - 17" - 10YR 5/3 (95%) 7.5YR 4/6 (5%)
