**As-built report for the Brigmon
Mitigation Site, Paint Fork Creek,
Madison County**

North Carolina Wildlife Resources Commission

October 31, 2000

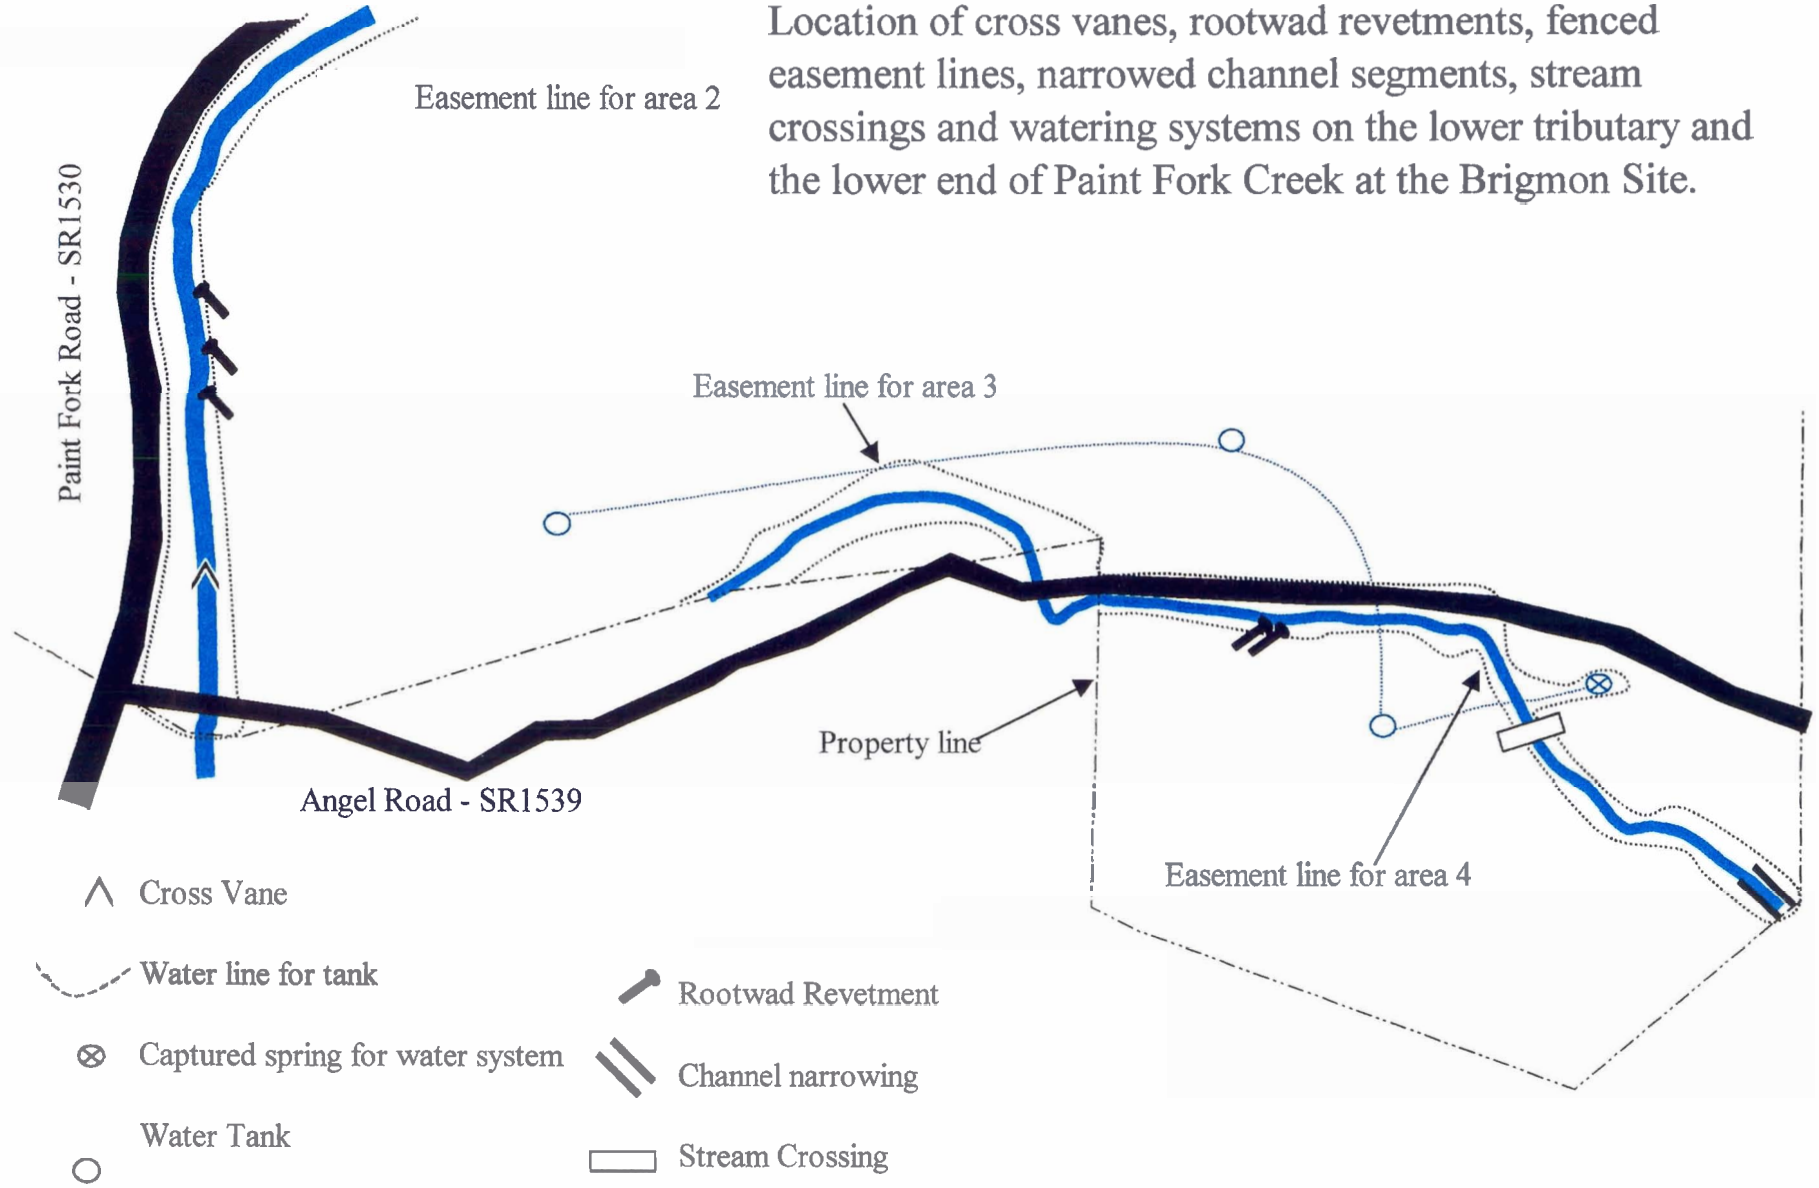
Location of cross vanes, rootwad revetments, fenced easement lines, narrowed channel segments, stream crossings and watering systems on the lower tributary and the lower end of Paint Fork Creek at the Brigmon Site.

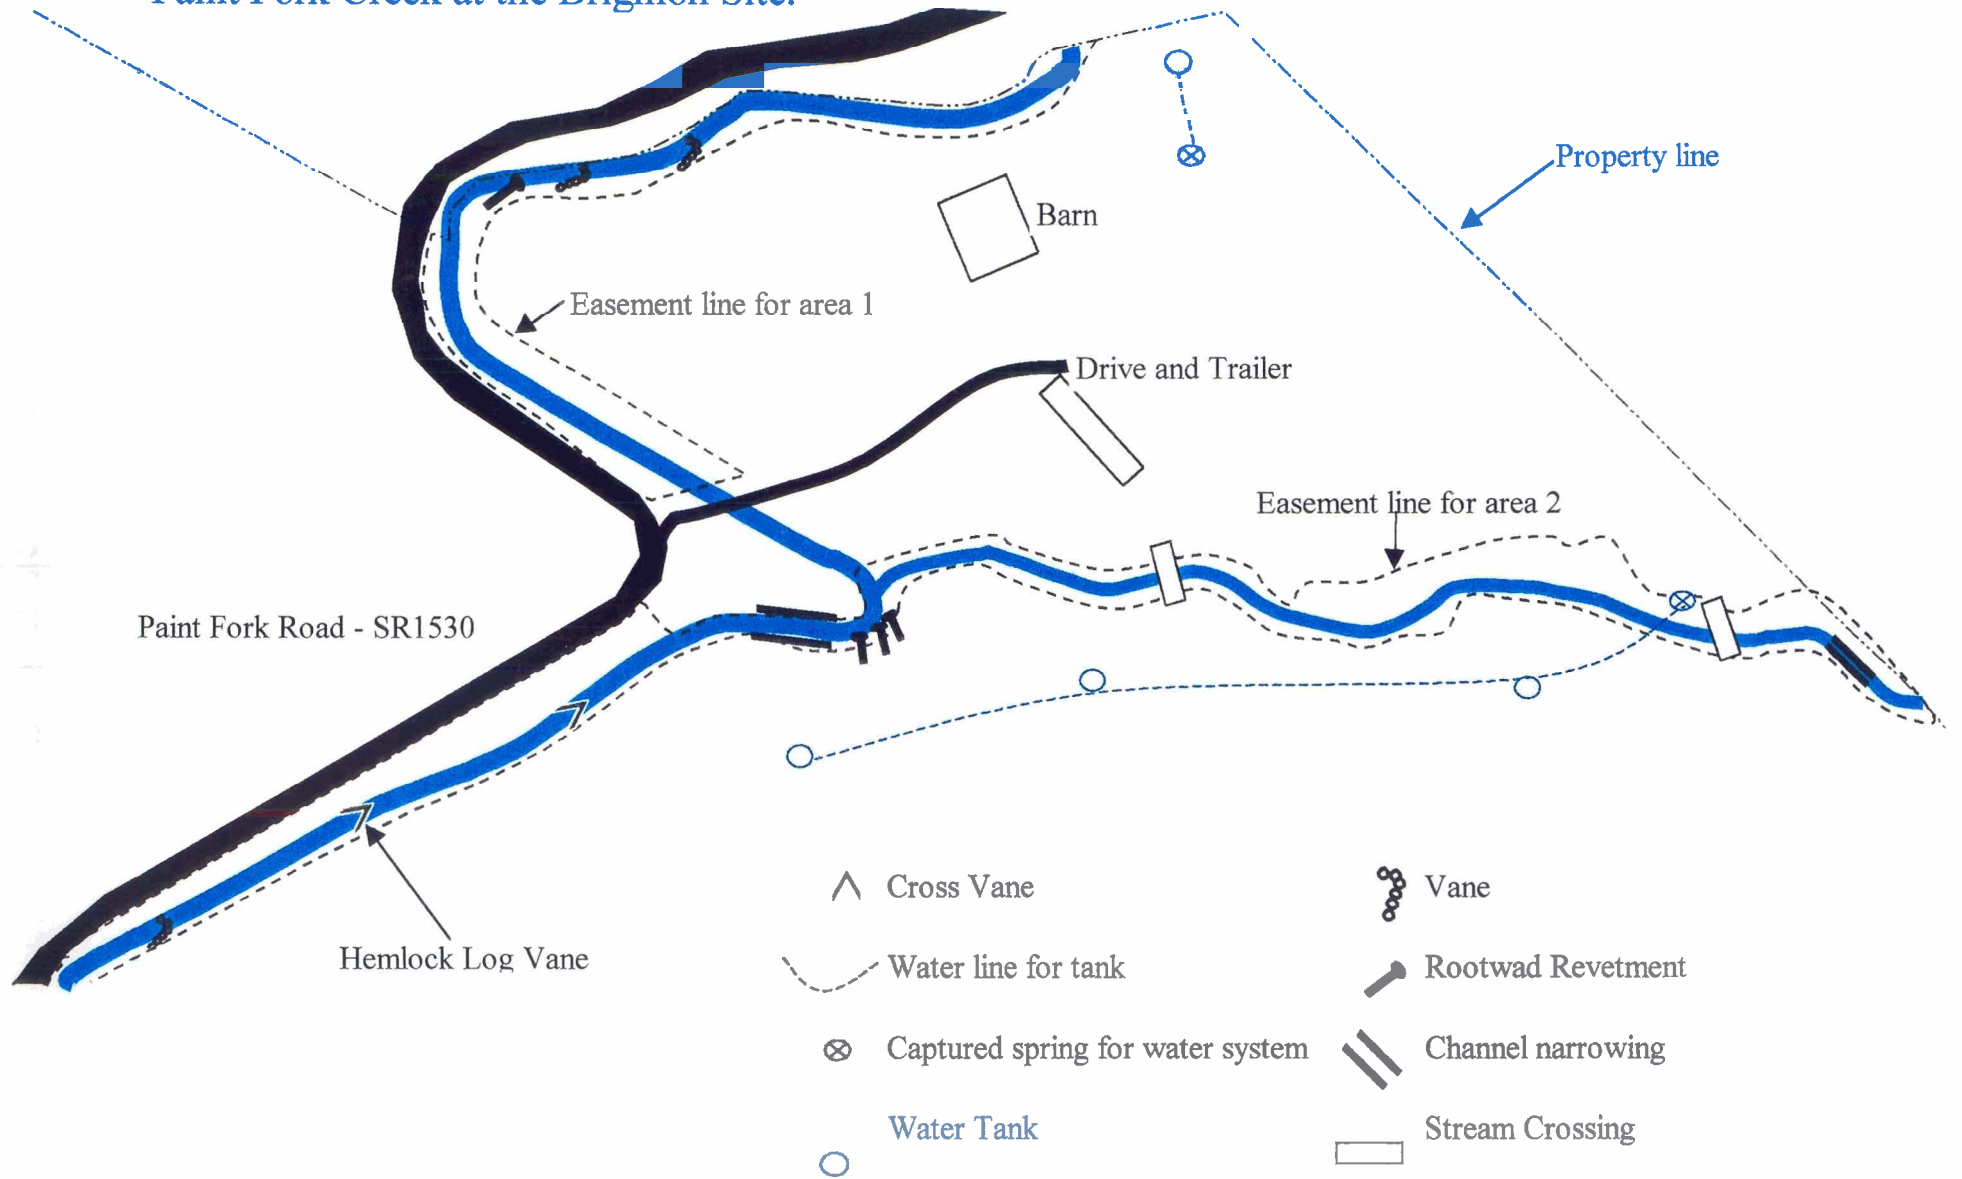
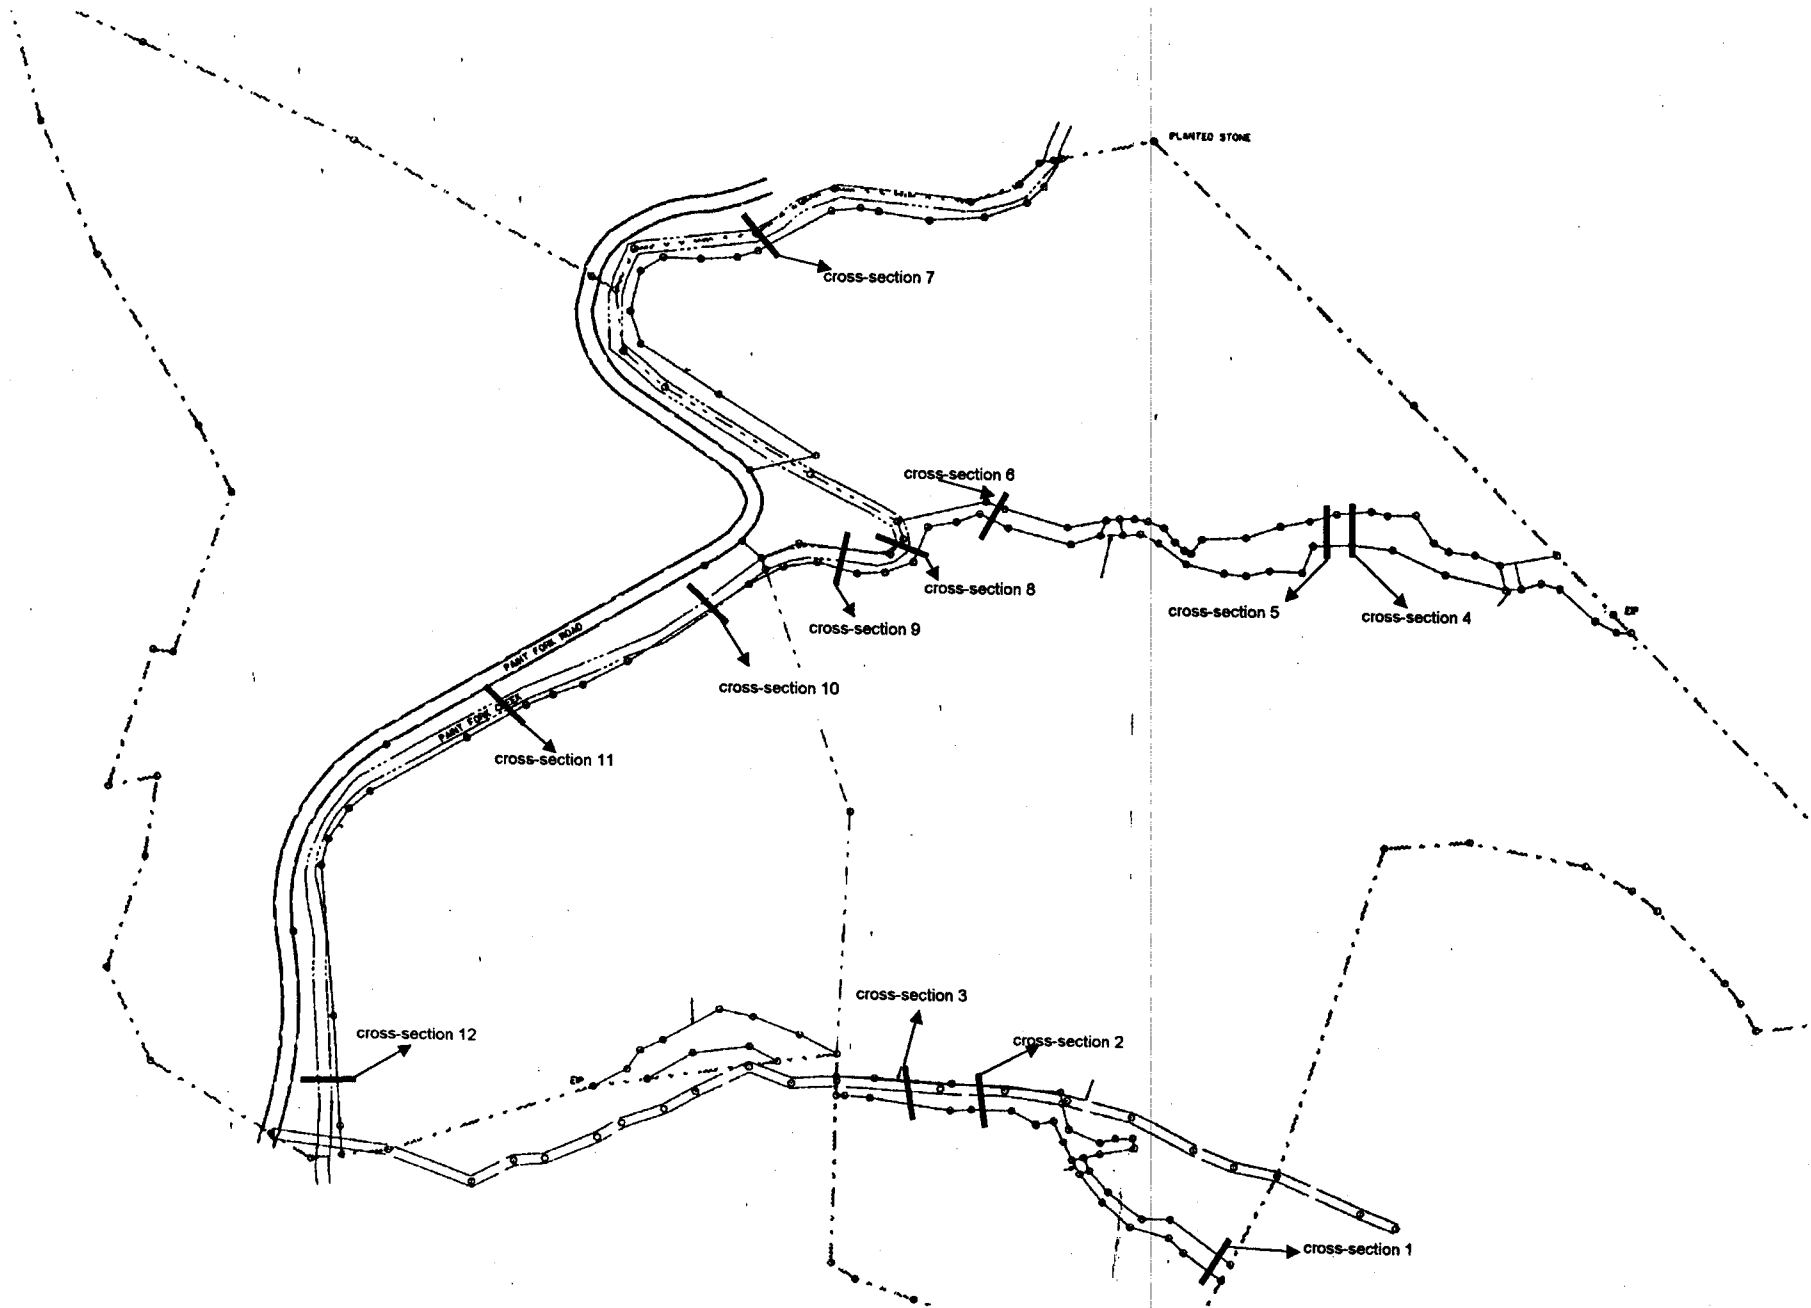
Location of cross vanes, rootwad revetments, fenced easement lines, narrowed channel segments, stream crossings and watering systems on the upper tributary and the upper end of Paint Fork Creek at the Brigmon Site.

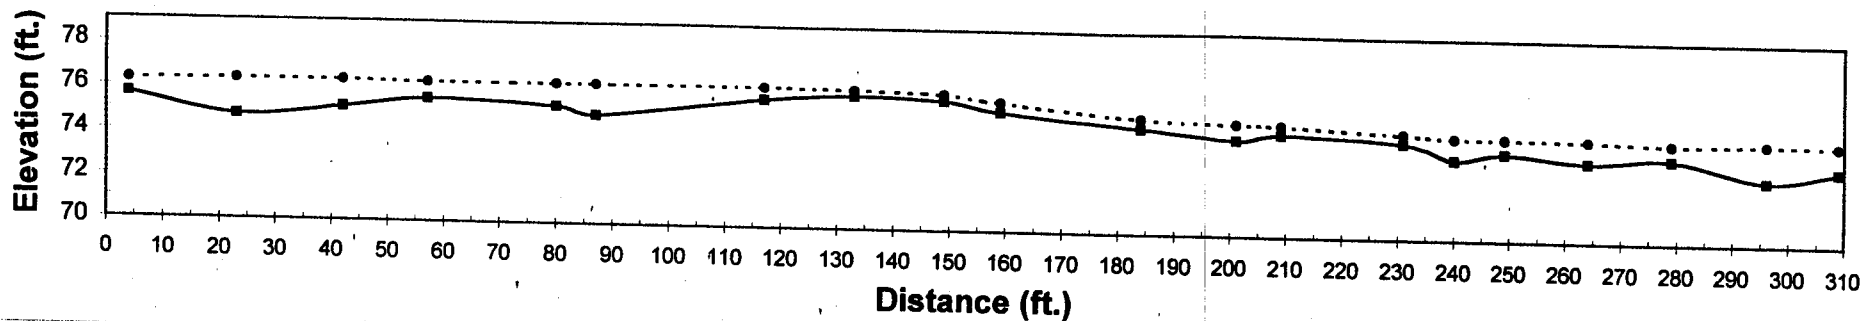
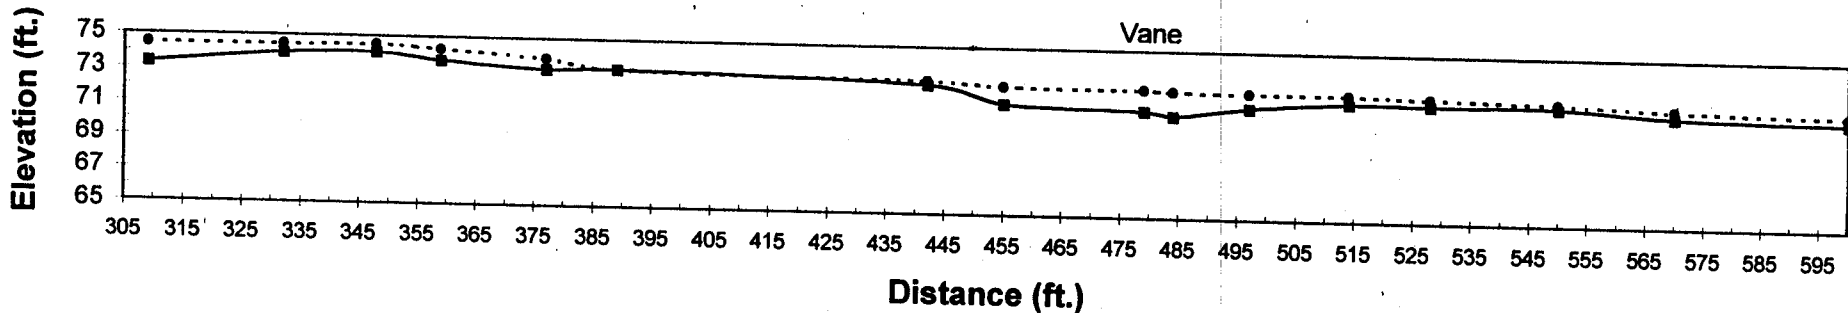
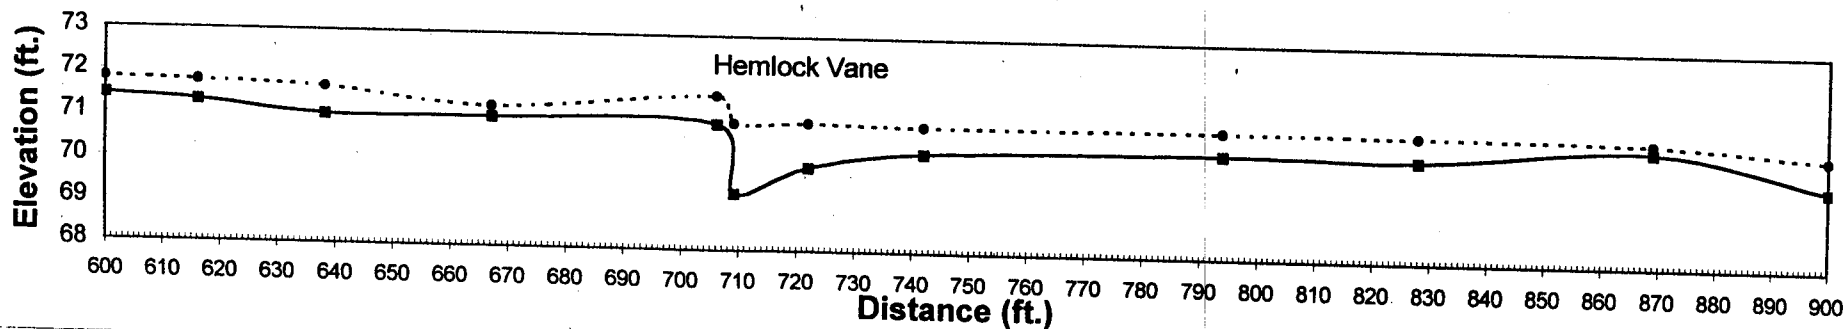
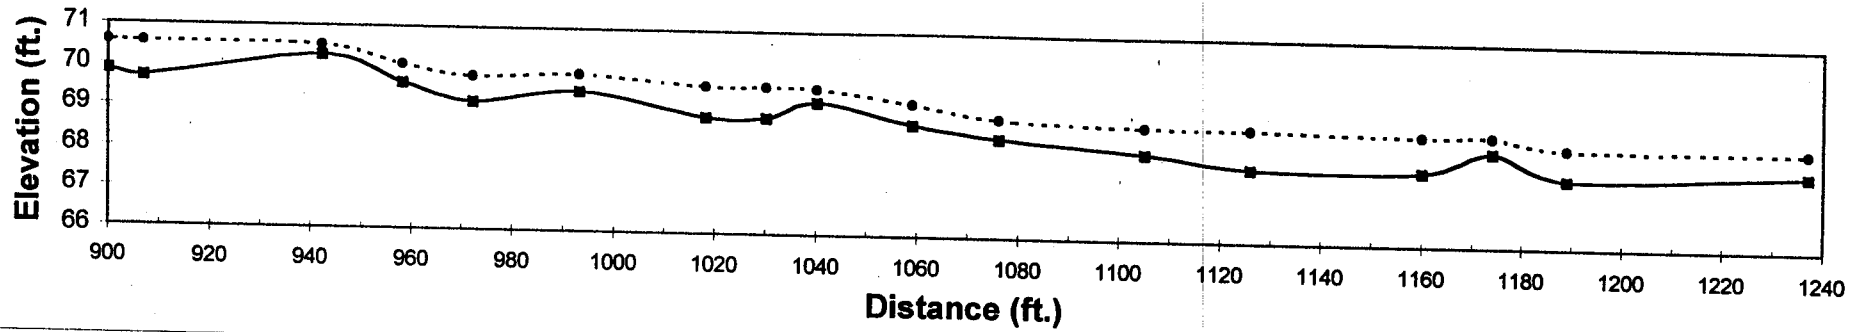
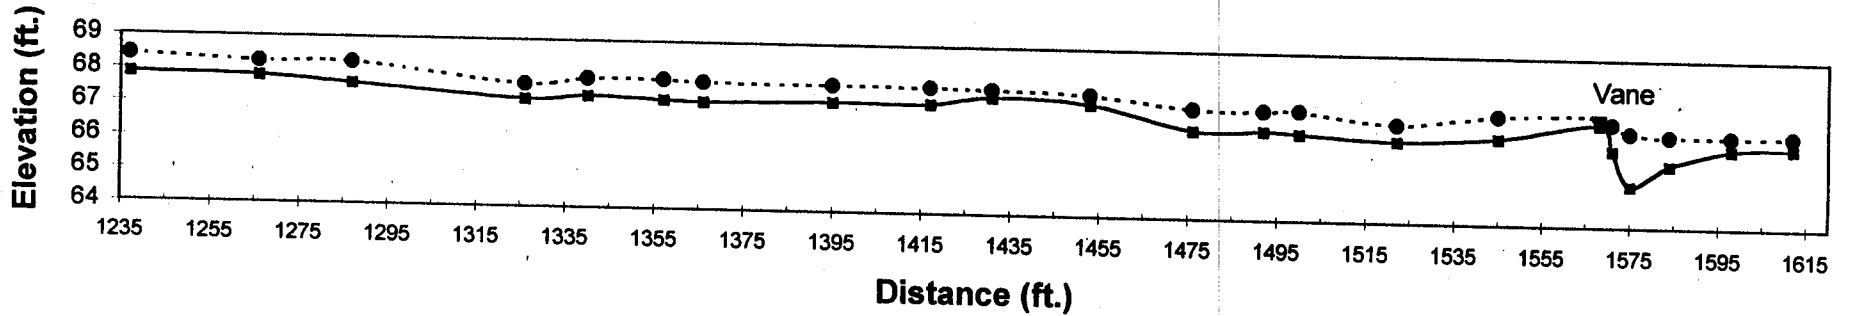
The attached longitudinal profile shows how vane construction has increased the deep-water habitat. The scour action of these vanes can be observed from this profile. The attached pebble count information, which was taken below the three cross-vanes, shows the decrease in fines below these vanes and the increase in smaller cobbles. To some extent this data reflects constructed conditions and not hydraulic influences; however, the site has had some high water over it since project completion, so direct alterations during construction do not account for all observed improved conditions. The vanes are creating the desired deep-water habitat and sorting bed material in a way that will provide needed spawning gravel. Dry conditions have been experienced most of this summer and fall so the functioning of these structures over a long period of high water has not yet been evaluated. No further erosion has been observed at this site. The attached cross-sections show post-construction conditions (with some also showing pre-conditions) and will be used to monitor channel stability. Additional cross-sections may be
