**ANNUAL REPORT FOR 2003**

**Paint Fork Creek Stream Mitigation Site (Brigmon Site)  
Madison County  
WBS Element 32573.4.1  
TIP No. A-10WM**

Prepared By:  
Office of Natural Environment & Roadside Environmental Unit  
North Carolina Department of Transportation  
December 2003

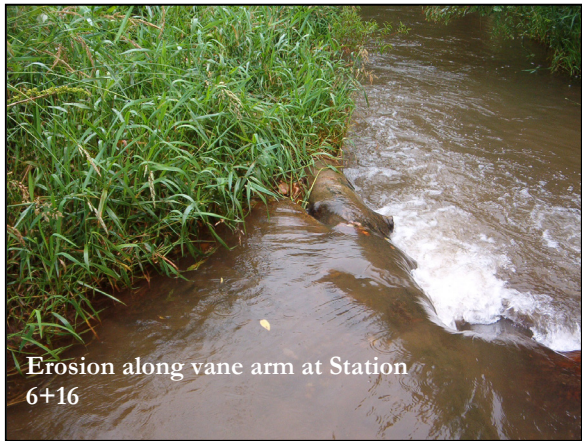
Erosion along vane arm at Station 6+16
