ANNUAL REPORT FOR 2004

Paint Fork Creek Stream Mitigation Site (Brigmon Site)
Madison County
WBS Element 32573.4.1
TIP No. A-10WM

Prepared By:
Office of Natural Environment & Roadside Environmental Unit
North Carolina Department of Transportation
March 2005

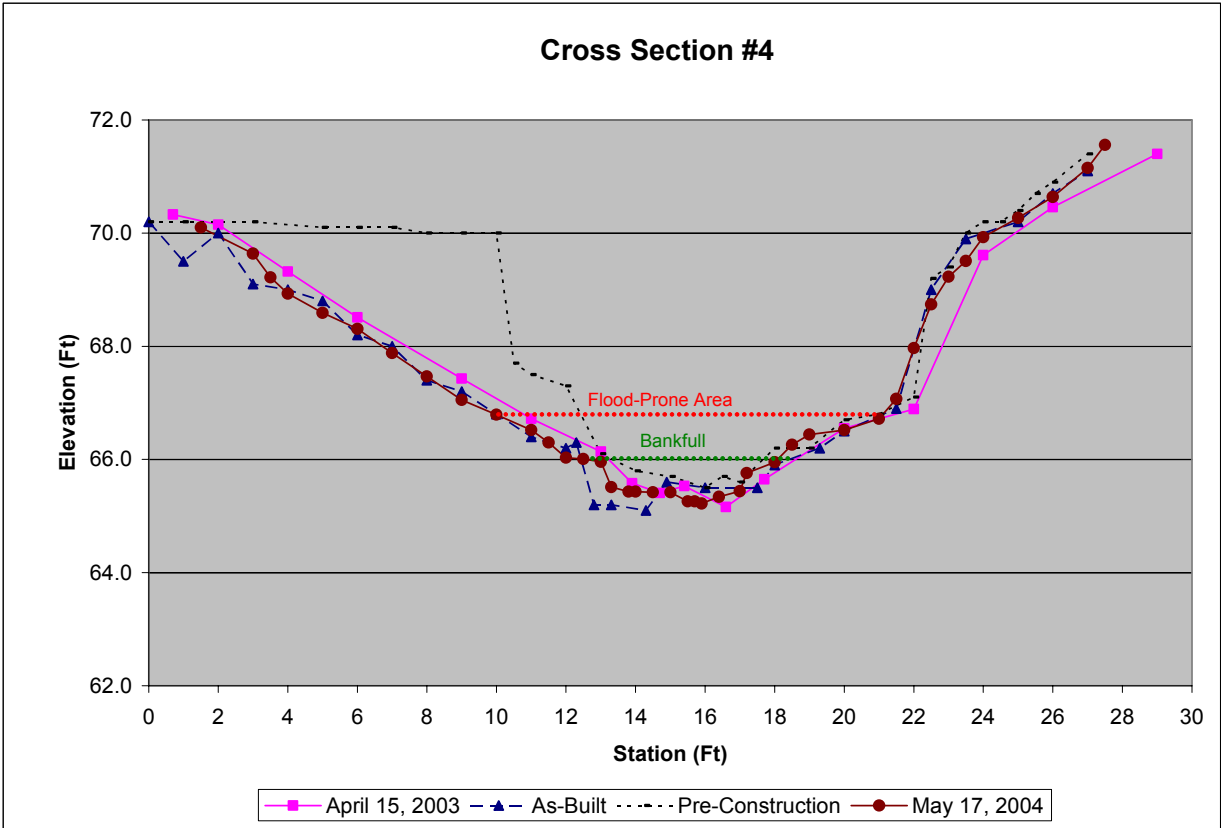
Cross-Section #4 Abbreviated Morphological Summary		
	2003	2004
Bankfull Cross Sectional Area (ft ²)	6.3	2.8
Maximum Bankfull Depth (ft)	1.4	0.8
Bankfull Mean Depth (ft)	0.7	0.5
Width/Depth Ratio	11.3	13.6
Entrenchment Ratio	2	2.1
Bankfull Width (ft)	8.4	6.1

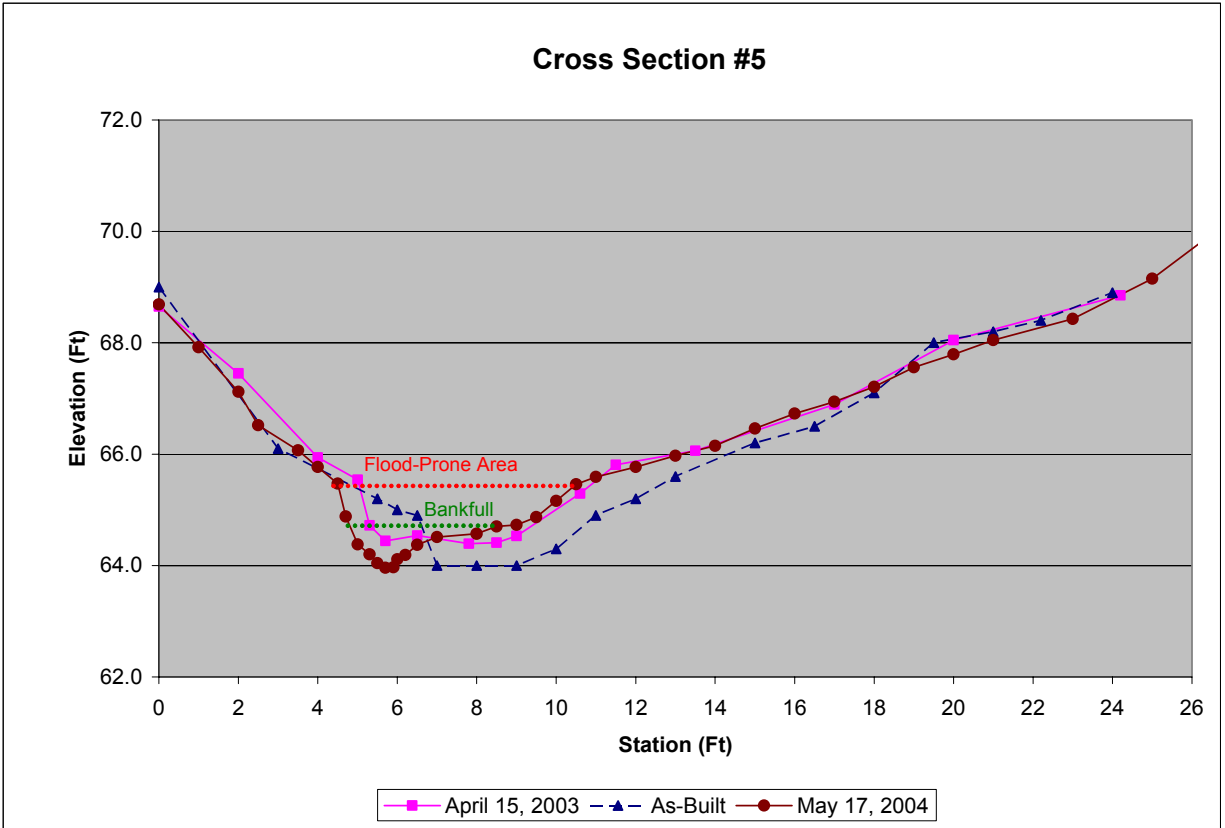
Cross-Section #5 Abbreviated Morphological Summary		
	2003	2004
Bankfull Cross Sectional Area (ft ²)	6.9	1.3
Maximum Bankfull Depth (ft)	1.4	0.8
Bankfull Mean Depth (ft)	1	0.3
Width/Depth Ratio	7.4	13.6
Entrenchment Ratio	2.1	1.7
Bankfull Width (ft)	7.2	4.2

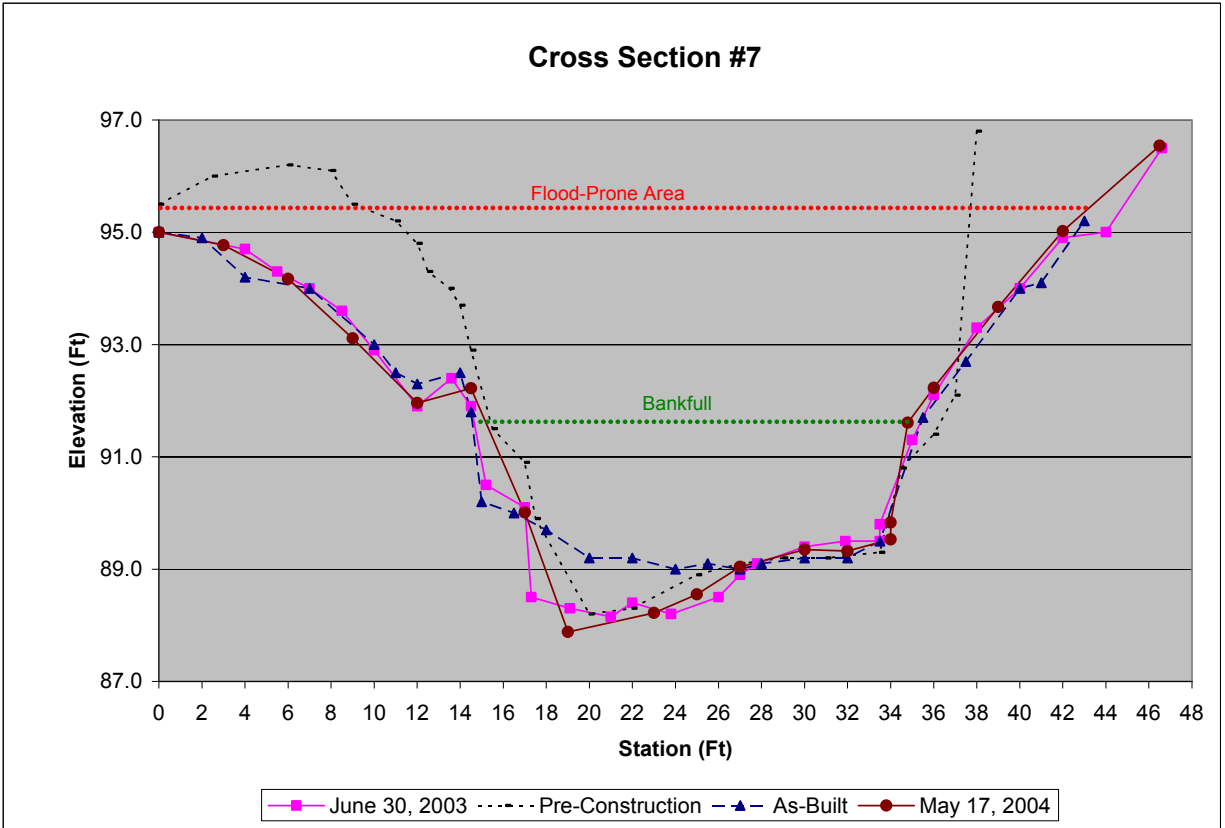
Cross-Section #7 Abbreviated Morphological Summary		
	2003	2004
Bankfull Cross Sectional Area (ft ²)	22.2	50
Maximum Bankfull Depth (ft)	2	3.7
Bankfull Mean Depth (ft)	1.3	2.5
Width/Depth Ratio	12.7	7.7
Entrenchment Ratio	1.4	2.2
Bankfull Width (ft)	16.8	19.6

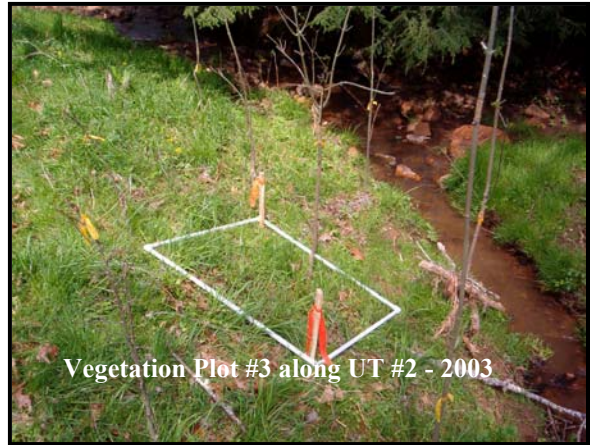
Vegetation Plot #3 along UT #2 - 2004

Plot 3. Fescue and jewelweed were observed in and immediately adjacent to the vegetation plot. In addition, four green ash and three hackberry (*Celtis laevigata*) were noted within five feet of the vegetation plot.

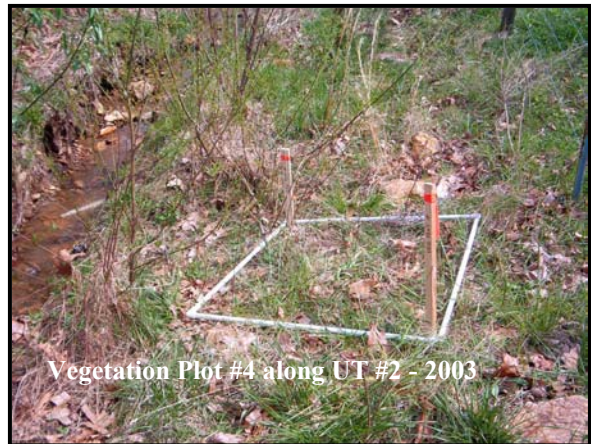
Vegetation Plot #4 along UT #2 - 2004

Plot 4. Fescue, goldenrod, jewelweed, plantain (*Plantago* sp.), and Japanese honeysuckle (*Lonicera japonica*) were observed in and immediately adjacent to the plot. Three black willow, two river birch, one silky dogwood, and one tulip poplar (*Liriodendron tulipifera*) stems were noted within five feet of the vegetation plot.
