**YEAR 3 MONITORING and CLOSEOUT REPORT**  
**for the**  
**BRIGMON MITIGATION SITE**  
**PAINFORK CREEK,**  
**MADISON COUNTY, NORTH CAROLINA**  
**EEP PROJECT NUMBER 92700**

Prepared in Partnership with the  
North Carolina Ecosystem Enhancement Program  
1652 Mail Service Center  
Raleigh, N.C. 27699-1652

North Carolina Wildlife Resources Commission  
Watershed Enhancement Group  
December 2008

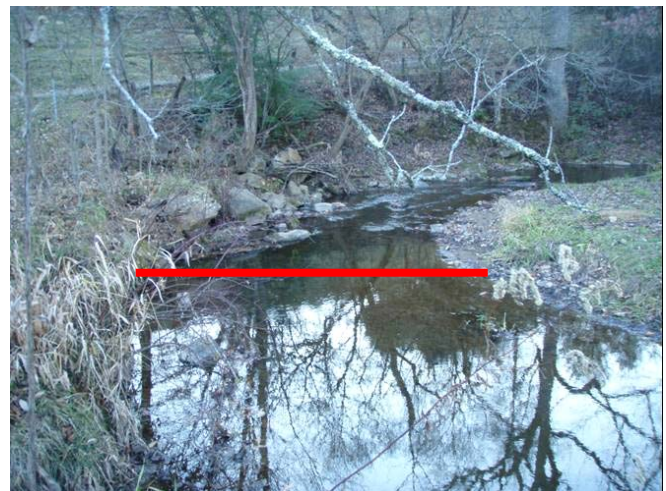
*Cross-section 8 (Pool; Appendix Table A.2.).*—Following the removal of automobile bodies and construction of a bench on the left bank at this location, cross-section 8 has remained stable with little observed change in the left bank location or thalweg elevation. Aggradation has occurred on the point bar side of this large meander bend since construction. Installed vegetation, along with boulder and root wad protection, on the outside of the meander bend have aided in the long-term stability of this cross-section. Bankfull mean depth values recorded during the MY1 and MY2 surveys combined with bankfull widths resulted in width/depth ratios exceeding 12.0, therefore outside the E stream type classification. However, the MY3 width/depth ratio was 11.4 suggesting an E stream type classification.

Cross-section 8, right to left bank, June 2000.

Cross-section 8, right to left bank, March 2003.

Cross-section 8, right to left bank, May 2004.

Cross-section 8, left to right bank, December 2007.

Cross-section 8, facing downstream, December 2007.

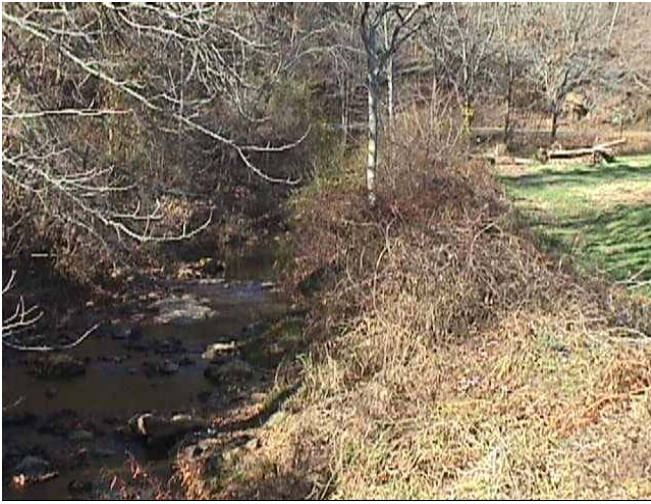
Photo sta. 1, pre-construction upstream of bridge, November 1999.

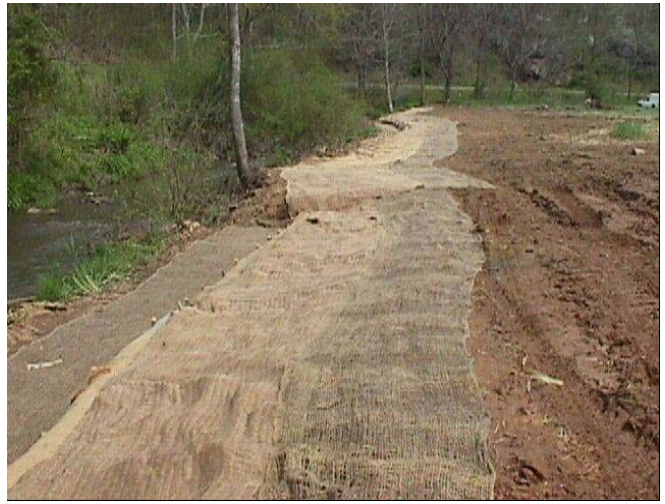
Photo sta. 1, facing upstream from bridge, May 2000.

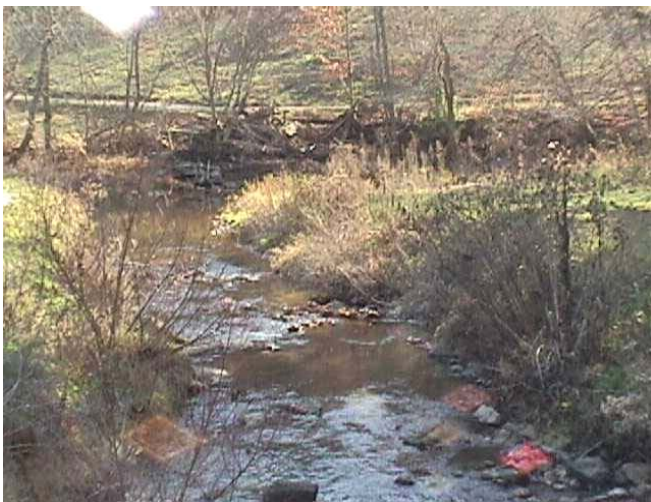
Photo sta. 2, facing downstream from bridge, November 1999.

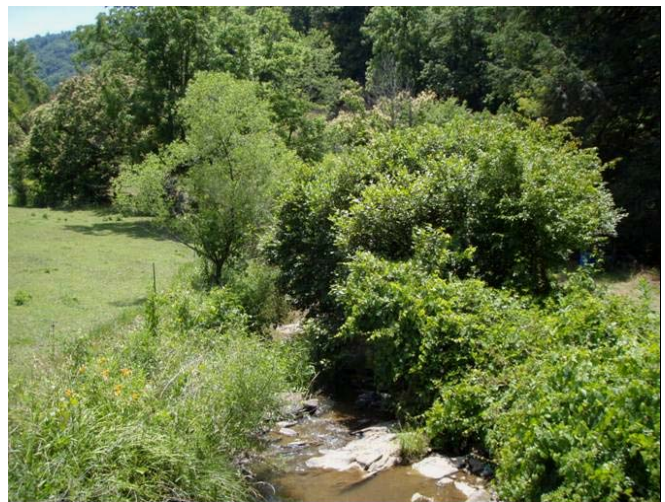
Photo sta. 2, facing downstream from bridge, June 2008.

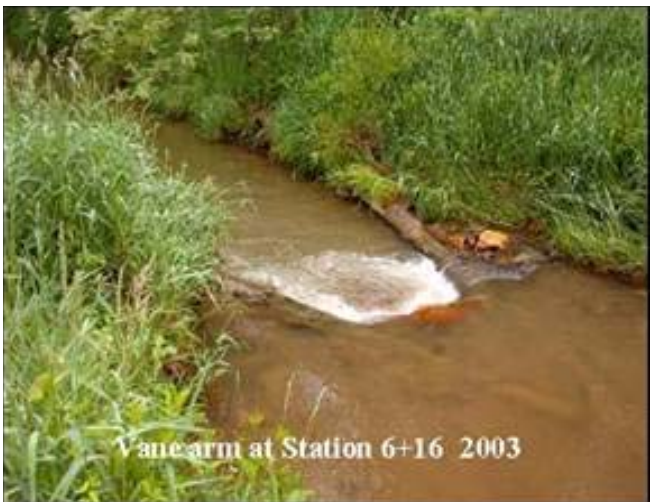
Photo sta. 4, hemlock vane facing downstream, March 2003.

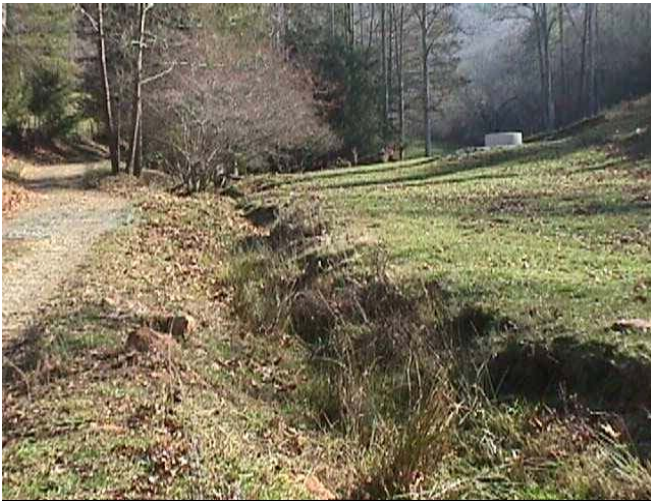
Photo sta. 6, lower tributary facing upstream, November 1999.

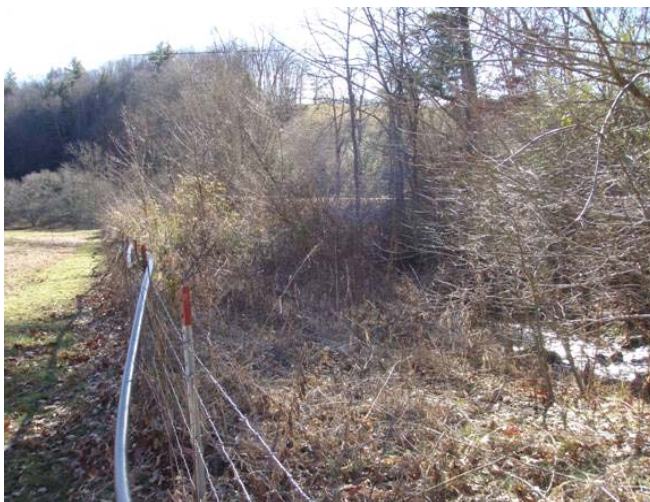
Tree plot A, left bank, facing downstream, January 2007.
